The 1.5 & 1.4 Ultimate Factors of Safety for Aircraft & Spacecraft – History, Definition and Applications

C. T. Modlin
J. J. Zipay
February, 2014

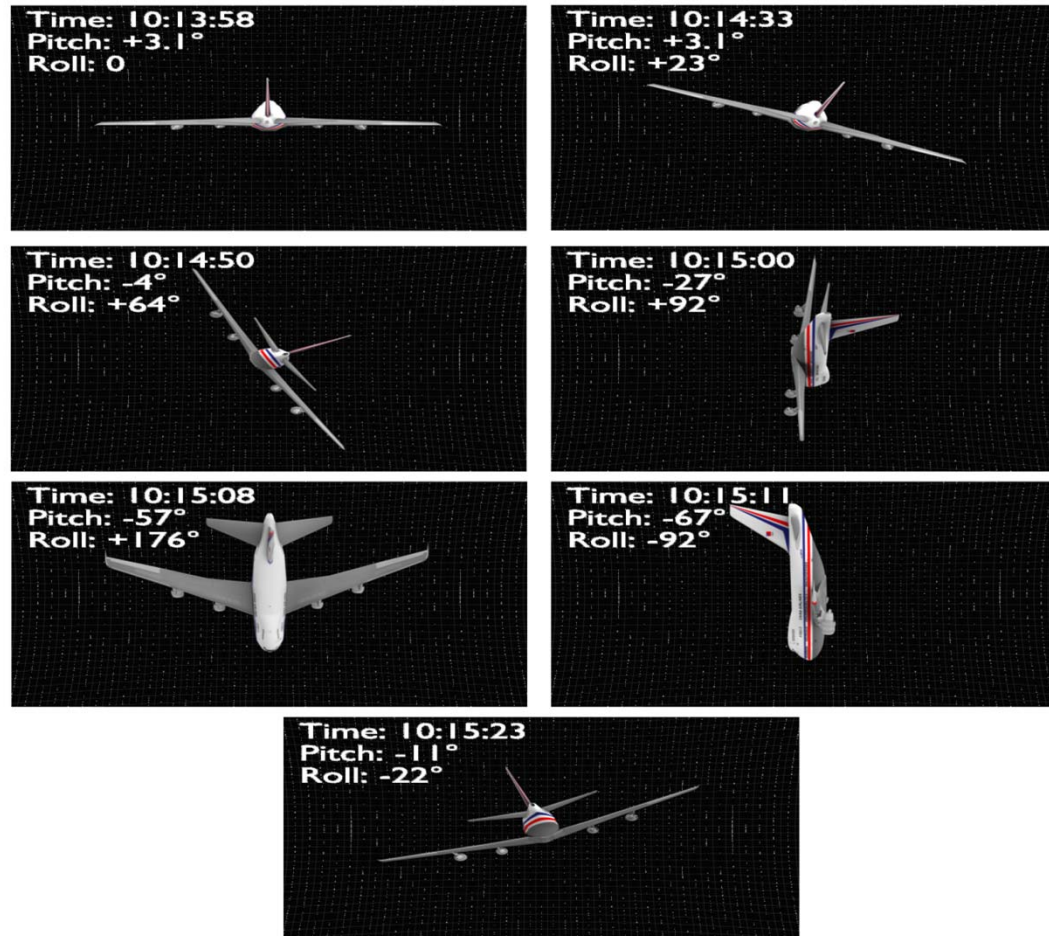
- Incidents exposing airliners to over-limit design conditions:
 - Only after breaking through the bottom of the clouds at 11,000 feet (3,400 m) did the captain orient himself and bring the plane under control, leveling out at 9,600 feet (2,900 m). They had descended 30,000 ft in under two and a half minutes. A restart attempt brought No. 4 back into use.

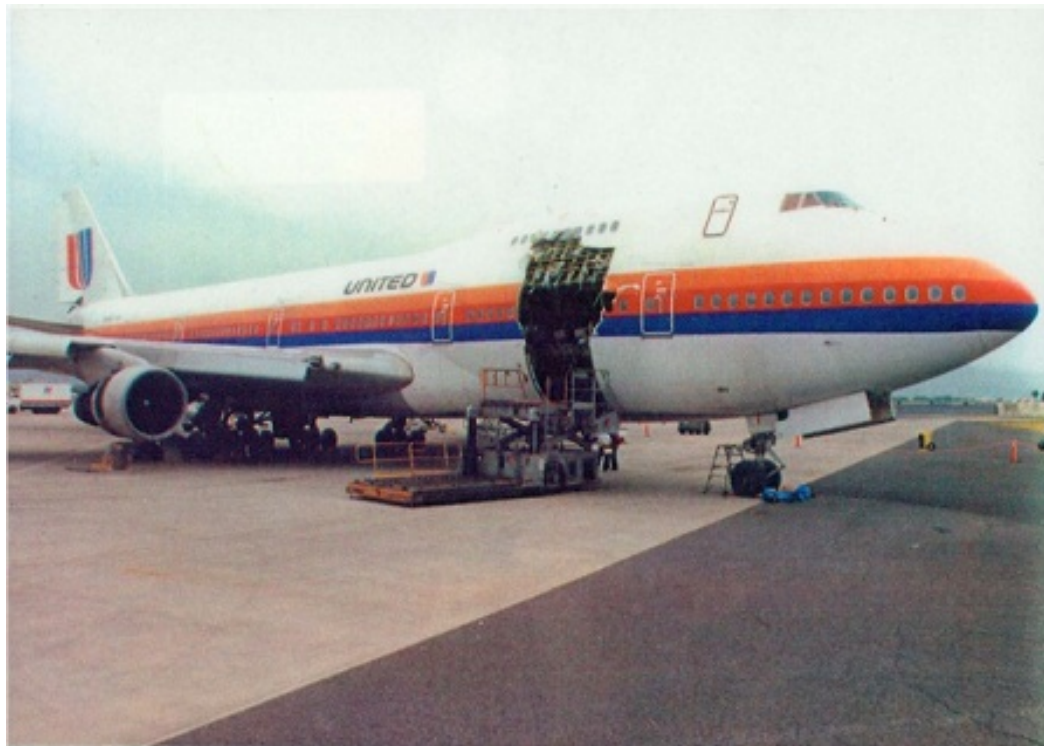
- Incidents exposing airliners to over-limit design conditions
 - As the airplane neared the airport, the landing gear were extended. The flaps could only be partially deployed as a result of damage sustained following the decompression. This resulted in a high landing speed of around 190–200 knots (350–370 km/h). Regardless, Captain Cronin was able to bring the airplane to a halt without overrunning the runway. Fourteen minutes had elapsed since the emergency was declared. Evacuation was carried out and all passengers and flight attendants exited the plane in less than 45 seconds. Every flight attendant suffered some injury during the evacuation, however, ranging from scratches to a dislocated shoulder

- A gaping hole was left in the aircraft. To reach an altitude where the air was breathable, they began an emergency descent, while also performing a 180-degree left turn to fly back to Honolulu. The debris ejected from the airplane during the explosive decompression caused severe damage to the Number 3 and 4 engines, causing visible fires in both. Engine 3 was experiencing heavy vibration, so the crew shut both engines down. Some of the explosively ejected debris damaged the right wing's Leading Edge Devices, dented the horizontal stabilizer on that side, and even struck the tailfin. The aircraft's skin was peeled off in some areas on the upper deck, revealing the frames and stringers and a massive hole in the side of the cabin. ¹³

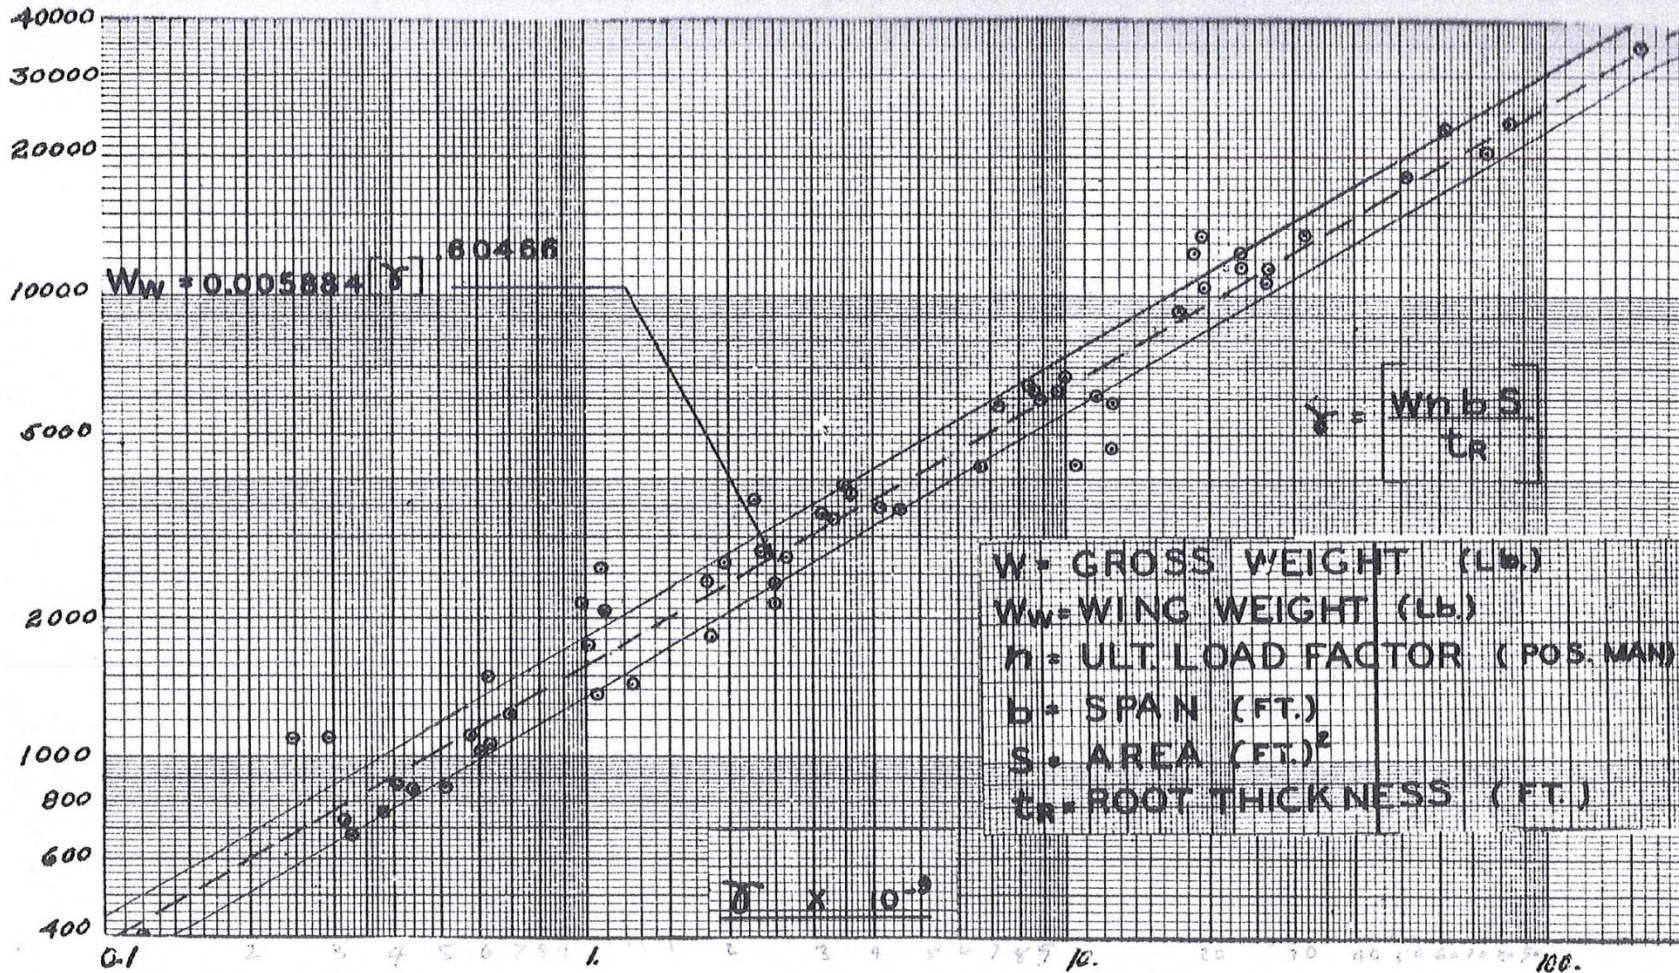
CHART FOR WING WEIGHT ESTIMATION FROM AAFTR 5161

If above equation is approximated by a line of slope 0.50 (instead of 0.60466) through $W/10^3 = 10$ and $W_w = 6300$ (with some sacrifice in accuracy) resulting equation is $W_w/S = \frac{2.0}{\sqrt{t_r}} \sqrt{nW}$ which agrees with Drigg's equation (p. A5:2) for $t_r = 4.2$ ft. Since mean thickness for wings $\sqrt{t_r} \sqrt{1000cm}$ plotted by Kelley was more nearly 2 ft., Drigg's equation (based chiefly on airplanes prior to 1930) is judged to need correction by a factor of approximately $\sqrt{2}$ to be applicable to newer airplanes, as shown in Fig. A5:7.

- Based on a study of aluminum airplanes built between 1930 and 1950.
 - Relationship applies if the ratio of the material yield to ultimate strength is less than 1.5 (chart provided on the next slide).
