# Burst Testing of Triaxial Braided Composite Tubes

## **Abstract**

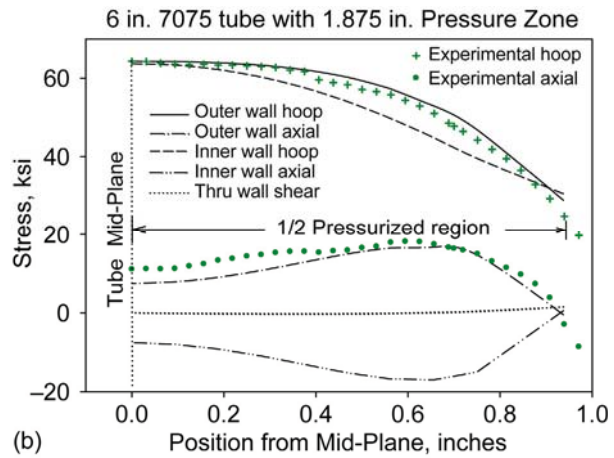
Figure 5.—(a) Tube schematic and (b) experimentally measured and theoretical stresses for a partially pressurized infinite aluminum tube (half-symmetry).

High strength aluminum, which has a similar elastic modulus to the composite, was used for experimental verification of tube testing. Pressurization was achieved by compressing a polymer plug between platens. Strain was monitored by using a photogrammetry system and associated software (Trilion Quality Systems). The elastic constants of the tube material were determined by compressing the tube while monitoring the surface displacements via the camera system.

Pressurization of the tube resulted in excellent agreement with theory for an infinite tube, as shown in Figure 5. The bending induced axial stress at the mid-plane is ~12 percent of the maximum hoop stress. However, by the time the hoop stress decays significantly (~5 percent); the axial stress has increased to ~25 percent of the hoop. Observations of failure locations in composite tubes, discussed in the following sections, indicated mid-plane failure, implying that the state is sufficiently uniaxial for engineering purposes.

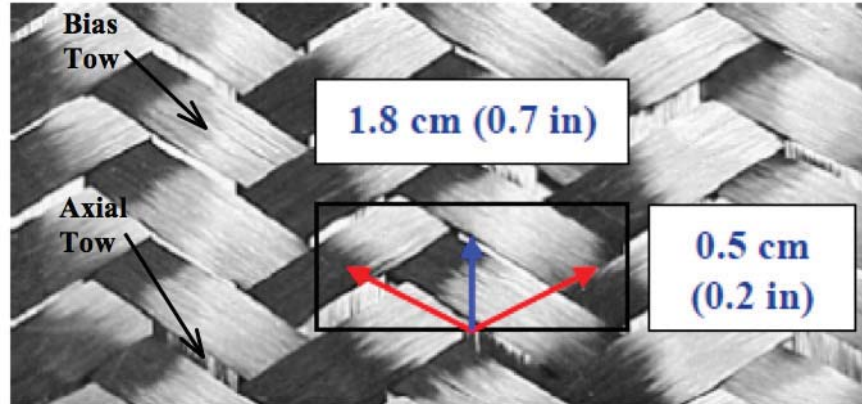
Figure 6.—Two-dimensional triaxial braid carbon fiber preform with highlighted unit cell. The blue arrow indicates the axial fiber direction, and the red arrows indicate bias fiber directions.

A representative picture of the 0/+60/-60 triaxial braid architecture unit cell is shown in Figure 6. The  $\pm 60^\circ$  bias fibers are visible on the surface, and portions of the  $0^\circ$  axial fibers that lie below the  $\pm 60^\circ$  bias fibers can be seen in open spaces. The  $0^\circ$  axial fibers were 24k flattened tows while the  $\pm 60^\circ$  bias fibers were 12k flattened tows. Although larger fiber bundles were used in the axial direction, the fiber bundle spacing in the axial and bias directions were adjusted to give the same fiber volume in the axial and bias directions. This fiber architecture is quasi-isotropic in-plane, so the in-plane stiffness is expected to be the same in all directions when the region of measurement includes several unit cells.

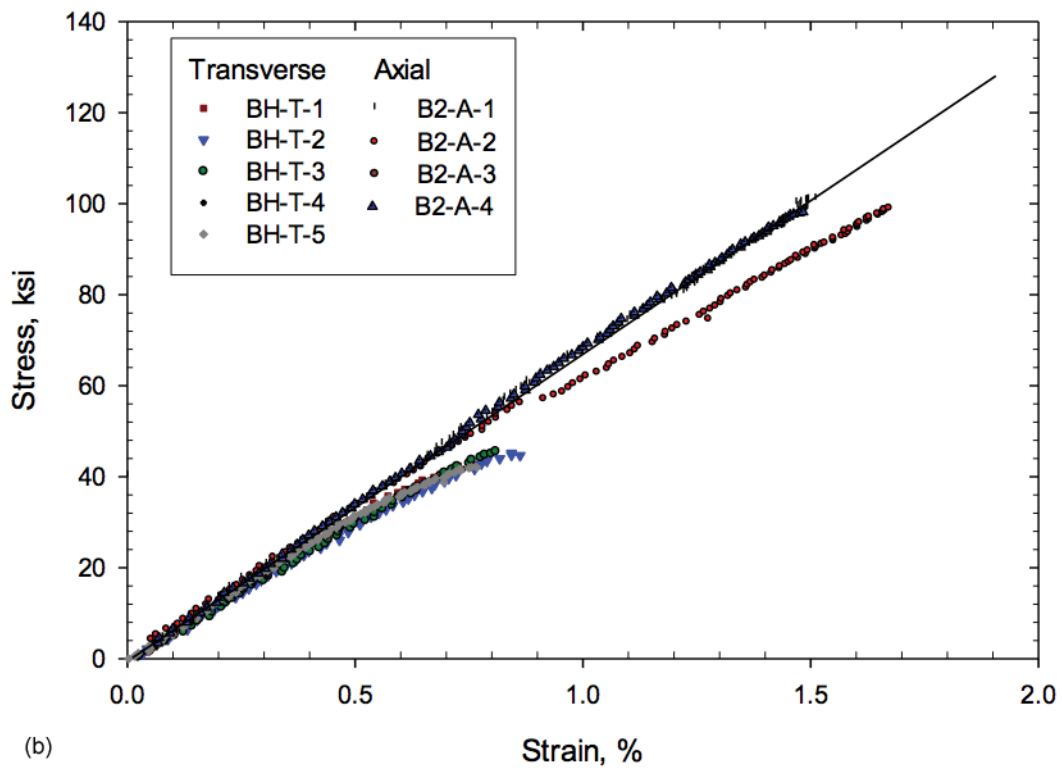
Figure 8.—ASTM D3039 axial and transverse global stress-strain curves for (a) T700S/E862 and (b) T700S/5208.

Axial and transverse, macro-level stress-strain curves are shown in Figure 8 for T700S/E862 and / 5208. For transverse loading, nonlinear extension occurs at  $\sim 0.5$  percent strain and  $\sim 25$  percent of the ultimate axial strength. A linear regression fit range of  $0.5$  percent, which was larger than that used previously ( $0.2$  percent, (Ref. 1)), provided more consistency in Poisson's ratio and met reciprocity requirements ( $\nu_{12}/E_{11} = \nu_{21}/E_{22}$ ) with  $E_{11} = 6.95 \times 10^3$  ksi,  $\nu_{12} = 0.34$ ,  $E_{22} = 6.03 \times 10^3$  ksi, and  $\nu_{21} = 0.30$ , as shown in Table 2.

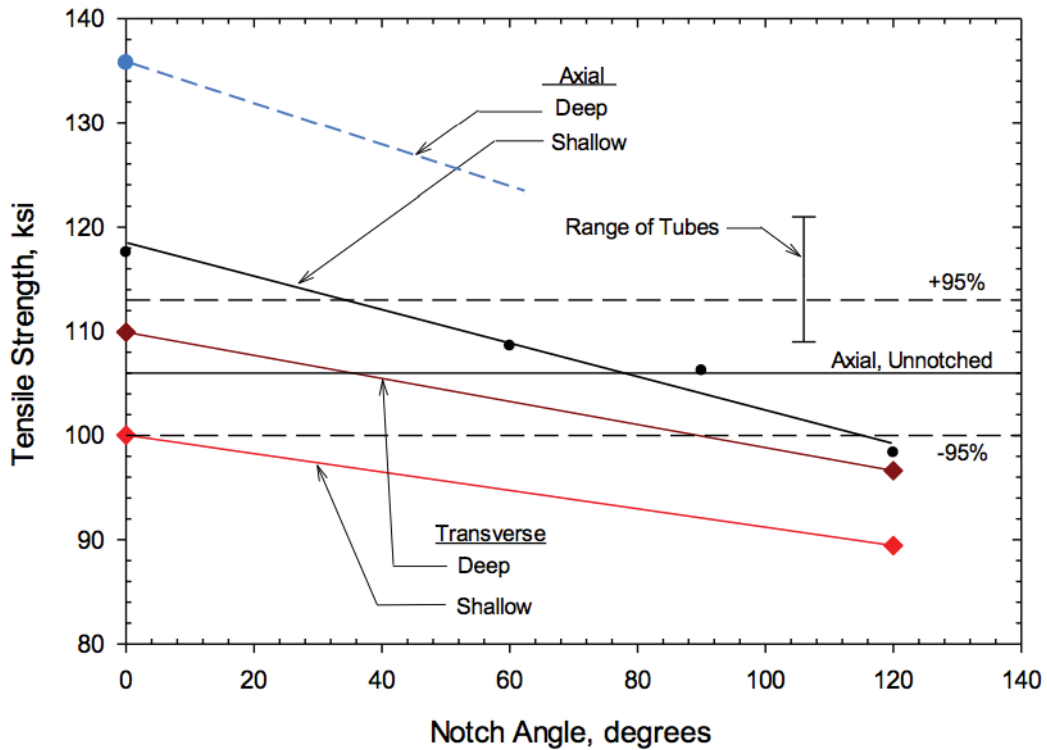
Figure 9.—Uniaxial net section strength as function of notch angle and depth for T700S/5208.

T700S/5208 exhibited less nonlinear extension prior to failure and lower fracture strength. The effects of notch angle and depth are shown in Figure 9, and imply that net section strength decreases with increasing notch angle for transverse and axial orientations. For transverse orientation, large angles cut bias tows thereby resulting in less length of bias tows through which load can be transmitted, and less shielding, via surrounding material, of tows that do carry load through the ligament. Interestingly, shallow notches exhibit lower strength than deep notches again implying that additional material to the side of a tow shields the loaded tow: unsupported tows running along a free edge (e.g., 60 notch) are weaker.

Tube data for T700S/5208 is summarized in Table 4. Figure 9 implies that deep notches ( $2a/W = 0.8$  with  $\theta = 0^\circ$  to  $60^\circ$ ) give the most comparable results to tubes for the current architecture. Clearly, notched specimens show systematic dependence on notch depth and angle for both transverse and axial orientations. It is noteworthy that both the strongest notched specimens and the tubes that presented testing difficulty due to plug extrusion exhibited nominal stresses of 140 ksi, implying that tube strength can be improved. More study of notched geometry effects is needed with various epoxies to give specific recommendations.

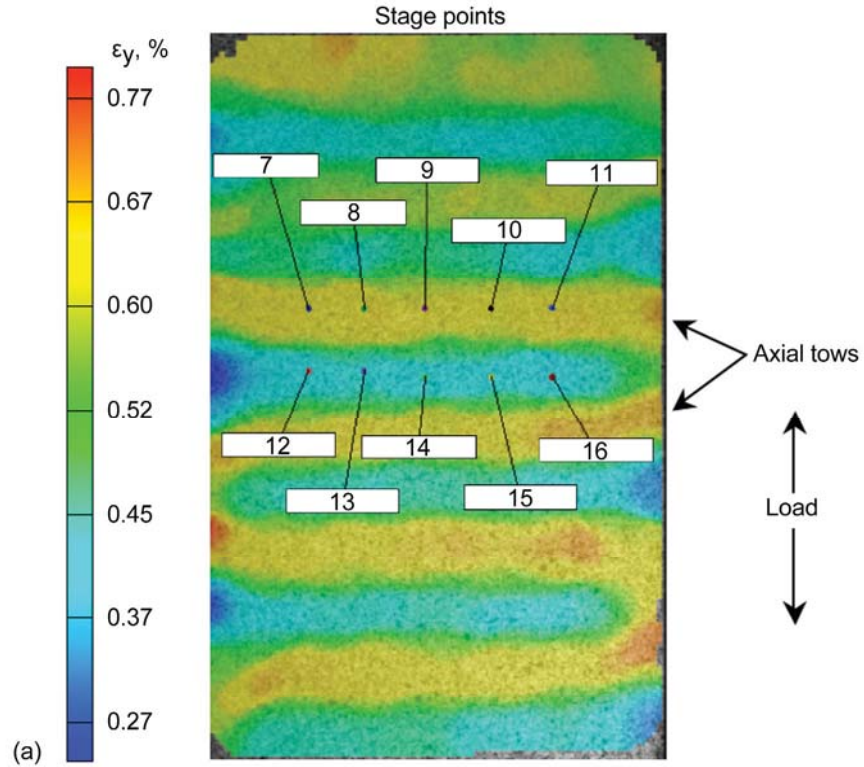
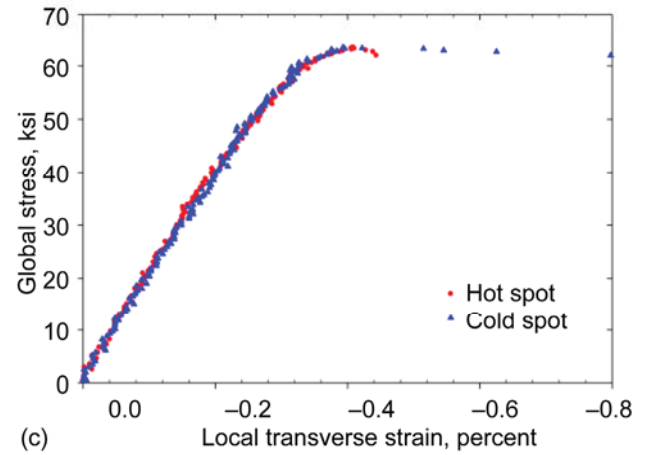
Figure 11.—Strain banding at 32 ksi (a) and correspond axial (b) and transverse (c) stress-strain curves for the high and low strain regions of a T700/5208 transverse tensile test.

Noteworthy for unnotched transverse specimens is the strain banding shown in Figure 11. These local strain concentrations and the applied stress were used to estimate local, effective elastic Young's modulus and Poisson's ratio. These *in situ* measurements gave  $E = 7.74 \times 10^3$  ksi and  $\nu = 0.41$  for the low strain regions between 0° tows and  $E = 5.11 \times 10^3$  ksi with  $\nu = 0.25$  in the high strain regions corresponding to tows. This is  $\sim \pm 10$  percent from the macro-level modulus values. Non-linear strains are exhibited in high strain regions at about two-thirds the applied stress required to create non-linearity in the low strain regions, and the equality of transverse strains implies good compatibility between regions, Figure 11(c). For the axial tests, banding is less apparent and the macro values are representative.

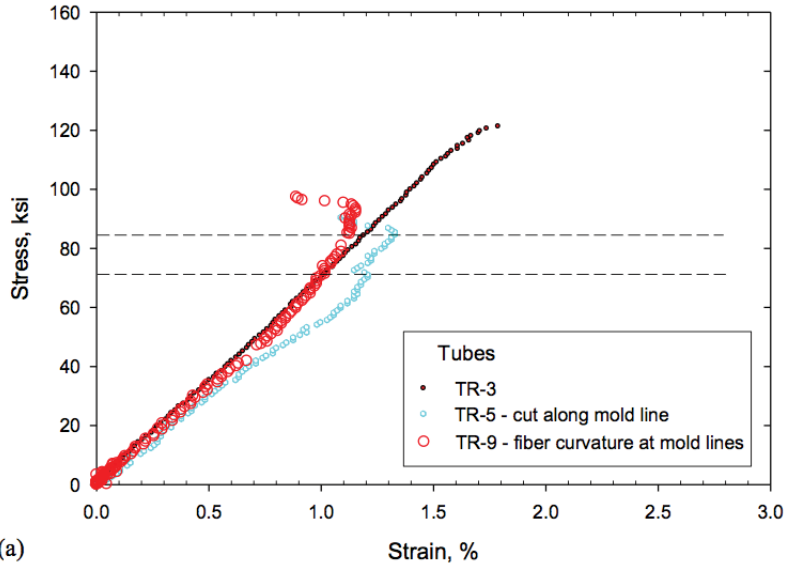
Figure 14.—(a) Stress-strain curves for T700S/E862 tubes with (b) damaged (TR-5 at 34 ksi) and (c) distorted fibers at mold lines (TR-9 at 89 ksi).
