# Creep Burst Testing of a Woven Inflatable Module

A woven Vectran inflatable module 88 inches in diameter and 10 feet long was tested at the NASA Johnson Space Center until failure from creep. The module was pressurized pneumatically to an internal pressure of 145 psig, and was held at pressure until burst. The external environment remained at standard atmospheric temperature and pressure. The module burst occurred after 49 minutes at the target pressure. The test article pressure and temperature were monitored, and video footage of the burst was captured at 60 FPS. Photogrammetry was used to obtain strain measurements of some of the webbing. Accelerometers on the test article measured the dynamic response. This paper discusses the test article, test setup, predictions, observations, photogrammetry technique and strain results, structural dynamics methods and quick-look results, and a comparison of the module level creep behavior to the strap level creep behavior.

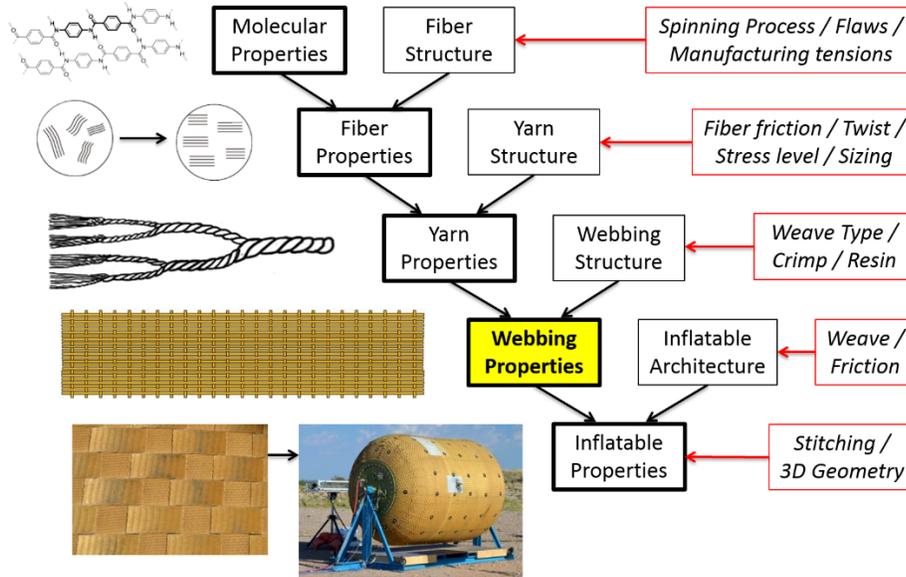
**Figure 1. Structural Hierarchy and Characteristics in a Softgoods Inflatable Module**

Four webbing variants have been studied in two strengths and two materials: 6,000 lbf and 12,500 lbf rated Kevlar and Vectran. A specific construction (or "architecture") for each webbing strength is defined via the Mil-T-87130 specification<sup>8</sup> and was used for both materials. The webbings and full-scale module are part of a complex structural hierarchy that strongly influences the properties of the final inflatable structure. Unlike metallic structures whose macro-properties are based directly on their molecular properties, softgoods inflatables consist of multiple layers of interacting structural elements, from fibers and yarns to the webbings and final module. Figure 1 illustrates the relationships between the properties and structures at each hierarchical level and the influence of manufacturing, fiber and yarn interactions and weave in both the webbings and inflatable module. This hierarchy leads to higher levels of variance in material behavior and creep life at the webbing level and consequently in the full-scale structure as well.

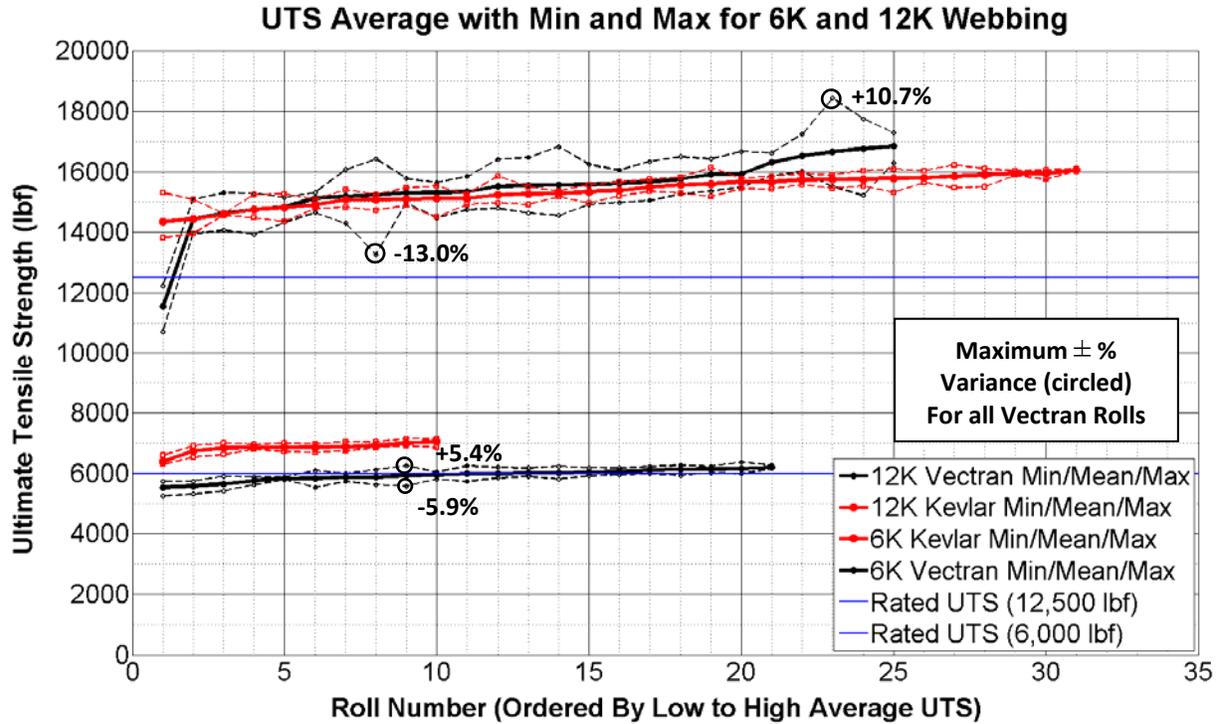
Figure 2. Kevlar and Vectran, 6,000 lbf and 12,500 lbf rated webbings. Minimum, average and maximum UTS points for each roll tested are shown. Solid lines are the average, dashed lines are the min/max.

The primary series of short-term tests performed before any creep tests are executed are Ultimate Tensile Strength (UTS) tests. Each of the four webbing variants are manufactured in a run of several thousand yards and are then cut into rolls of material, 25 to 60 yards long. Five UTS tests are performed on each roll to give an average breaking strength. This average UTS can then be used to set the load level for a webbing creep test as a percentage of that average. UTS tests also provide data on strength and stiffness variance across a manufacturing run and provide load vs. strain plots for each roll. Figure 2 plots the minimum, average and maximum UTS for every roll of material tested, along with lines representing the two strength ratings. The Vectran webbings (black) display greater variance in strength than the Kevlar (red) webbings. The Vectran webbings that were rated at 12,500 lbf, exhibit a 9.4% average total variance about the mean, versus 3.7% average total variance in the 12,500 lbf Kevlar. Creep life in these materials increases exponentially with a linear decrease in the applied load, thus a large variance in strength can significantly broaden the creep life range. One can also observe the fidelity in which each webbing variant meets the rated load. The Kevlar webbings in both strengths easily exceed the required minimum and do so over a smaller variance in absolute breaking strengths than the Vectran. The 6,000 lbf rated Vectran meets the specification in less than half the rolls (9-of-21), while the 12,500 lbf rated Vectran exceeds the minimum by up to 48% (18439 lbf), with one roll below the minimum. Both Kevlar and Vectran in the higher strength rating, exceeded the rated load on average by approximately 23%. This indicates the architecture is not well optimized, and Vectran has greater variance (up to twice the range of average UTS values for 12,500 lbf-rated) than Kevlar under the Mil-T-87130 specification. It should be noted that Mil-T-87130 is specified for para-aramids (*aromatic polyamides*), and although in a similar class of materials, Vectran (an aromatic polyester) is not an aramid. More research is needed on the manufacturing process and specific architectures of these webbings to reduce the variance observed and increase predictability in their strength. Specifically, the tensions, temperatures, yarn paths and coatings used throughout the process would need to be carefully documented and the effects of different weave architectures with the same goal strength would need to be tested and compared to the current webbings to identify optimization approaches. The goal would be a well-documented and repeatable manufacturing approach that could produce several webbing architectures that maintain low variances in both strength and stiffness behavior.

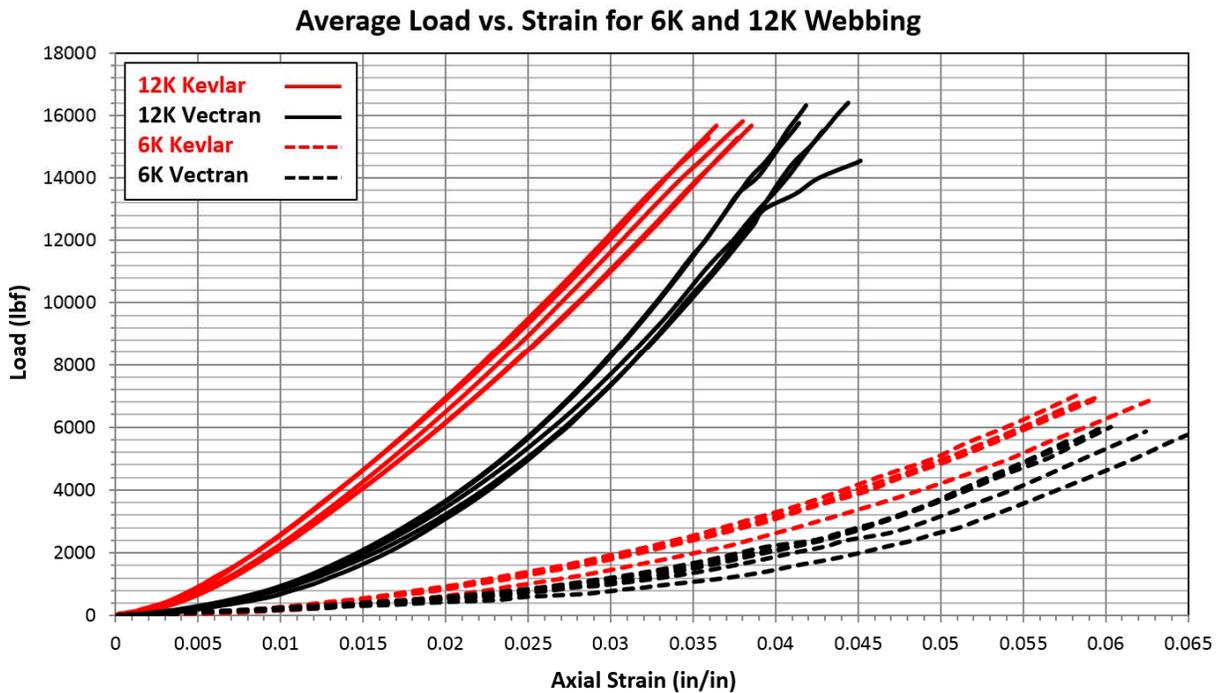
Figure 3. Kevlar and Vectran, 6,000 lbf and 12,500 lbf rated webbings. Average Load vs. Strain curves for five rolls of each webbing variant. Each curve represents the average of five webbings.

Load versus Strain data from the UTS tests can be used to characterize the stiffness behavior of the webbings and provides a means for converting measured strains into loads during testing of a full-scale module. Once these data are gathered for a given roll or run of webbing, they can be used in coordination with a strain measurement system such as photogrammetry to back-out the loads in the webbings of an inflatable module, as detailed later in this paper. Load is used rather than stress in plots of webbing behavior due to the difficulty in measuring stress precisely from a pliable cross-section. Figure 3 illustrates the variance in stiffness behavior for five rolls of each webbing variant. Given that each roll of a webbing variant is from the same manufacturing run and has the same number of axial fibers (i.e. same architecture), the more compliant curves suggest fewer of those fibers are being loaded and it is likely those rolls would then fail at lower strengths due to higher distributed fiber stresses. This tends to hold true on average for all webbings and is most likely a result of slightly uneven loading of the fibers during load up due to: stick-slip and friction between fibers and yarns, uneven decrimping and fiber-lock, and micro-level differences in the number of flaws. If a better understanding of the mechanisms behind the variance in stiffness behavior can be found, it could elucidate the cause of the high variance in the strength of these webbings. Studying these mechanisms would require instrumentation that could measure small differential movements between fibers and yarns over the length of the test section, and microscopic examination of the fibers for observable flaws over the webbing cross-section. Photogrammetry instrumentation doesn't have the resolution to perform this level of measurement over the full length of the test section, but zooming in and observing only a small area of the webbing precludes the capture of uneven differential movement of the fibers in other areas of the test section. The study of the micro-level behavior of the webbings is therefore currently beyond the scope of this research.

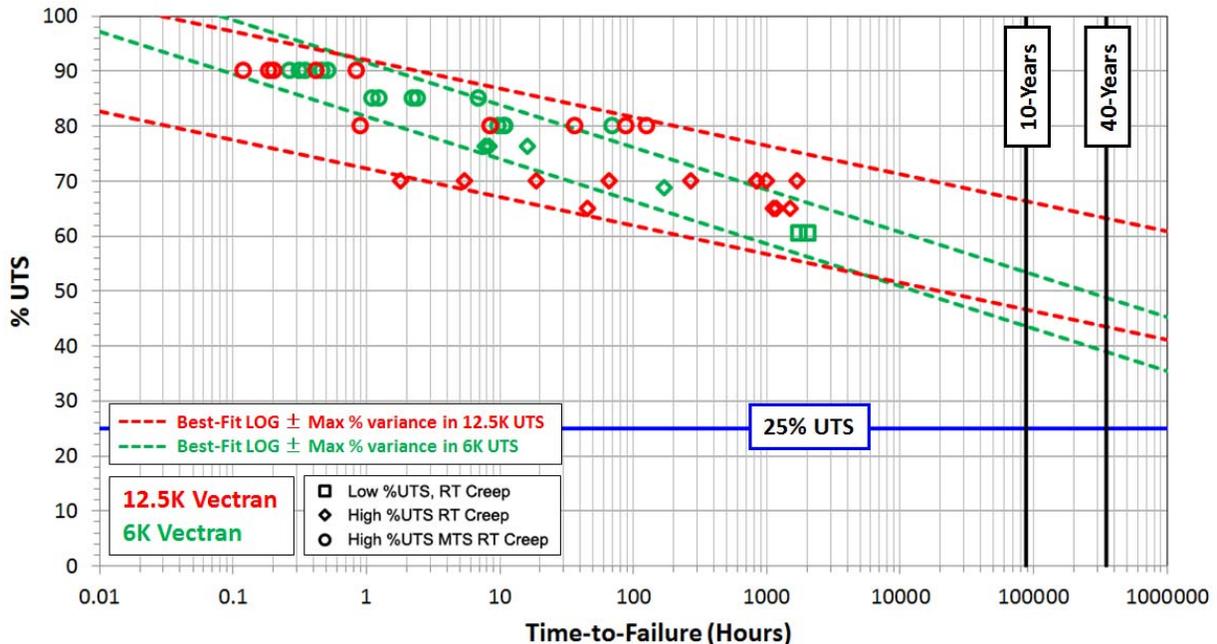
Figure 4. 6,000 lbf and 12,500 lbf rated Vectran. %UTS vs. Creep Life Time-to-Failure

It can be observed that using the maximum UTS variance as the shift factor for the best-fit creep life curve, bounds the data points extremely well. This illustrates the direct link between the variance in short-term properties and their effects on the long-term behavior of the webbings. It should be noted that if only a few rolls are tested,

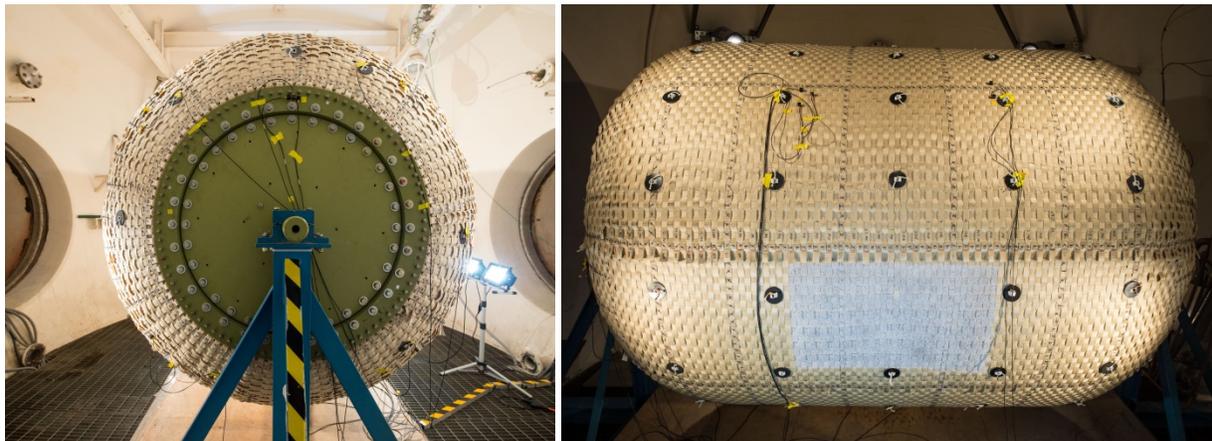
Figure 5. The Creep Burst Test Article. The module is shown inside the test chamber.

The test article was fabricated from a weave of one-inch wide Vectran webbing, in the same style developed during NASA's TransHab project. The webbing was manufactured per MIL-T-87130 with the exception that it was fabricated from Vectran. The webbing is woven together in a basket weave pattern<sup>1,5</sup>. Axial straps, running from bulkhead to bulkhead, have a rated strength of 6,000 lb/in. Hoop straps in the cylindrical region of the structure have a rated strength of 12,500 lb/in. The test module is 88 inches in diameter and 10 feet long. There are metal bulkheads on each end with trunnions along the central axis. The module rests on the trunnions in a cradle stand. Interior to the restraint layer is a urethane coated nylon air bladder that is oversized to ensure the restraint layer carries the structural loads and the bladder is not loaded.

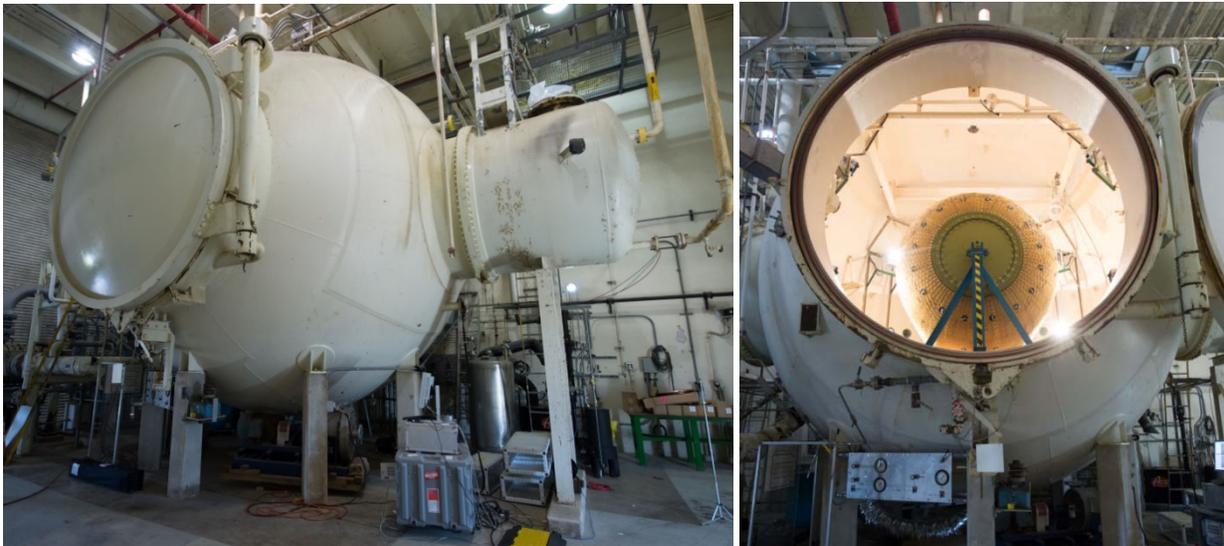
**Figure 6. The test chamber at the JSC Energy Systems Test Area where the Creep Burst Test was performed.**

It was desirable to use high speed cameras to capture video footage of the burst event, but this was not practical due to the possibility of a long test. High speed cameras would have difficulty running continually for such a long period of time, and there was not expected to be any indication that a burst was imminent in the moments before a burst occurred. Also, for safety reasons, personnel were not allowed in the test chamber, or the test cell surrounding the chamber, after the test article pressure surpassed 5 psig. The test setup had to be configured such that no modifications were required in the test cell if the test continued for several months. For these reasons, it was decided to record video footage on three cameras at 60 FPS. Two cameras were inside the chamber in the “ears” on the east and west sides of the chamber, 180 degrees apart. The third camera was outside the chamber on the top, looking through a viewing window. The east ear also contained a pair of additional cameras to record still images for photogrammetry. Photogrammetry is described in detail in Section V. Protective enclosures were built for all of the cameras inside the test chamber. Lighting was provided by eight LED lamps mounted to the walls of the chamber.

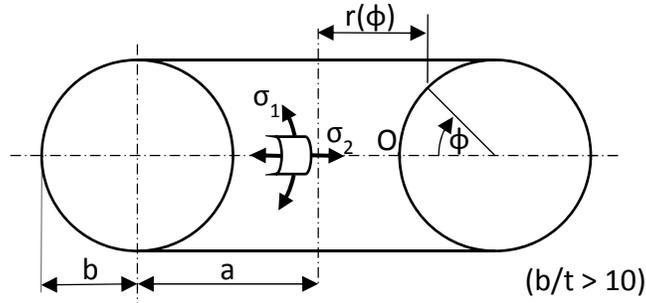
Figure 7. Toroid shape diagram.

$$\sigma_1(\varphi) = \frac{qb r(\varphi) + a}{2t r(\varphi)} \quad (3)$$

where  $r$  is a function of  $\varphi$  measured from point  $O$ . The equation for the hoop stress in a toroidal pressure vessel is

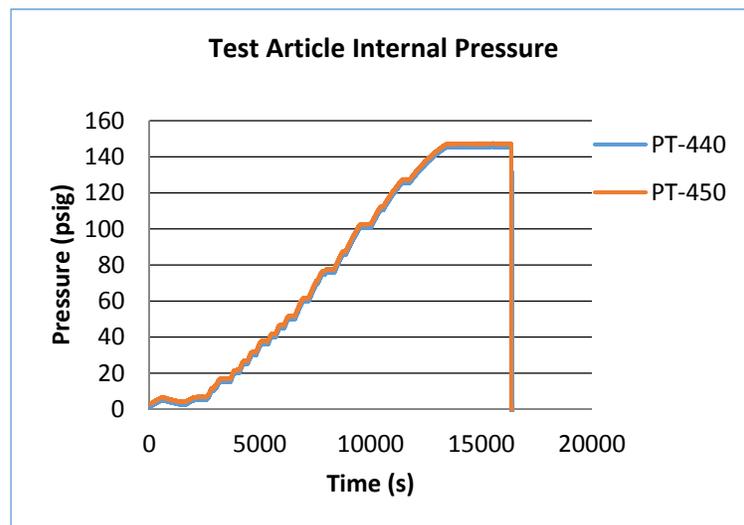
Figure 9. Test Article Internal Pressure vs. Time.

The test was performed on March 11, 2014. The module was first inflated to a pressure of 0.5 psig for the installation of instrumentation, calibration of photogrammetry cameras, and inspection of the restraint later straps. The test article was inflated to a proof pressure of 5 psig, held at pressure for several minutes, and then vented down to 2.5 psig. At 2.5 psig, personnel were allowed to approach the test article for one final verification check before the chamber was sealed and the pressure was increased. Over a period of more than 3 hours, the test article pressure was increased from 2.5 psig to the target pressure of 145 psig. There were several arbitrarily selected hold points

during the pressurization for the purposes of collecting accelerometer data. At each hold point, the pressure was held constant for several minutes. These holds occurred at 5, 15, 36, 50, 75, 100, and 125 psig. Upon reaching the target pressure of 145 psig, the pressure was held constant. Actual pressure readings on the two test article internal pressure gages were 145.55 psi and 147 psi. During the pressurization, sounds could be heard that can best be described as “pops”. These sounds have been heard in other pressurization tests of woven inflatable test articles. The pops are believed to be the straps overcoming static friction and sliding relative to each other. These events were picked up by the accelerometers and are discussed in more detail in Section VI.

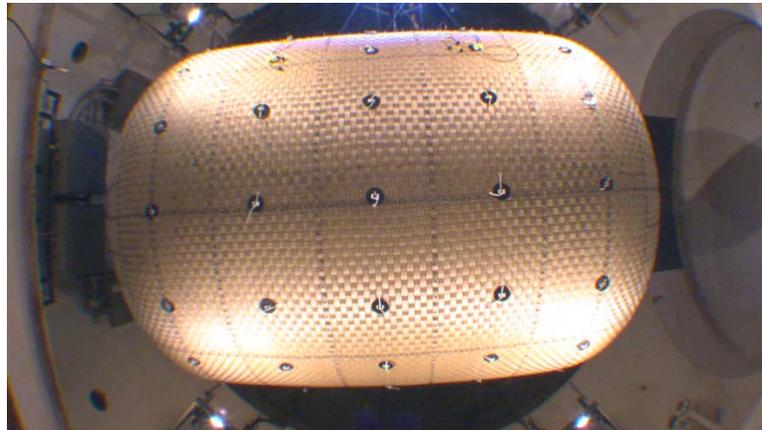
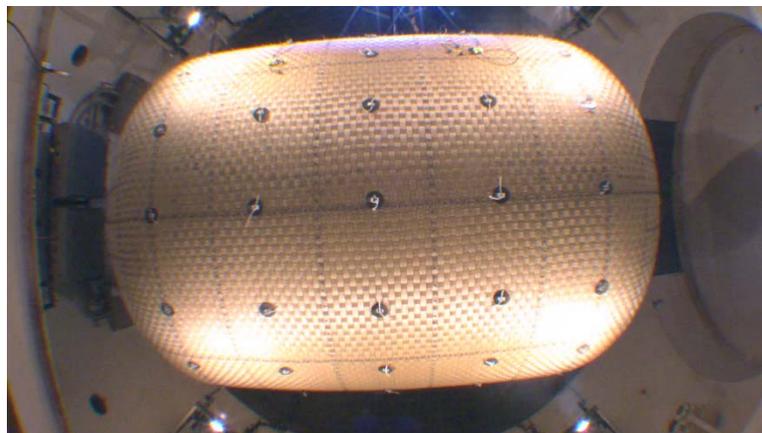
**Figure 10. Video of burst – Frame 1.**

**Figure 11. Video of burst – Frame 2.**

**Figure 12. Video of burst – Frame 3.**

After 49 minutes holding at the test pressure, the test article experienced a dramatic burst event. The event occurred in a fraction of a second, and produced an explosion loud enough to shake the building. Immediately before the burst event, personnel monitoring the test from the control room did not observe any signs indicating that a failure was imminent. The final frames of the test video are shown in Figure 10, Figure 11, and Figure 12.

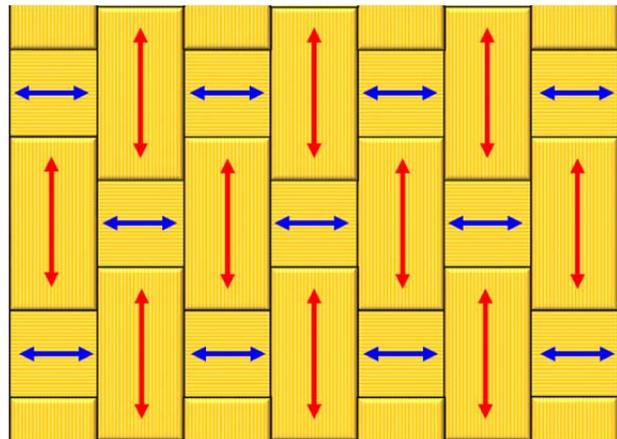
**Figure 13. Weave pattern and the strain direction for each of the straps.**

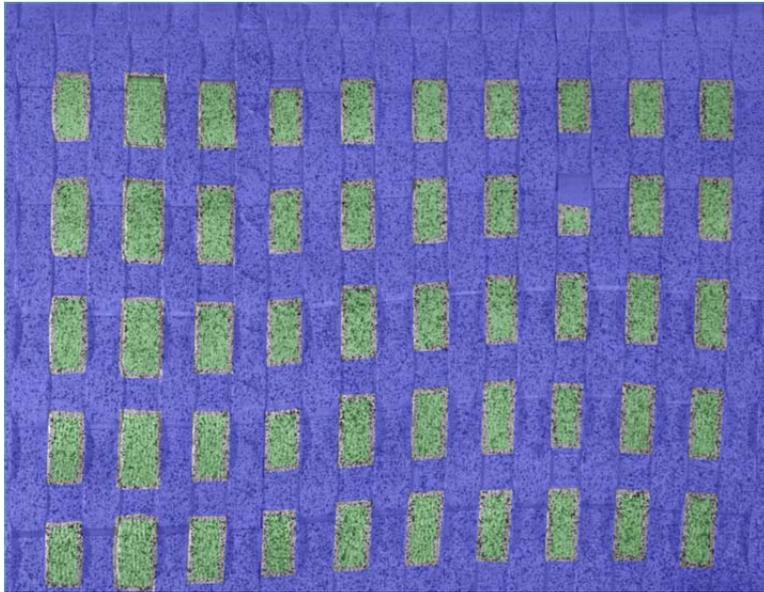
**Figure 14. Masking technique to isolate the Hoop straps prior to processing.**

To avoid interaction between adjacent straps, masking around the chosen straps is necessary (see Figure 10). Once the mask is created, the individual areas can now be correlated and processed into 50 sections for the Hoop straps and 28 sections for the Axial straps. The results are two different sets of measurements, one for each axis the strap is tensioning. As an outcome, we receive a better result in the data where the strain is not being influenced by the movement of adjacent straps.

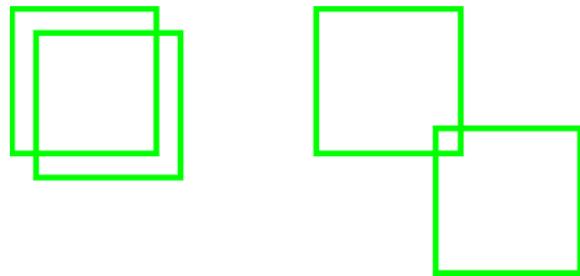
**Figure 15. Showing the difference between facet steps for a given size facet. Large overlap (left), and small overlap (right).**

deformation of the test specimen<sup>10</sup>. To increase the amount of data points, a higher overlap between facets is crucial. This is called a “Facet Step”. As an example (Figure 11) a square facet size of 15 pixels and step size of 4 pixels will have an overlap of 73% while one with a step size of 11 pixels will have an overlap of 27%. Therefore the 15 pixel by 4 pixel parameters will create a denser population of data points for each section of strap.

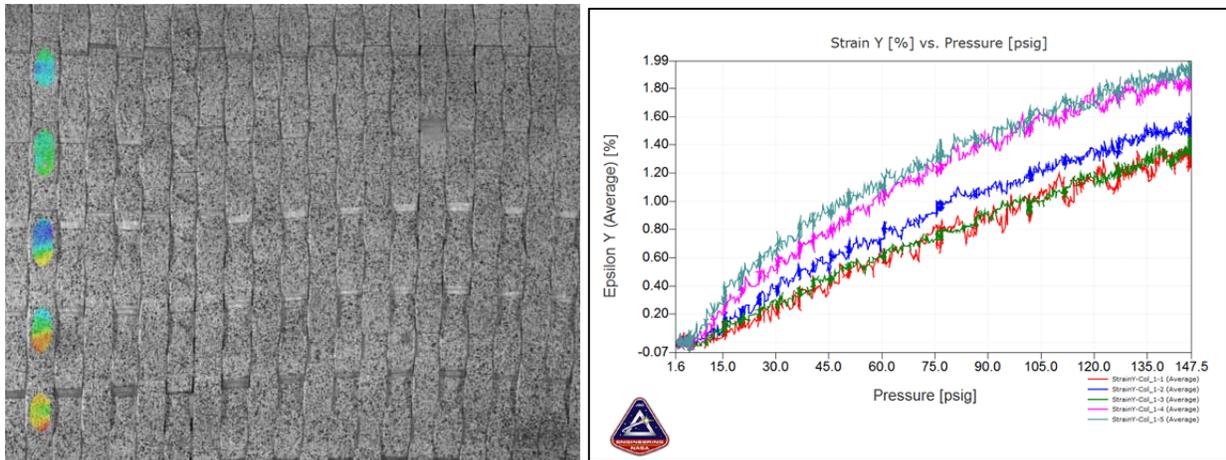
**Figure 16. Hoop strain in the Y axis with data overlay and its respective plot.**

During the analysis, an average of the data points in each section of the strap was computed. The statistical analysis tool within the Aramis software is used to calculate the average strain for each section of each strap for a specific strain axis. The results can be plotted (see Figure 16) within the Aramis software or exported for further analysis with other tools. The data acquired through photogrammetry will be discussed in Section VII.

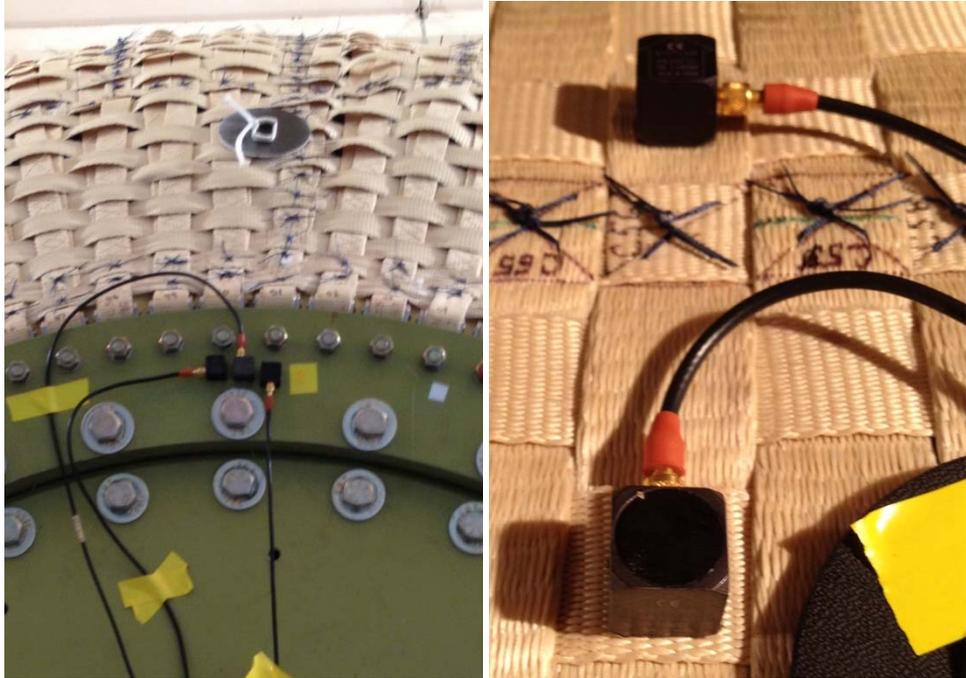
Figure 17. Close-up Images of Installed Accelerometers on the Creep Burst Test Article

Fifteen Kistler 8632C10 PiezoBEAM cube accelerometers were mounted on the test article while inflated at 2 Psi delta pressure. These piezoelectric sensors were rated to measure 10 g of acceleration in either direction and were configured as a cube with a .56-in x .56-in x .56-in footprint. Previously, these sensors were used for structural health monitoring measurements on the Space Shuttle Orbiters as part of the Shuttle Modal Inspection System (SMIS)<sup>13</sup>. The sensors were not expected to survive the failure of the test article. Figure 5 shows global context images of the sensors and the associated cabling installed on the test article. Figure 17 shows close-up images of sensors installed on the soft goods and metallic core of the test article. Figure 18 and Figure 19 show schematics of the test article with the accelerometer locations and directions denoted.

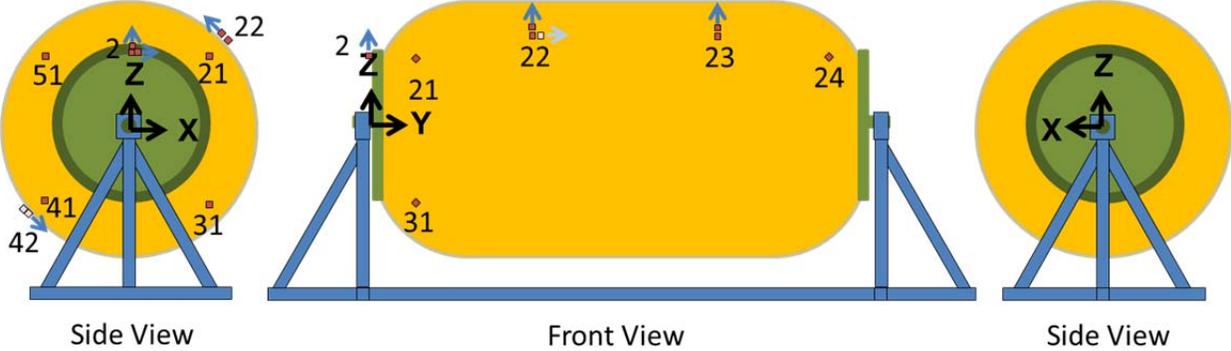
Figure 18. Location and Direction Schematic of Installed Accelerometers (Three Views)

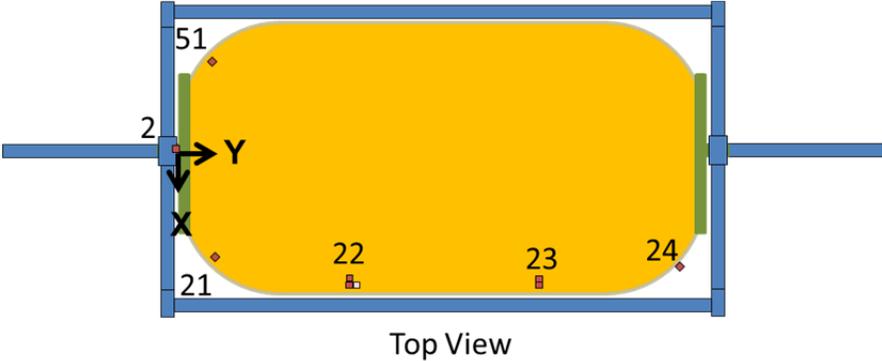
Figure 19. Location and Direction Schematic of Installed Accelerometers (Top View)

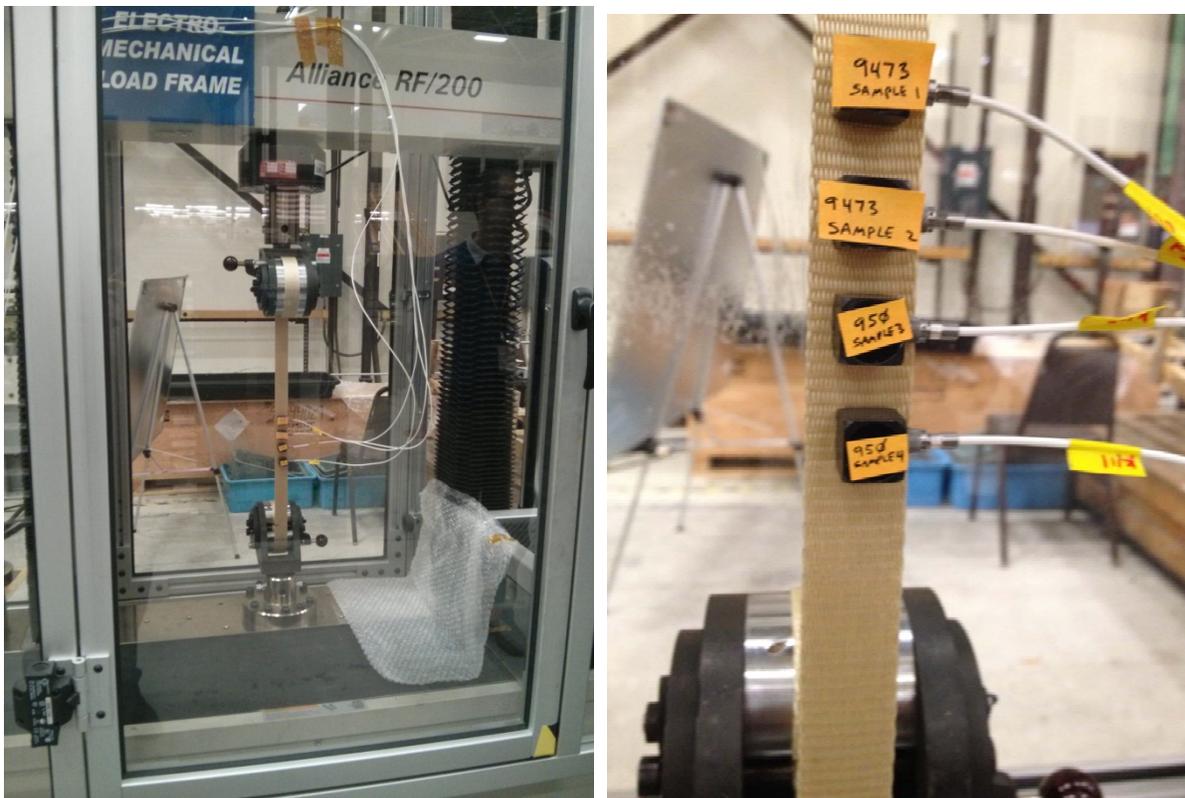
**Figure 20. The Single Strap Test to Assess Adhesive Accelerometer Mounting Systems**

A test using a single strap of the restraint layer material loaded in a tensile test machine was used to assess installation techniques. Two different adhesive tapes (which had previously been tested for other long-term sensor installation applications) were assessed. Each adhesive was assessed using an installation with and without back pressure being applied during installation. The single strap was loaded with the equivalent force that a similar strap would see on the test article with an internal pressure of 2 psig. Four sensors were installed in each of these test case combinations and then the tension was increased to the equivalent of the 146 psig test pressure. Both adhesive systems performed well during the test both with and without back pressure. However, the 3M F9473PC adhesive tape appeared to be a more tenacious application with no back pressure and was selected for use to mount the accelerometers in the test.

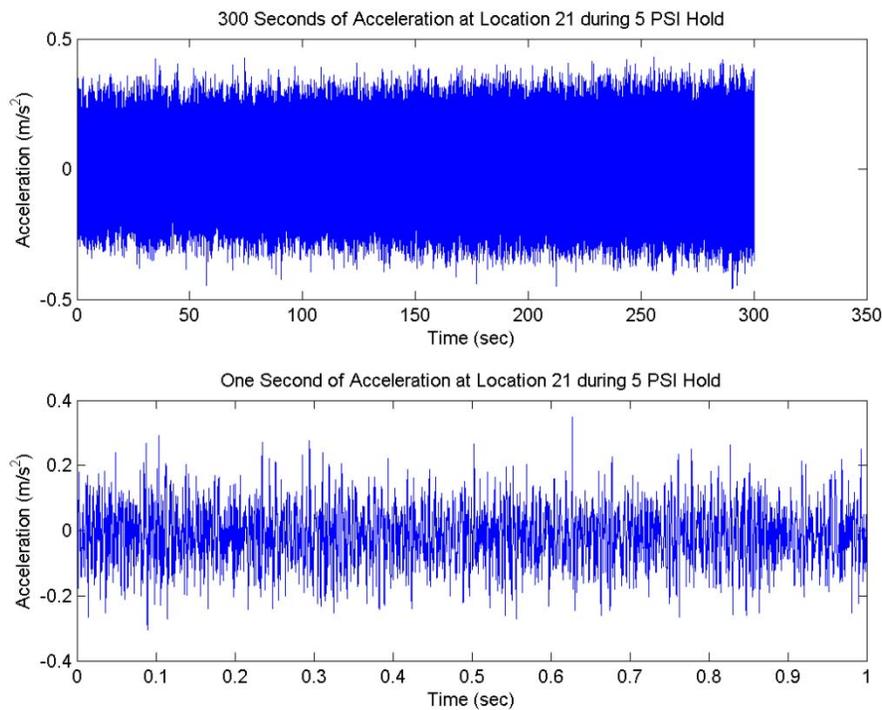
**Figure 21. Five Minute and One second Accelerometer Time History at 5 PSI Hold**

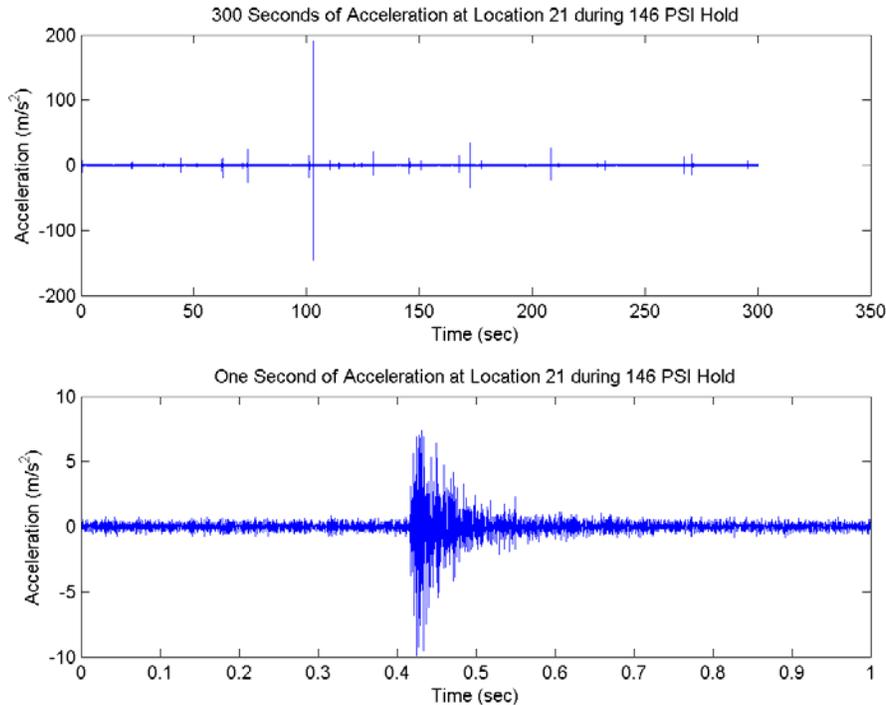
**Figure 22. Five Minute and One second Accelerometer Time History at 146 PSI Hold**

These impulse events, as seen in Figure 22, make a traditional modal analysis of these data challenging. However, techniques to effectively process the data have been developed and are reported in the companion paper<sup>12</sup>. One feature that has been extracted from the vibration noise floor is a fairly consistent 1000 Hz dynamic phenomena. This feature can be found in the data throughout the entire test. The interesting aspect of this feature is that it does vary throughout the test (including the run-up to failure). Figure 23 shows the quick-look estimation of the frequency of this phenomena during several of the constant pressure data sets. The frequency increase from around 1000Hz to approximately 1013Hz suggests that this phenomena is a feature of the test article and does not have an external or electrical source. The low damping and consistent presence suggest that there might be any number of sources including a leak or an acoustic phenomena. However, a lightly damped and easily excited mode of the test stand/metallic core is also a possibility. Efforts continue to understand this phenomena and to more fully characterize the other phenomena in the data. As a note, there are a rich set of dynamics phenomena in the 100 to 400Hz region in certain directions as well as some electrical harmonics that appear in the data.

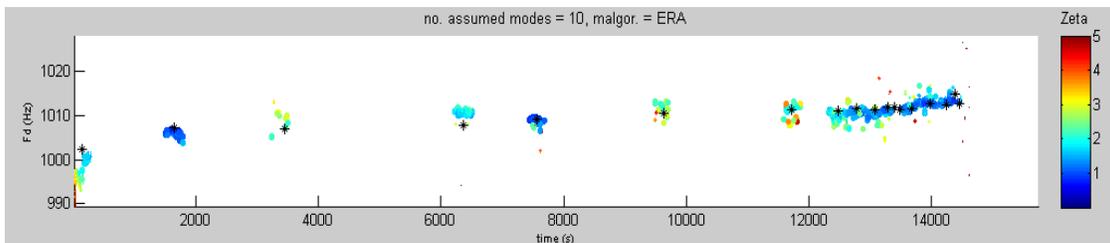
**Figure 23. Trend of Increasing Frequency of the 1000 Hz Phenomena with Time**

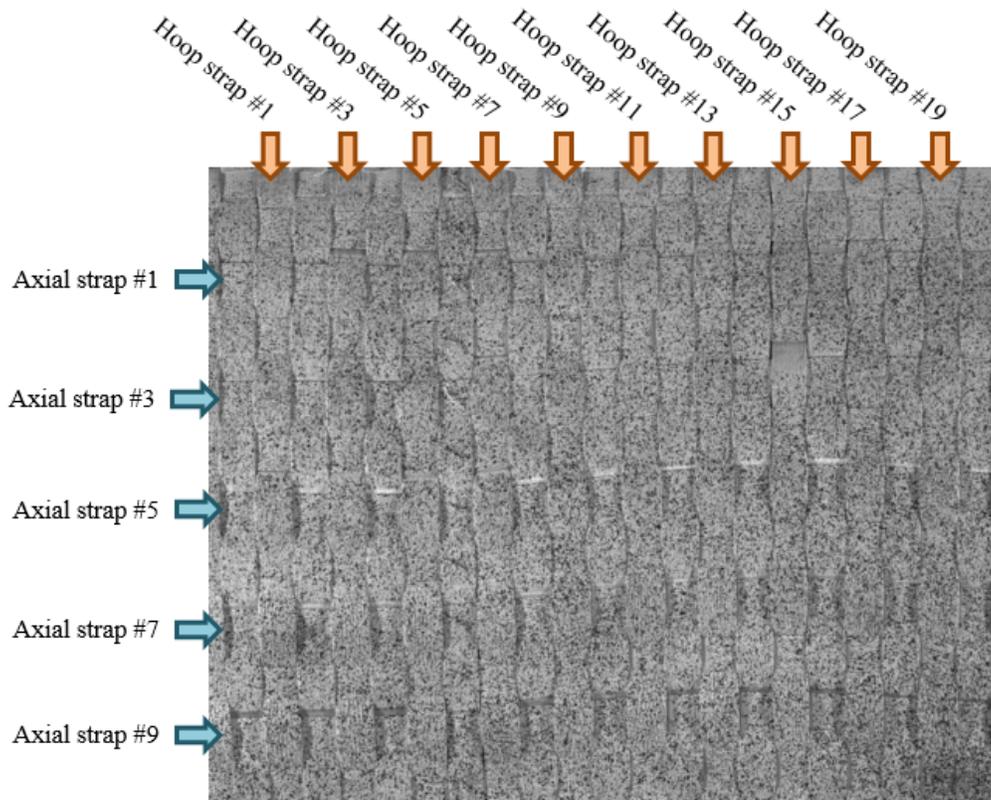
**Figure 24. Location of Hoop Straps and Axial Straps measured**

Strain data were obtained from the photogrammetry images, as described in Section V. Five Axial straps (shown horizontally in Figure 24) and ten Hoop straps (shown vertically in Figure 24) were selected for the first round of analysis. Strain measurements were taken at ten locations across each Axial strap and 5 locations across each Hoop strap, as seen in Figure 10 and Figure 16. Figure 25 shows the strain measurements at each of the locations on Axial strap 1. The plots for the other straps look similar to Figure 25. The strain is converted to load using the load vs. strain equations generated in the strap level testing (Section IIA and Figure 3) and the average load for the strap is calculated (Figure 26). Figure 27 shows the average load in each of the Axial straps (Axial straps 1, 3, 5, 7, 9), and the comparison to the predicted load. The analytical prediction is determined as described in Section III E. The curve labeled “burst prediction” is determined based on the typical average ultimate tensile strength seen in strap level tensile testing, and the hydrostatic burst pressure observed in previous burst tests of this same restraint layer design. The hoop strap plots shown in Figure 28 and Figure 29 were generated by the same process used for the axial straps.

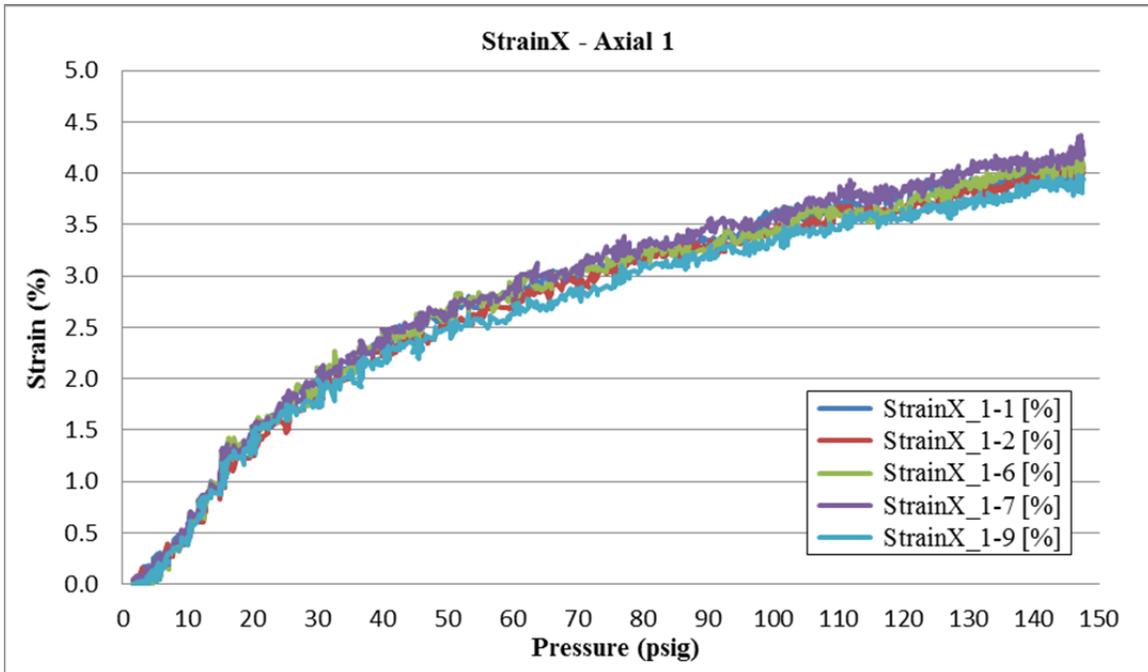
**Figure 25. Strain on Axial Strap 1.**

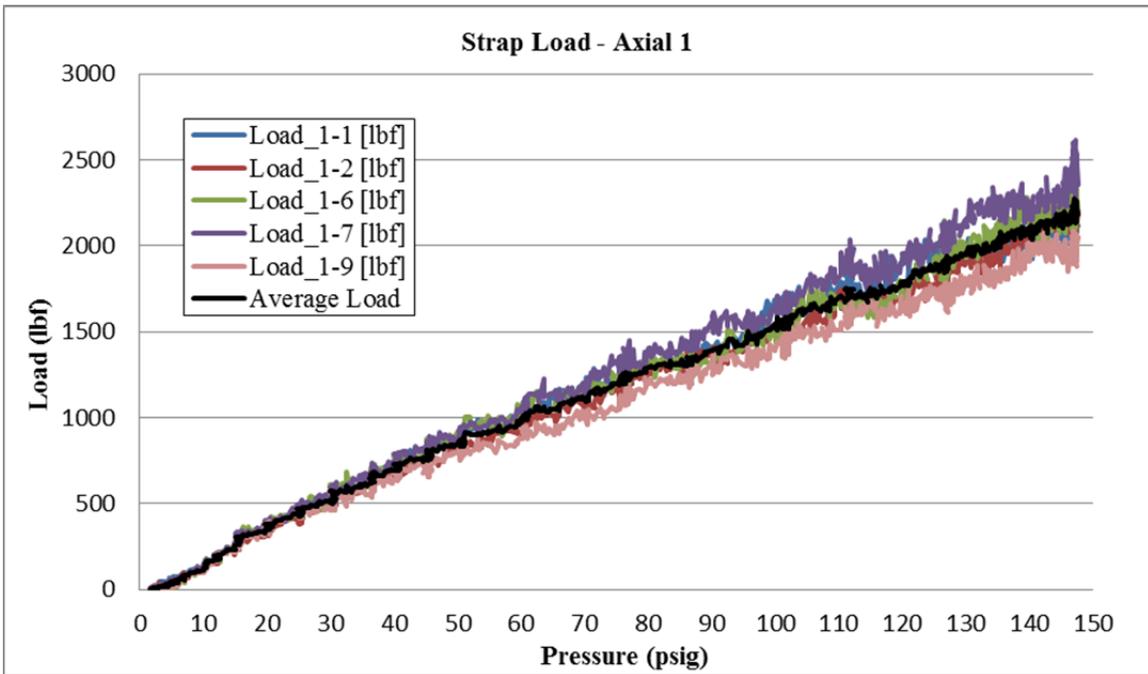
**Figure 26. Load on Axial Strap 1.**

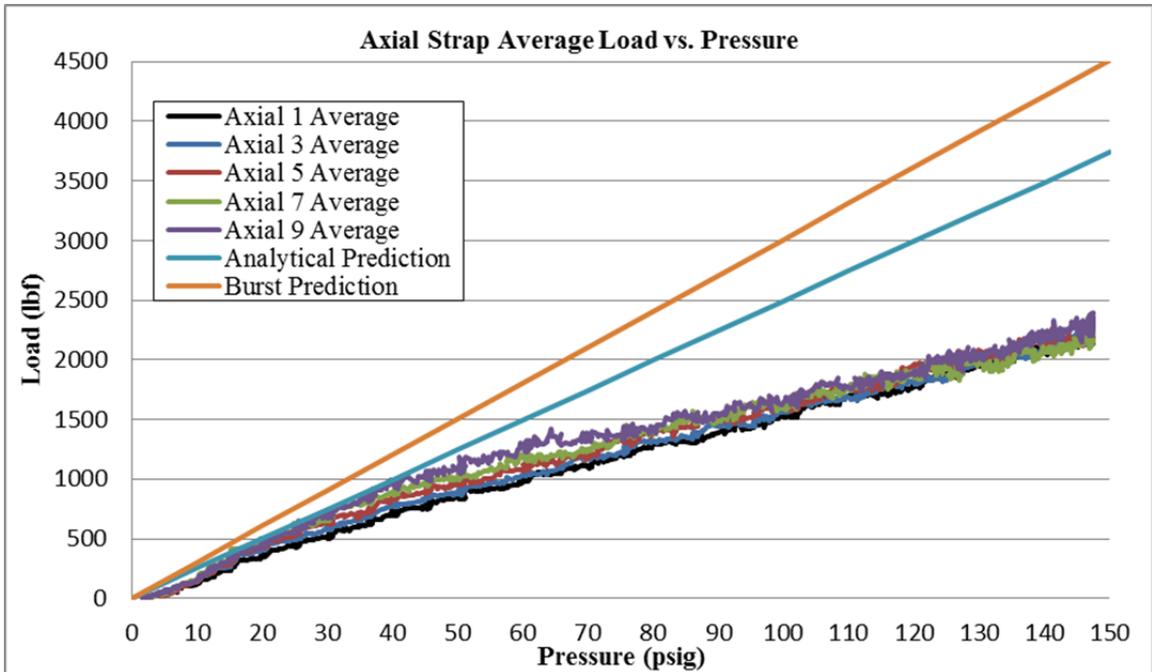
Figure 27. Axial Strap Average Load vs. Pressure.

The strap load data obtained from Photogrammetry measurements falls below the prediction curves for both the axial straps and the hoop straps. This is consistent with observations from previous tests. More work is necessary to perfect the technique of photogrammetry on tightly woven softgoods, to identify alternate means of measuring the strap load without disturbing the restraint configuration, and to develop more accurate analytical methods.

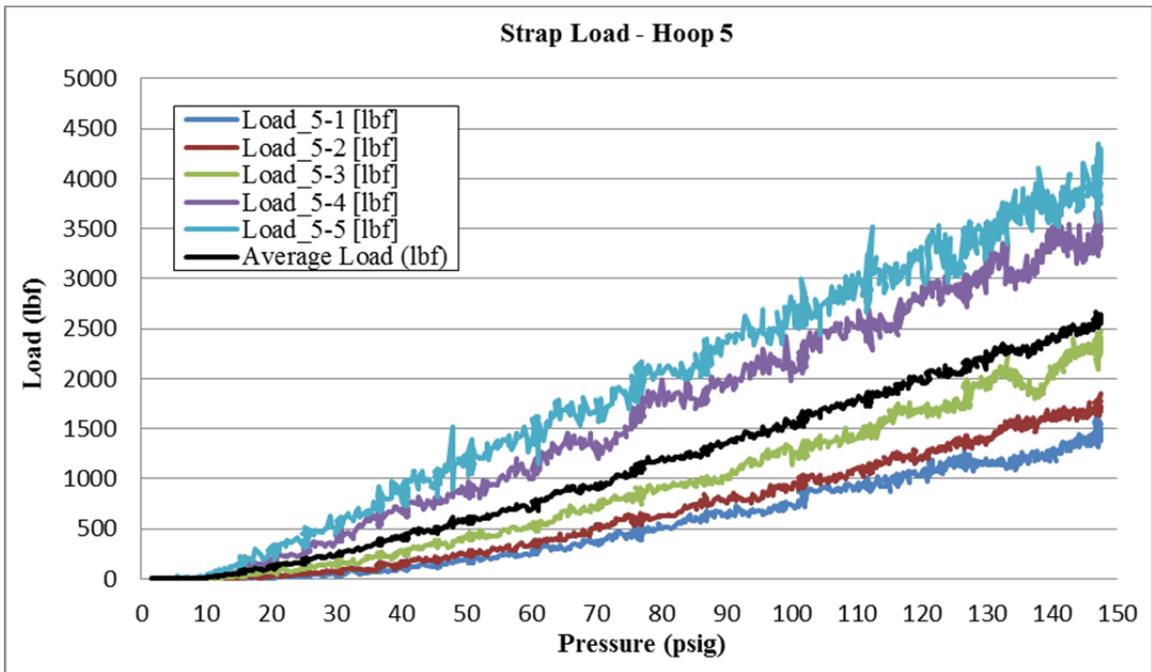
Figure 28. Strain on Hoop Strap 5.

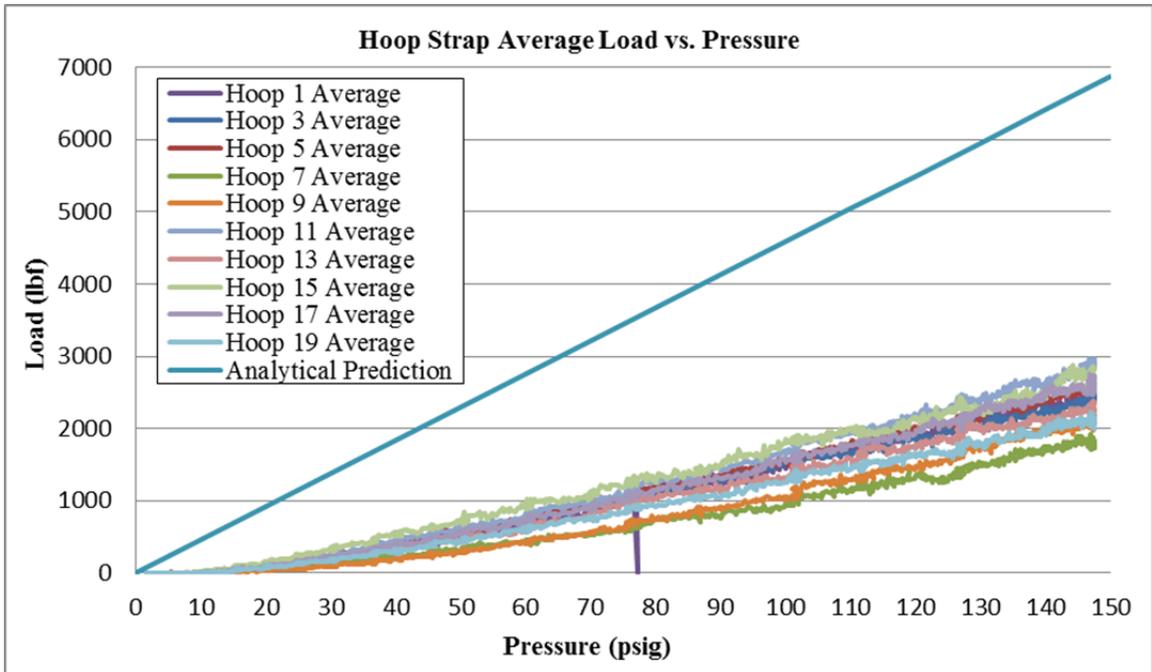
Figure 29. Hoop Strap Average Load vs. Pressure.

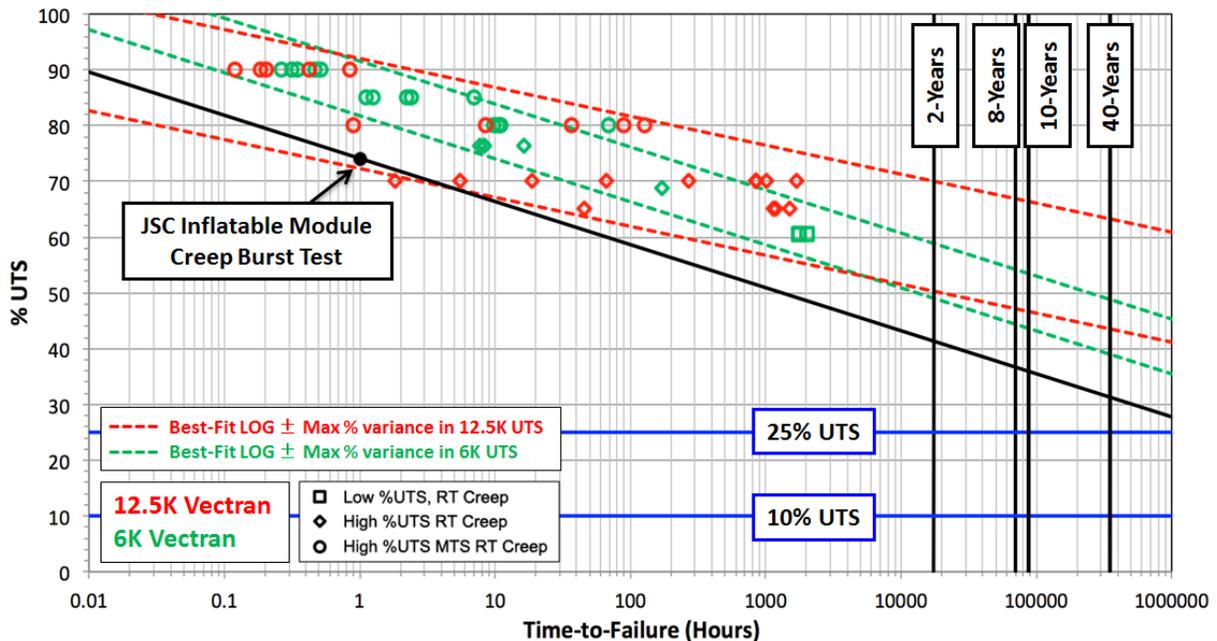
Figure 30. Vectran creep curve projections.

When the module level creep results are plotted with the strap level creep results, the effects of the multi-strap architecture are observed. Figure 30 is a plot of Creep life versus percent of ultimate loading for 6,000 lb/in (shown in green) and 12,500 lb/in (shown in red) for Vectran webbing procured by NASA. The vertical axis shows the percent of ultimate strength and the horizontal axis shows time-to-failure on a log-scale. Also shown (black dot) is where the 88-inch diameter inflatable module burst.

Based on prior tests and analysis, it was determined that the first failure mode of the assembled module was in one of the 6,000 lb/in structural webbings. For the 6,000 lb/in webbings there is a large failure range for webbings loaded between 60% and 90% of ultimate. That range is bound by the two dashed green lines and projected for longer durations. The black line is drawn through the point where the test article failed and parallel to the dashed green lines that bound 6,000 lb/in webbing failures.
