# Landsat-8 Thermal Infrared Sensor (TIRS) Vicarious Radiometric Calibration

Abstract: Launched in February 2013, the Landsat-8 carries on-board the Thermal Infrared Sensor (TIRS), a two-band thermal pushbroom imager, to maintain the thermal imaging capability of the Landsat program. The TIRS bands are centered at roughly 10.9 and 12 µm (Bands 10 and 11 respectively). They have 100 m spatial resolution and image coincidently with the Operational Land Imager (OLI), also on-board Landsat-8. The TIRS instrument has an internal calibration system consisting of a variable temperature blackbody and a special viewport with which it can see deep space; a two point calibration can be performed twice an orbit. Immediately after launch, a rigorous vicarious calibration program was started to validate the absolute calibration of the system. The two vicarious calibration teams, NASA/Jet Propulsion Laboratory (JPL) and the Rochester Institute of Technology (RIT), both make use of buoys deployed on large water bodies as the primary monitoring technique. RIT took advantage of cross-calibration opportunity soon after launch when Landsat-8 and Landsat-7 were imaging the same targets within a few mi

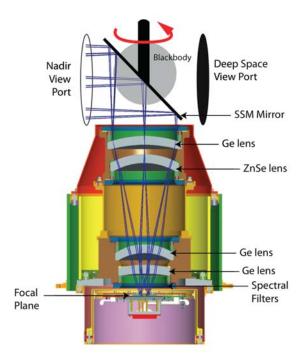
**Figure 1.** TIRS optical diagram. The SSM mirror rotates between the nadir viewport, blackbody and deep space viewport to provide calibration at least once an orbit.

The instrument features a four-element refractive optics telescope, with three germanium (Ge) elements and one zinc selenide (ZnSe) element, which directs the incoming energy onto the focal plane (Figure 1). A flat mirror at the front of the telescope, the Scene Select Mechanism (SSM), switches the field of view between the earth and the two internal calibration positions for view of deep space and the on-board blackbody.

The internal calibration system consists of a variable temperature blackbody, a port by which the instrument can view deep space, and a Scene Select Mechanism (SSM) that allows the sensor to view the blackbody, deep space or the earth (see Figure 1). The blackbody and deep space views are acquired at the bottom of the descending pass and at the top of the ascending pass every orbit. During these opportunities, the SSM is moved so that the instrument captures a one-minute image of deep space. The mirror flips to the blackbody position for a one-minute image and then back to the deep space for another one minute image. The blackbody is nominally kept at a single temperature (295 K). Details of the on-board calibration methods can be found in [10]. The purpose of discussing them here is to demonstrate that the TIRS instrument appears to be stable based on the on-orbit internal calibrator results. A responsivity metric *g*, of the on-board stability is calculated from the response to the blackbody and deep space for individual calibration sequences:

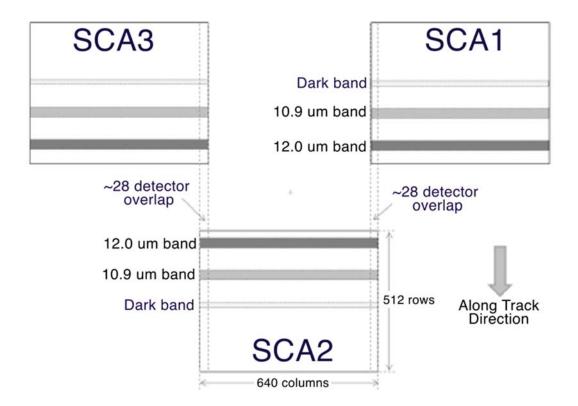
**Figure 2.** TIRS focal plane diagram. The areas of the three SCAs covered by the spectral filters are indicated, along with the region on each SCA used to measure the dark signal.

The pushbroom focal plane consists of three separate Sensor Chip Assemblies (SCAs), each  $512 \times 640$  pixels. Figure 2 shows the layout of the chips on the focal plane; two SCAs are slightly offset from the third in the along-track direction by about 300 rows in Band 10 and 200 rows in Band 11. The SCAs overlap in the across-track direction by 28 pixels. The temperature of the focal plane is controlled by the cryocooler to ~40 K and maintained to within  $\pm 0.01$  K [9]. The spectral interference filters lay on top of the SCAs, covering about 30 rows of the 512-row chip. Of these 30 rows, only one row per-band is read out to generate the standard image product. A second row per-band is designated as backup, in case a detector in the primary row fails. Several rows outside of the spectral filter are completely blocked from incoming energy and are used to characterize the internal instrument dark signal.

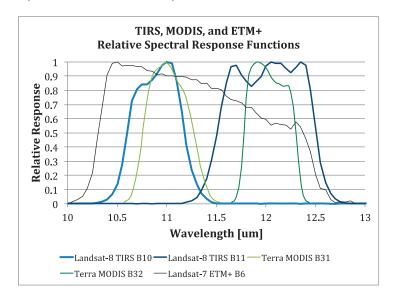
**Figure 3.** The relative spectral responses (RSR) of the TIRS bands (B10 and 11). Also shown for comparison are the RSRs of ETM+ band (B6) and the equivalent MODIS bands (B31 and 32). The TIRS and ETM+ RSRs are band-average but the MODIS RSRs are each for a specific detector (detector 5 in both cases).

The spectral interference filters were designed to provide the optimal band combination for use in a split-window atmospheric correction algorithm [11]. Figure 3 shows the final band-average TIRS relative spectral responses (RSRs) for each band.

The three sensors, TIRS, ETM+ and MODIS, cover the same spectral regions but don't have identical RSRs (Figure 3). Sensor reaching radiance can be converted to top-of-atmosphere brightness temperature using the Planck function.

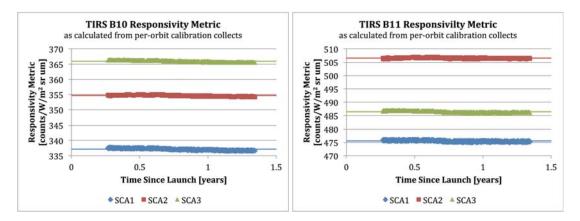
**Figure 4.** The SCA-average per-calibration sequence responsivity metric for both TIRS bands along with the per-SCA lifetime average. Based on this and other metrics, the TIRS instrument is internally stable.

where  $Q_{BB}$  is the bias-subtracted, linearized digital counts extracted from the blackbody image,  $Q_0$  is the instrument offset which incorporates instrument and electronic biases,  $L_{BB}$  is the spectral radiance of the blackbody as converted from the monitor thermistor readout and  $L_{space}$  is the spectral radiance of deep space, assuming a 4 K background. The metric is calculated per-SCA since all detectors on a single SCA share electronics. Note that this is not the actual gain equation. Instrument gain and bias are covered in detail in [12]. Since launch, the SCA-average metric may have a slowly decreasing trend (maximum of -0.28%/year  $\pm 0.005\%$ /year in the worst case) but the total variability over the lifetime is still only 0.08% ( $1\sigma$ ) for the worst case (Figure 4).

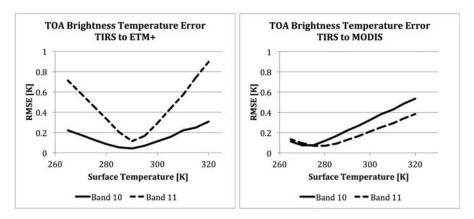
**Figure 6.** The estimated root-mean-squared error (RMSE) error in comparing the ETM+ (**left**) or MODIS (**right**) to TIRS brightness temperatures over a range of surface temperatures and through a variety of atmosphere types. The largest errors are due to less likely conditions, *i.e.*, a very warm surface in a very cold atmosphere.

A study simulating the difference between spectral radiance and brightness temperature was performed to verify the ability to compare data between two different calibrated sensors. Using MODTRAN to perform the radiometric propagation, four North American Regional Reanalysis (NARR) atmospheres [19] were processed to test the difference between brightness temperature for ETM+ or MODIS and the TIRS bands. The NARR atmospheres were selected to cover a wide range of atmospheric conditions, from hot and dry to cold and wet. When compared in terms of apparent temperature, Landsat-7 Band 6 temperatures and Landsat-8 Band 10 or 11 temperatures over water should agree to within  $\pm 0.5$  K for most realistic conditions and within  $\pm 1$  K for extreme conditions (e.g., very warm moist air over very cold water) (Figure 6). The agreements are better between MODIS Band 31 and TIRS Band 10 and MODIS Band 32 and TIRS Band 11, where even the worst cases should be within  $\pm 0.5$  K.

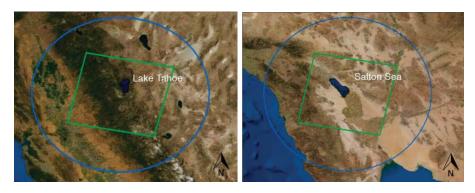
**Figure 8.** The 185 km wide scene boundaries of the standard Lake Tahoe, located at 39N, 120W (**left**), and Salton Sea, located at 33.3N, 115.8W (**right**), image frames are indicated by the green box. The blue circle indicates the 15° ring source of stray light (though the stray light does not necessarily come from the whole circle). In both cases, the source of the stray light is primarily from land (given that no snow or clouds are covering the surface) outside the area observed by Landsat-8.

The extent of the stray light contribution was defined by lunar scans so the source of the stray light in the vicarious calibration imagery can at least be examined. Lake Tahoe and the Salton Sea are both relatively small water bodies, surrounded by land. The out-of-field contribution for these targets comes in large part from the arid desert regions of Nevada and southern California (Figure 8). For many of the RIT sites, the buoys are largely surrounded by water, though some, as in Figure 7, are inland buoys.

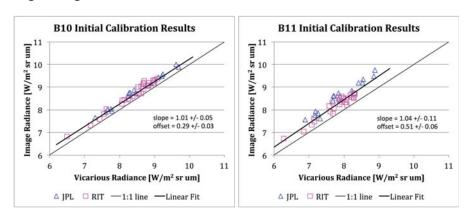
**Figure 9.** The initial vicarious calibration results for both TIRS bands, based on the day JPL and RIT buoy data. If the instrument were perfectly calibrated, the data would fall scattered about the 1:1 line. All results for both bands are above the 1:1 line indicating that the instrument is predicting too high.

The initial calibration error was calculated in November 2013, based on all the available daytime buoy data from JPL and RIT. The TOA-predicted radiance (vicarious radiance) was compared to the TIRS estimated radiance (image radiance) point for point. The data were spread amongst all three SCAs, though all of the JPL data falls on SCA2. All data from both teams and the three SCAs were treated as one data set and the slope and offset were assessed to determine the calibration error (Figure 9). The slope of the trend was not statistically significant, indicating that there was not likely an error in the calibration gain. However, the data were all above the 1:1 line, indicating that the instrument is predicting a radiance that is too high. This bias error was calculated as the average difference between the vicarious radiance and the TIRS image radiance for all data points for each band.

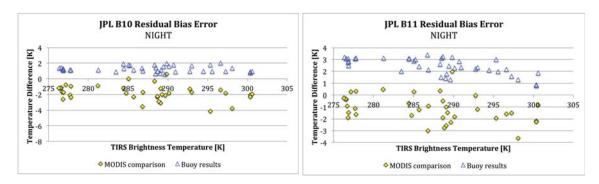
**Figure 13.** JPL buoy and MODIS comparison results plotted versus target brightness temperature. The trends do not overlap but they both indicate that the residual error is not dependent on target temperature. The trend in the Band 11 data is a function of the seasonal effect of the stray light.

The JPL MODIS to TIRS comparison illustrates how the biases are different day and night, how there is more scatter in the day than night data and how there is more scatter with Landsat-8 band 11 than with Landsat-8 band 10. The fact that there is a larger scatter than with the buoy comparisons can be attributed to mismatch in the acquisition times between the two sensors (Figure 13) and highlights why these sensor-to-sensor comparisons do not provide a substitute for validation against in-situ data. As noted in the introduction, the next step in this analysis will be to derive the surface skin temperature from the MODIS data and use that in a similar manner to the way the buoy data are used to remove the RSR differences.

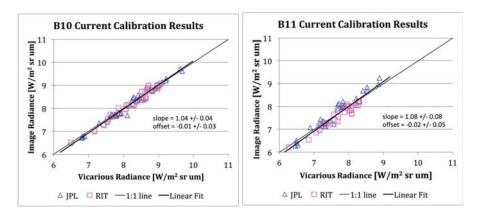
**Figure 14.** Current vicarious calibration results for the two TIRS bands, including both RIT and JPL data for all SCAs, but only displaying day data. The data are scattered about the 1:1 line, indicating that the residual error has been removed. Neither the slope nor the offset is statistically significant.

on the collected dataset now does not have a statistically significant bias error (Figures 14 and 15 and Table 4).

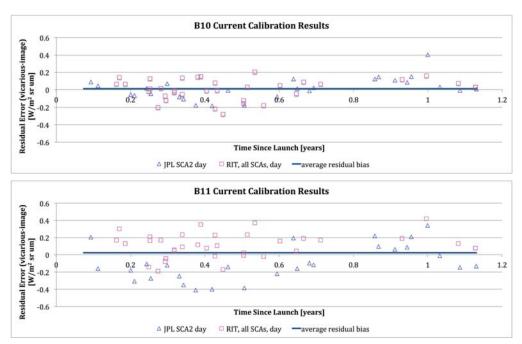
**Figure 15.** Current vicarious calibration results for the two TIRS bands over time. The residual difference between the vicarious radiance and the image radiance is scattered about the zero axis.
