# ATLAS Beam Steering Mechanism Lessons Learned

This paper describes the design, testing, and lessons learned during the development of the Advanced Topographic Laser Altimeter System (ATLAS) Beam Steering Mechanism (BSM). The BSM is a 2 degree-of-freedom tip-tilt mechanism for the purpose of pointing a flat mirror to tightly control the co-alignment of the transmitted laser and the receiver telescope of the ATLAS instrument. The high resolution needs of the mission resulted in sub-arcsecond pointing and knowledge requirements, which have been met. Development of the methodology to verify performance required significant effort. The BSM will fly as part of the Ice, Cloud, and Elevation Satellite II Mission (ICESat II), which is scheduled to be launched in 2017. The ICESat II primary mission is to map the Earth's surface topography for the determination of seasonal changes of ice sheet thickness and vegetation canopy thickness to establish long-term trends.

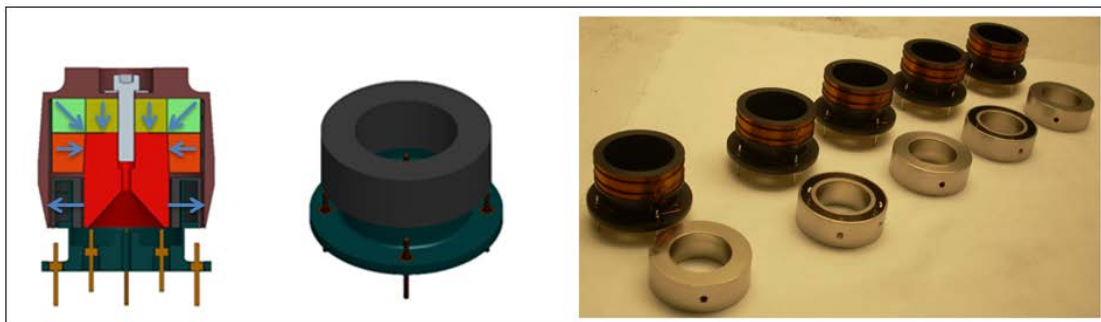
**Figure 3. BSM Actuator Cross Section, Bobbin Assy., and Bobbins with Sleeves**

Passive damping with a shorted coil, such as a solid copper sleeve, can waste power when slewing. In the case of the BSM, operational mirror velocities are very small, thus there is insignificant impact upon operational power required to overcome shorted coil passive damping. Thus, shorted coil damping was implemented in the BSM actuator design. Figure 3 shows actuator cross section and component views.

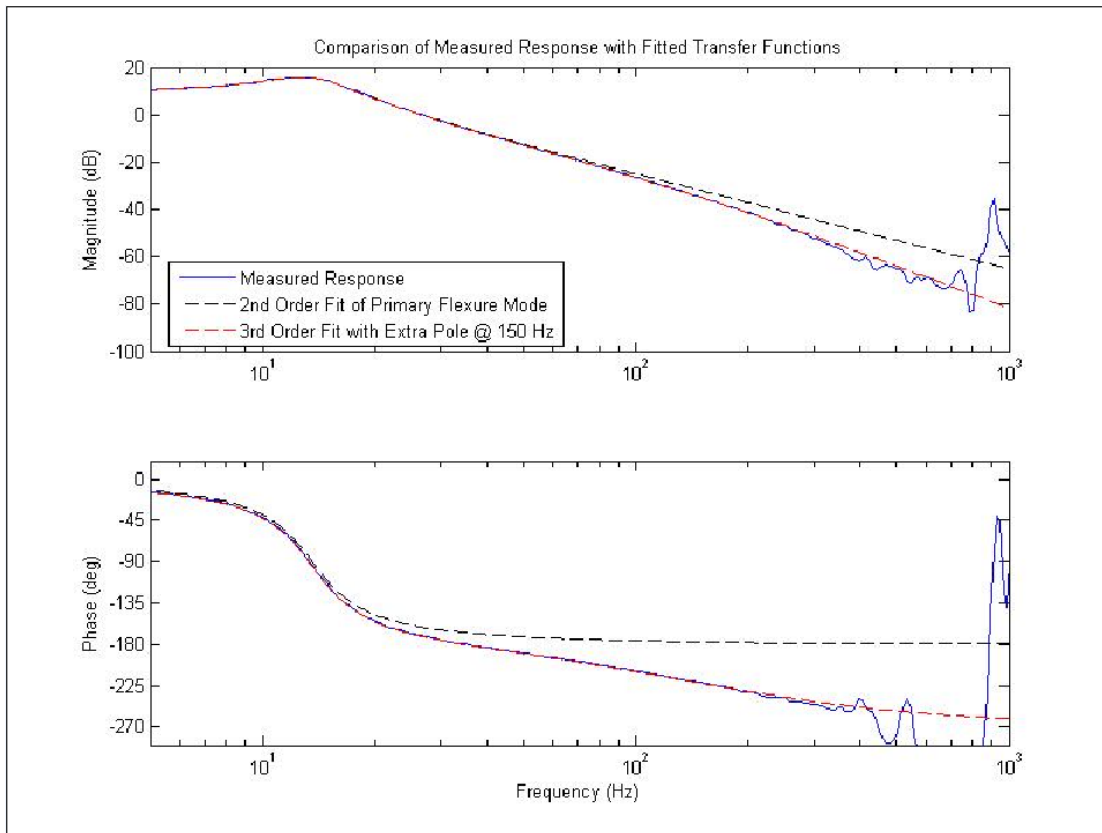
**Figure 10. Unknown Pole**

An unknown pole of 150 Hz was present in the frequency response, but was accommodated with filtering. The pole is unknown in that a MATLAB/Simulink model of the BSM, based upon the mechanical and electrical specifications, did not reveal such a pole. Similar behavior was observed on the Cassini Composite Infrared Spectrometer (CIRS) Scan Mechanism developed in the early 1990s, which also had damping designed into its custom actuator. Since in both cases, we needed to deliver hardware on a tight schedule and we were able to meet performance requirements with the extra pole, we moved forward. In both cases the project ended without the opportunity to spend the time to fully understand the physics behind the behavior. However, we believe the unknown pole to be the result of coupling between the actuator windings and the damping sleeve, which were arranged coaxially in both projects (Figure 10).
