Materials Characterization of Electron Beam Melted Ti-6Al-4V

An in-depth material characterization of Electron Beam Melted (EBM) Ti-6Al-4V material has been completed on samples fabricated on an ARCAM A2X EBM machine. The specimens were fabricated under eight separate builds with the material divided into two lots for material testing purposes. Hot Isostatic Pressing (HIP) was utilized to close porosity from fabrication and also served as a material heat treatment to obtain the desired microstructure. The changes in the microstructure and chemistry from the powder to pre-HIP and post-HIP material have been analyzed. Several nondestructive evaluation (NDE) techniques were utilized to characterize the samples both before and after HIP. The test matrix included tensile, high cycle fatigue, low cycle fatigue, fracture toughness, and fatigue crack growth at cryogenic, room, and elevated temperatures. The mechanical properties of the EBM Ti-6Al-4V are compared to conventional Ti-6Al-4V in the annealed condition. Fractography was performed to determine failure initiation site. The EBM Ti-6Al-4V had similar or superior mechanical properties compared to conventionally manufactured Ti-6Al-4

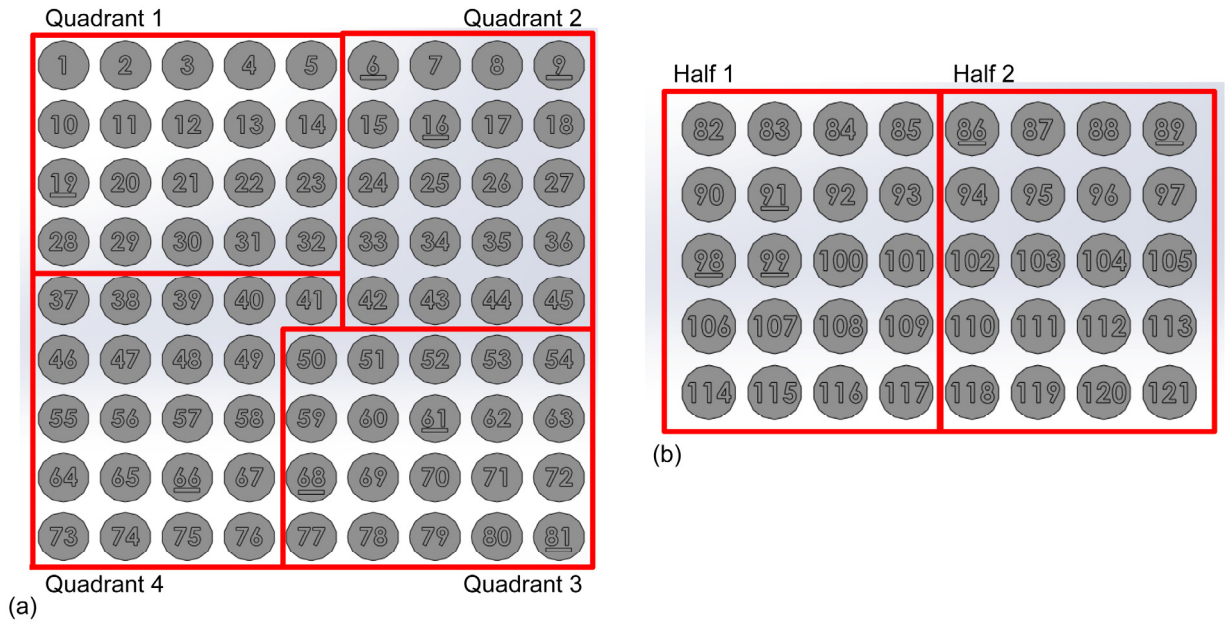
Figure 1.—Lot 1 tensile and fatigue samples built vertically over 2 builds with (a) build 1_1 using 4 quadrants and (b) build 1_2 using 2 halves. The build, or z-direction, is out of the plane of the paper.

A visual comparison was made of the sample HCF lives to the build location (shown in Figs. 1 and 4). It was thought that certain build locations might exhibit consistently lower lives than others. No obvious correlation was discovered. Moreover, it was thought that certain build locations may encourage the formation of inclusions or certain types of inclusions. Again no specific correlation was found. This implies that given the specific build patterns used here, defects were random throughout the builds. Nonetheless, certain inclusions should not have appeared in this material at all (such as Nb) and better care should be taken in maintaining powder cleanliness.

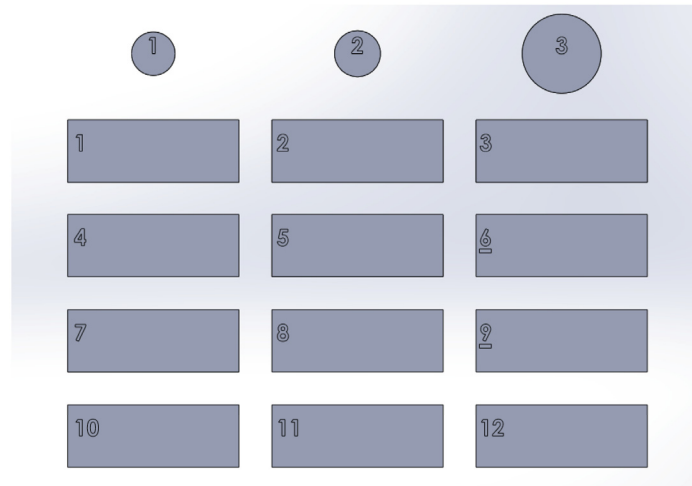
Figure 2.—Build 2 fabricated lot 1 thermal analysis and fracture toughness samples. The same layout was used for lot 2 fracture toughness samples number 13 to 24 in build 5. The build or z-direction is out of the plane of the paper.

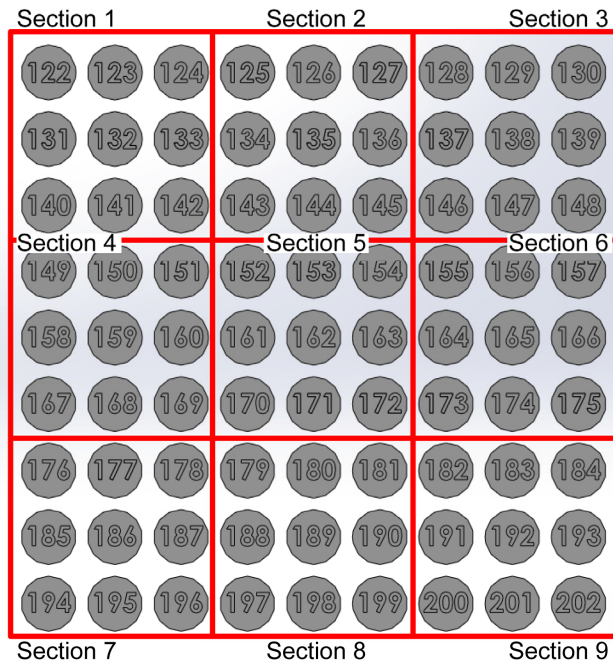
Figure 4.—Lot 2 tensile and fatigue samples built vertically using 9 sections. The build or z-direction is out of the plane of the paper.

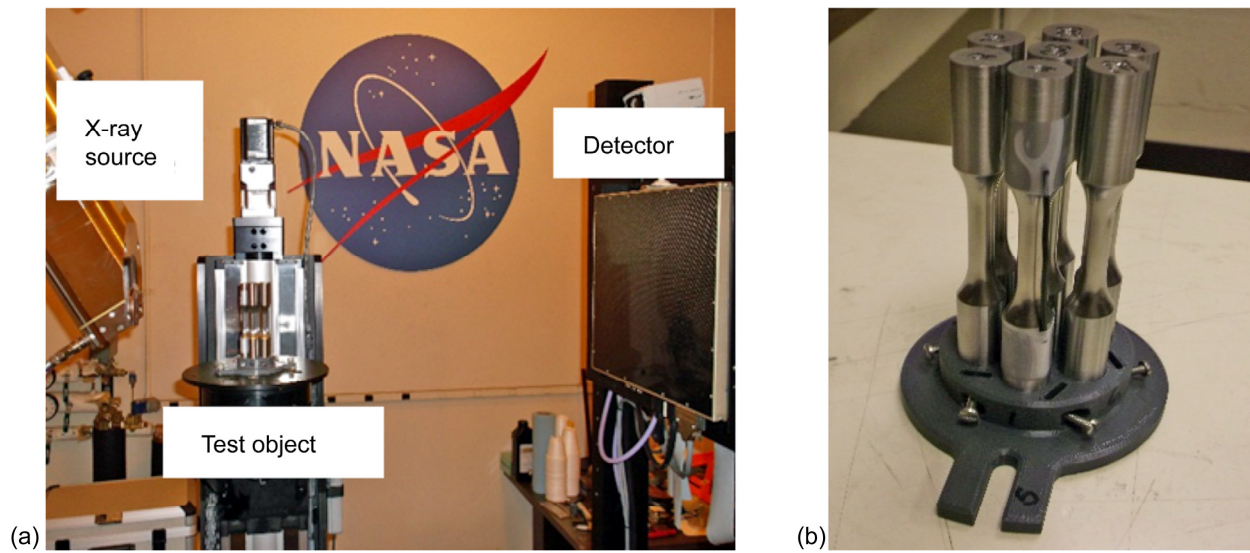
Figure 6.—(a) Micro-focus computed tomography (CT) system with a fixture mounted on a rotating stage allowing (b) 6 samples to be scanned simultaneously.

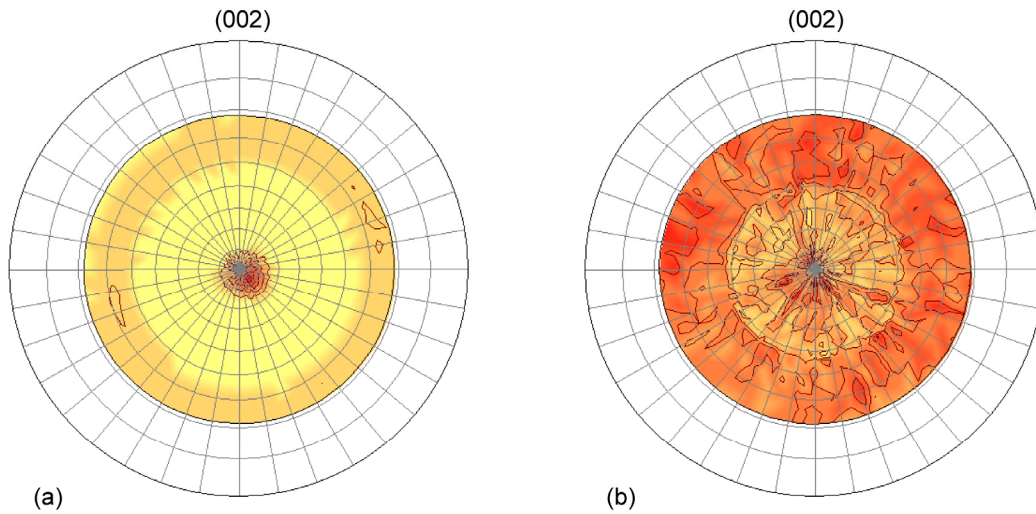
Figure 13.—(002) pole figures from (a) lot 1 showing fiber texture, (b) lot 2 showing random texture with sample surface oriented perpendicular to the build direction.

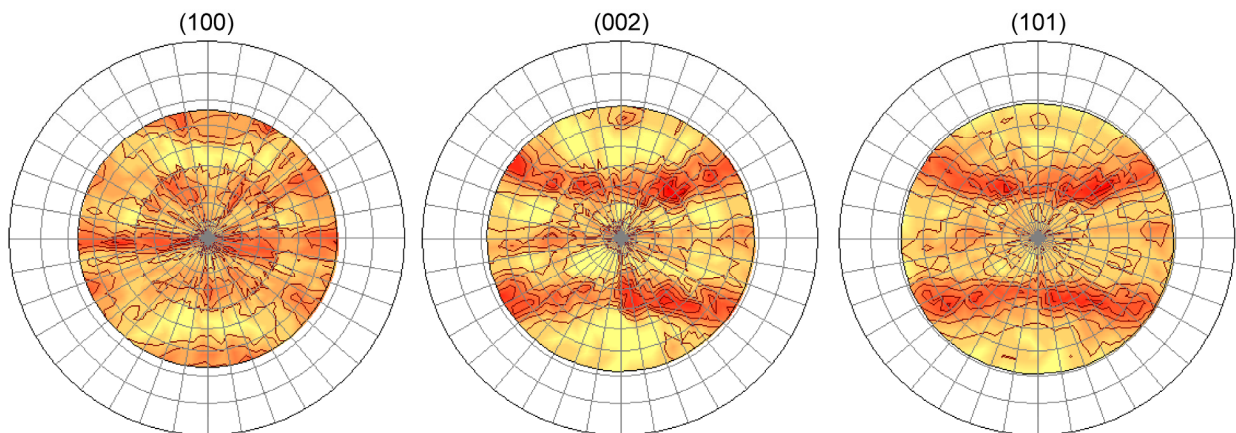
Figure 14.—(100), (002), and (101) Pole figures from a horizontal sample with the sample surface perpendicular to the growth direction. Pole figures show coexisting (100), (002), and (101) α -Ti fiber textures with all three fiber axes parallel to the build direction.

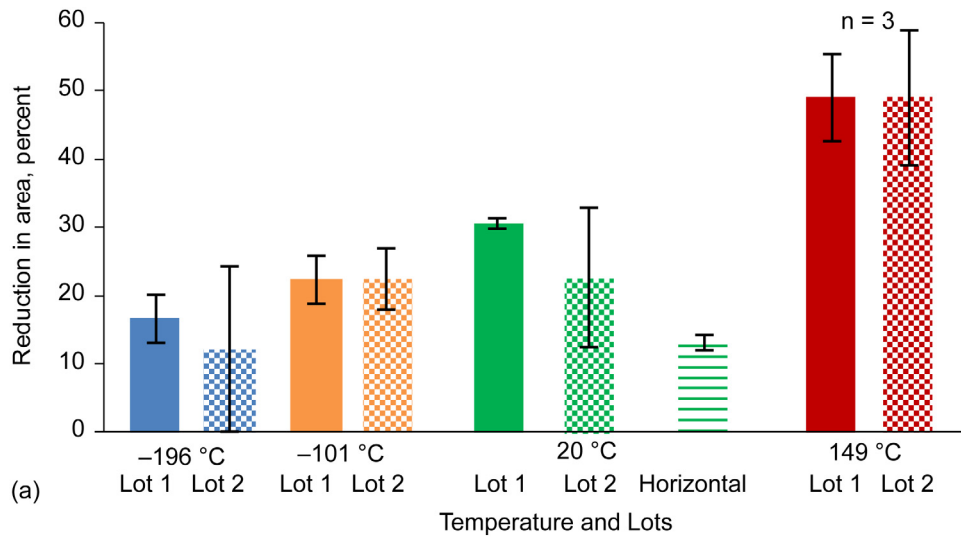
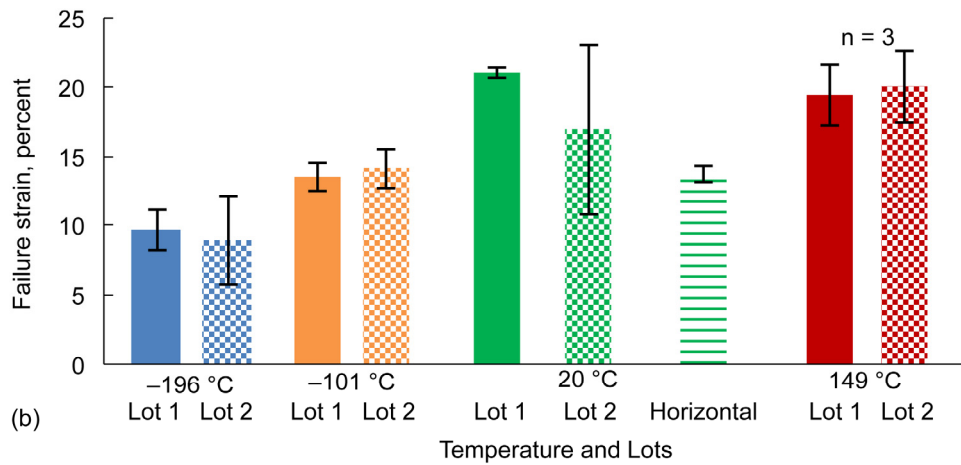
Figure 17.—Plots of (a) failure strain and (b) reduction in area as a function of temperature and sample lots. Error bars represent +/- one standard deviation.

The effect of temperature on tensile properties is shown in Figures 16 and 17. The horizontal samples were only tested at room temperature. As the temperature increased, the YS and UTS decreased and the ductility increased. Even at $-196 \text{ }^\circ\text{C}$, the failure strain was nearly 10 percent and the fracture surfaces exhibited ductility as shown in Figure 18. The difference in strength between lot 1 and 2 samples was consistent over the entire temperature range. The strain to failure exceeded 20 percent from 20 to $149 \text{ }^\circ\text{C}$ for the vertical samples, with the exception of one RT sample (186). Tensile properties are shown in Table IV for all temperatures and samples. Figure 17 depicts the failure strain and RA as a function of temperature and lot, where the error bars equal \pm one standard deviation. The increasing ductility as a

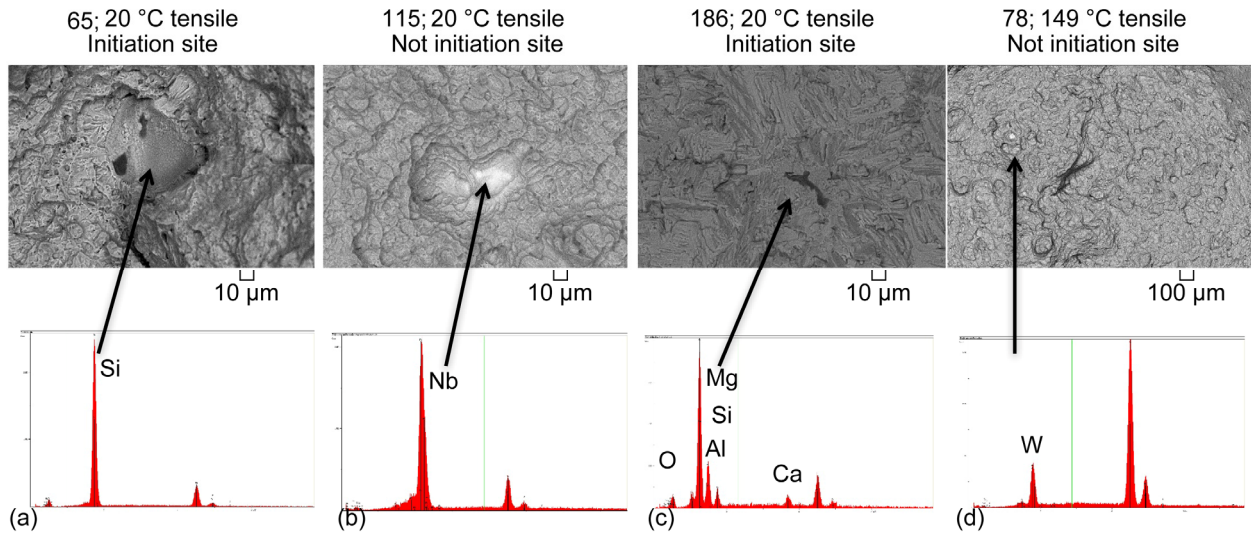
Figure 19.—Tensile fracture surfaces with unusual features. (a) 65 failure initiated at a Si inclusion. (b) 115 had a Nb inclusion on the fracture surface although the fracture did not initiate at the inclusion. (c) 186 fracture initiated at a Mg, Si-rich inclusion which was surrounded by a Si-rich area. (d) a W particle was on the fracture surface of 78 but was not the initiation site.

Tensile fracture surfaces with inclusions are shown in Figure 19. Sample 65, tested at RT, failed at a Si inclusion; however, the tensile properties of sample 65 were not affected. Sample 115, also tested at RT, had an Nb inclusion on the fracture surface, but the Nb inclusion was not the fracture initiation site. Sample 186, mentioned above, was the only sample in which the tensile properties were affected by an inclusion. Sample 186 from lot 2 failed at 9.8 percent, well below the average of 20.8 percent for other vertical RT samples. A low-density inclusion, on the order of 40 μm long, initiated failure, Figure 19(c). Energy dispersive spectroscopy (EDS) analysis shows the inclusion contained Si, Al, O, and Ca. Sample 78 had a W particle on the fracture surface but not at the initiation site. The W could be coming off of the electron beam filament during melting.

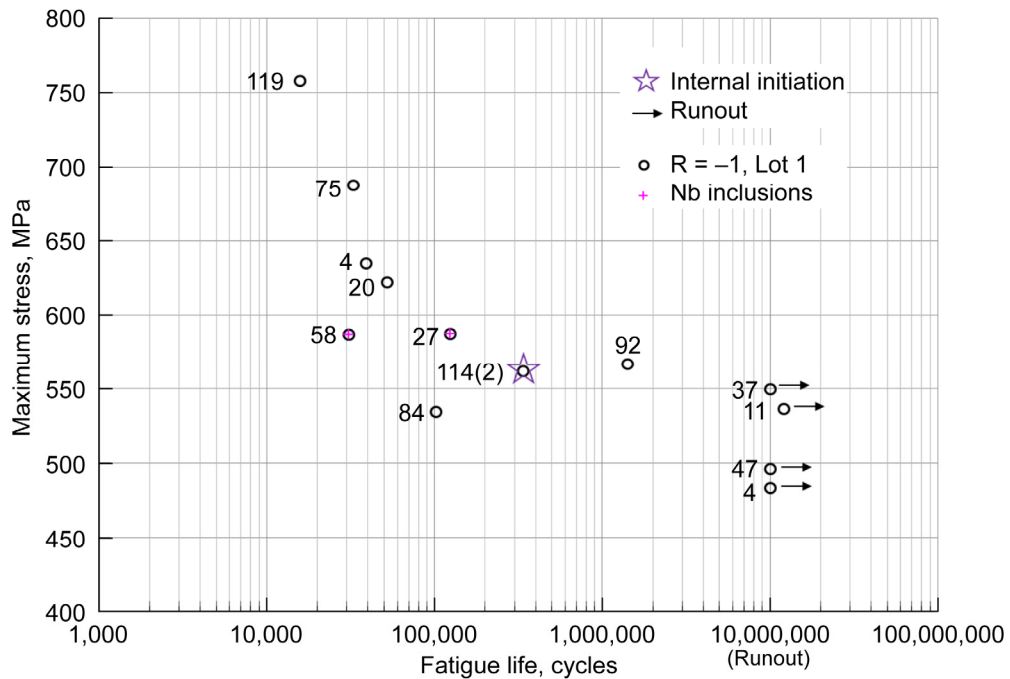
Figure 20.—HCF data for test conditions of 20 °C and $R_{\sigma} = -1$.

The data are plotted in the next several figures. In Figures 20 to 23 the results at 20 $^{\circ}\text{C}$ are plotted as maximum stress, σ_{max} , versus fatigue life, N_f . Figure 20 displays the data for the fully-reversed case ($R_{\sigma} = -1$). Only samples from lot 1 were tested under these conditions. Four of these tests were runouts having reached at least ten million cycles. The remaining samples represent specimen failures (complete separation). The sample numbers are plotted to the left of the symbols for easy reference. All of these samples initiated at the surface with the exception of sample 114 which initiated internally, 1280 μm from the sample surface. This sample was previously runout at a load ratio of 0.5 and a maximum stress of 716 MPa. Similarly, sample 4 was first runout at a stress of 483 MPa and then boosted to a maximum stress of 635 MPa and run until failure at 39,108 cycles. Two of the samples, 27 and 58, both failed at 100 μm diameter Nb-inclusions at the surface. The observation of Nb and other types of inclusions found at HCF initiation sites is discussed later in the paper. With the exception of samples 58 and 84, all of the other tests would appear to fall on a smooth curve with an asymptote (fatigue limit) at 550 MPa.

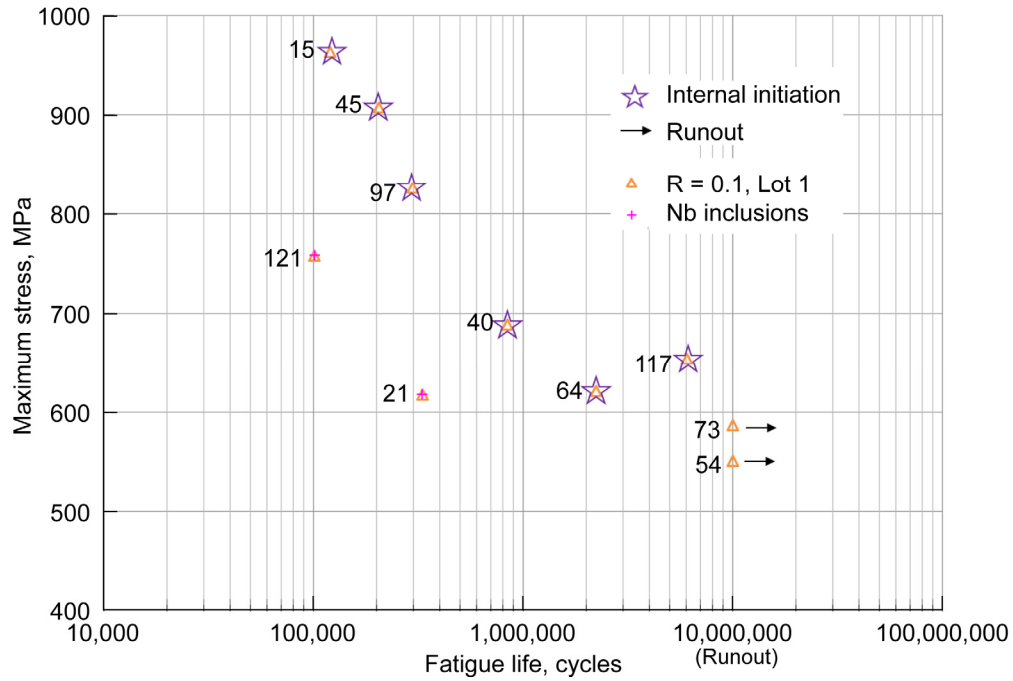
Figure 21.—HCF data for test conditions of 20 °C and $R_\sigma = 0.1$.

For a load ratio of 0.1 the data are plotted in Figure 21 and again only lot 1 samples were run under this condition. Two samples achieved the ten million-cycle limit, all others failed. Most of the samples lie on a smooth curve with an apparent fatigue limit of approximately 600 MPa. Two of the samples (21 and 121) had smaller lives and both had Nb inclusions at their surface initiation site. The remainder of the samples all failed at internal initiations.

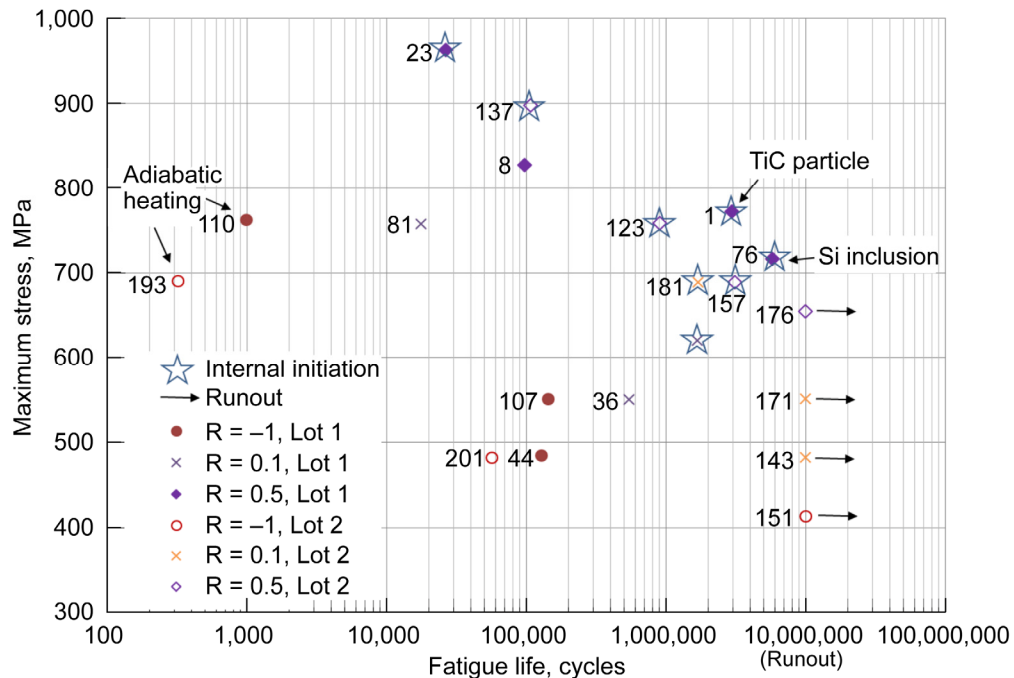
Figure 24.—HCF data for test conditions of 149 °C and various load ratios.

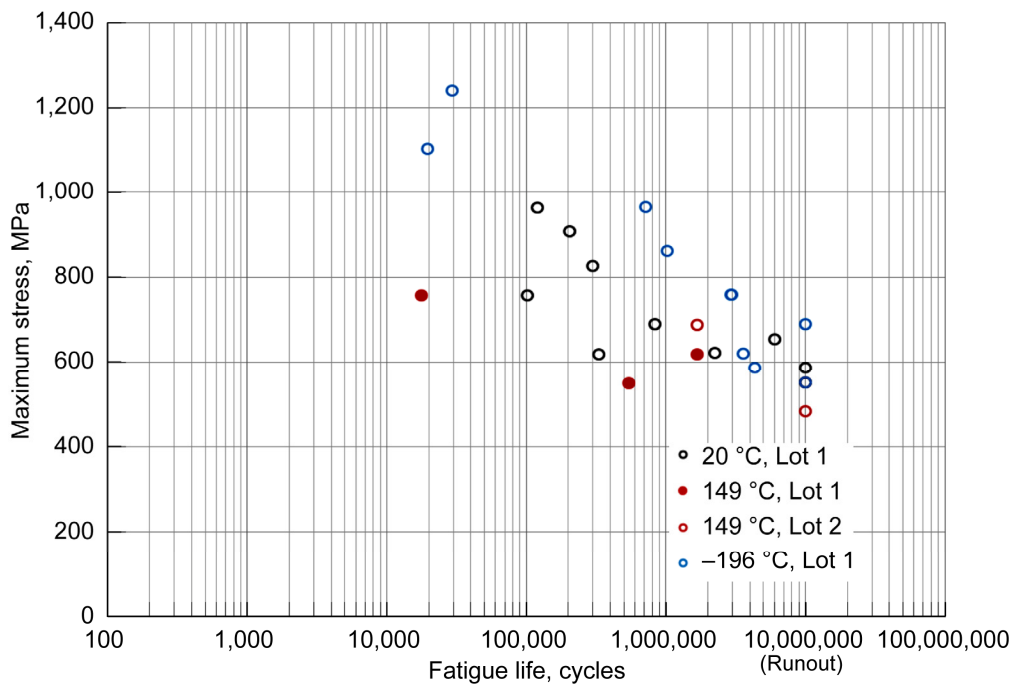
Figure 28.—HCF data for test conditions $R_\sigma = 0.1$ and various temperatures.

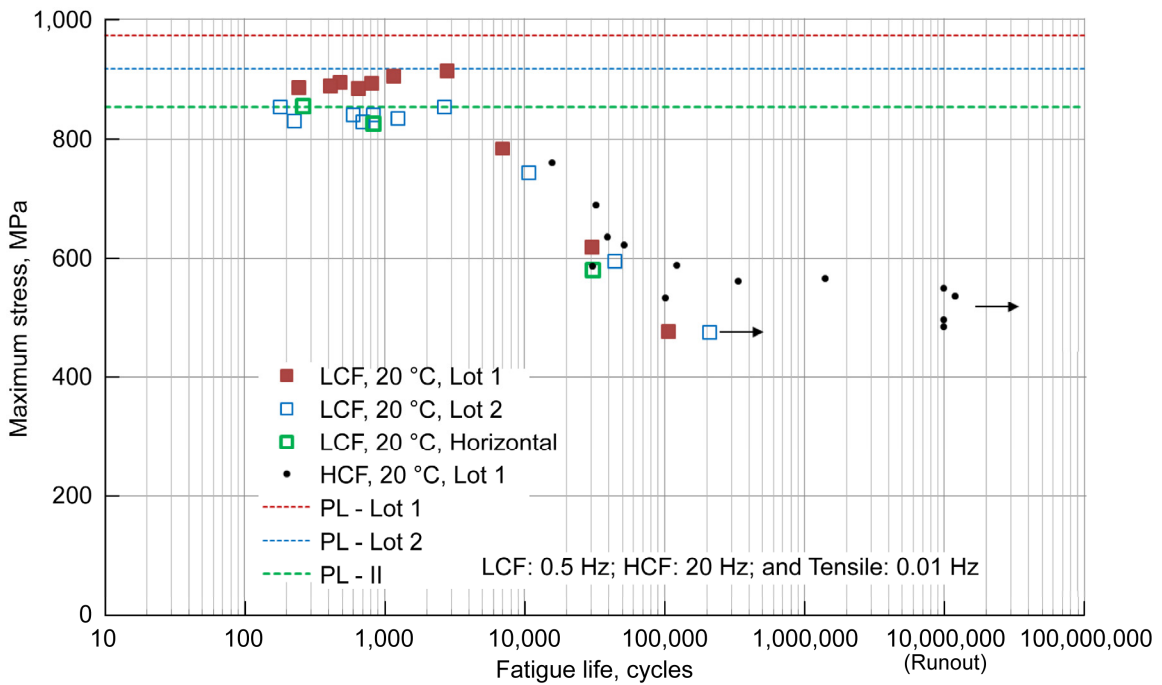
Figure 32.—Fatigue at conditions of 20 °C and fully-reversed loading.

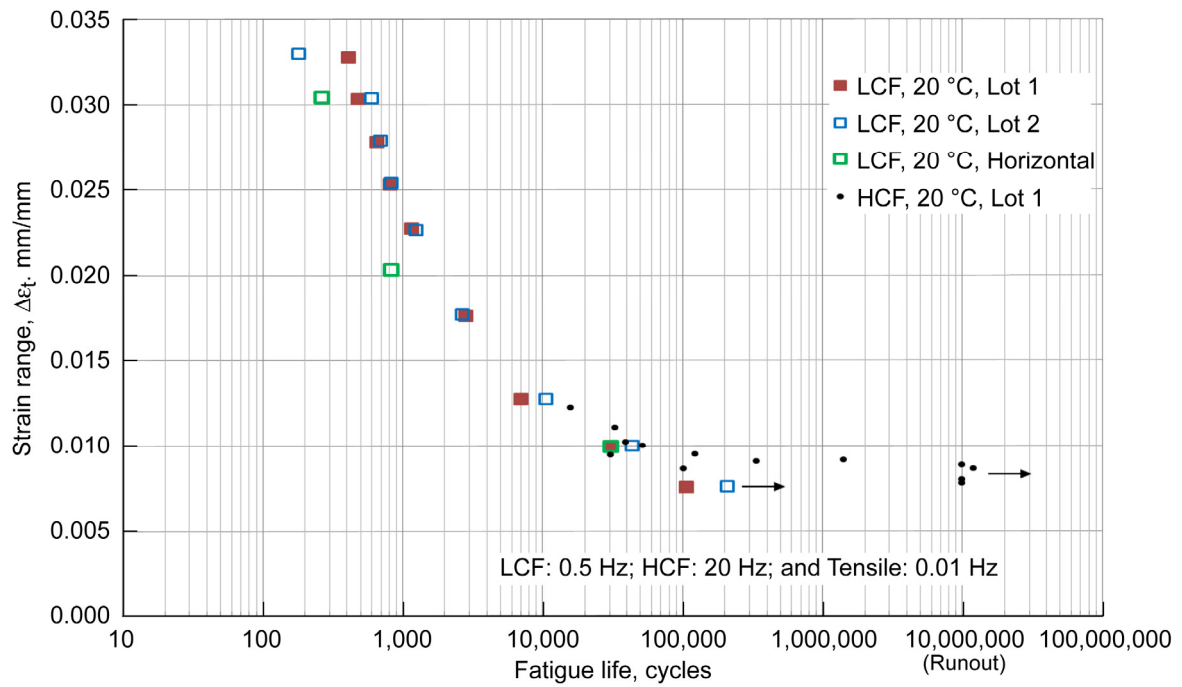
Figure 33.—Fatigue at conditions of 20 °C, $R_\sigma = -1$, and fully-reversed loading.

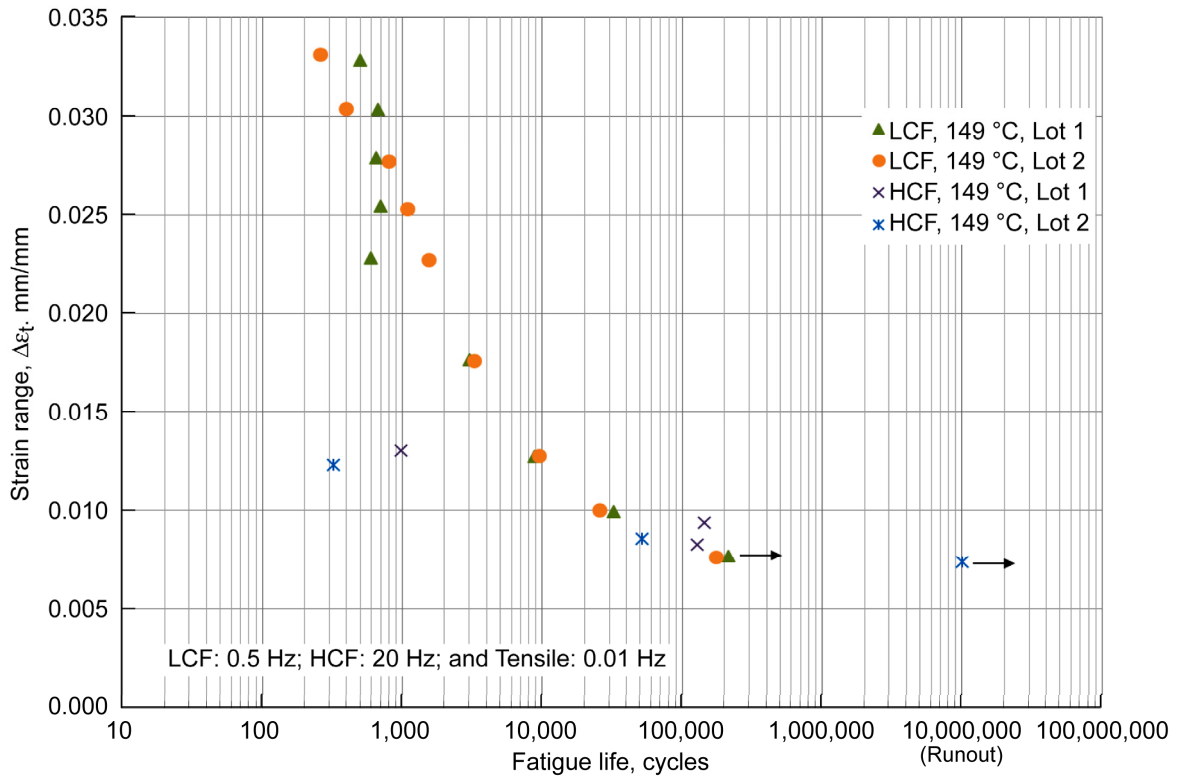
Figure 37.—Fatigue at 149 °C, $R_\sigma = -1$, and fully-reversed loading.
