White Sands Test Facility

Task: Develop Critical Profilometers to Meet Current and Future Composite Overwrapped Pressure Vessel (COPV) Interior Inspection Needs

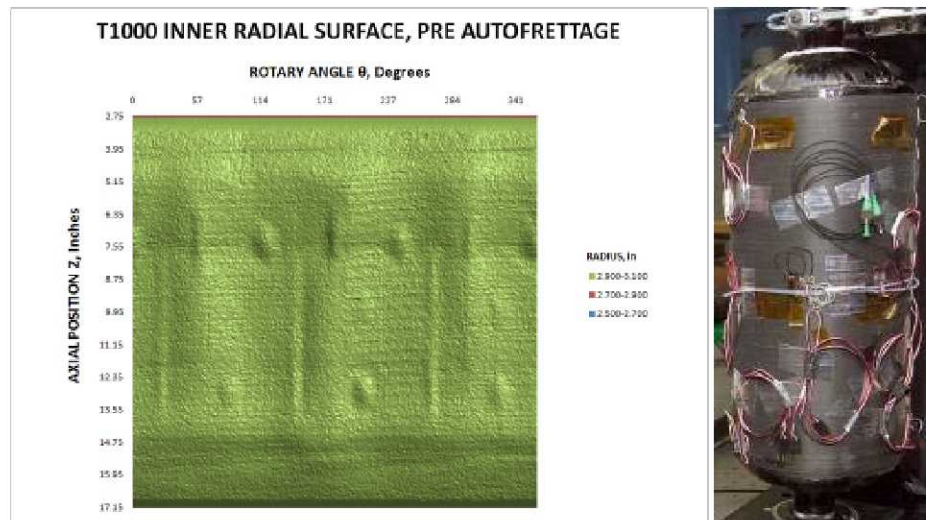
Figure 1

360-degree scan of COPV liner prior to autofrettage (at left), and associated vessels shown with external instrumentation

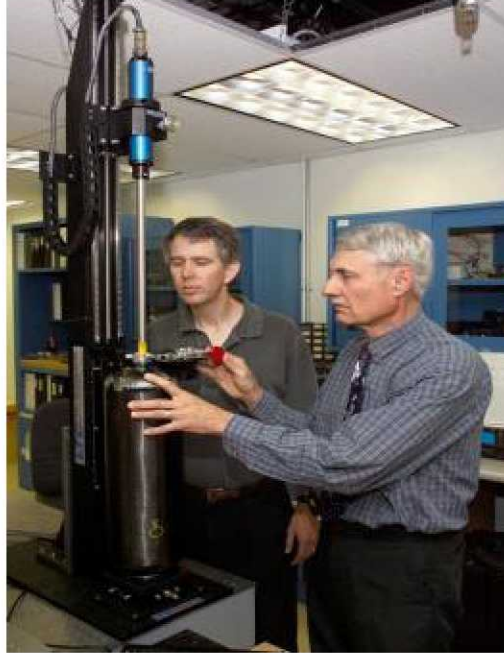
Figure 3
WSTF and Laser Techniques Company personnel evaluate a COPV for the NESC Plastically Responding Liner Project
