RESULTS OF THE
SECOND UNITED STATES
MANNED ORBITAL SPACE FLIGHT
MAY 24, 1962

NASA SP-6

NATIONAL AERONAUTICS AND SPACE ADMINISTRATION
Manned Spacecraft Center
PROJECT MERCURY

1. SPACECRAFT AND LAUNCH-VEHICLE PERFORMANCE

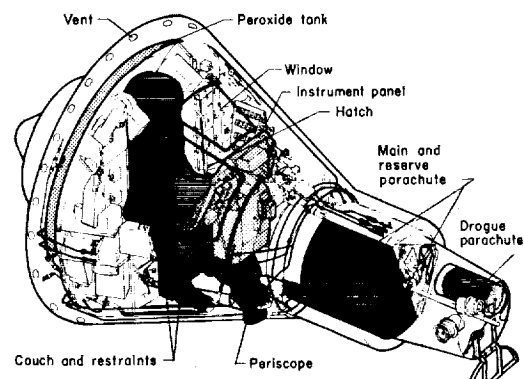
FIGURE 1-1.—Mercury spacecraft systems.

The Aurora 7 spacecraft and Atlas launch vehicle used by Astronaut Carpenter in successfully performing the second United States manned orbital mission (MA-7) were nearly identical to those used for the MA-6 flight. The Mercury spacecraft provided a safe and habitable environment for the pilot while in orbit, as well as protection during the critical flight phases of launch and reentry. The spacecraft also served as an orbiting laboratory where the pilot could conduct limited experiments which would increase the knowledge in the space sciences. The intent of this paper is to describe briefly the MA-7 spacecraft and launch vehicle

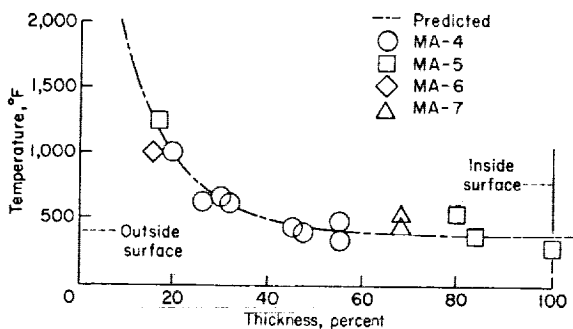
FIGURE 1-2.—Maximum ablation-shield temperatures.

Two temperature measurements were made in the ablation shield, one at the center and the other approximately 27 inches from the center. The maximum recorded values are graphically shown and compared with previously obtained orbital reentry values in figure 1-2. The magnitudes of these temperatures, as well as the ablation-shield weight loss during reentry, are comparable with previous flights. The supporting structure behind the ablation shield was found to be in excellent condition following the flight. A more complete temperature survey of points around the afterbody than on previous flights was conducted for MA-7. This survey was made possible by the addition of a low-level commutator circuit. The data, which are shown in figure 1-3, were within expected ranges, and the integrity of the structure was not affected by the thermal loads experienced.

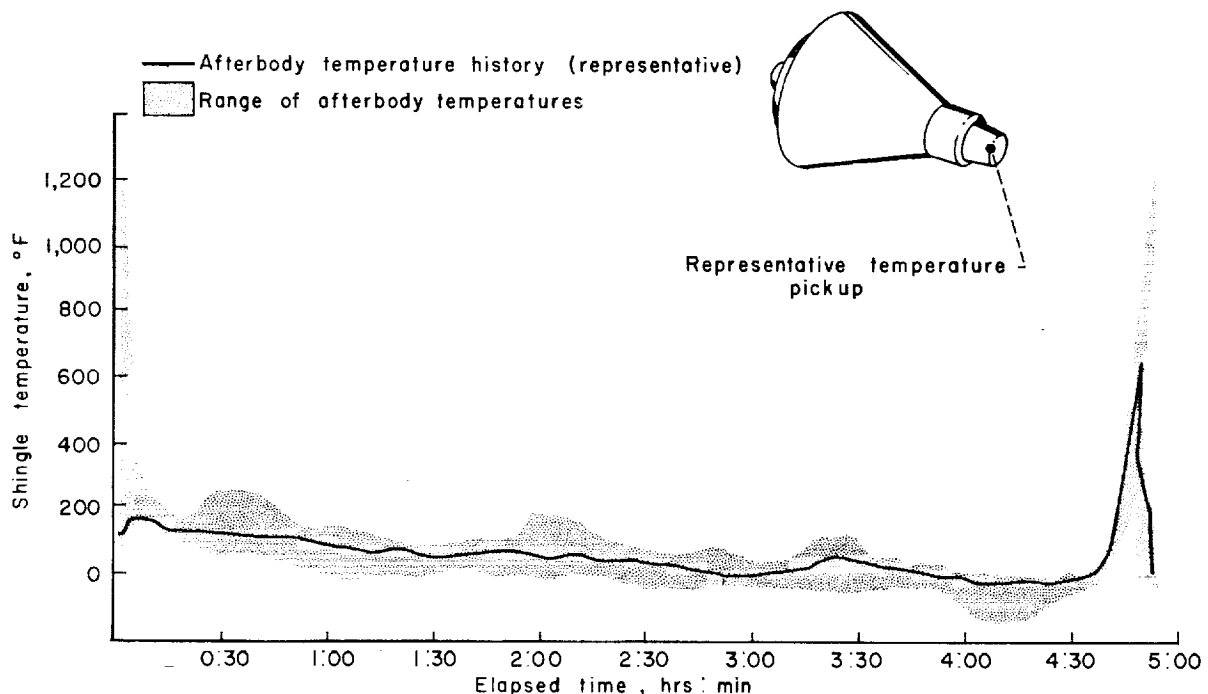
FIGURE 1-3.—Afterbody temperature from low-level commutator circuit.

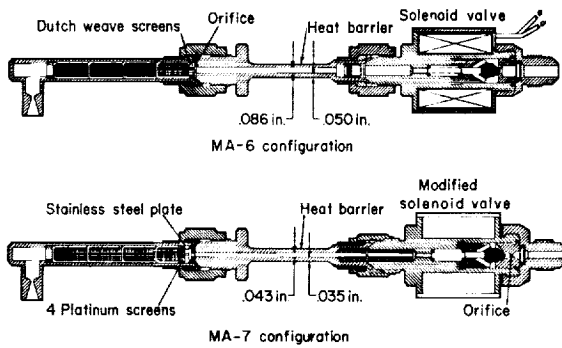
FIGURE 1-4.—Comparison between MA-6 and MA-7 thrusters.

modification to the 1-pound units involved replacing the stainless-steel fuel distribution (Dutch weave) screens (see fig. 1-4) with platinum screens and a stainless-steel fuel distribution plate, reducing the volume of the heat barriers of the automatic RCS, and moving the fuel-metering orifice to the solenoid inlet. The only modification to the 6-pound units was the

replacement of the stainless-steel screens with platinum screens. These changes proved to be effective, as all thrust units operated properly throughout the flight.

The reaction control components were of the standard configuration, with the exception of the 1-pound and 6-pound thruster assemblies which had been slightly modified to correct deficiencies which occurred on earlier flights. The

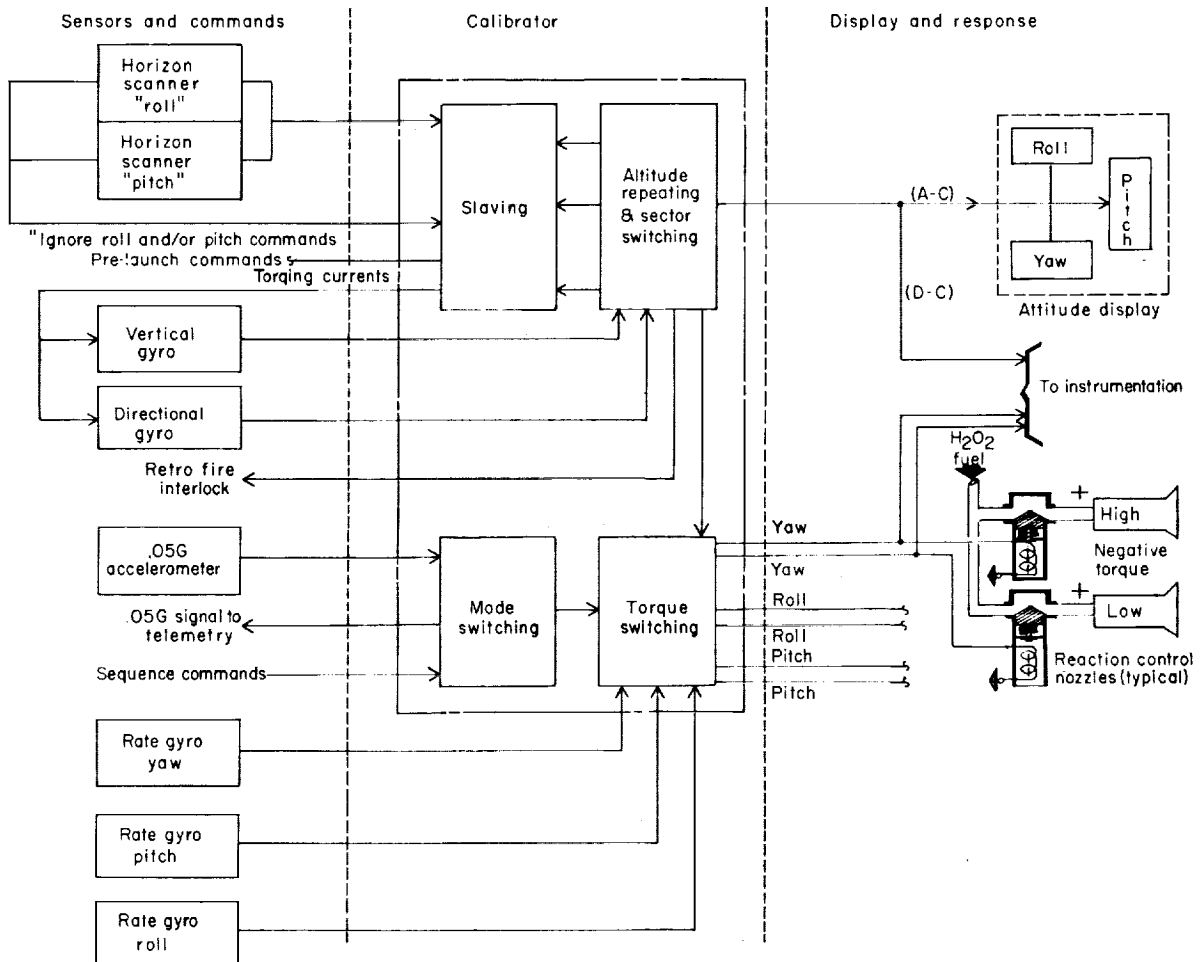
FIGURE 1-5.—Control system schematic diagram.

The horizon scanners are employed to provide a correction reference for the spacecraft attitude gyros which is indicated in the basic schematic diagram shown in figure 1-5. An error introduced by the pitch horizon scanner circuit was present during launch and apparently remained to some degree throughout the flight. Since the scanners were lost when the antenna canister was jettisoned during the normal landing sequence, postflight inspection and analysis of these units were impossible; however, the failure is believed to have been in the scanner circuit and was apparently of a random nature in view of the fact that the scanner system has been fully qualified on previous flights.

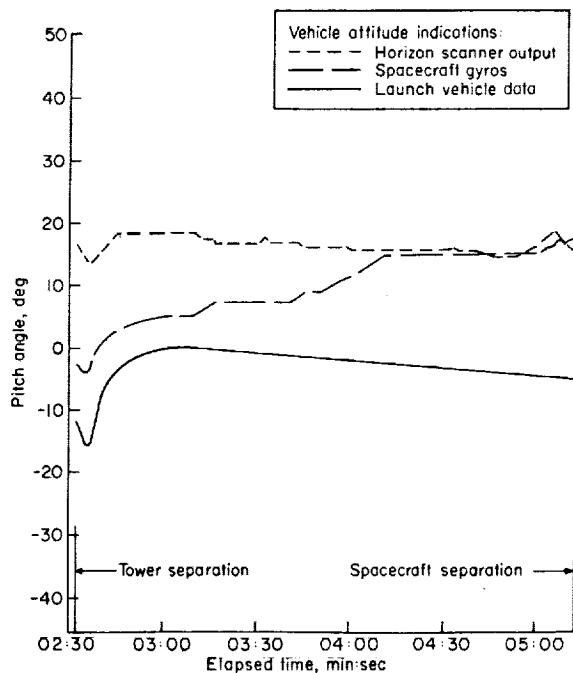
FIGURE 1-6.—Spacecraft attitudes during launch.

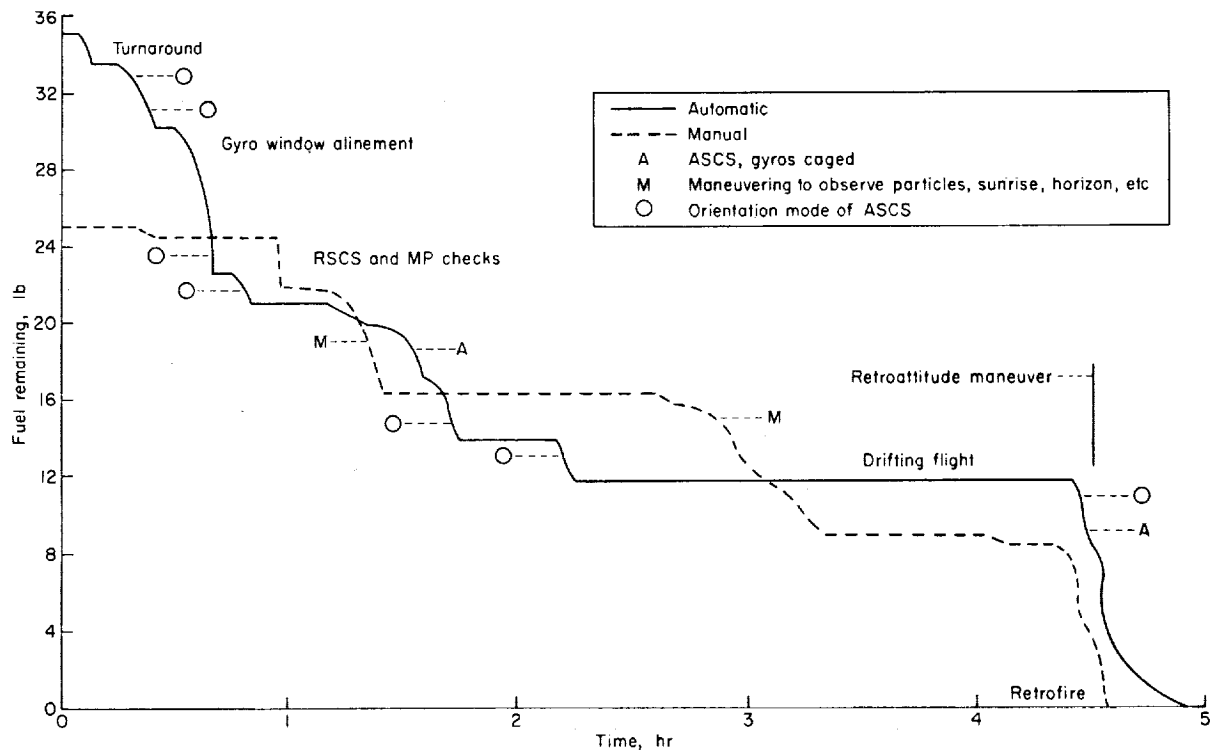
FIGURE 1-7.—Fuel usage rates.

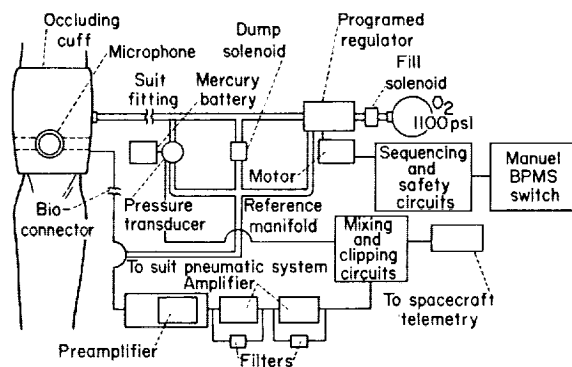
FIGURE 1-8.—Semiautomatic blood-pressure measuring system.

The data transmitted from the blood-pressure measuring system were questionable at times during the flight, primarily because of the magnitude of the data and the intermittency with which it was received. The intermittent signals were found to have resulted from a broken cable in the microphone pickup, shown in figure 1-8. This malfunction, however, could not have affected the magnitude of the transmitted information, since an intermittent short either sends valid signals or none at all. The BPMS was thoroughly checked during postflight tests in the laboratory using actual flight hardware, with the exception of the microphone and cuff. Tests of the controller unit and amplifier were also conducted, and no component failure or damage in the BPMS has been detected to date. However, a number of uncertainties regarding the calibration and operation of the BPMS still

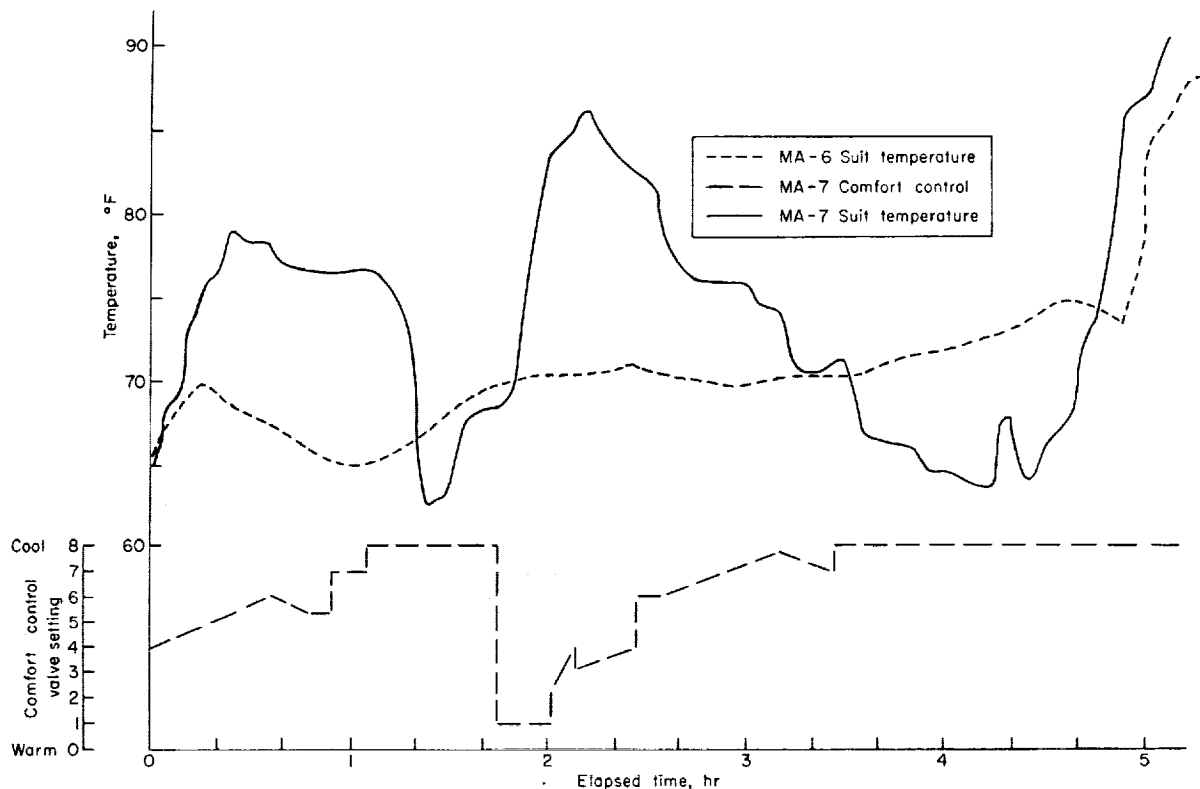
FIGURE 1-11.—Suit-inlet temperature and comfort control valve setting.

been turned down early in the flight. The valve setting was reduced by the pilot during the first orbital pass when the cabin heat exchanger indicated possible freezing. It is believed that some freezing at the heat exchanger did occur during the flight which may have resulted in less efficient cooling, but this is not the primary cause of the above-normal temperature.

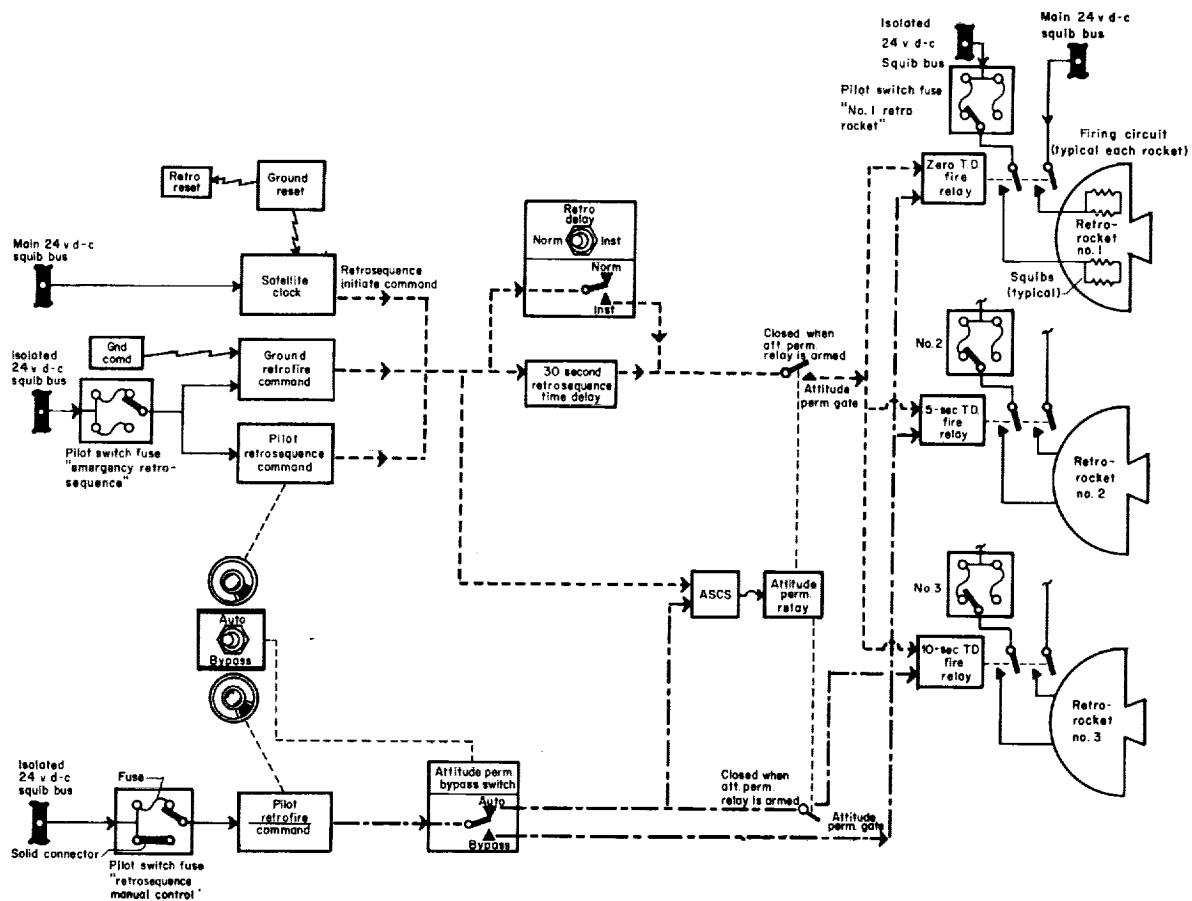
FIGURE 1-12.—Retrosequence schematic diagram.

The sequential system for MA-7 deviated only slightly from that used for MA-6, which is described in detail on page 26 of reference 1. The major change involved the addition of a control barostat in the landing sequence circuit, which is discussed in a previous section. The MA-7 sequential system performed adequately during the mission. The one anomaly that was experienced is discussed subsequently.

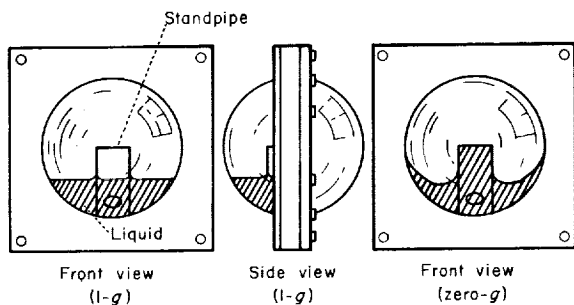
FIGURE 1-13.—Zero-gravity experiment.

The objective of the zero-gravity experiment was to examine the behavior of a liquid of known properties in a weightless state using a particular container configuration. The apparatus consisted of a glass sphere containing a capillary tube which extended from the interior surface to just past the center, as shown in figure 1-13. A liquid mixture representing the viscosity and surface tension of hydrogen peroxide was composed of distilled water, green dye, aerosol solution and silicon, and consumed about 20 percent of the internal volume. The diameter of the sphere was $3\frac{3}{8}$ inches. The application of the results of this experiment is primarily in the design of fuel tanks for fu-

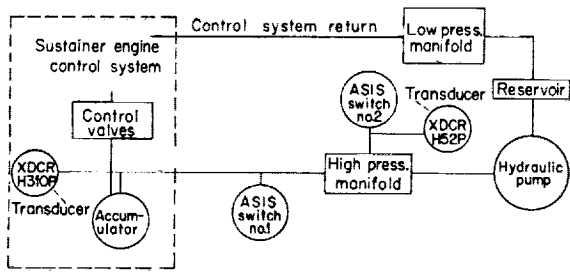
FIGURE 1-14.—Launch-vehicle hydraulic diagram.

Although the abort sensing and implementation system (ASIS) performed satisfactorily during the flight, hydraulic switch no. 2 for the sustainer engine actuated to the abort position at 4:25 minutes after lift-off. This switch and the pressure transducer H52P for the sustainer hydraulic accumulator are connected to a common pressure-sensing line as shown in figure 1-14. For an unknown reason this transducer was apparently faulty and showed a gradual

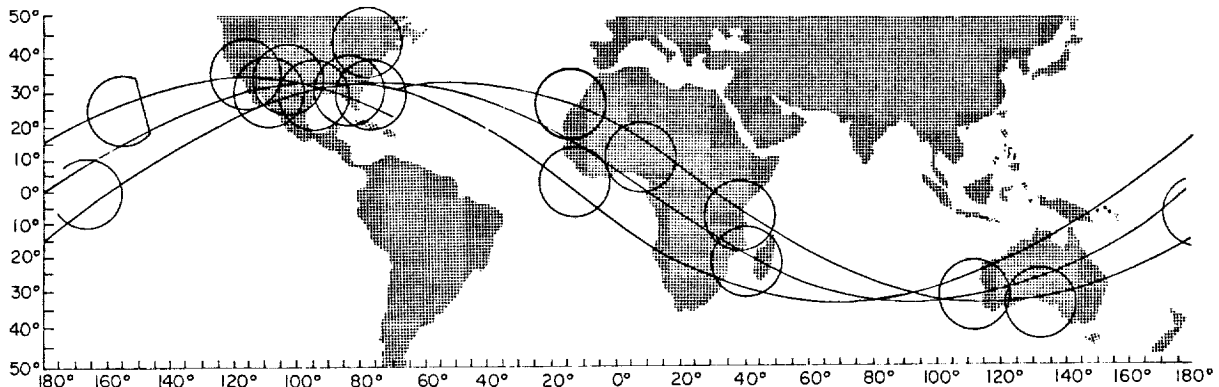
FIGURE 2-1.—Mercury Network configuration for MA-7.

- (1) Provide ground radar tracking of the spacecraft and data transmission to the Goddard computers.
- (2) Provide launch and orbital computing during the flight with real-time display data transmitted to the Mercury Control Center.
- (3) Provide real-time telemetry display data at the sites and summary messages to Mercury Control Center (MCC) for flight control purposes.

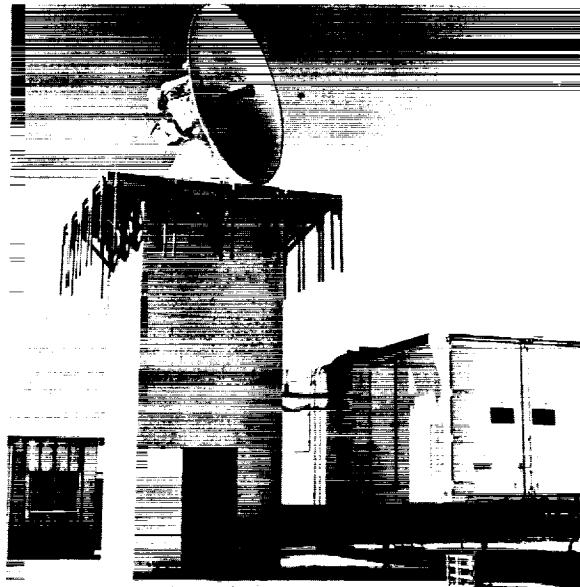
FIGURE 2-3.—Verlorl radar installation at Guaymas, Mexico.

Two principal types of precision tracking radars are used in the Mercury ground range to track the spacecraft: the AN/FPS-16 and Verlorl radars. The AN/FPS-16, shown in figure 2-2, is a precision C-band tracking radar with a 12-foot dish. It operates on a frequency of 5,500 to 5,900 mc and has a beam width of approximately 1.2° . It is the most accurate of our tracking devices. The S-band, or Verlorl, radar, shown in figure 2-3, is a very long-range tracking radar with a 10-foot dish. It operates on a frequency of 2,800 to 3,000 mc and has a beam width of approximately 2.5° . The redundancy provided by both of these radar systems supplies the computers with sufficient data to determine the orbit, should one of the spacecraft beacons fail. The active acquisition aid has a quad-helix antenna, which is shown in figure 2-4. It has a broad beam width of 20° , operates on telemetry frequencies (215 to 265

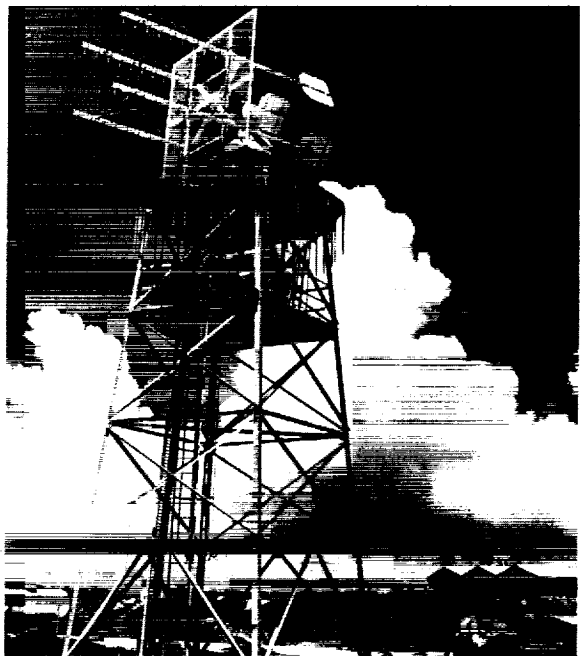
FIGURE 2-4.—Acquisition aid quad-helix antenna at Bermuda.

This acquisition capability is most critical at sites with the FPS-16 radar since this radar is a narrow-beam device requiring precise pointing information to locate the target. Once the radar has acquired the spacecraft, the radar

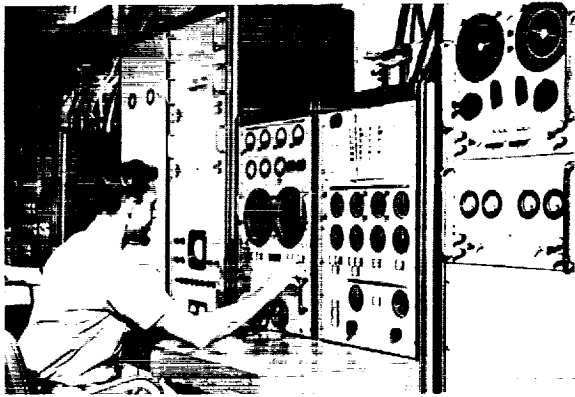
FIGURE 2-5.—Acquisition aid console and equipment racks.

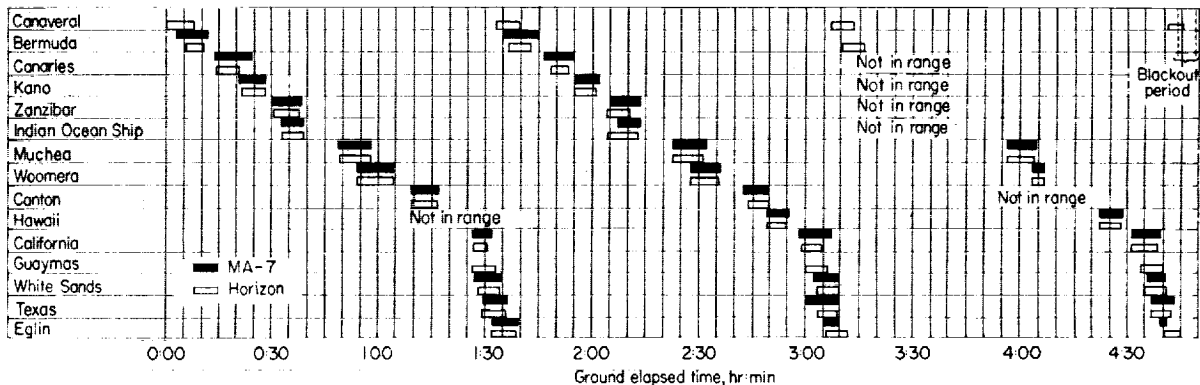
FIGURE 2-6.—Acquisition system coverage.

The acquisition system performance was very good; the only difficulty encountered was the failure of the elevation drive motor at the Zanzibar station. This failure did not influence the reception of data since the operator was able to operate successfully the antenna elevation in the manual mode. The coverage periods of the acquisition system for the Network are shown in figure 2-6.

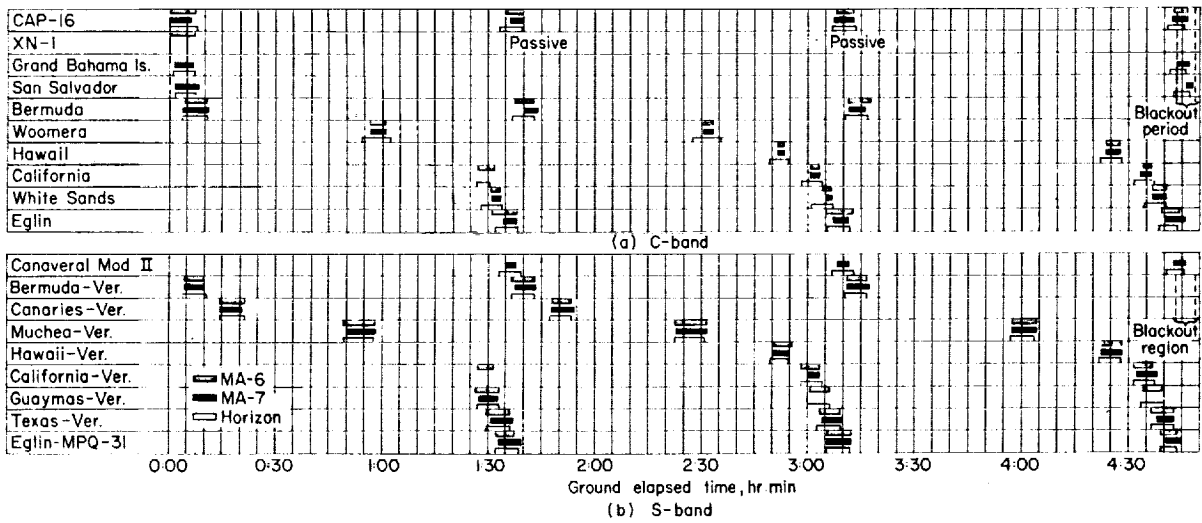
FIGURE 2-7.—Comparison of radar coverage for MA-6 and MA-7.

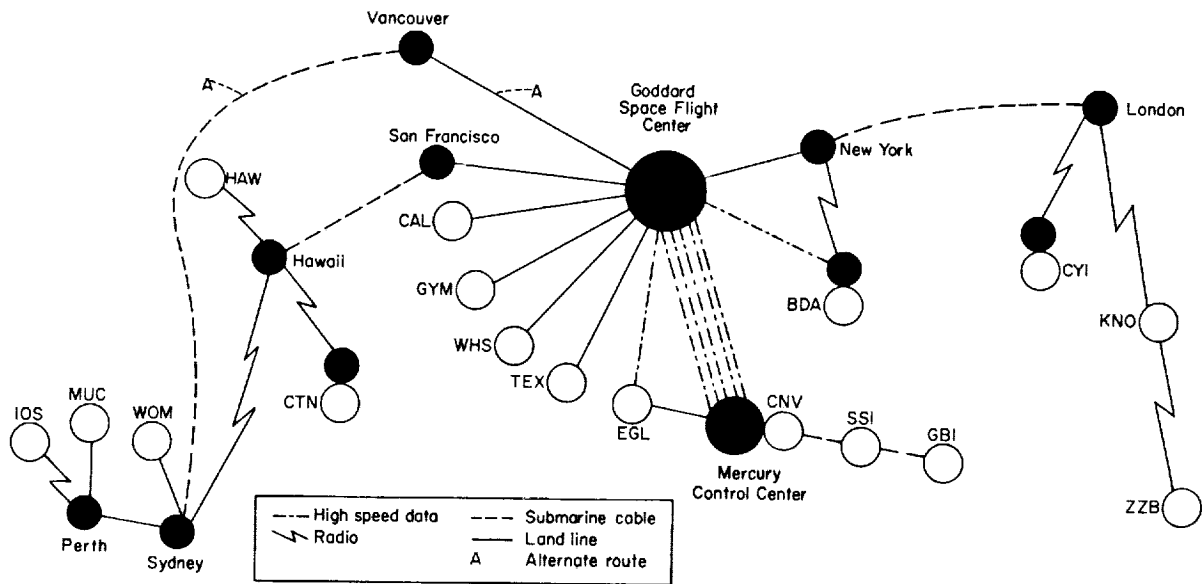
FIGURE 2-8.—Data circuits for Project Mercury.

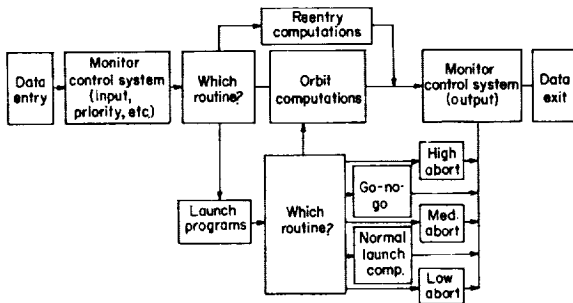
FIGURE 2-10.—Real-time monitor control system.

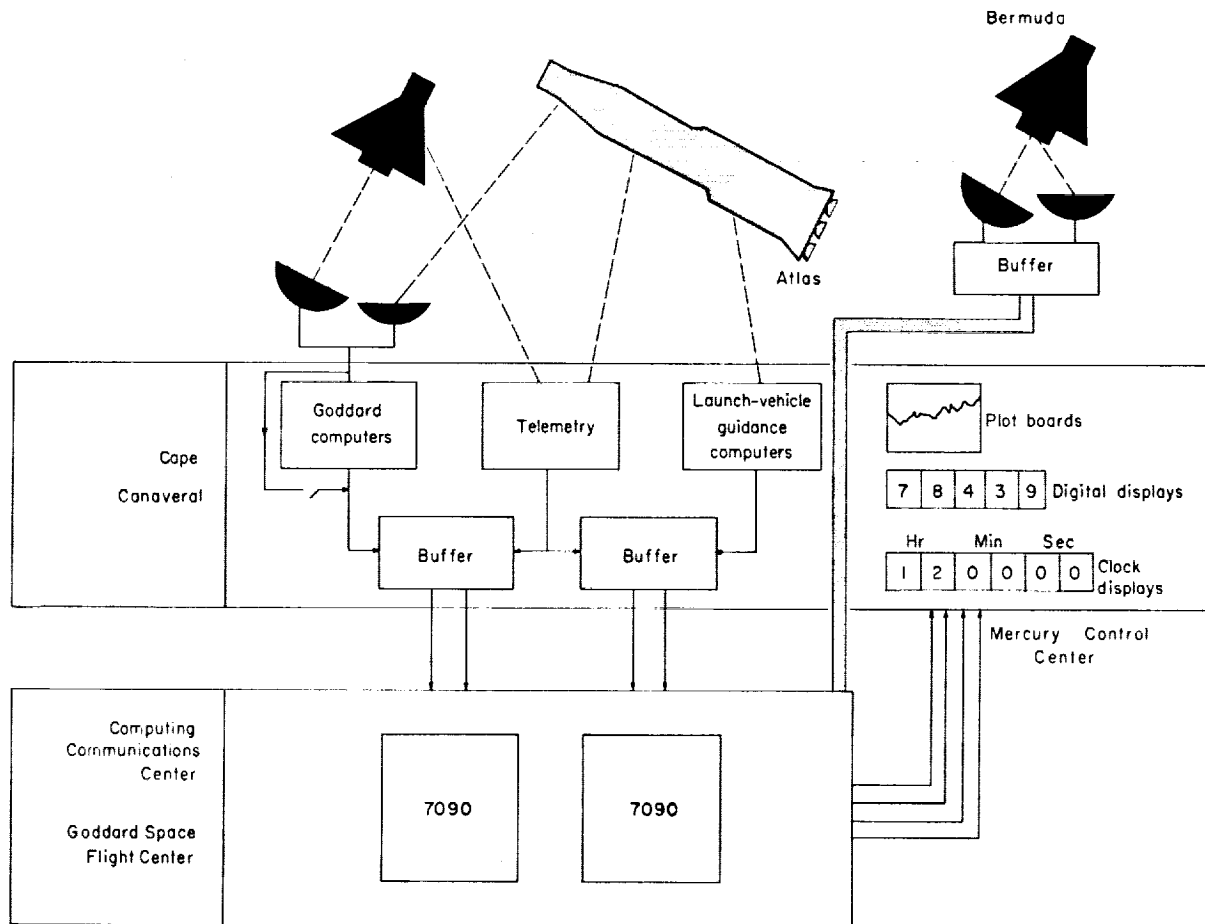
FIGURE 2-11.—Computer data sources during launch.

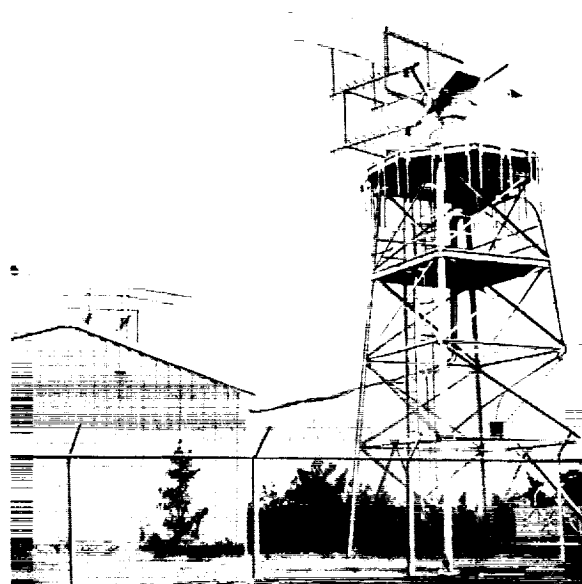
FIGURE 2-12.—Telemetry antenna installation at Kano, Nigeria.

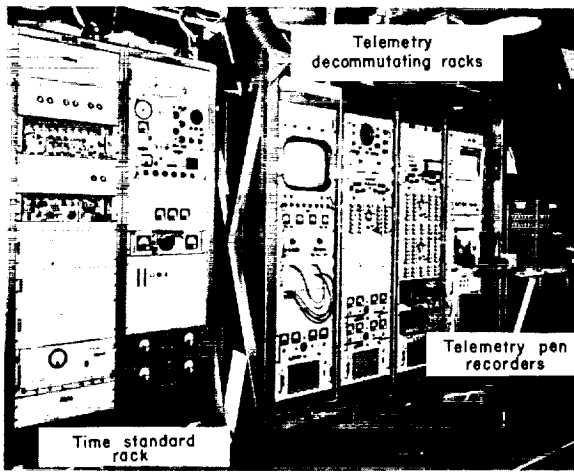
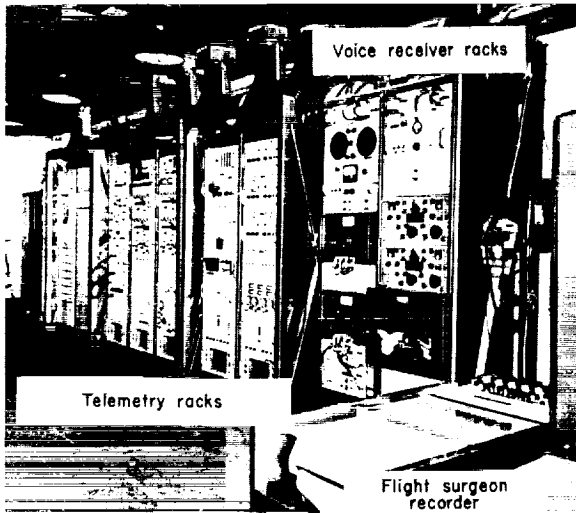
FIGURE 2-13.—Typical telemetry receiving equipment.

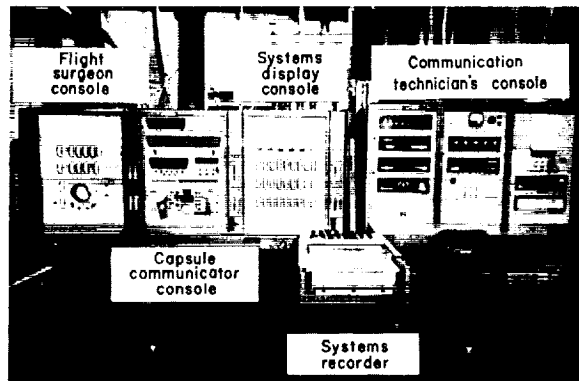
FIGURE 2-14.—Typical display consoles at remote stations.

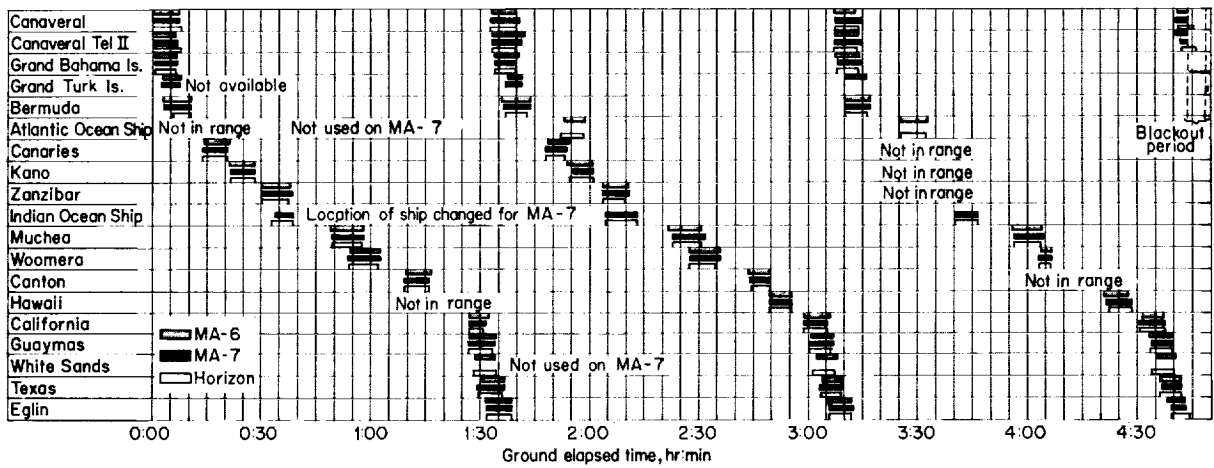
FIGURE 2-15.—Comparison of telemetry coverage times for MA-6 and MA-7.

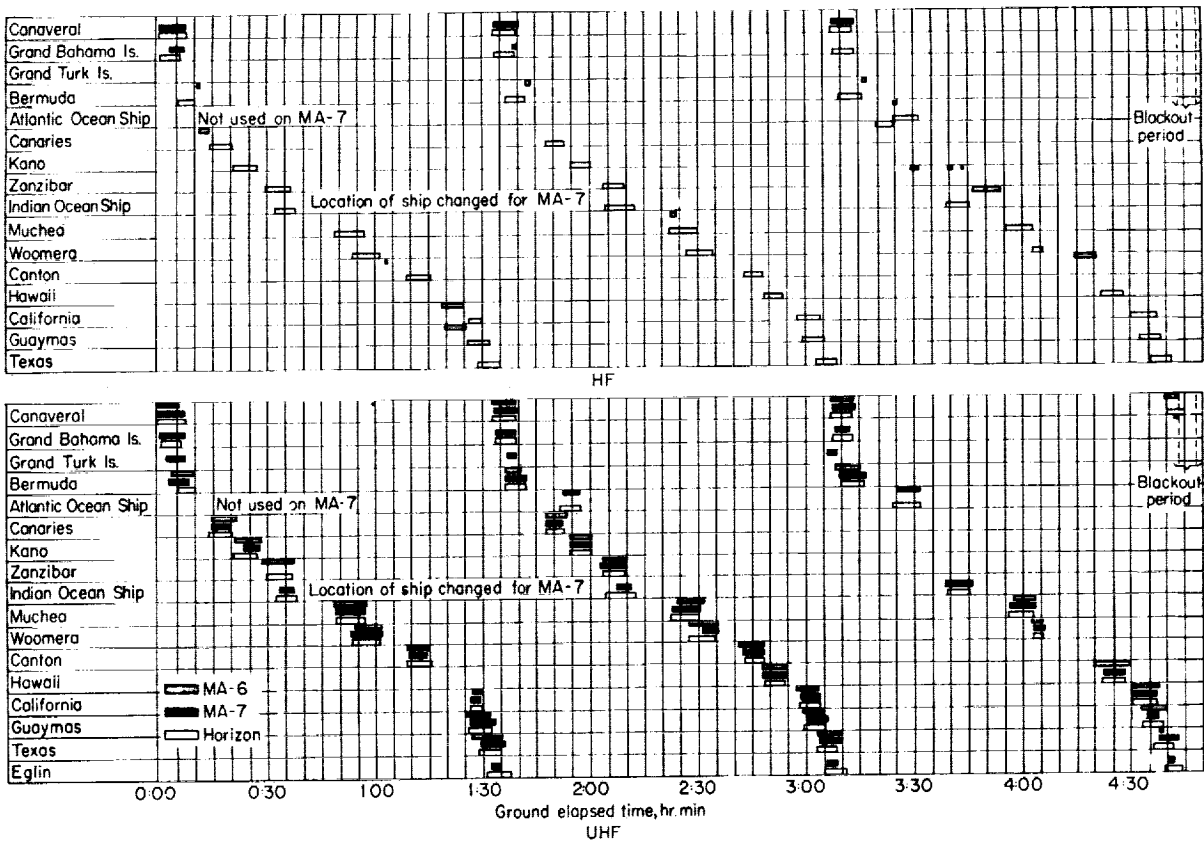
FIGURE 2-16.—HF and UHF coverage for MA-6 and MA-7.

It was noted that when the ground-to-spacecraft circuit was patched to the between-stations voice conference, the quality was not as good as the MA-6 mission. This effect is being investigated by studying the recordings made at various locations on the circuits. The generally weaker signal strength may account for part of this problem. Figure 2-16 shows the HF and UHF coverage for both the MA-6 and MA-7 missions.

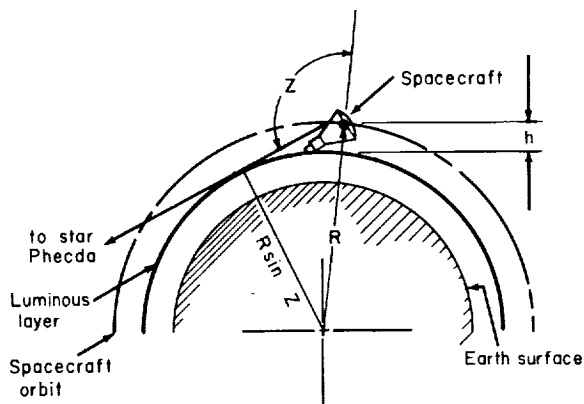
FIGURE 4-1.—Parameters used to calculate height of layer.

In method 3, the time of passage of the star below the brightest part of the luminous layer was used. Through careful timing of the spacecraft tape and conversation with the astronaut, the time has been fixed at approximately 04:05:25 ground elapsed time (g.e.t.) or 16 hours 50 minutes 41 seconds G.m.t. To find the true height at that time, a special set of computations was made at Goddard Space Flight Center, starting from the spacecraft latitude

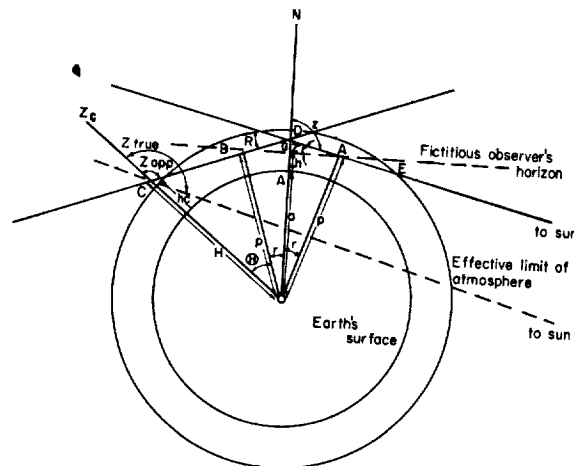
FIGURE 4-3.—Geometry employed in computation of refraction.

B = coefficient involving the index of refraction μ and the polytropic index n .

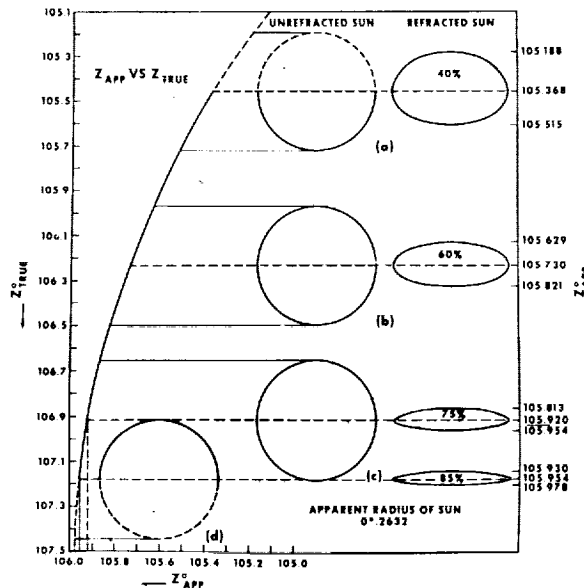
FIGURE 4-4.—Stages of the setting sun.

The flattening of the image of the setting sun is best illustrated in the plot of Z_{app} versus Z_{true} . An image representing the sun to scale may be placed at any Z_{true} , and points around the limb extended to the curve may be located on the Z_{app} axis. This procedure yields the apparent zenith distance of those points. Since the horizontal axis is not affected by refraction, parallels of altitude may be laid off on the unrefracted image of the sun and similarly on the apparent image of the sun. The apparent image may be rectified for easy comparison. The theoretical profiles of four phases of a setting sun are illustrated in figure 4-4, which is a plot of Z_{true} vs. Z_{app} for four true zenith distances of the sun's center. These distances are $Z_{true} = 105.460^\circ$, $Z_{true} = 106.236^\circ$, $Z_{true} = 106.918^\circ$ (sun's lower limb on the horizon), and $Z_{true} = 107.180^\circ$ (sun's center on horizon). The ratios in percent of the vertical to horizontal diameters are approximately 0.63, 0.46, 0.17, and 0.11, respectively. Considering the spacecraft angular velocity of $4^\circ/\text{min}$, it is seen that the entire refraction effect took place in the relatively short interval of about 20 seconds.

The uncertainty in photography times precludes an exact comparison of theory and observations. However, figure 4-4(c) most nearly simulates the photographs in figures 4-5 and 4-6 which show the effects of the spacecraft motion and still demonstrate the arresting effect. Figure 4-5 was photographed by Astronaut Glenn on February 20, 1962. He specifically states that he did not see the sun as a narrow, flat object. He observed it as spreading out about 10° on either side and merging with the twilight band.

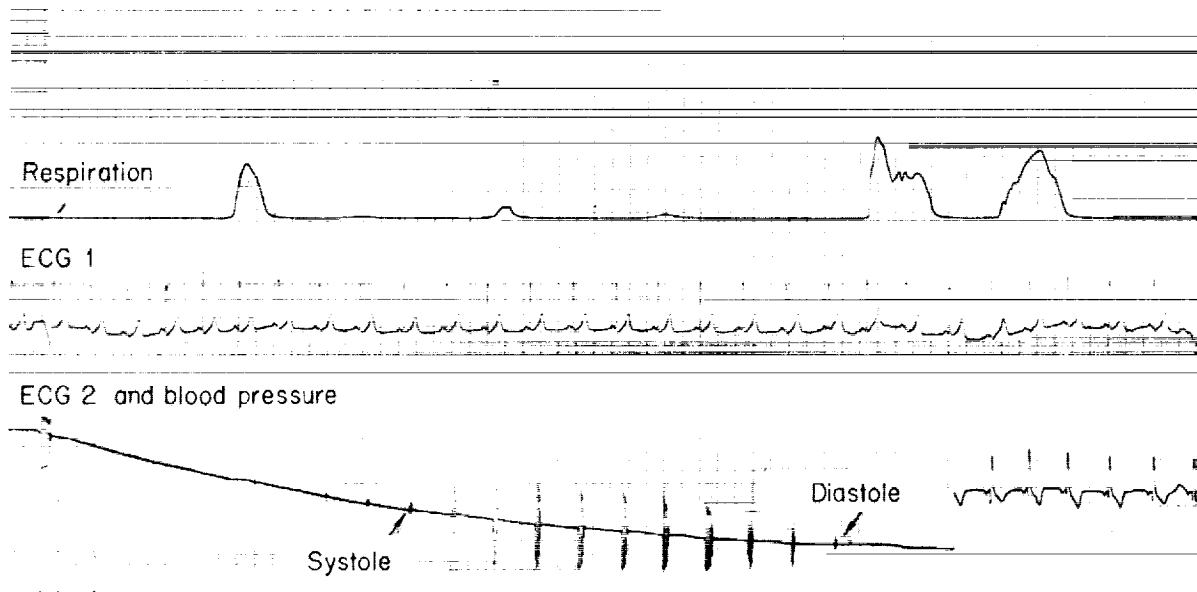
FIGURE 5-4.—Biinstrumentation from blockhouse records (T-68 minutes).

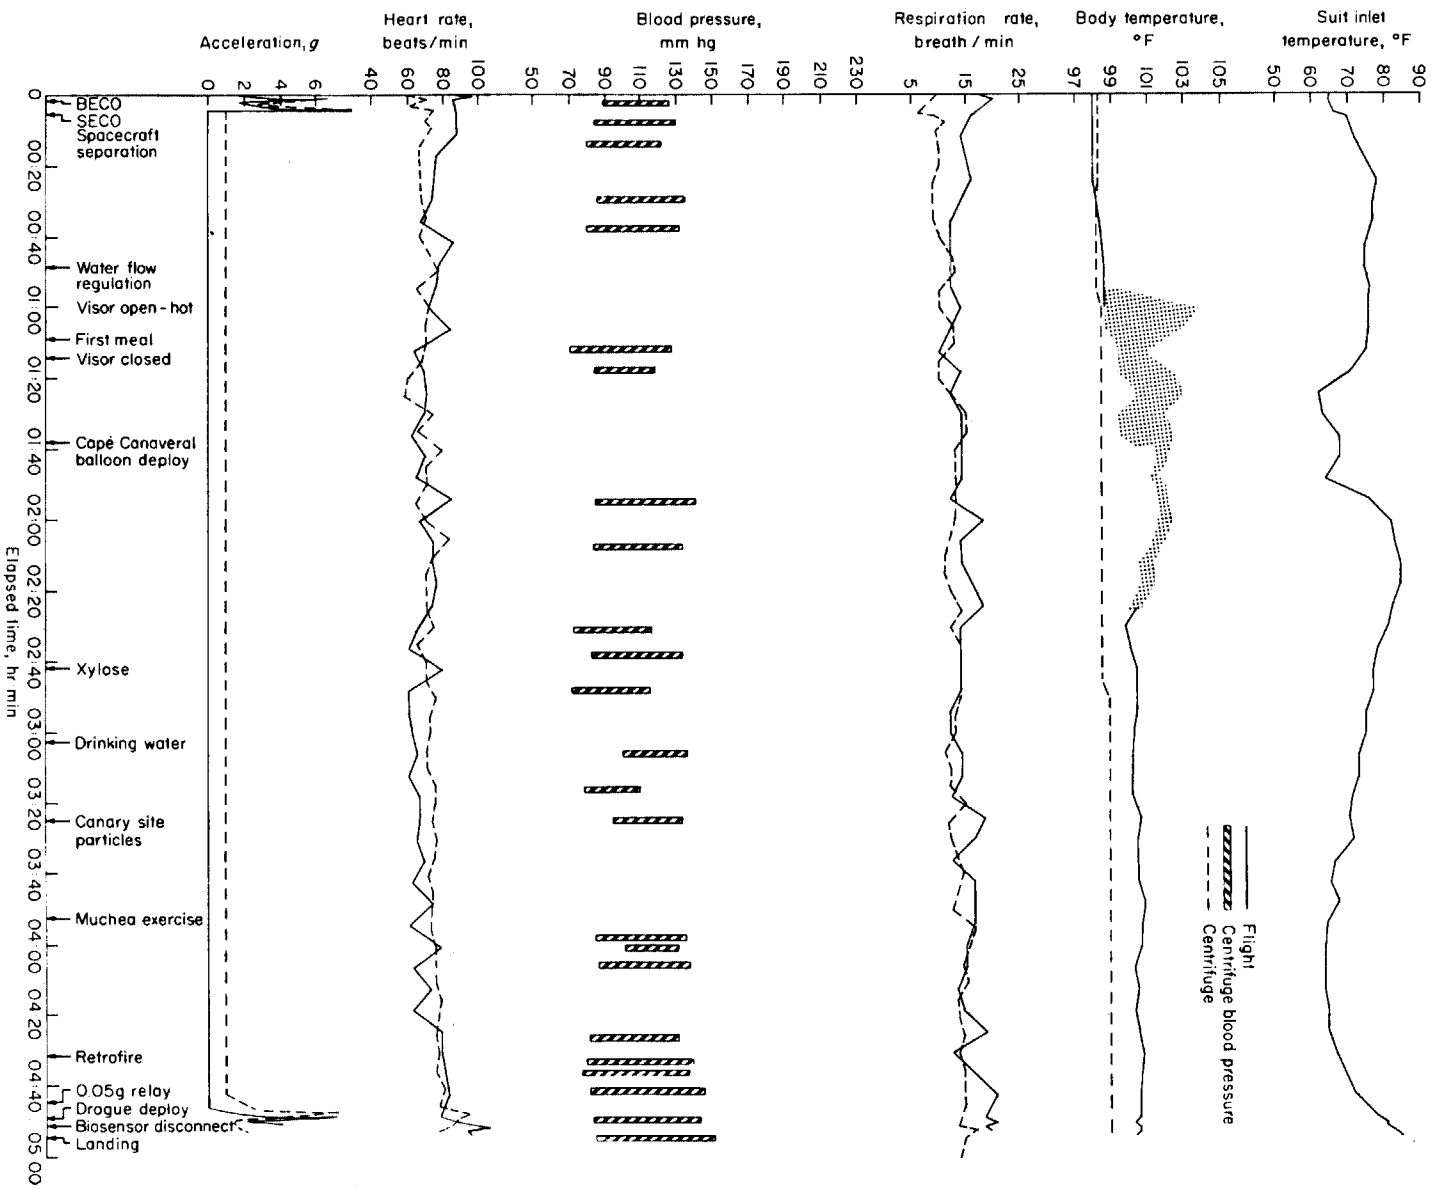
FIGURE 5-5.—Biinstrumentation in flight.

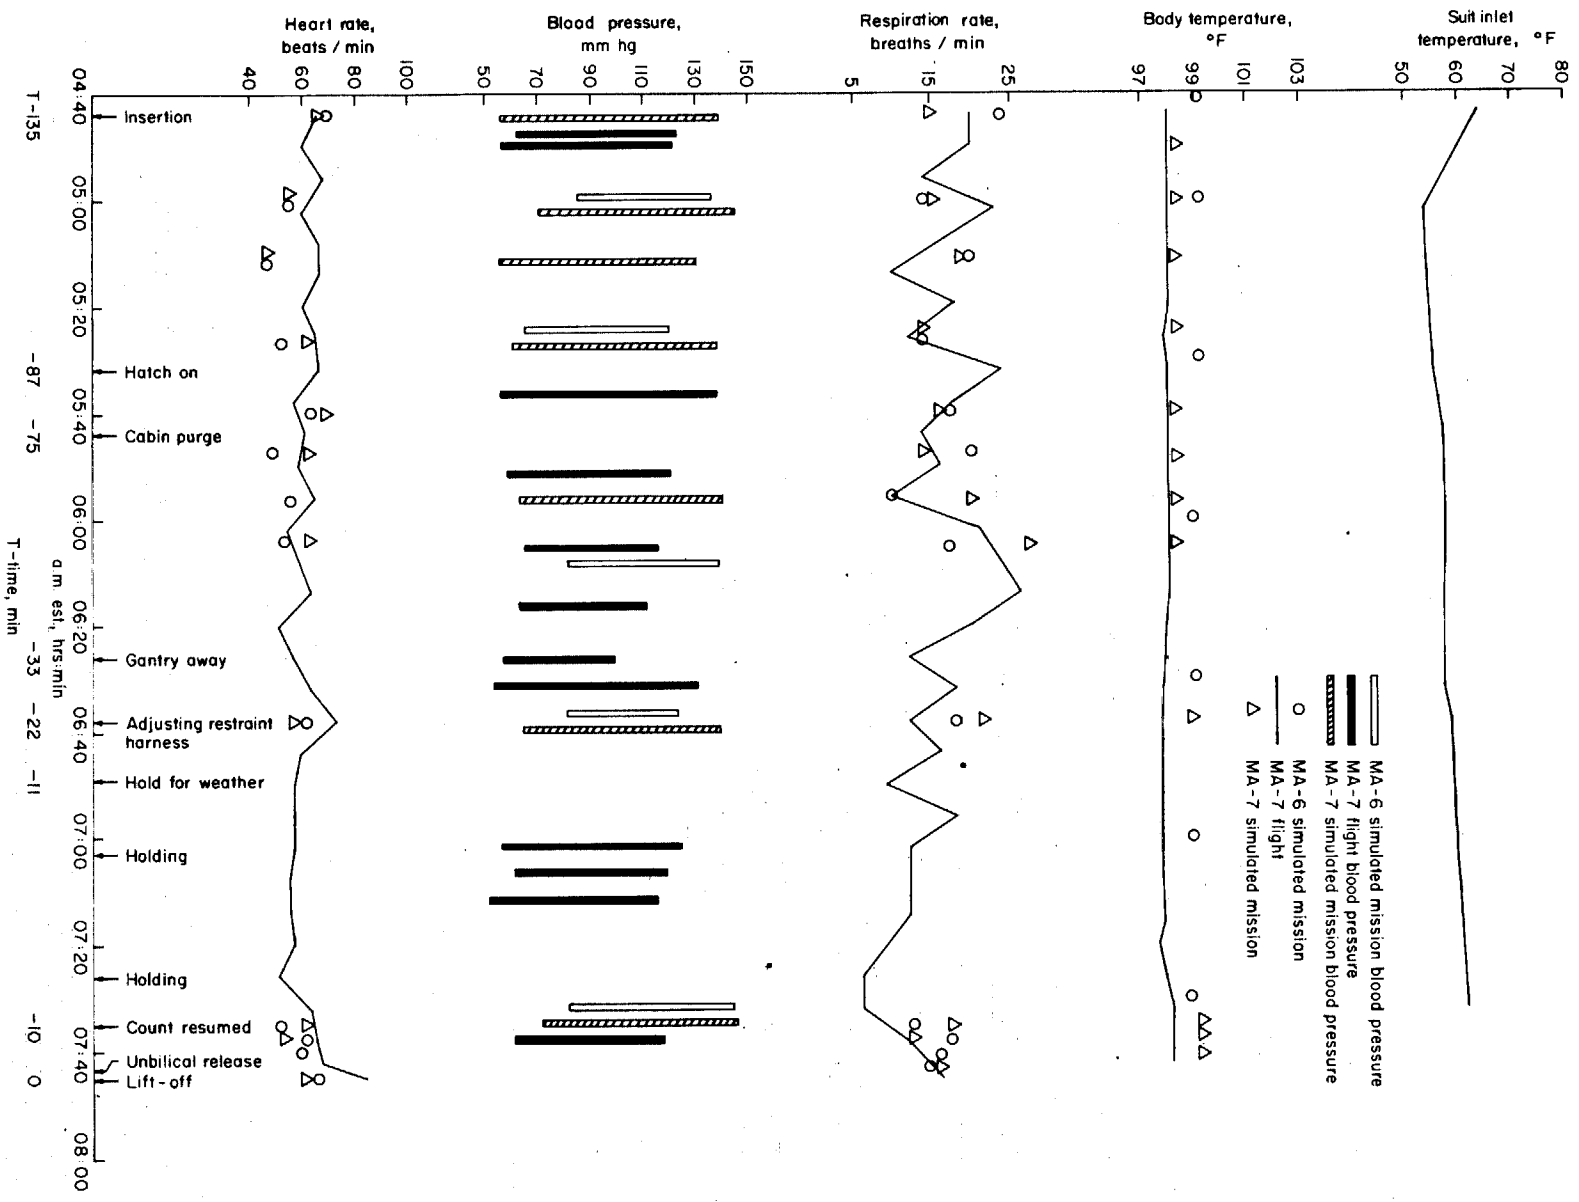
FIGURE 5-6.—Biinstrumentation in countdown and launch.
