RESULTS OF THE
SECOND UNITED STATES
MANNED ORBITAL SPACE FLIGHT
MAY 24, 1962

NASA SP-6

NATIONAL AERONAUTICS AND SPACE ADMINISTRATION
Manned Spacecraft Center
PROJECT MERCURY

1. SPACECRAFT AND LAUNCH-VEHICLE PERFORMANCE

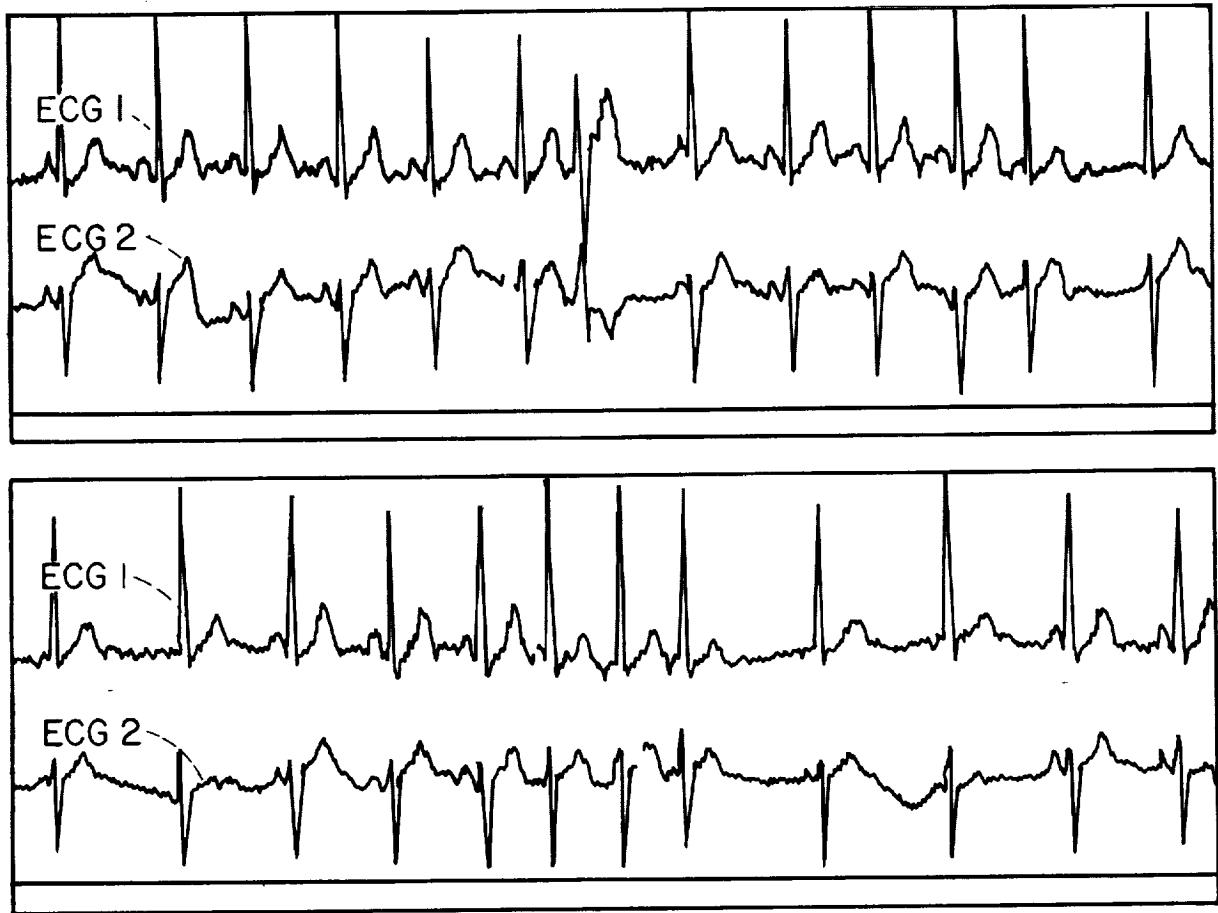
FIGURE 5-7.—Onboard physiological reentry data.

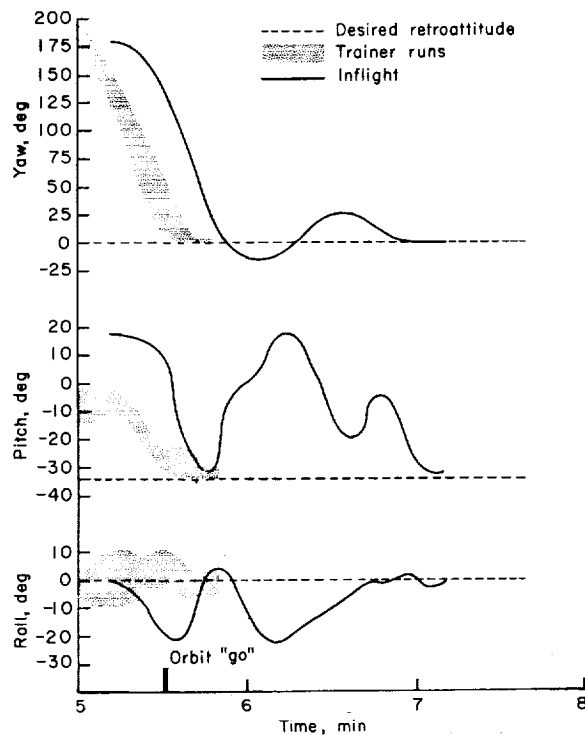
FIGURE 6-3.—Turnaround maneuver.

The primary purpose in scheduling a manual turnaround after spacecraft separation was to conserve reaction control system fuel.

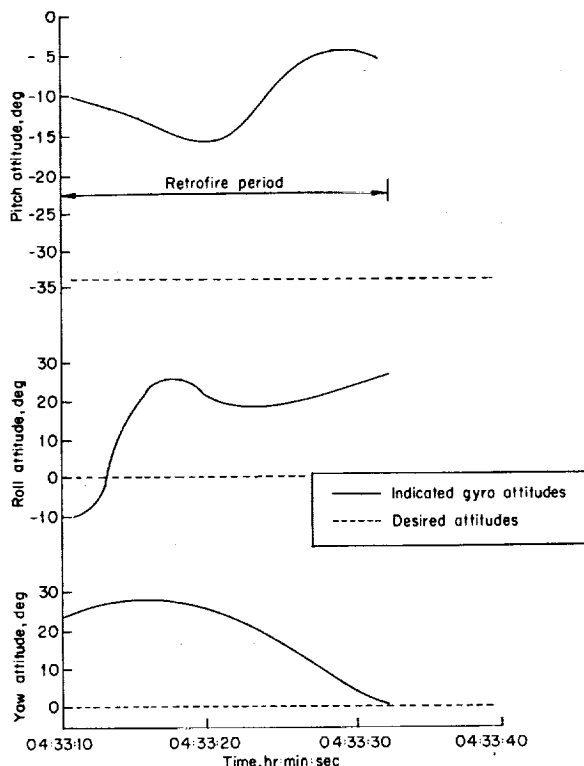
FIGURE 6-4.—Indicated spacecraft attitudes during retrofire. Not corrected, gyros free.
