RESULTS OF THE SECOND U.S. MANNED SUBORBITAL SPACE FLIGHT JULY 21, 1961

MANNED SPACECRAFT CENTER
NATIONAL AERONAUTICS
AND SPACE ADMINISTRATION

FOREWORD

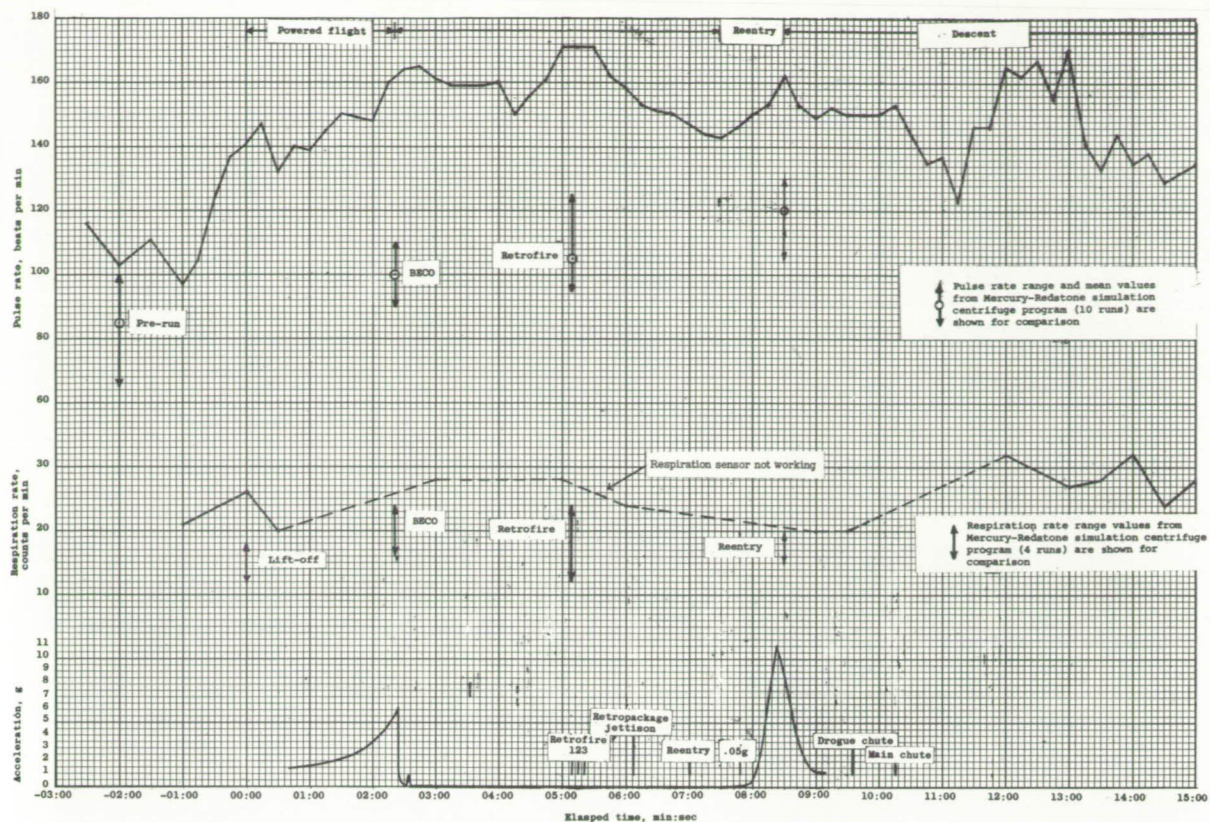
FIGURE 4-7. Pulse and respiration rates during flight.

Astronaut Grissom's Mercury-Redstone centrifuge pulse rates were tabulated and are presented graphically in figure 4-7 for comparison with the flight pulse data. The highest rate noted for his centrifuge experience was 135 beats per minute. Also shown in figure 4-7 are Astronaut Grissom's respiratory rate responses during four Mercury-Redstone centrifuge sessions.

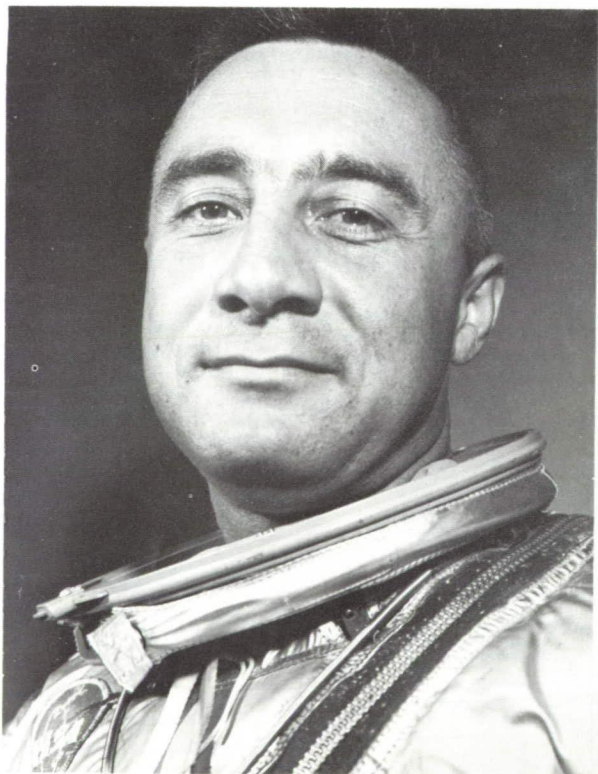
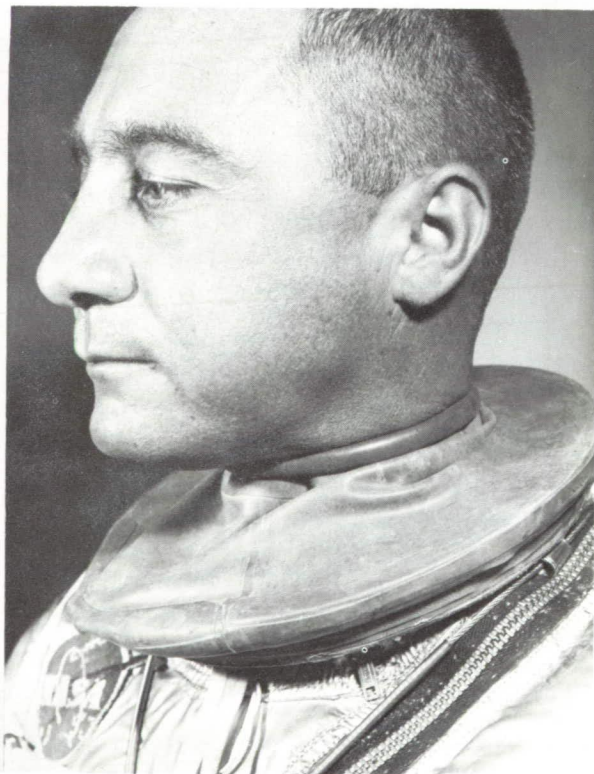
(a) Normal stored position.

(b) Unrolled position.

FIGURE 7-6. Neck dam.
