## DEVELOPMENT OF A METEOROID PENETRATION DISTRIBUTED TRANSDUCER

**THIRD QUARTERLY REPORT FOR**  
NATIONAL AERONAUTICS AND SPACE ADMINISTRATION  
GEORGE C. MARSHALL SPACE FLIGHT CENTER  
HUNTSVILLE, ALABAMA

CONTRACT NAS-8-20194  
**QUARTERLY REPORT**

NSL 65-138-3  
MARCH 1966

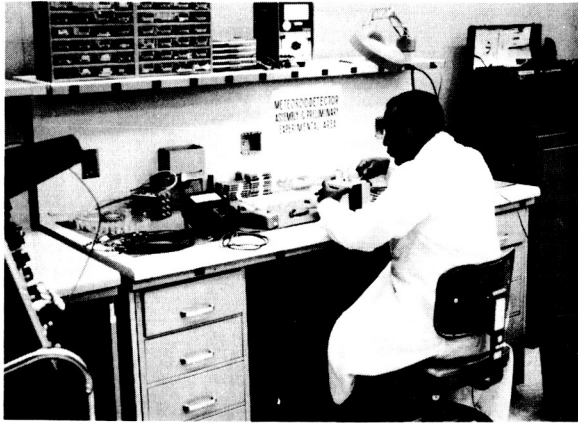
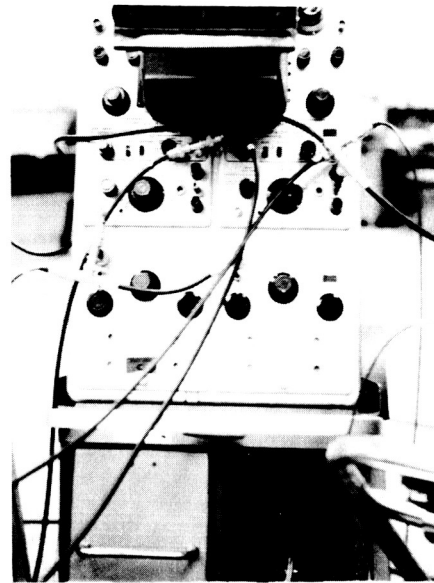
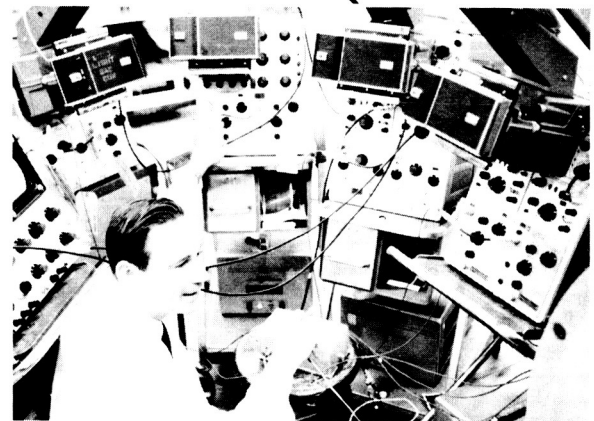
FIGURE 2-1 TARGET ASSEMBLY AND INSTRUMENTATION

Experimental Target  
Assembly at NSL

Cabling and Line  
Terminations on  
Master Gating  
Oscilloscope

Target Assembly and  
Amplifiers on Location

Master Gating  
Oscilloscope

Instrumentation on Location  
During Test Series

The first series of tests employed impacts by 2.8 mg lexan projectiles with velocities ranging between 20,000 and 26,000 ft/sec. Figure 2-1 shows, besides the experimental target assembly area at NSL, the recording instrumentation as it was used during the tests. A diagram of a typical recording system arrangement is shown on Figure 2-2. A particular arrangement of this sort depends to a large degree on the type of equipment (oscilloscopes, etc.) that is available at the site, and also on the type of synchronizing and timing signals obtainable from the hypervelocity projector, as well as noise pick-up conditions, etc. Settings of the oscilloscopes gains, time bases, etc., must be empirically determined for each test series.

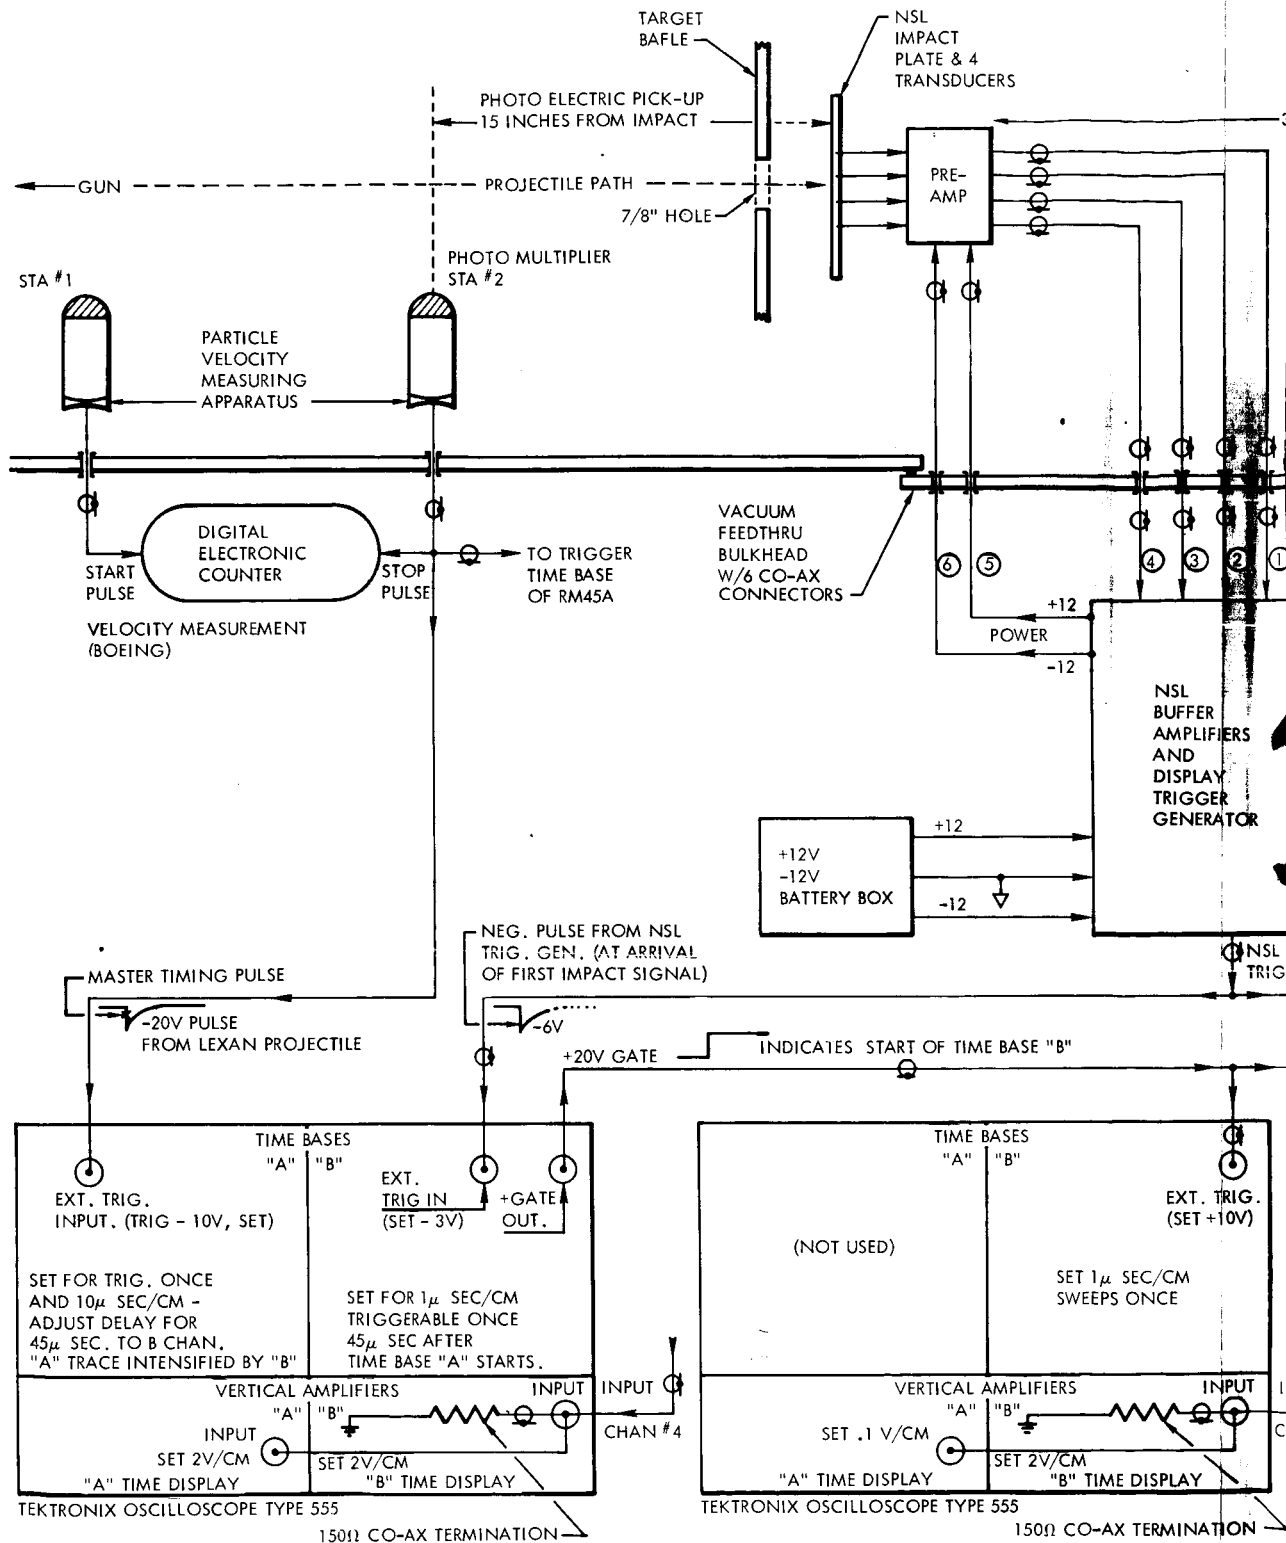
FIGURE 2-2 RECORDING EQUIPMENT ARRANGEMENT (Lexan for Tests 5 - 10)

BOEING (SEATTLE)  
HYPERVELOCITY PROJECTOR - VACUUM CHAMBER & INSTRUMENTATION END.

Five oscilloscopes are shown on Figure 2-2. Four of these have been used to record transducers outputs and one oscilloscope was used to show correspondence between the particle velocity, timing pulses from the projector, particle impact time, and NSL trigger output. Where possible each transducer output was recorded at two gain levels to accommodate amplitude variations caused by differences in distances travelled by the stress wave from the point of impact to the particular transducer in question, and also by the variation in the projectile velocity.

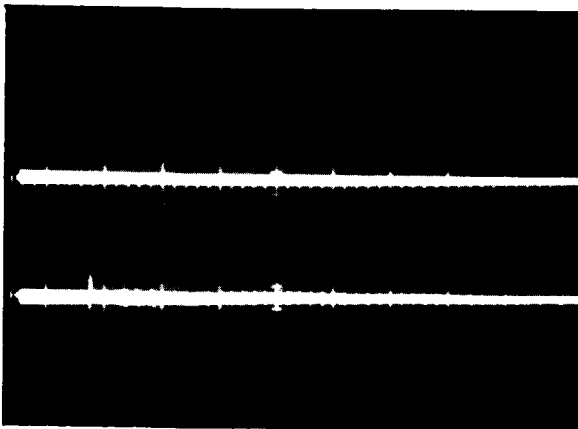
FIGURE 2-4  
IMPACT TEST NO. 1  
(Channels #1, 2, 3)  
27 January, 1966 - Shot #1  
PROJECTILE: LEXAN SLUG (2.8 mg)

Channel 3

Upper:  $10\mu$  sec/div. (cm)  
2V/div. (cm)  
Lower:  $10\mu$  sec/div. (cm)  
0.05V/div. (cm)  
Gain (Xducer/Scope): 0.73

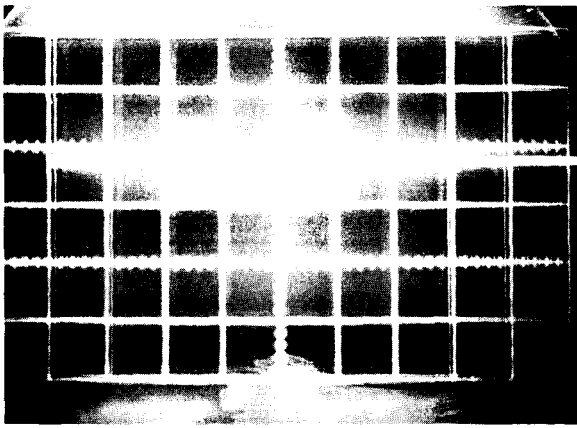
FIGURE 2-5  
 IMPACT TEST NO. 1  
 (Channel #4 and NSL Trigger Display)  
 27 January, 1966, - Shot #1  
 PROJECTILE: LEXAN SLUG (2.8 mg)

#### Channel 4

Upper:  $10\mu$  sec/div. (cm)  
 2V/div. (cm)  
 Lower:  $10\mu$  sec/div. (cm)  
 0.05V/div. (cm)  
 Gain (Xducer/Scope): 0.73

- All oscilloscopes triggered by velocity measuring phototube circuit ( $35\mu$  sec delay added)
- Projectile Velocity: 27,200 ft/sec
- NSL Trigger not employed
- Transducers: Quartz X-cut wafers 0.25" in diameter and 0.063" thick
- Impact Plate: 4" x 4" x 1/8" 2024-T3 Aluminum

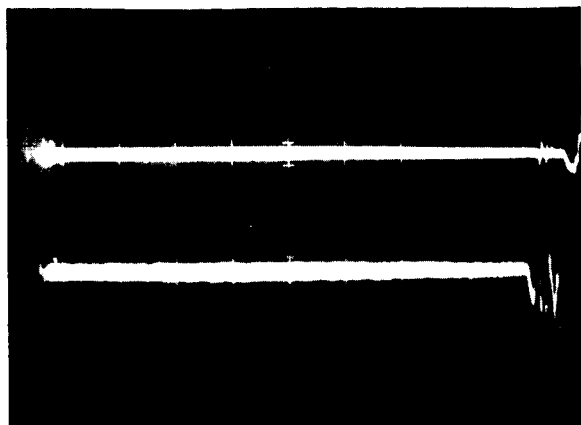
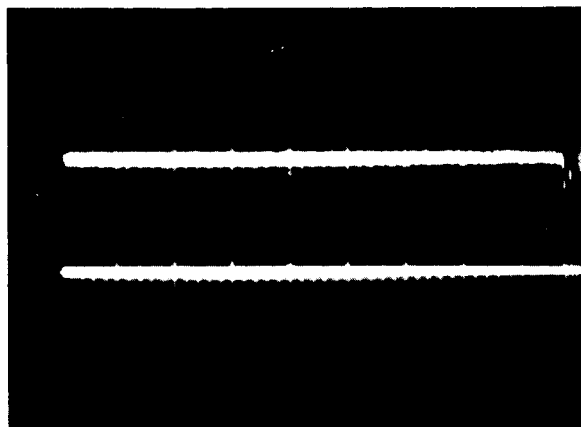
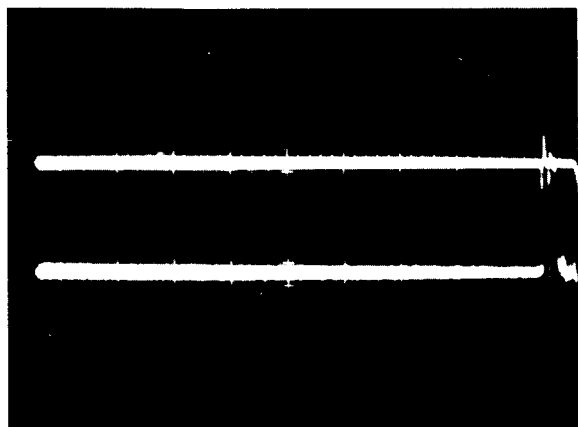
FIGURE 2-6  
 IMPACT TEST NO. 2  
 (Channels #1, 2, 3)  
 28 January, 1966 - Shot #1  
 PROJECTILE: LEXAN SLUG (2.8 mg)

#### Channel 1

Upper:  $5\mu$  sec/div. (cm)  
 2V/div. (cm)  
 Lower:  $5\mu$  sec/div. (cm)  
 0.05V/div. (cm)  
 Gain (Xducer/Scope): 0.73

#### Channel 2

#### Channel 3

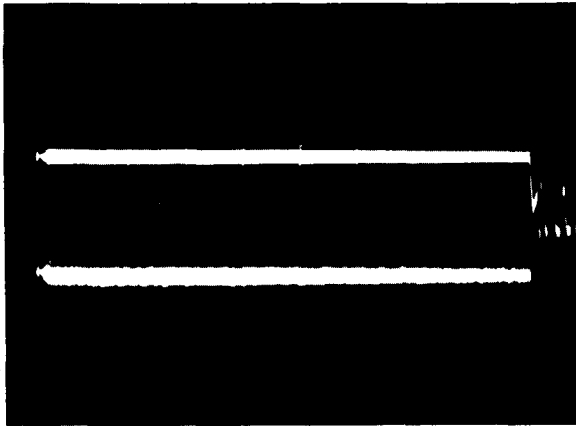
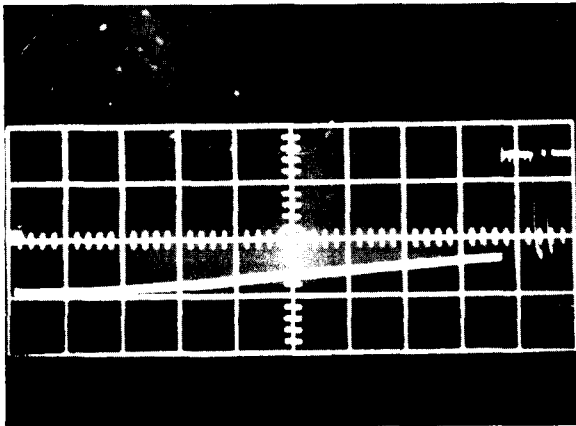
#### FIGURE 2-7

#### Channel 4

Upper:  $5\mu$  sec/div. (cm)  
 2V/div. (cm)  
 Lower:  $5\mu$  sec/div. (cm)  
 0.05V/div. (cm)  
 Gain (Xducer/Scope): 0.73

#### NSL Trigger Display (Inverted and Velocity Measuring Phototube Negative Pulse Added)

- All oscilloscopes triggered by velocity measuring phototube circuit (transducer displays delayed by  $40\mu$  sec)
- Projectile disintegrated
- Projectile velocity: (of fragments) approximately 16,000 ft/sec
- Transducers: Quartz X-cut wafers 0.25" in diameter and 0.063" thick
- Impact Plate: 4" x 4" x 1/8" 2024-T3 Aluminum

IMPACT TEST NO. 2  
 (Channel #4 and NSL Trigger Display)  
 28 January, 1966 - Shot #1  
 PROJECTILE: LEXAN SLUG (2.8 mg)

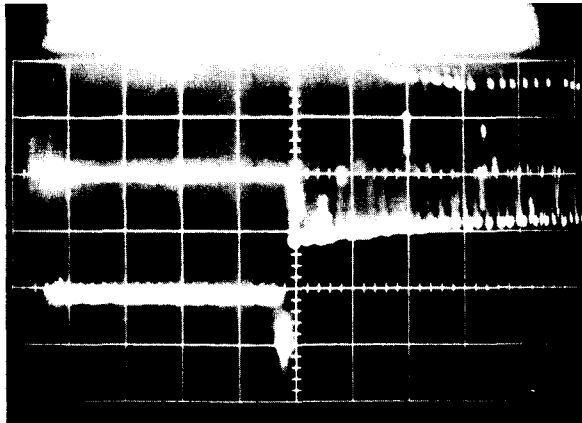
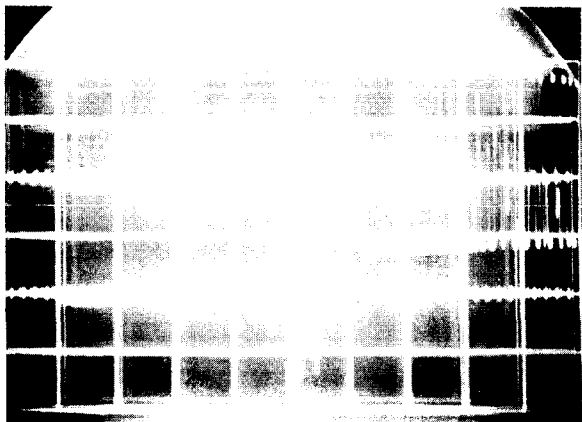
FIGURE 2-9  
 IMPACT TEST NO. 3  
 (Channels #1, 2, 3)  
 28 January, 1966 - Shot #2  
 PROJECTILE: LEXAN SLUG (2.8 mg)

Channel 2

Upper:  $5\mu$  sec/div. (cm)  
 2V/div. (cm)  
 Lower:  $5\mu$  sec/div. (cm)  
 0.05V/div. (cm)  
 Gain (Xducer/Scope): 0.73

Channel 3

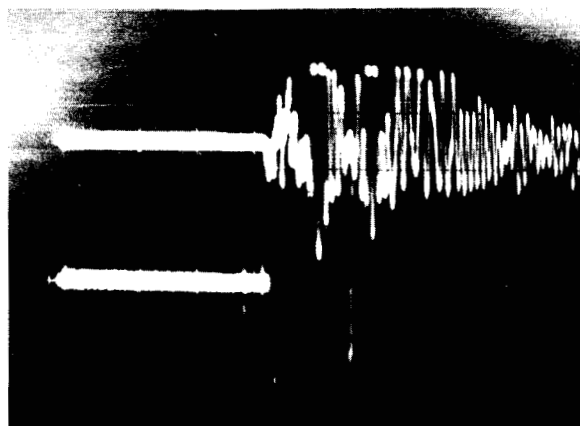
FIGURE 2-11  
 IMPACT TEST NO. 4  
 (Channels #1, 2, 3)  
 1 February, 1966 - Shot #1  
 PROJECTILE: LEXAN SLUG (2.8 mg)

Channel 1

Upper:  $5\mu\text{sec/div. (cm)}$   
 $2\text{V/div. (cm)}$   
 Lower:  $5\mu\text{sec/div. (cm)}$   
 $0.05\text{V/div. (cm)}$

Channel 3

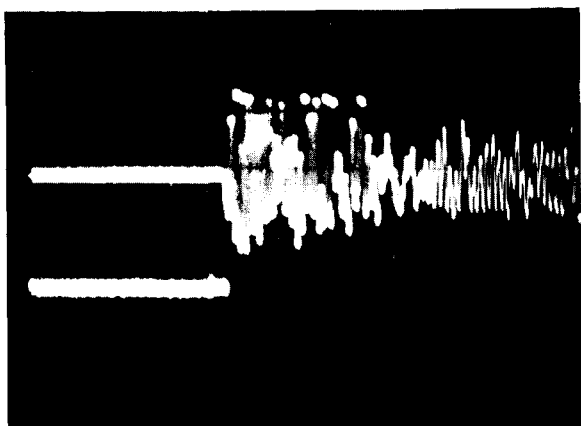
FIGURE 2-12  
IMPACT TEST NO. 4  
(Channel #4 and NSL Trigger Display)  
1 February, 1966 - Shot #1  
PROJECTILE: LEXAN SLUG (2.8 mg)

#### Channel 4

#### NSL Trigger Display

(Baseline has drifted downward)

- Channels 1, 2, 3, and 4 triggered by velocity measuring phototube circuit (40 sec delay added)
- Trigger Display oscilloscope triggered by NSL trigger circuit
- Projectile velocity: 25,050 ft/sec
- Transducers: Quartz X-cut wafers 0.25" in diameter and 0.063" thick
- Impact Plate: 4" x 4" x 1/8" 2024-T3 Aluminum

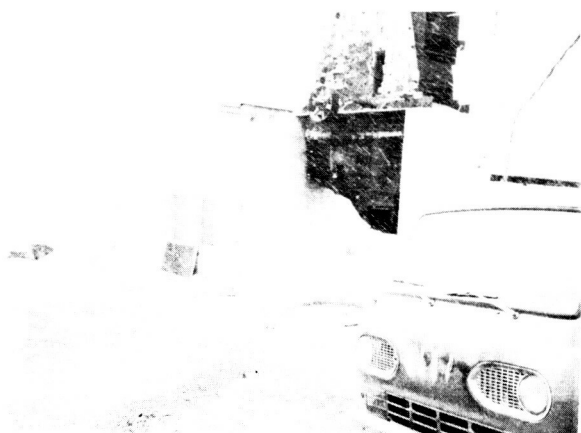
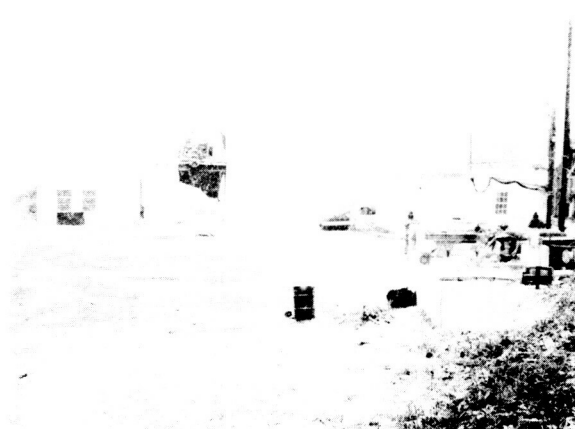
FIGURE 2-17 IMPACTED TARGETS AND GENERAL ELECTRIC COMPANY  
HYPERVELOCITY FACILITY

Targets Impacted by 2.8 mg Lexan Projectiles  
at Velocities of 20,000 - 26,000 ft/sec

G. E. Hypervelocity Facility Accelerating 10 - 100  $\mu$  Iron Fragments

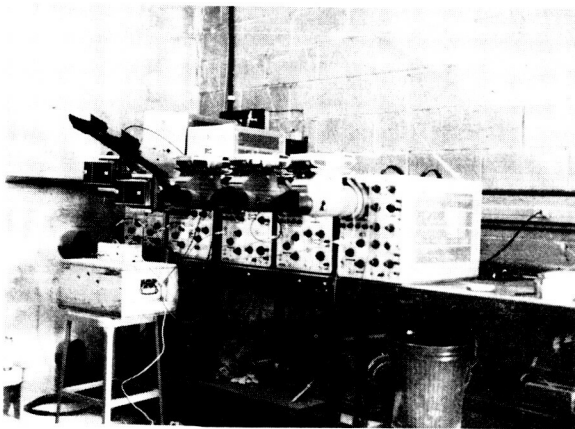
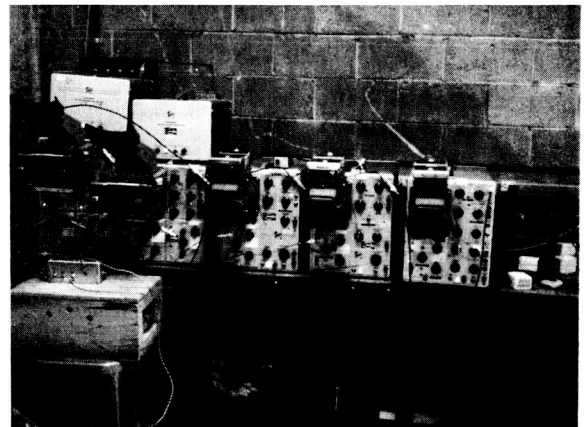
FIGURE 2-19 RECORDING INSTRUMENTATION AND VELOCITY MEASUREMENT  
FOR IRON FRAGMENTS IMPACT TESTS

Velocity Measurement Recording  
(Distance between screens = 4",  
time elapsed =  $11.2 \mu$  sec,  
velocity = 29,7000 ft/sec)

Recording Instrumentation for Iron Fragments Impact Tests

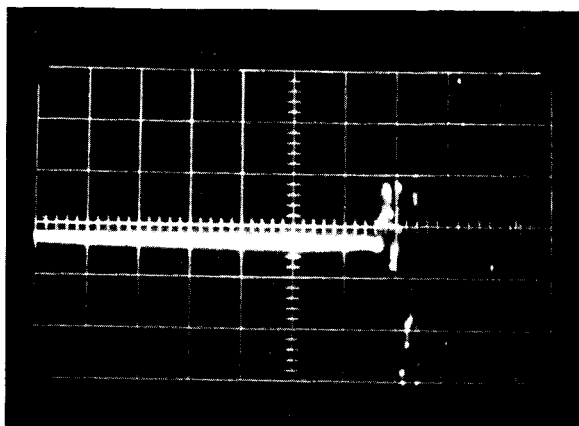
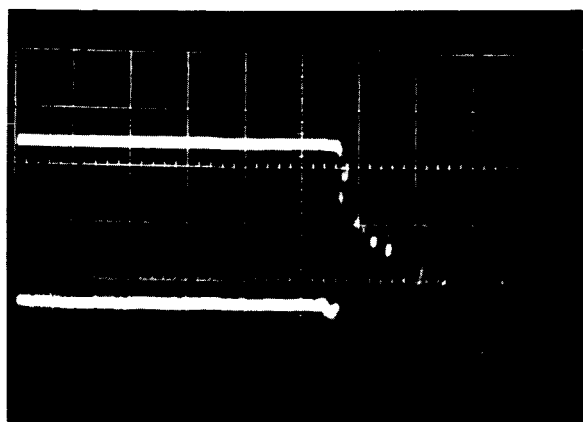
FIGURE 2-31  
 IMPACT TEST NO. 5  
 (Channels #1, 2, 3)  
 28 February, 1966 - Shot #1  
 PROJECTILE: IRON FRAGMENTS (10 - 100 $\mu$ )

Channel 1  
 $3\mu$  sec/div. (cm)  
 0.5V/div. (cm)  
 Gain (Xducer/Scope): 50

Channel 3  
 Upper:  $3\mu$  sec/div. (cm)  
 1V/div. (cm)  
 Lower:  $3\mu$  sec/div. (cm)  
 0.2V/div. (cm)  
 Gain (Xducer/Scope): 50

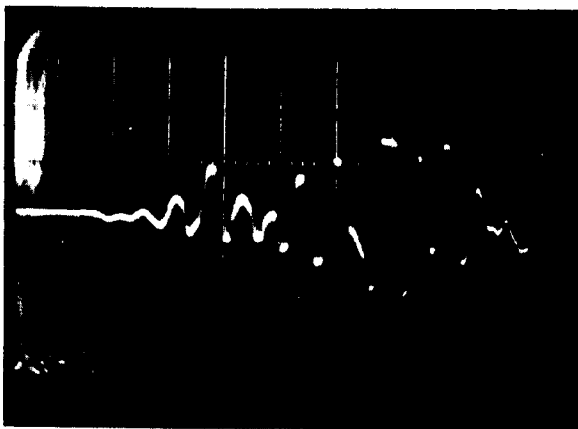
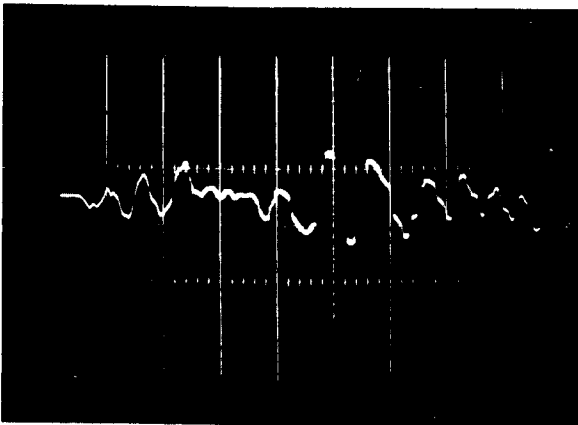
FIGURE 3-2  
 IMPACT TEST NO. 7  
 (Channels #1, 2, 3)  
 3 February, 1966 - Shot #2  
 PROJECTILE: LEXAN SLUG (2.8 mg)

#### Channel 1

Upper:  $1 \mu \text{sec/div. (cm)}$   
 $2 \text{V/div. (cm)}$   
 Lower:  $1 \mu \text{sec/div. (cm)}$   
 $0.05 \text{V/div. (cm)}$   
 Gain (Xducer/Scope): 0.12

#### Channel 2

#### Channel 3

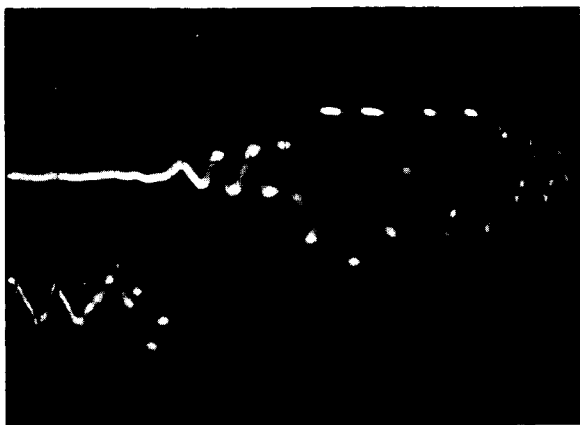
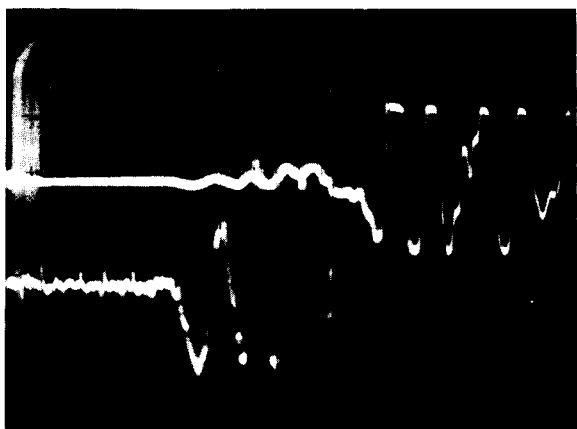
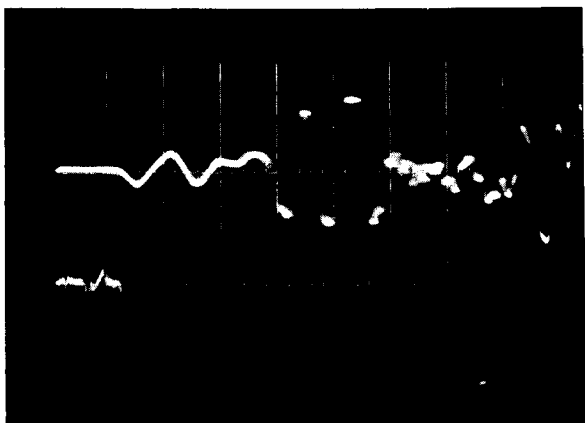
FIGURE 3-4  
 IMPACT TEST NO. 8  
 (Channels #1, 2, 3)  
 4 February, 1966 - Shot #1  
 PROJECTILE: LEXAN SLUG (2.8 mg)

#### Channel 1

Upper:  $1 \mu\text{sec/div. (cm)}$   
 $2\text{V/div. (cm)}$   
 Lower:  $1 \mu\text{sec/div. (cm)}$   
 $0.1\text{V/div. (cm)}$   
 Gain (Xducer/Scope): 0.12

#### Channel 2

#### Channel 3

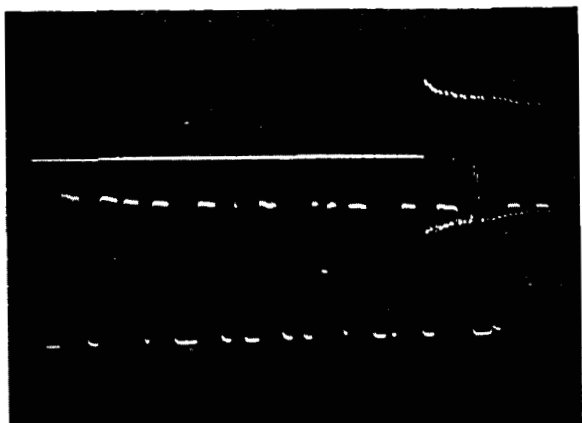
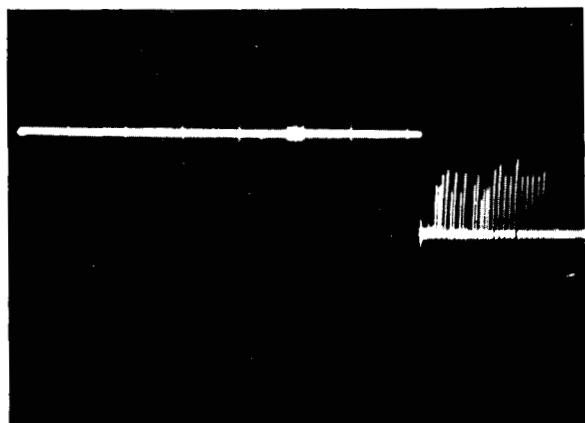
FIGURE 3-5  
 IMPACT TEST NO. 8  
 (Channel #4 and NSL Trigger Display)  
 4 February, 1966 - Shot #1  
 PROJECTILE: LEXAN SLUG (2.8 mg)

#### Channel 4

Upper: 10  $\mu$ sec/div. (cm)  
 2V/div. (cm)  
 Lower: 1  $\mu$ sec/div. (cm)  
 2V/div. (cm)  
 Gain (Xducer/Scope): 0.73

#### NSL Trigger Display

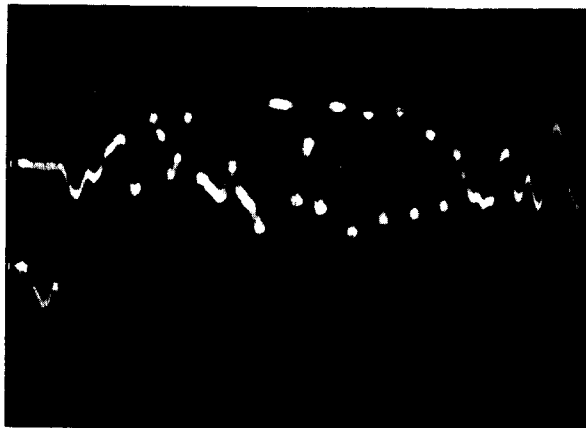
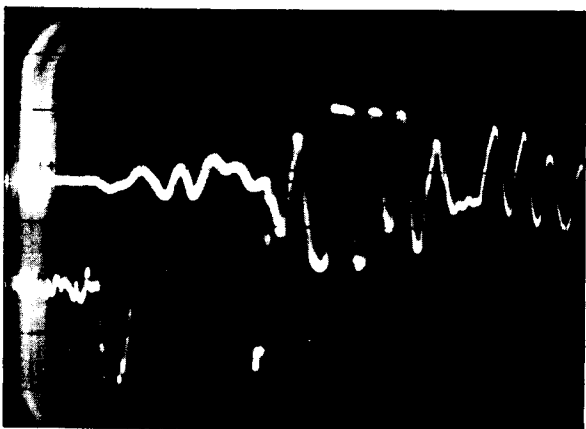
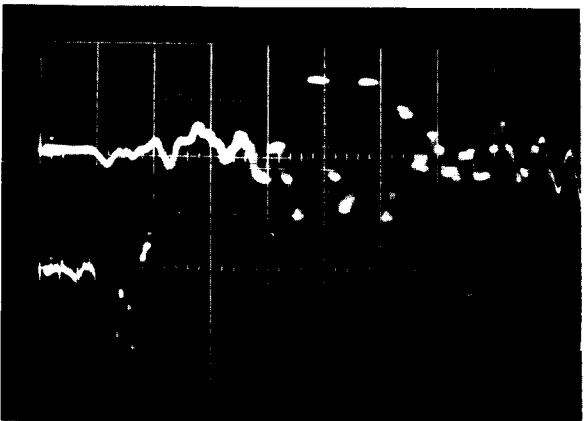
FIGURE 3-7  
 IMPACT TEST NO. 9  
 (Channels #1, 2, 3)  
 4 February, 1966 - Shot #2  
 PROJECTILE: LEXAN SLUG (2.8 mg)

Channel 1

Upper:  $1\mu\text{ sec/div. (cm)}$   
 $2\text{V/div. (cm)}$   
 Lower:  $1\mu\text{ sec/div. (cm)}$   
 $0.1\text{V/div. (cm)}$   
 Gain (Xducer/Scope): 0.12

Channel 2

Channel 3

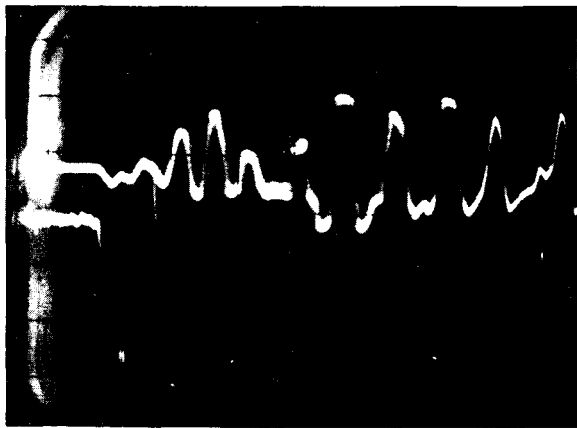
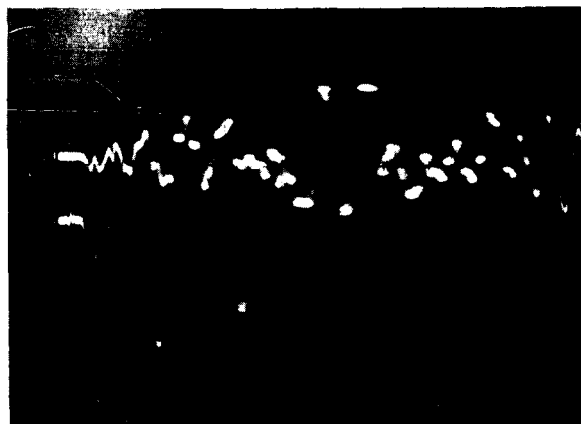
FIGURE 3-9  
IMPACT TEST NO. 10  
(Channels #1, 2, 3)  
4 February, 1966 - Shot #3  
PROJECTILE: LEXAN SLUG (2.8 mg)

Channel 2

Upper:  $1\mu\text{ sec/div. (cm)}$   
 $2\text{V/div. (cm)}$   
Lower:  $1\mu\text{ sec/div. (cm)}$   
 $0.1\text{V/div. (cm)}$   
Gain (Xducer/Scope): 0.12

Channel 3
