# GRAVITY GRADIENT STABILIZATION SYSTEM for the

DOCUMENT NO. 65SD4464  
20 OCTOBER 1965

## FIFTH QUARTERLY PROGRESS REPORT

NASA CONTRACT NAS 5-9042

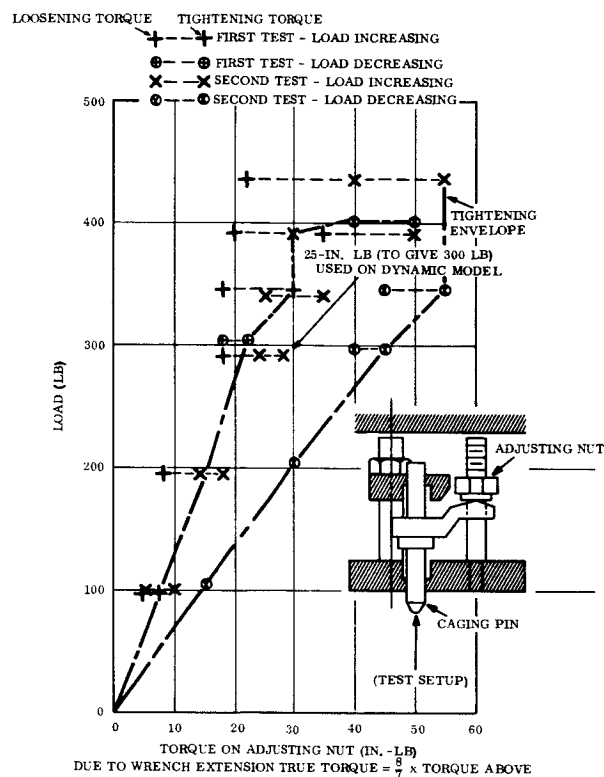
Figure 4-4. Eddy Current Caging Torque Test Results

actual parts of the CPD which were being simulated. The holes were anodized, as in the actual parts. The torque readings were taken with a torque wrench having a calibrated 7-inch torque arm. This wrench was used with a 1-inch-long open end extension to fit the adjusting nut to give a total torque arm of 8 inches. This combination gives a true torque which is  $8/7$  times the torque read from the wrench; the reading was recorded. The torque action was rather erratic and is plotted as a range rather than a single value. Two tests were run with the nut turned 90 degrees between tests to present a new surface to the guide. Both the nut and guide showed some local deformation at the higher loads. The design load on the eddy current caging pin is 300 pounds. To give this load, the adjusting nuts on the Dynamic Model were tightened to 25-inch pound reading on the wrench. They performed satisfactorily on the vibration tests. The nuts showed less local deformation than in the test (the load was less). The local deformation probably helps prevent loss of adjustment.

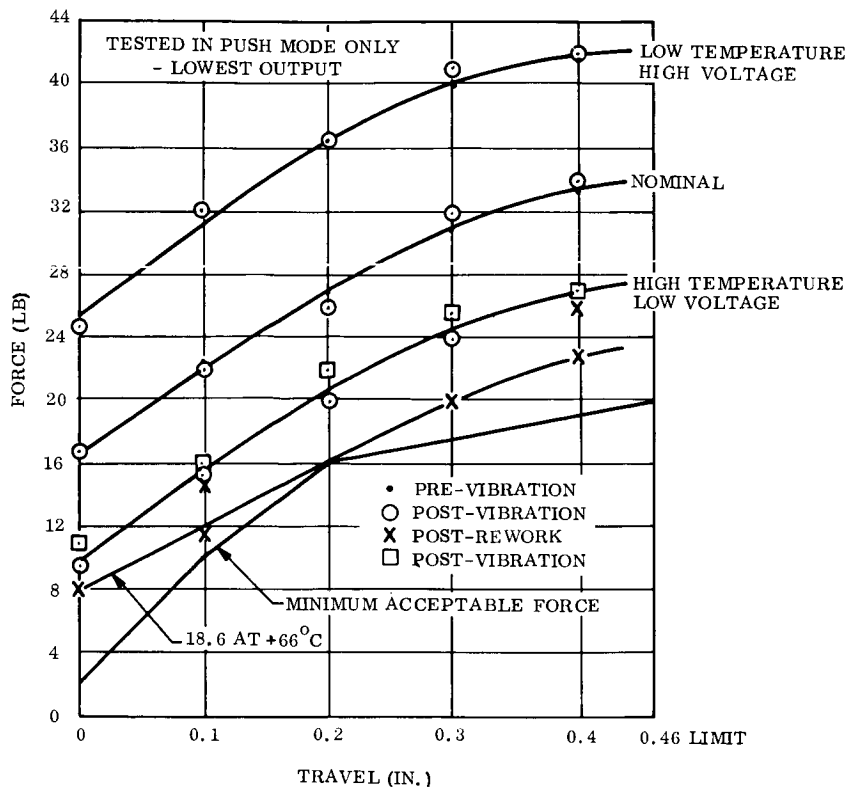
Figure 4-6. Force Versus Travel Test Results for Engineering Unit 1 Solenoid

Present indications, based on the testing of two solenoids (one at Koontz-Wagner and one at both Koontz-Wagner and GE), are that the minimum allowable solenoid voltage to meet the force versus travel requirement is 18.78 volts. This value is based on:

- Maximum solenoid temperature: 60<sup>o</sup>C (latest input from thermo-analysis)
- Maximum push coil resistance at 24<sup>o</sup>C: 2.660 ohms
- Minimum coil current: 6.20 amperes.

The above information seems very reasonable based on test results to date. If this information is assumed to be correct, a voltage drop of 5.32v dc exists between the unregulated voltage bus and the solenoid (when the solenoid is at + 60°C, the push mode winding is at a maximum resistance, and the unregulated bus is at a minimum of -24.3v dc), and the solenoid would actuate the clutch mechanism.

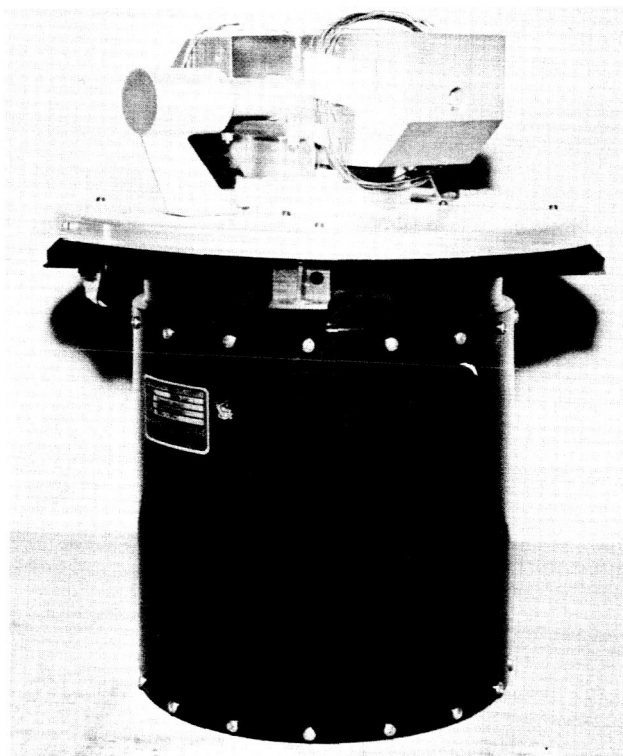
Figure 6-1. CPD with Damper Boom in Stowed Position - Thermal Models

- a. Combination Passive Damper and Damper Boom (Figure 6-1)
- b. Primary Boom Package (Figure 6-2)
- c. TV Camera with Lens and Camera Control Unit (Figure 6-3)
- d. Solar Aspect Sensor Electronics Unit and Five Sun Sensor Detectors (Figure 6-4)
- e. Power Control Unit (Figure 6-5)

The external configuration of each component has been held as closely as possible to the ATS-A configuration. The units are not intended to be used for mock-up purposes to establish clearance or connector locations on the vehicle. The finishes used on the thermal models have been selected to be representative of the flight hardware.

The dynamic models are similar to the thermal units shown in Figures 6-1 through 6-5.
