## SNAP-8 ELECTRICAL GENERATING SYSTEM DEVELOPMENT PROGRAM

### PROGRESS REPORT FOR OCTOBER - DECEMBER 1966

NATIONAL AERONAUTICS AND SPACE ADMINISTRATION  
LEWIS RESEARCH CENTER

VON KARMAN CENTER  
AEROJET-GENERAL CORPORATION  
AZUSA, CALIFORNIA

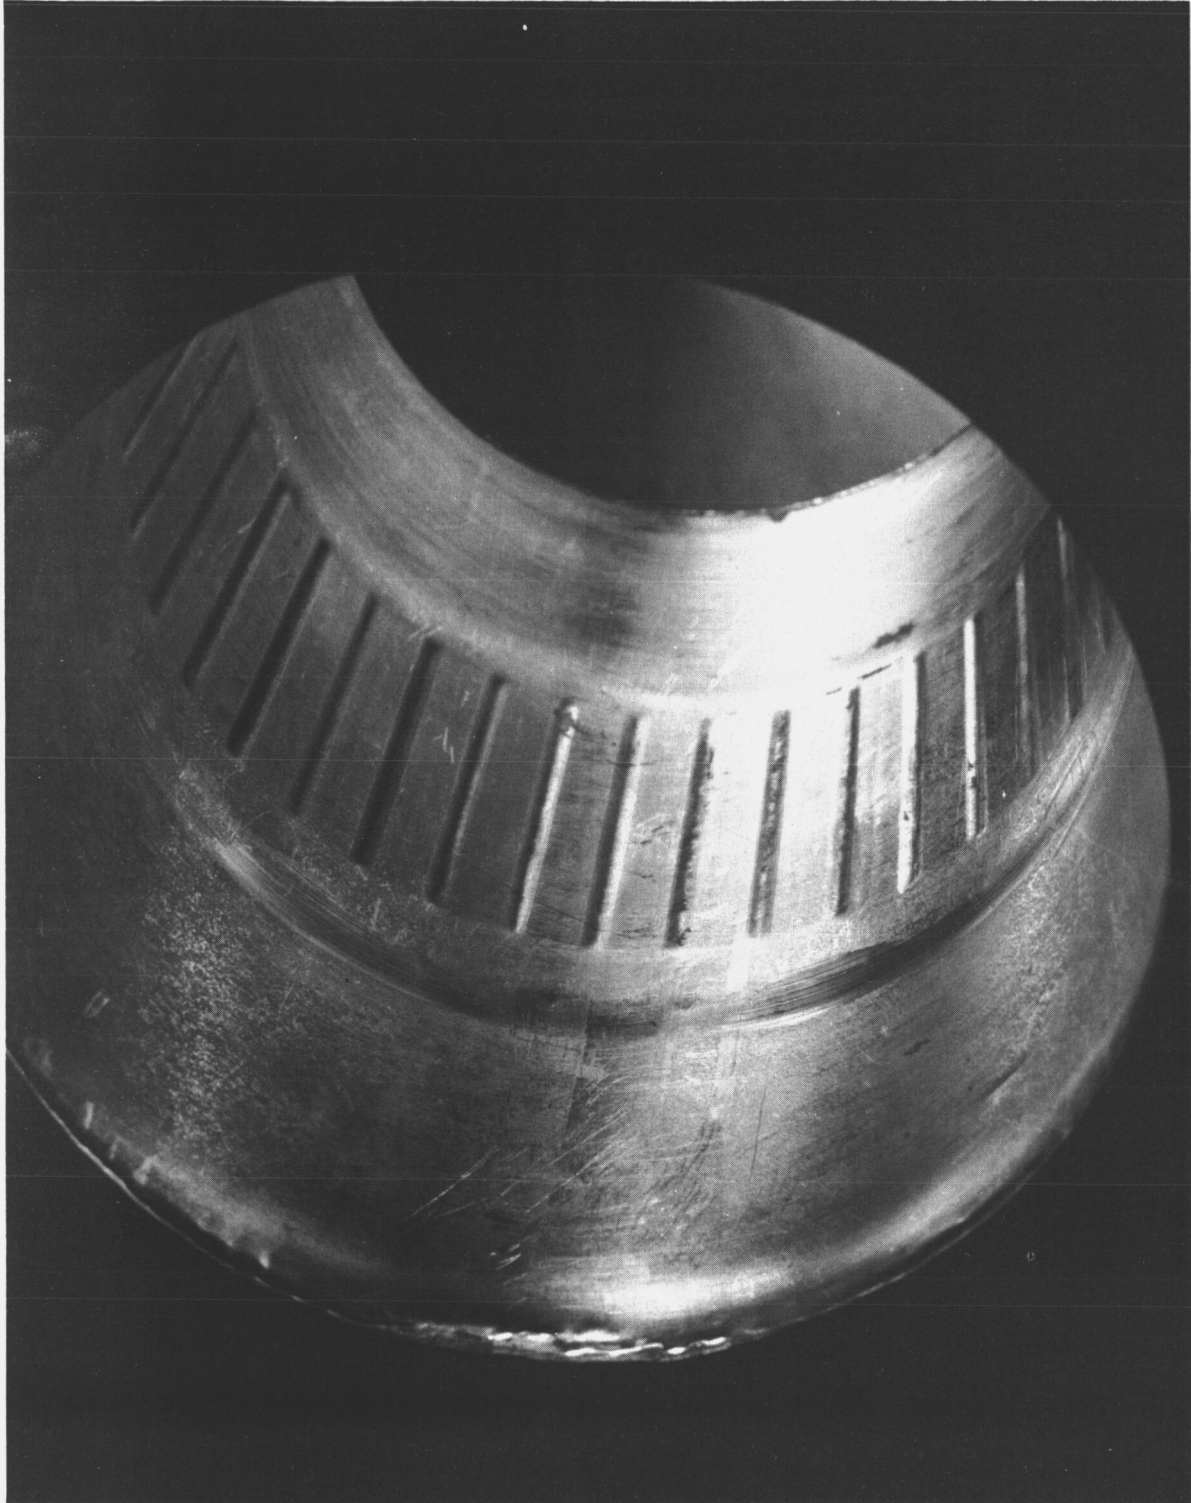
Figure II-5

NaK Pump-Motor Stator Housing (P/N 092992-1) from  
INL-3 Unit 2/3 - Recirculation Pump End

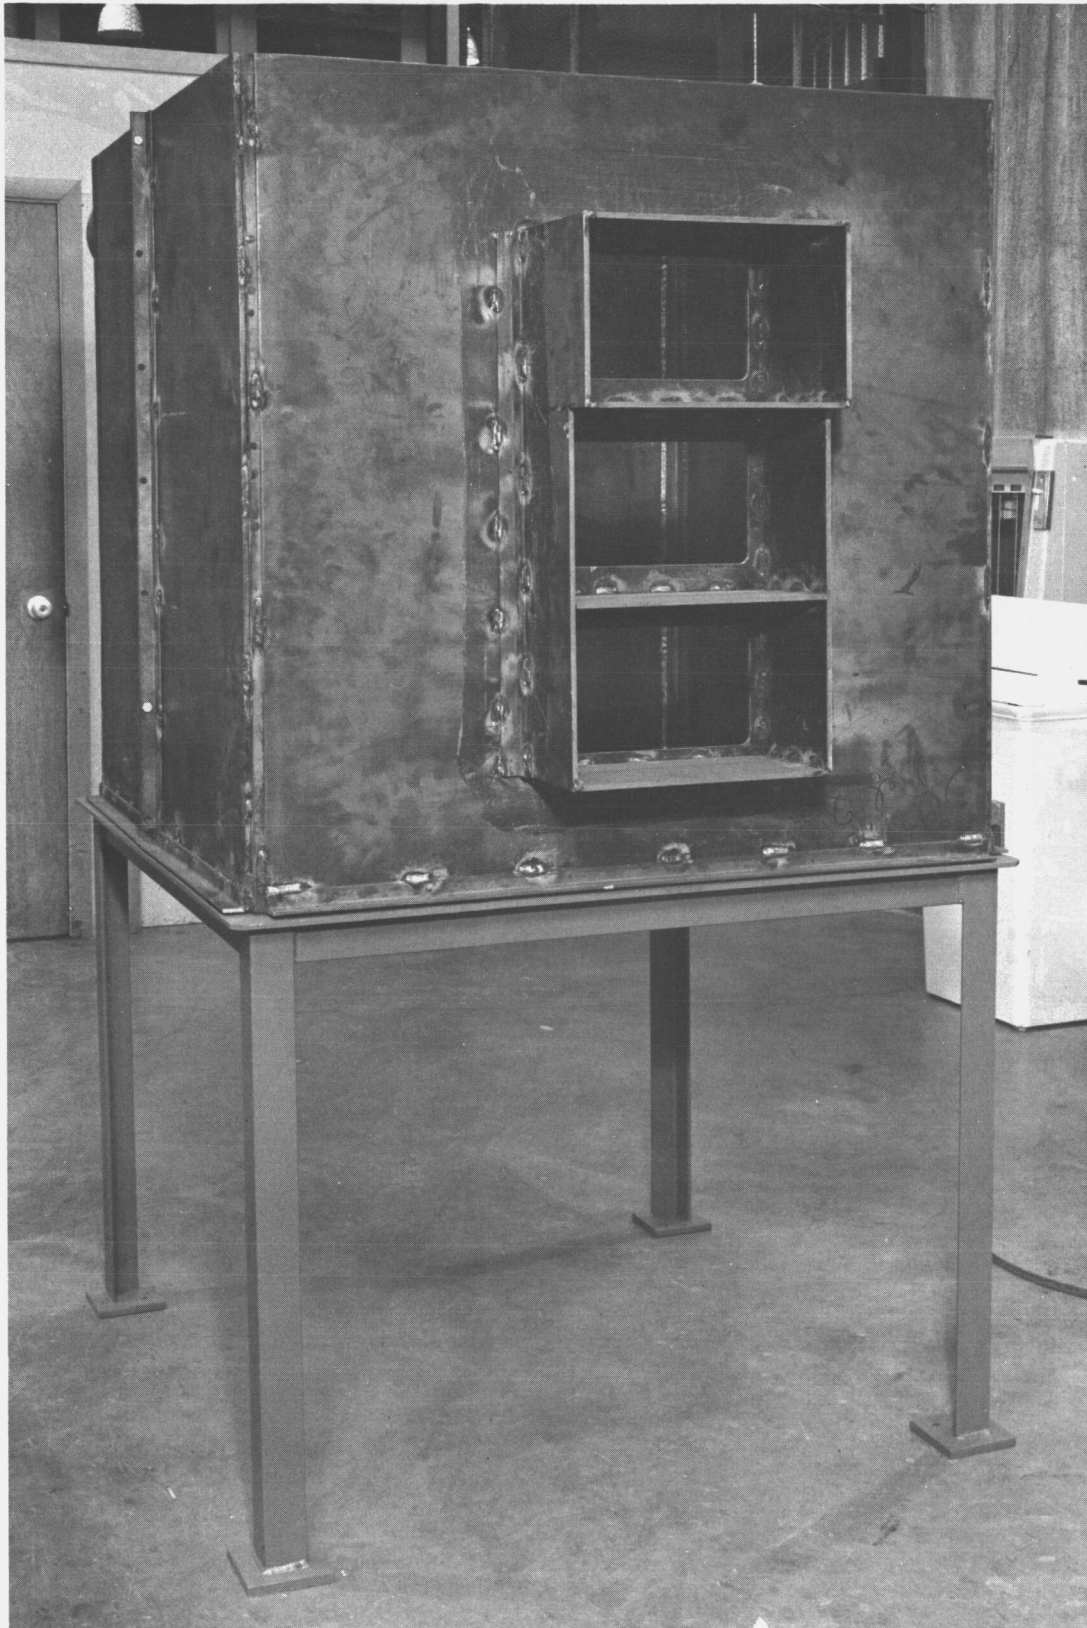
Figure V-17

NaK Heater Housing

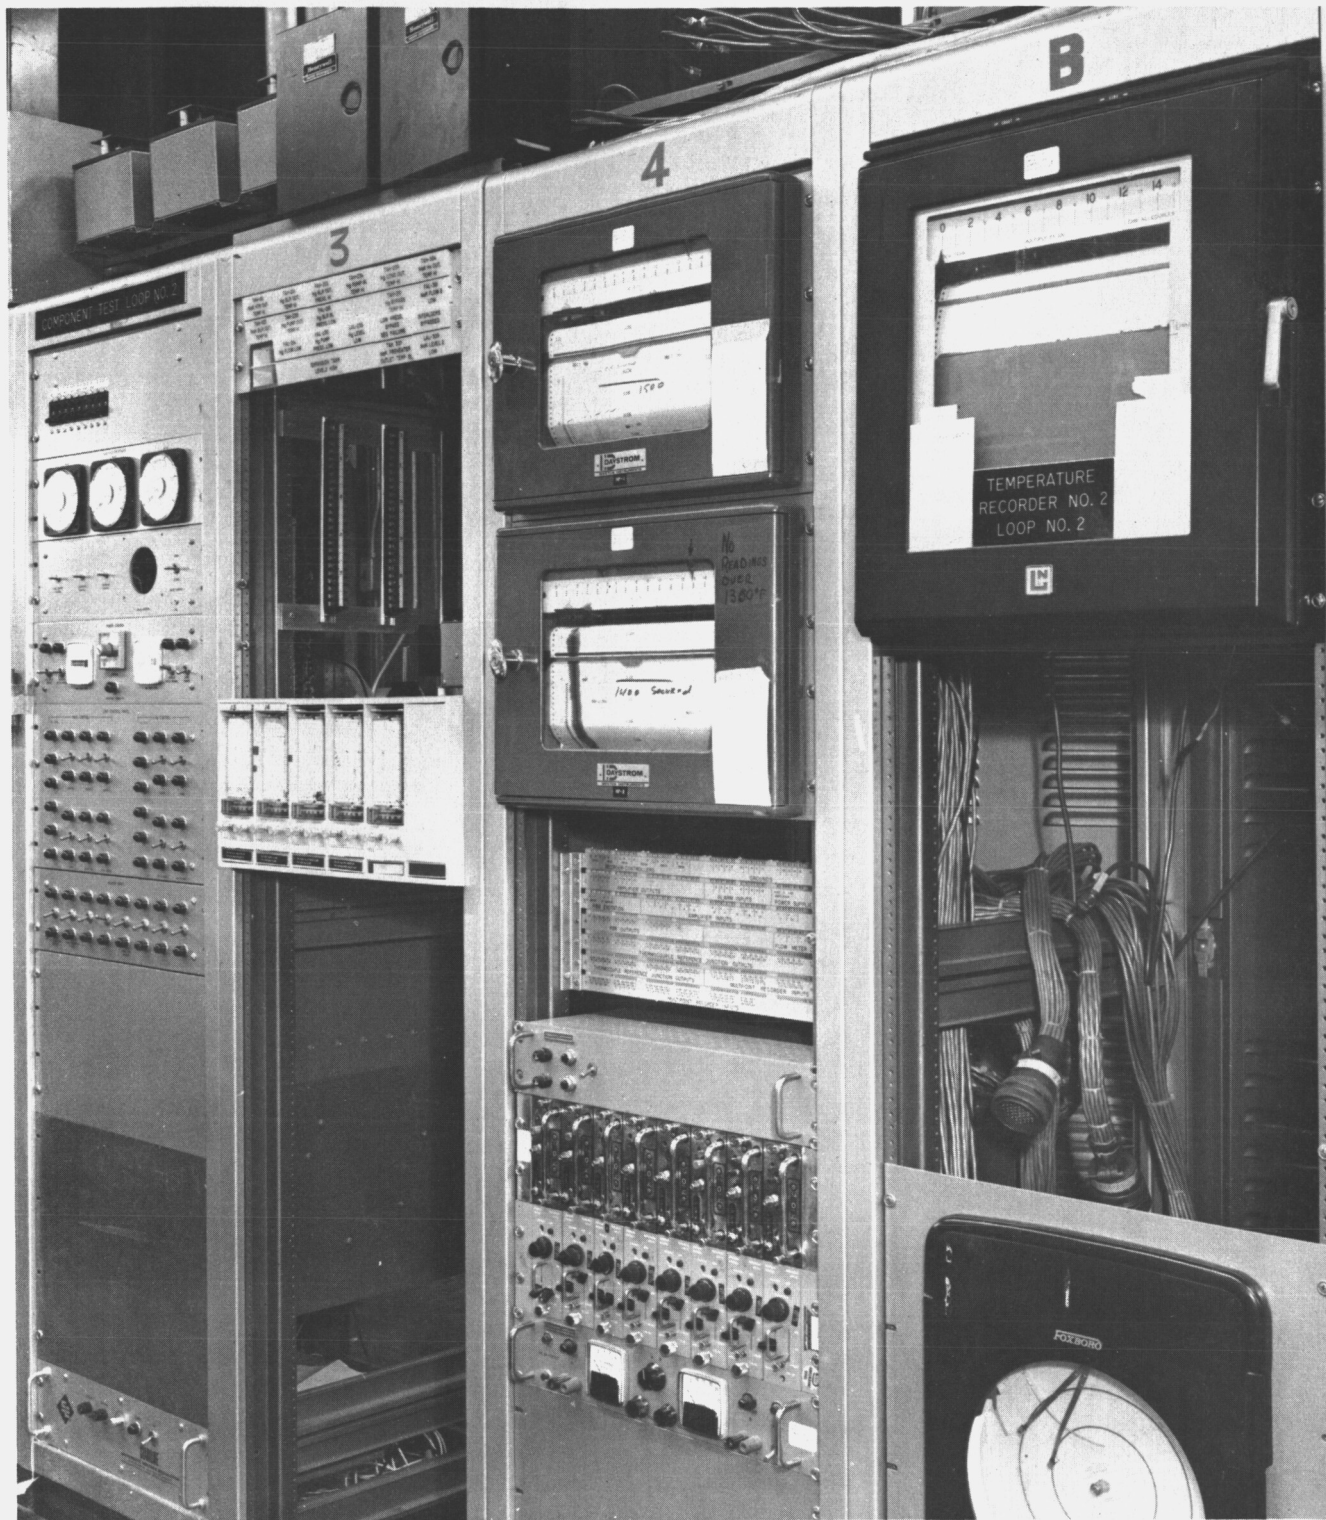
Figure V-21

Seventh-Scale Loop Control Console
