Technical Report 32-953

*Mariner Mars 1964 Basic Structure,
Design and Development*

**JET PROPULSION LABORATORY
CALIFORNIA INSTITUTE OF TECHNOLOGY
PASADENA, CALIFORNIA**

May 1, 1967

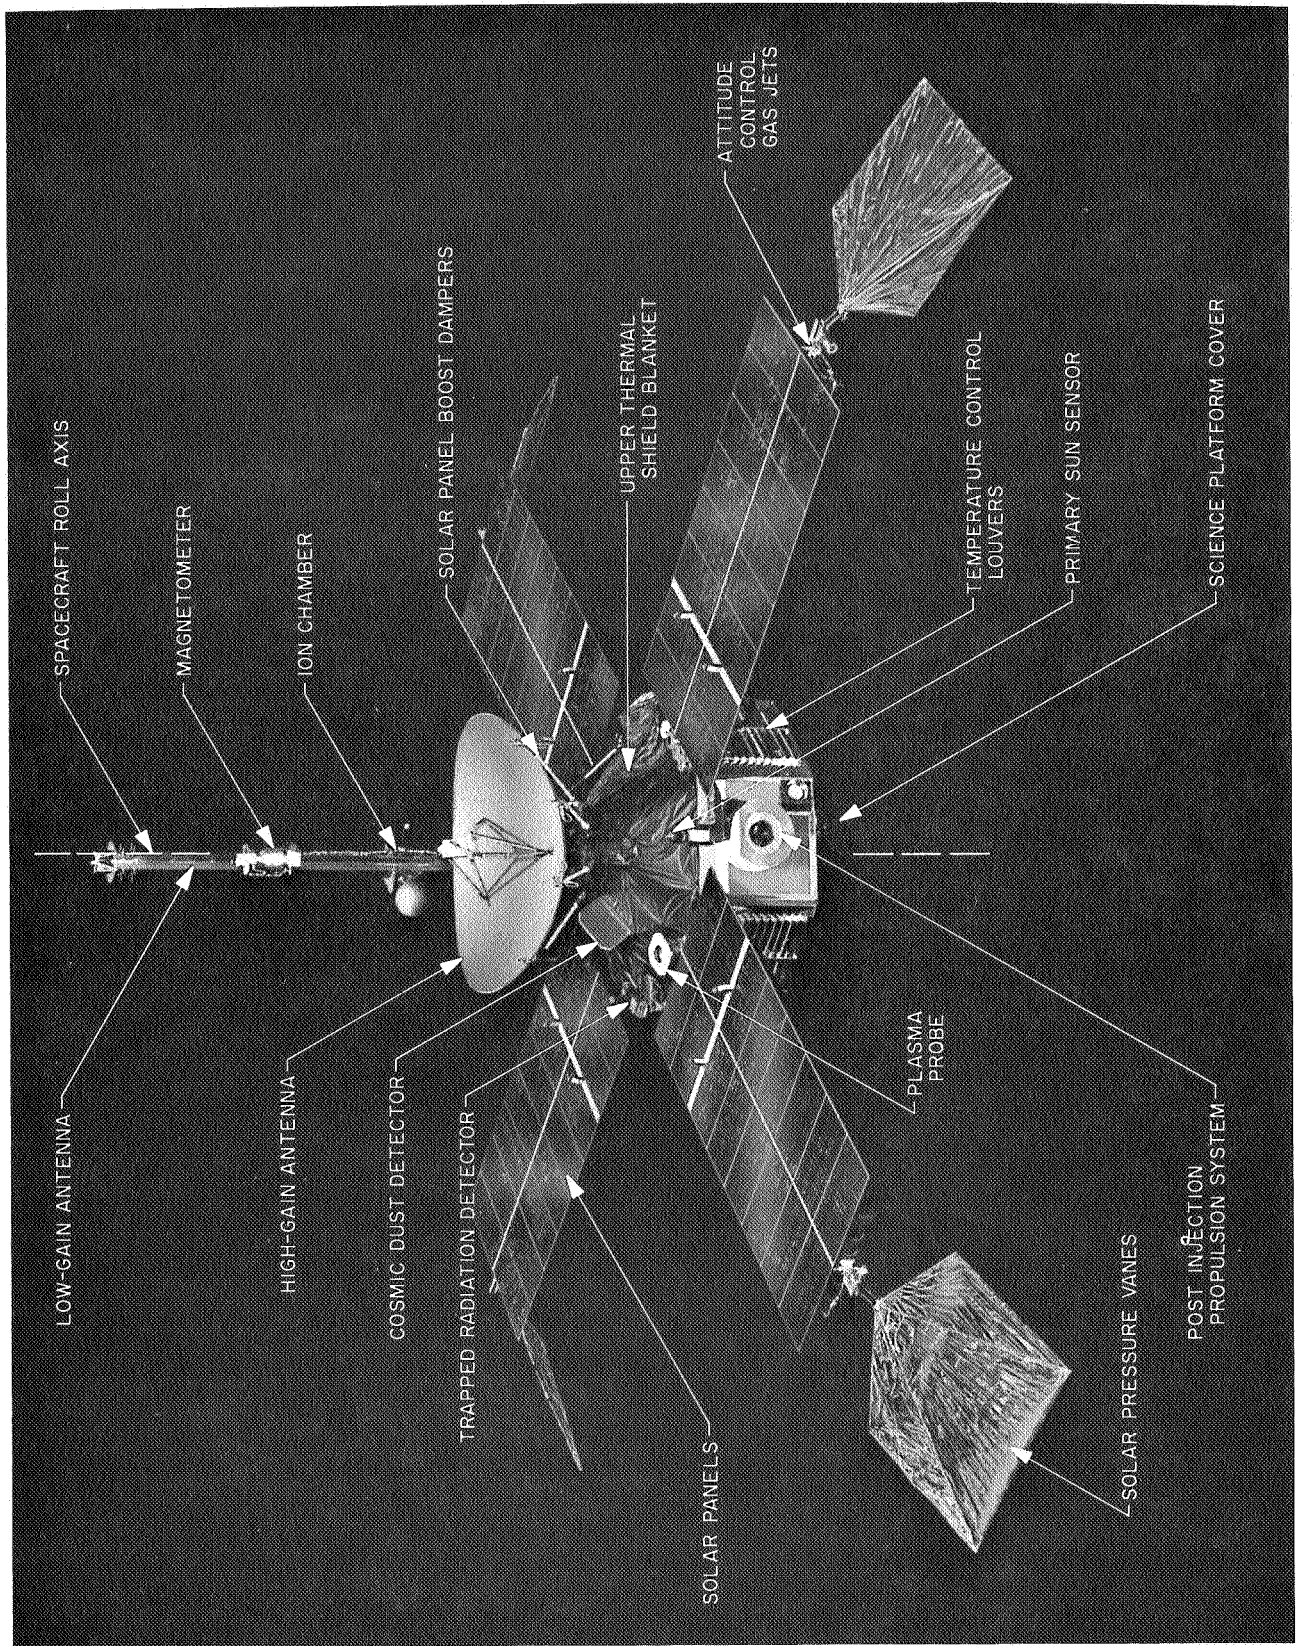
Fig. 1. Mariner IV spacecraft in cruise configuration

The 575-lb *Mariner IV* spacecraft (Fig. 1) was launched by an *Atlas-Agena D* on November 28, 1964 on a 229-day trip to Mars. The objectives of the mission were to obtain (1) scientific data on space — both interplanetary and near Mars, (2) close-up television pictures of the Mars surface, and (3) Mars atmospheric data — by the occultation of the spacecraft RF signals. All of the objectives of the mission were successfully completed.

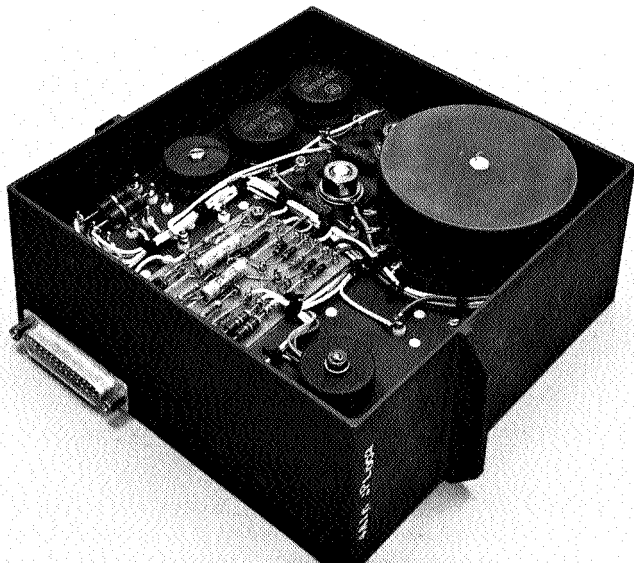
Fig. 2. Typical 6- × 6-in. electronic subchassis

was that of using the 6- × 6-in. electronic subassembly profile (Fig. 2) that had been used in *Ranger* and *Mariner II*. It was felt, and later confirmed, that integrating the electronic assembly into the structure would provide significant weight reductions without compromising the design flexibility and operational accessibility. Structural designs were actively pursued involving four structural configurations.

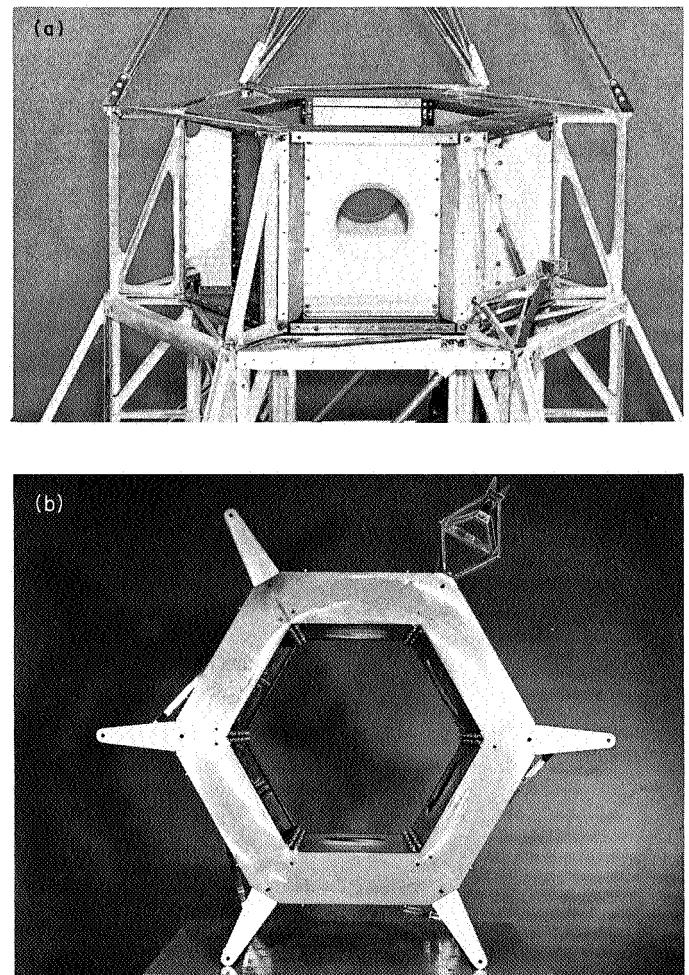
Fig. 3. *Mariner A Venus-Centaur* structure

d. Octagon configuration. The final design of the spacecraft primary structure was an outgrowth of a design that was fabricated and assembled for the *Mariner A Venus-Centaur* spacecraft (Fig. 3). The chosen design used integrally machined octagonal rings, which were separated vertically by longerons. The electronic chassis, which housed two vertical rows of subassemblies, bolted to openings formed by the longerons and rings. Structurally, these chassis were similar to those used on the *Ranger* and *Mariner II* designs. The rings and the longerons formed the sides of the chassis and the outer face

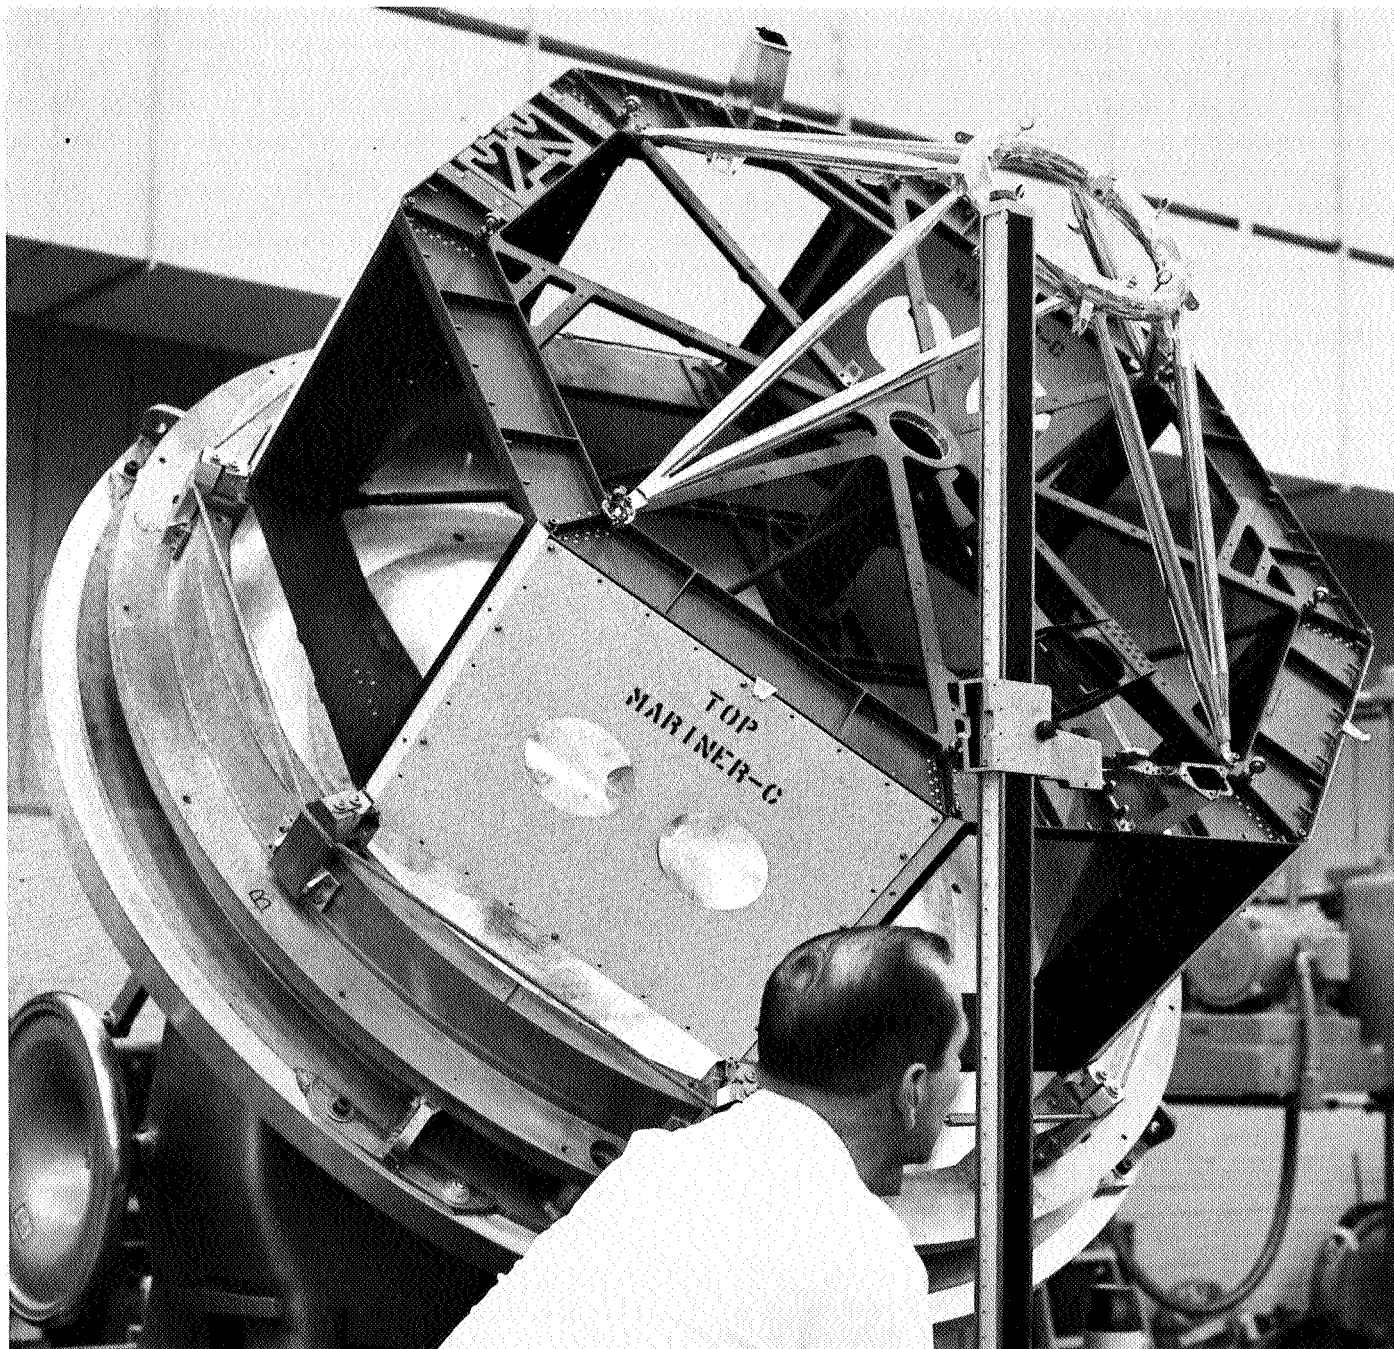
Fig. 4. Basic octagon structure (with superstructure attached)

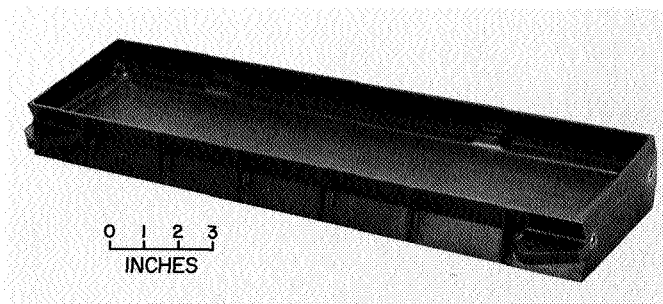
Fig. 5. Octagon longerons

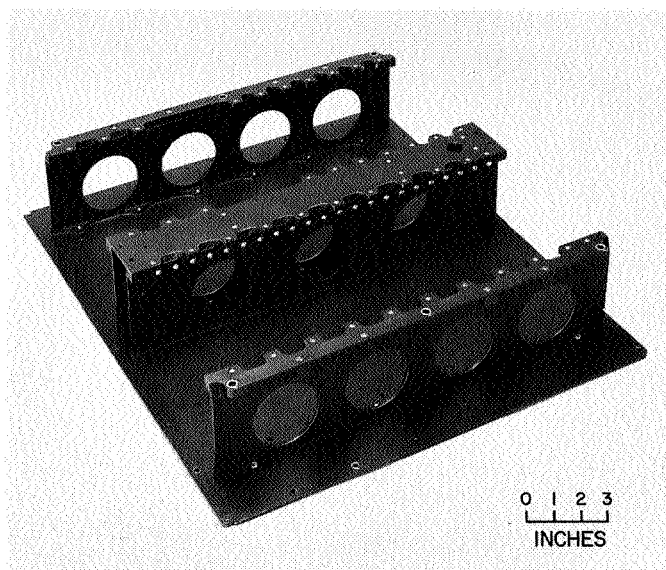
Fig. 6. Basic electronic chassis

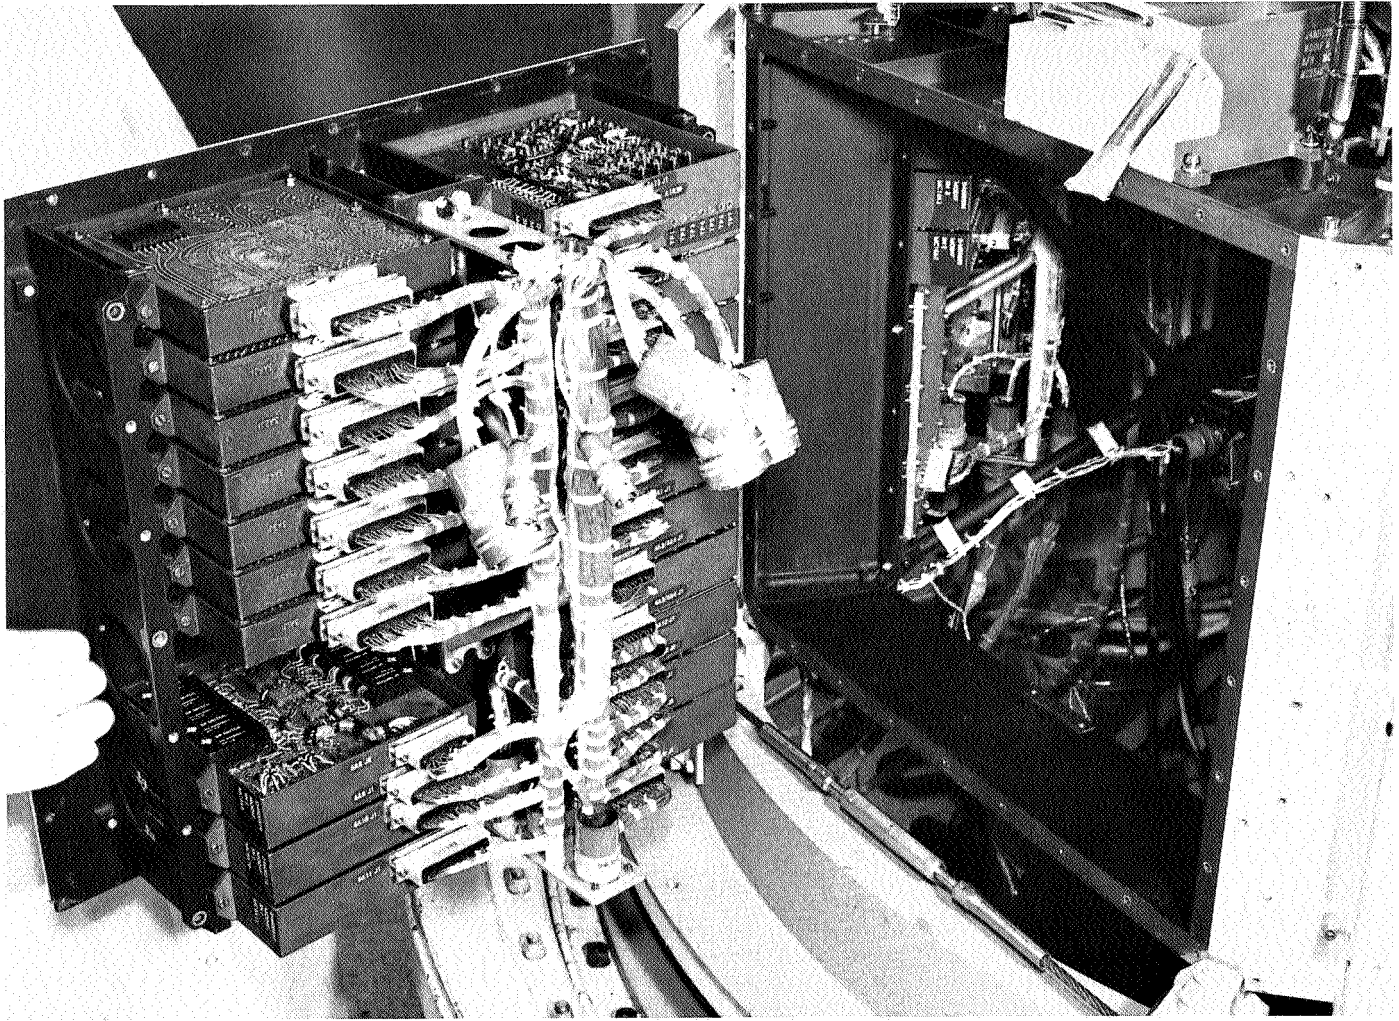
Fig. 7. Electronic assembly being installed into spacecraft structure

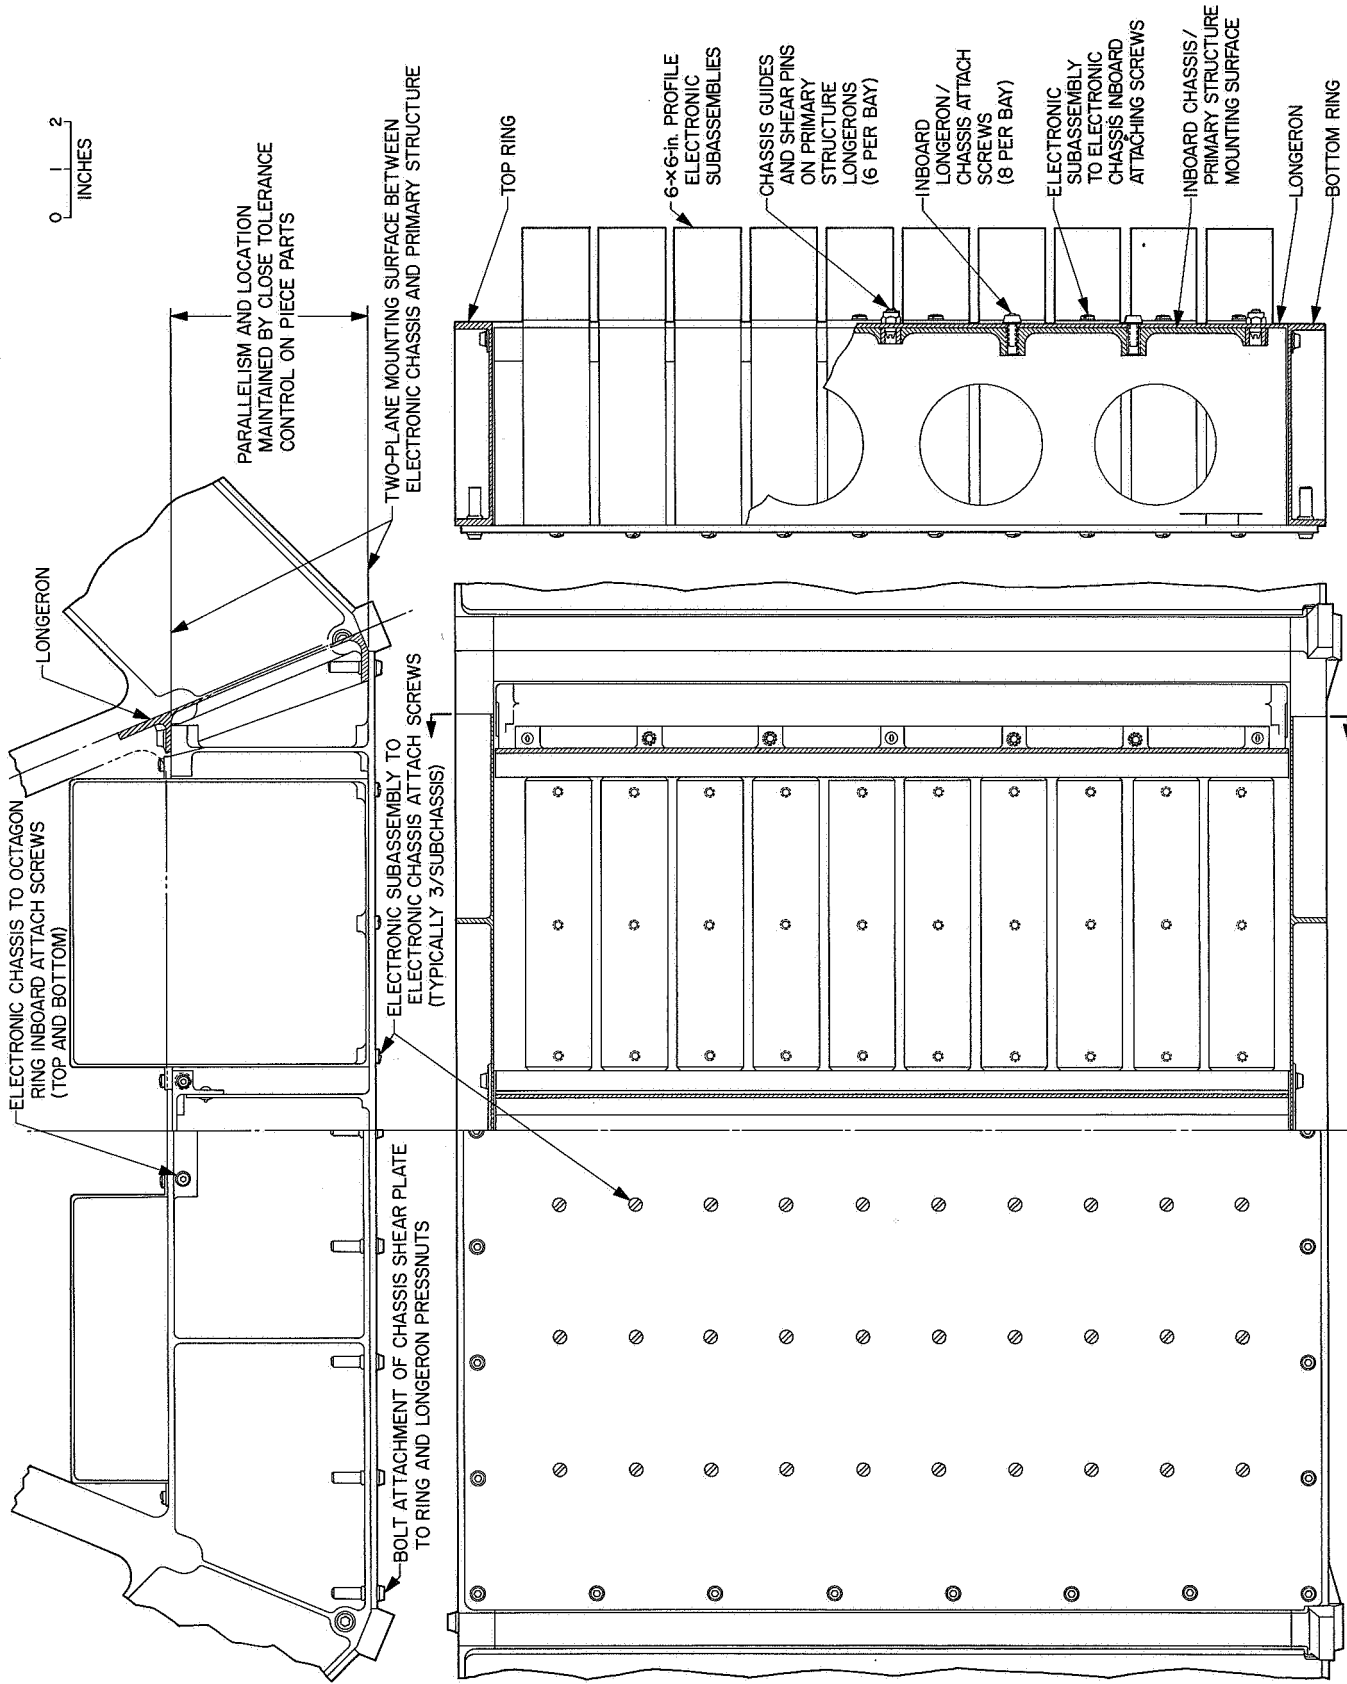
Fig. 8. Typical electronic chassis/octagon structure installation

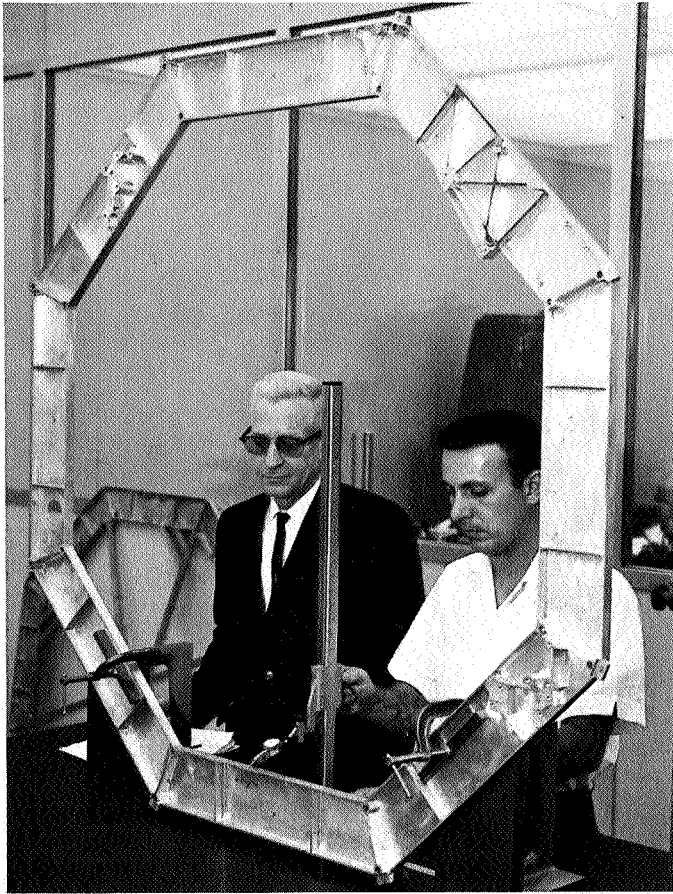
Fig. 9. Primary structure lower ring

The lower ring, Fig. 9, provided mounting surfaces for switches, adapter hardware, a sun shutter, and optical sensors. The sun sensors and Canopus tracker were bolted to mounting and indexing surfaces that were machined directly on the lower ring. The ring was composed of a channel cross section with stiffening gussets provided at the eight corners.

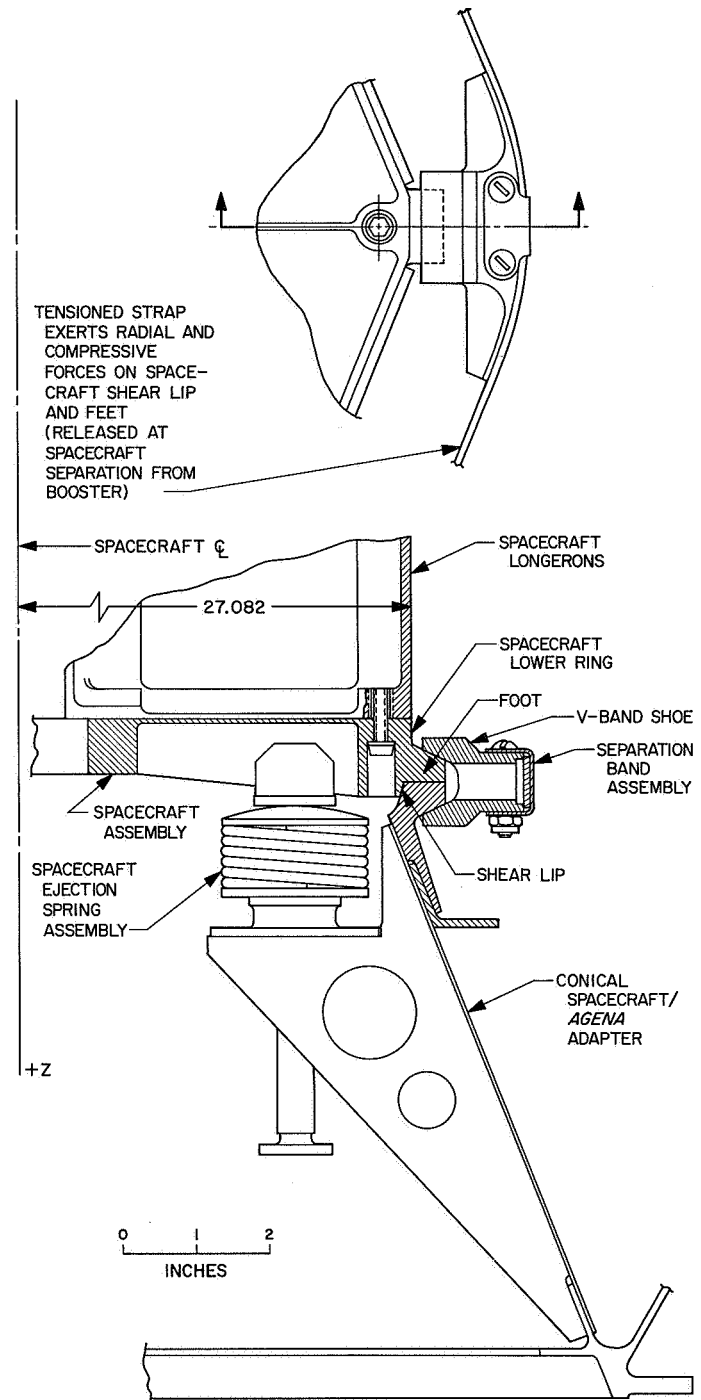
Fig. 10. Attachment detail, spacecraft to Agena adapter

The spacecraft was attached to the *Agona* adapter at the eight exterior corners of the lower ring. It was held in place by a V-band that clamped eight 1-in.-wide feet (Fig. 10) to bear on a corresponding surface on the adapter. The compressive force of the tensioned V-band reacting on the upper surface of the foot, reacted the axial loads. Radial loads were reacted by a shear lip on the lower ring, which bore against a corresponding surface on the adapter. Because of the natural dimensional variation between adapter and spacecraft, the adapter

The spacecraft adapter mounting surface was designed to be coplanar within 0.005 in. The radial tolerances between the shear lips were held to 0.010 in. across the 55-in. diameter. During the assembly, test operations, and shipment, the spacecraft was attached to a support structure called a *universal ring* (U-ring). This ring supported the spacecraft as it would be supported when on the launch vehicle, with the exception that it was much more rigid than the flight adapter.

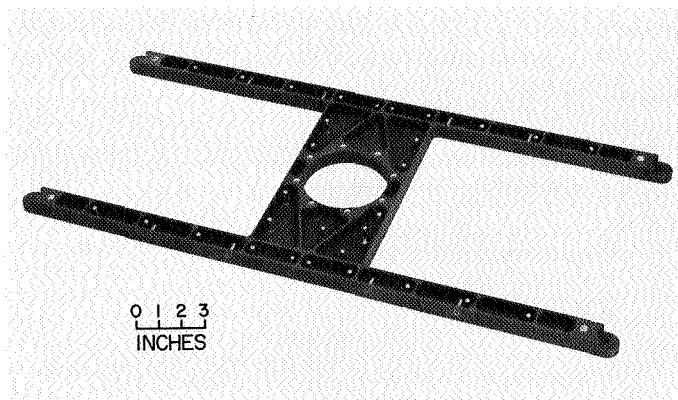
Fig. 11. H-frame structure

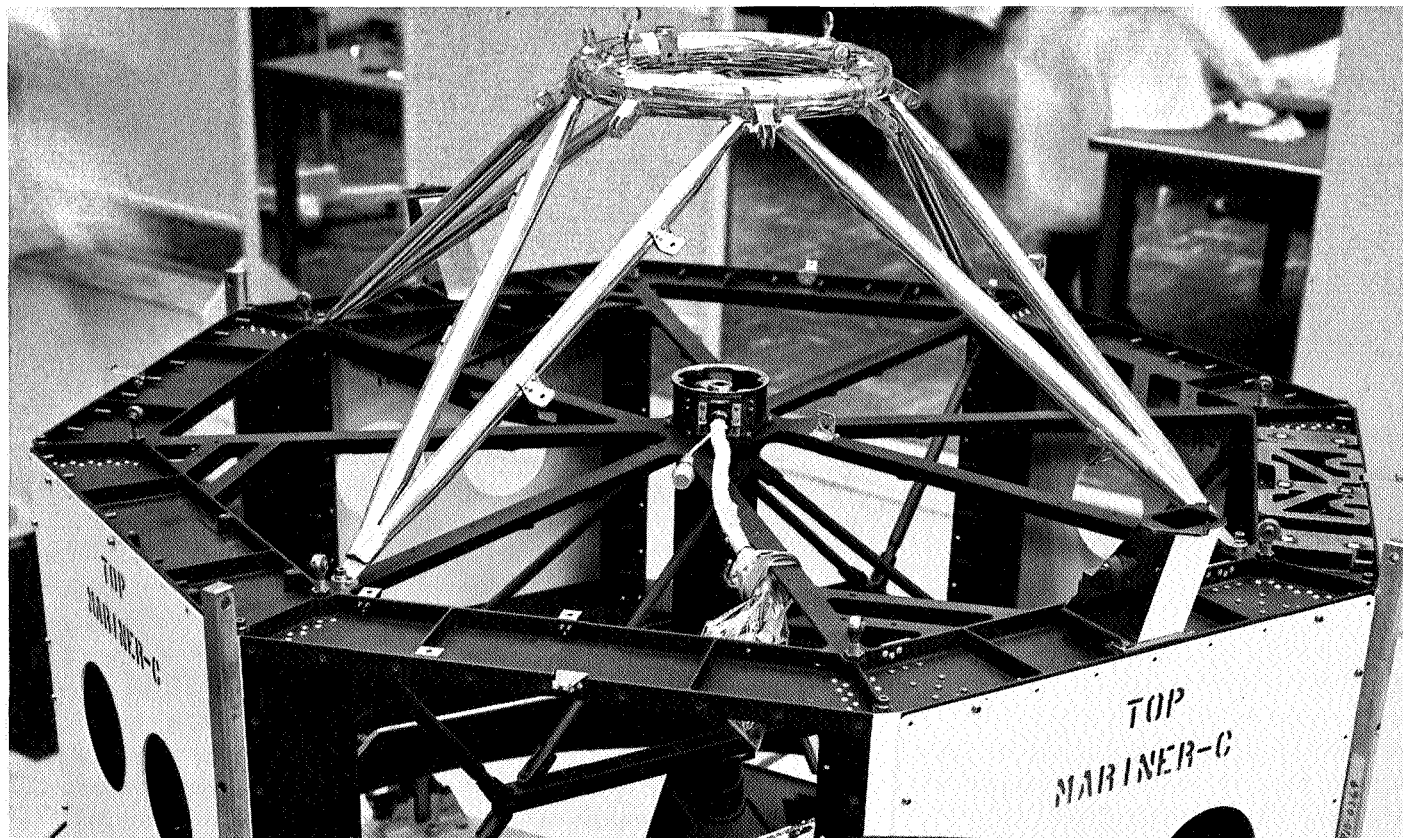
Fig. 12. Superstructure

3. Superstructure. The superstructure was an eight-membered, welded, aluminum truss, which attached at four points to the primary structure (Fig. 12) and culminated in a circular top ring which contained attach points for the high-gain antenna, one low-gain antenna

damper, and the solar panel boost dampers. The truss was 44 in. in diameter, 17-in. high, and weighed 3.06 lb.

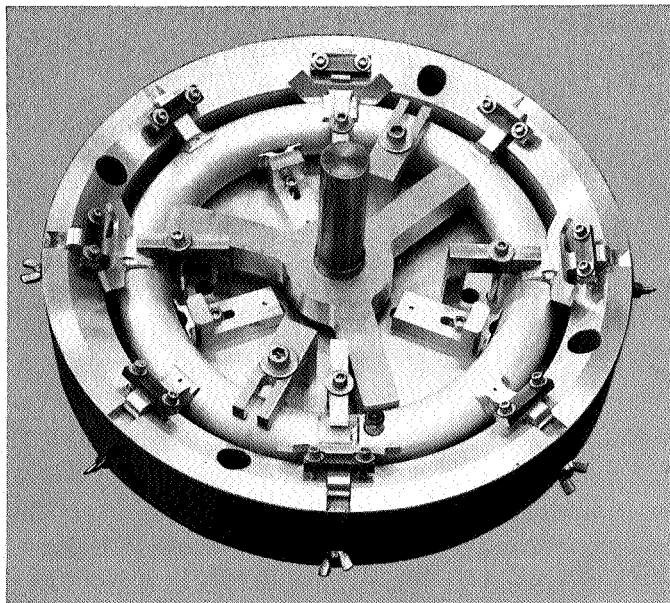
Fig. 13. Superstructure ring welding fixture

The ring weldment and fittings were tack-welded in a fixture (Fig. 13) in a heated environment (hot plate and photo floodlights). After tacking, the assembly was removed from the fixture and finish-welded in the heated environment in a sequenced manner to minimize distortion. After welding, all welds were radiographically and fluorescent-penetrant inspected. If unacceptable

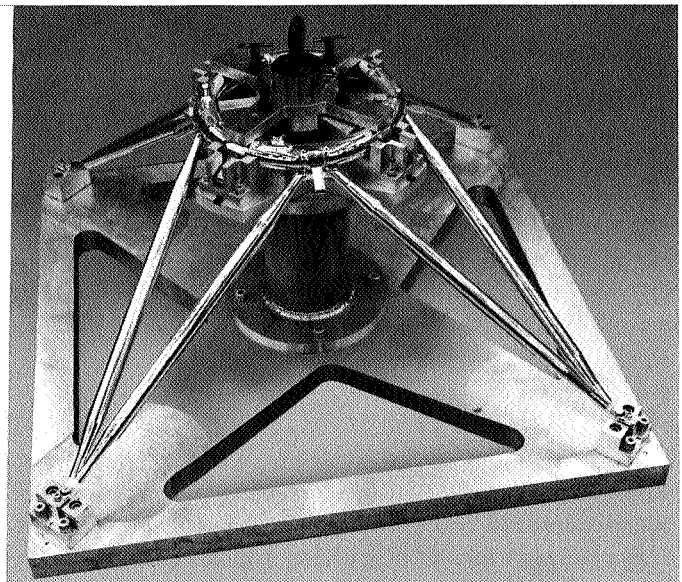
Fig. 14. Superstructure in welding fixture

- (2) *Truss strut tubes.* The truss strut tubes were formed of 1-in. diameter 6061-0 aluminum tubing with 0.035-in.-thick wall. The ends of the tubes were swaged to 0.59 in. to minimize the size requirements for the end fittings. After swaging and treating to the T6 condition, the ID of the swaged ends was honed to remove inclusions and imperfections caused by the forming process. The tubes were then fluorescent-penetrant inspected and machined. After the tubes were polished and inspected, they were ready for final assembly.
- (3) *Final assembly.* Final assembly welding took place in the welding fixture shown in Fig. 14. The truss

ring weldment, truss strut tubes, and four feet were tack-welded together in the fixture and then finished welded in the free state. The welds were then radiographically and fluorescent-penetrant inspected. If rework were required, it was performed in the same manner as that described for the truss-ring weldment. When all welds were acceptable, the assembly was replaced in the welding fixture and stress relieved. After stress relieving, the assembly was placed in another fixture similar to that used for welding and machined to final dimensions. Following final machining, brackets were riveted on, Pressnuts installed, polished surfaces touched up and the assembly inspected.
