THE APPLICATION OF LIQUID CRYSTALS  
FOR THERMOGRAPHIC TESTING OF BONDED STRUCTURES

Prepared Under Contract No. NAS8-20627 by  
THE PROFICIENCY DEVELOPMENT LABORATORY  
Quality Engineering Department  
LOCKHEED-GEORGIA COMPANY  
Marietta, Georgia

Marshall Space Flight Center  
NATIONAL AERONAUTICS AND SPACE ADMINISTRATION

September 11, 1967

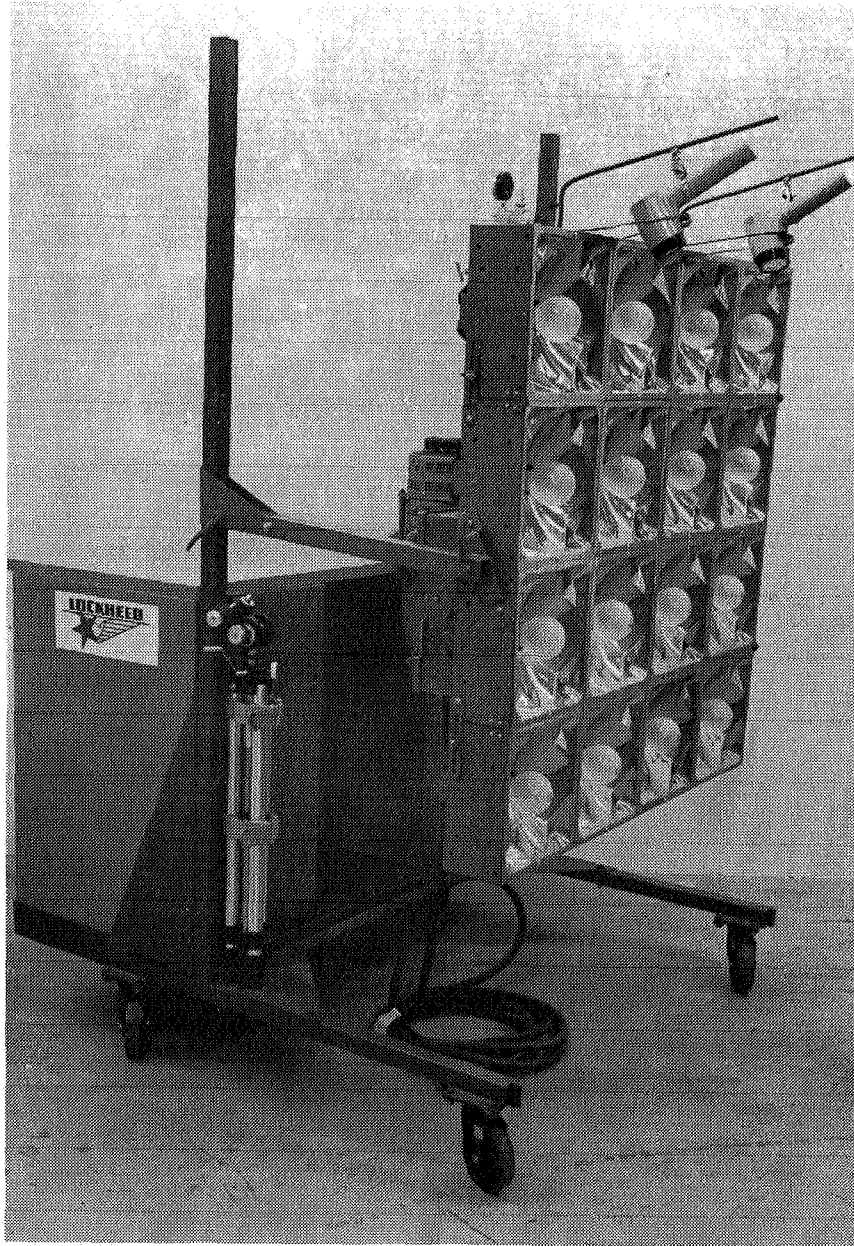
Figure 2 shows a front view of the portable NDT unit. The heating unit has sixteen specular gold plated reflectors. Overall dimensions of the reflectors are 44 by 44 inches. The entire bank of lamps can be raised or lowered 38 inches vertically, and can be pivoted on its supporting points. The top and bottom sections are hinged to permit contouring to the job. Four section switches are provided to control each horizontal section individually. A fused master switch is provided and also a toggle switch. The toggle switch is located adjacent to the transformer. The transformer allows adjustment of rate of heat input. The lamps are incandescent 300 watt, 130 volt, frosted. Power requirements are 240 volts AC, 60 cycle, single phase, 3 wire, 20 Amps. Figure 3 shows a left side view of the equipment as set up for testing. The final lamp configuration was chosen after experimenting with various types of reflector flood lamps and infrared lamps in an adjustable framework. The heating unit is also used to illuminate the test panel during the heating cycle. Final verification of heating and lighting conditions was accomplished by using a panel coated with liquid crystals.

FIGURE 2 - PORTABLE NDT UNIT - FRONT VIEW

Two Honeywell Strobunar electronic flash units mounted as shown in Figure 2 eliminated the need for filters and did not heat the test panel. This arrangement was used to test the panels supplied by NASA for evaluating liquid crystals. The only drawback is that just prior to taking the photograph the heating unit must be shut off to prevent reflections on the panel.
