TESTING AND EVALUATION  
OF NICKEL-CADMIUM SPACECRAFT-TYPE CELLS

FINAL TECHNICAL REPORT  
6 May 1966 to 6 May 1967

CONTRACT NO. NAS 5-10213

Prepared By  
William G. Ingling  
Ronald L. Koesters  
DAYRAD LABORATORY  
Dayton, Ohio

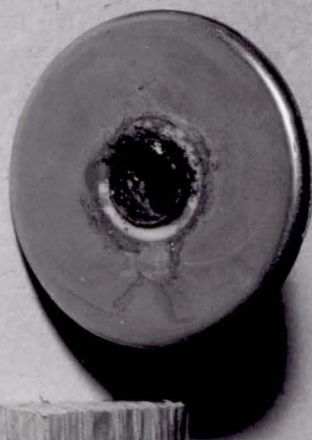
Cell No. R39 Sonotone, 19906 Cycles 10%  
Depth at 25°C

Internal examination of cell R39 revealed a poor weld between the positive tab and terminal as well as corrosion as the cause of failure.

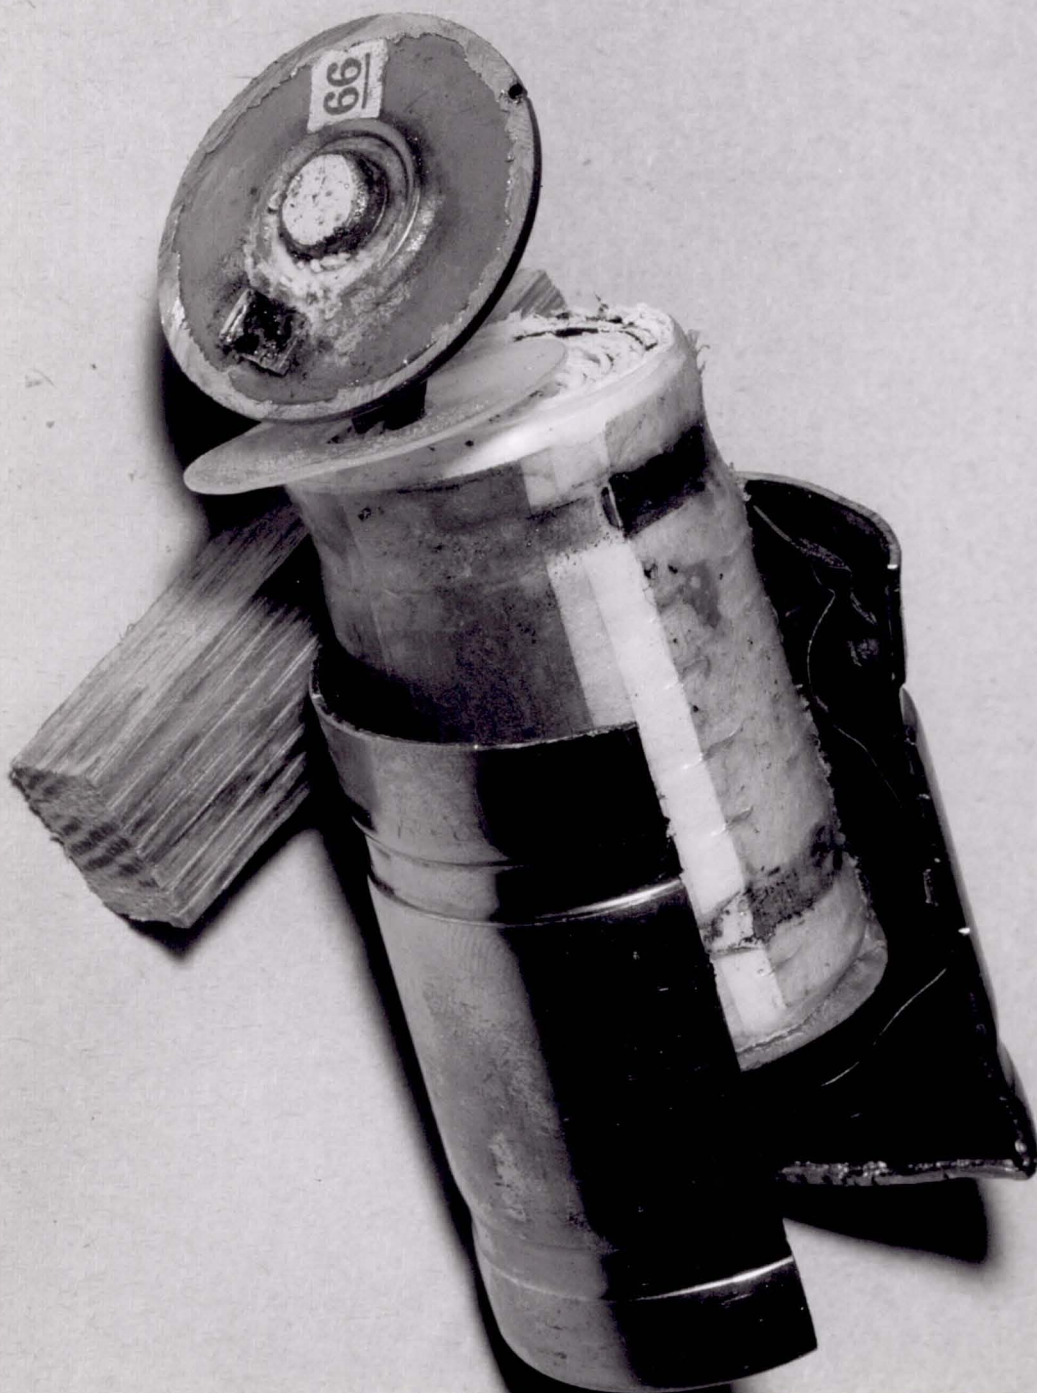
Cell No. 66 Sonotone, 19906 Cycles 10%  
Depth at 25°C

Internal examination of cell 66 revealed dry separators and corrosion between positive terminal and the case as the cause of failure.
