Surveyor Spacecraft System

**SURVEYOR II FLIGHT PERFORMANCE  
FINAL REPORT**

JPL Contract 950056/January 1967

SSD 68189-2R

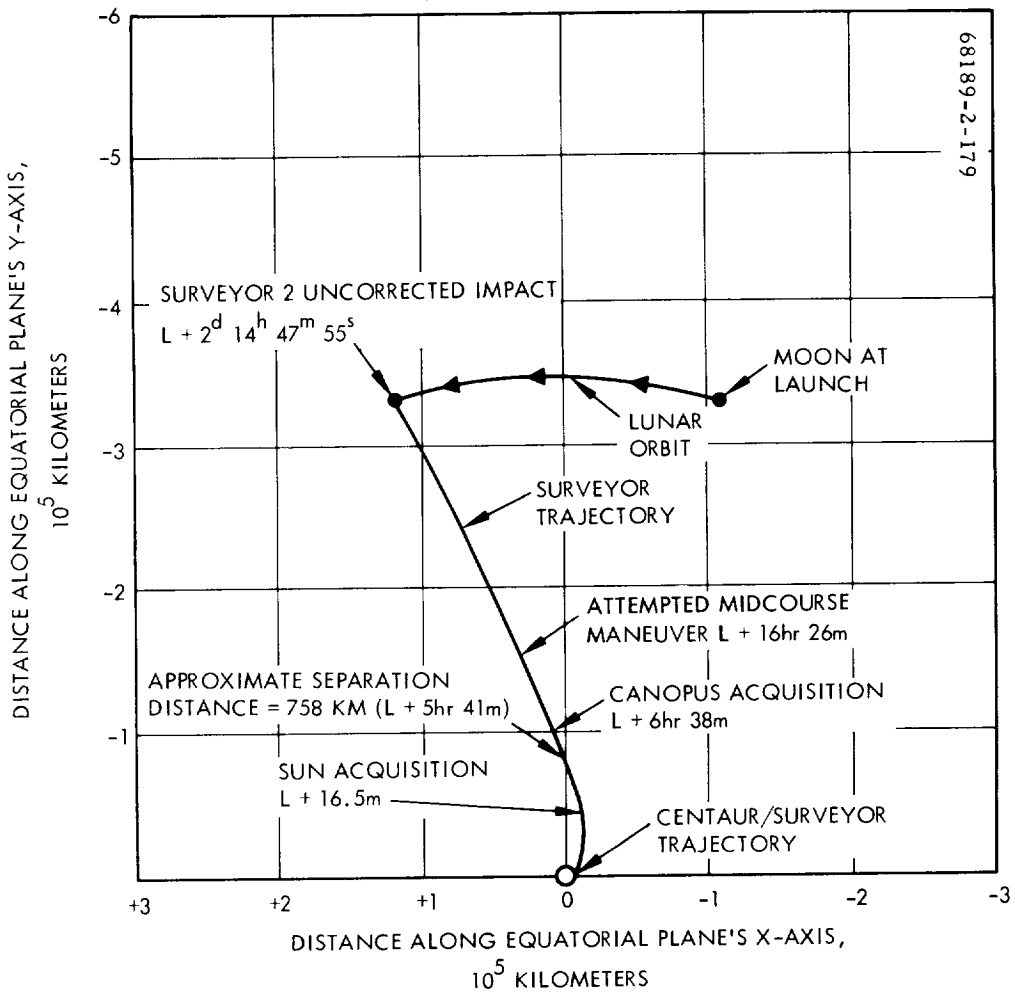
Figure 4.1-9. Surveyor and Centaur Trajectory in Earth's Equatorial Plane

Figure 4.1-9 illustrates the Centaur and Surveyor trajectories. The projection of earth trajectory is plotted on the earth's equatorial plane. The best estimate of the Centaur injection conditions was obtained from AFETR. Although considered poor ( $1\sigma$  velocity error = 13 m/sec), these conditions are the best available. They were mapped out to 5 hours, and the Centaur/Surveyor separation distance was calculated to be 680 kilometers. A mission design constraint states that the separation distance must be 335 kilometers by at least 5 hours after injection to eliminate possible Centaur interference during Canopus acquisition. Therefore, using this "poor" set of Centaur injection conditions, the constraint is well satisfied.

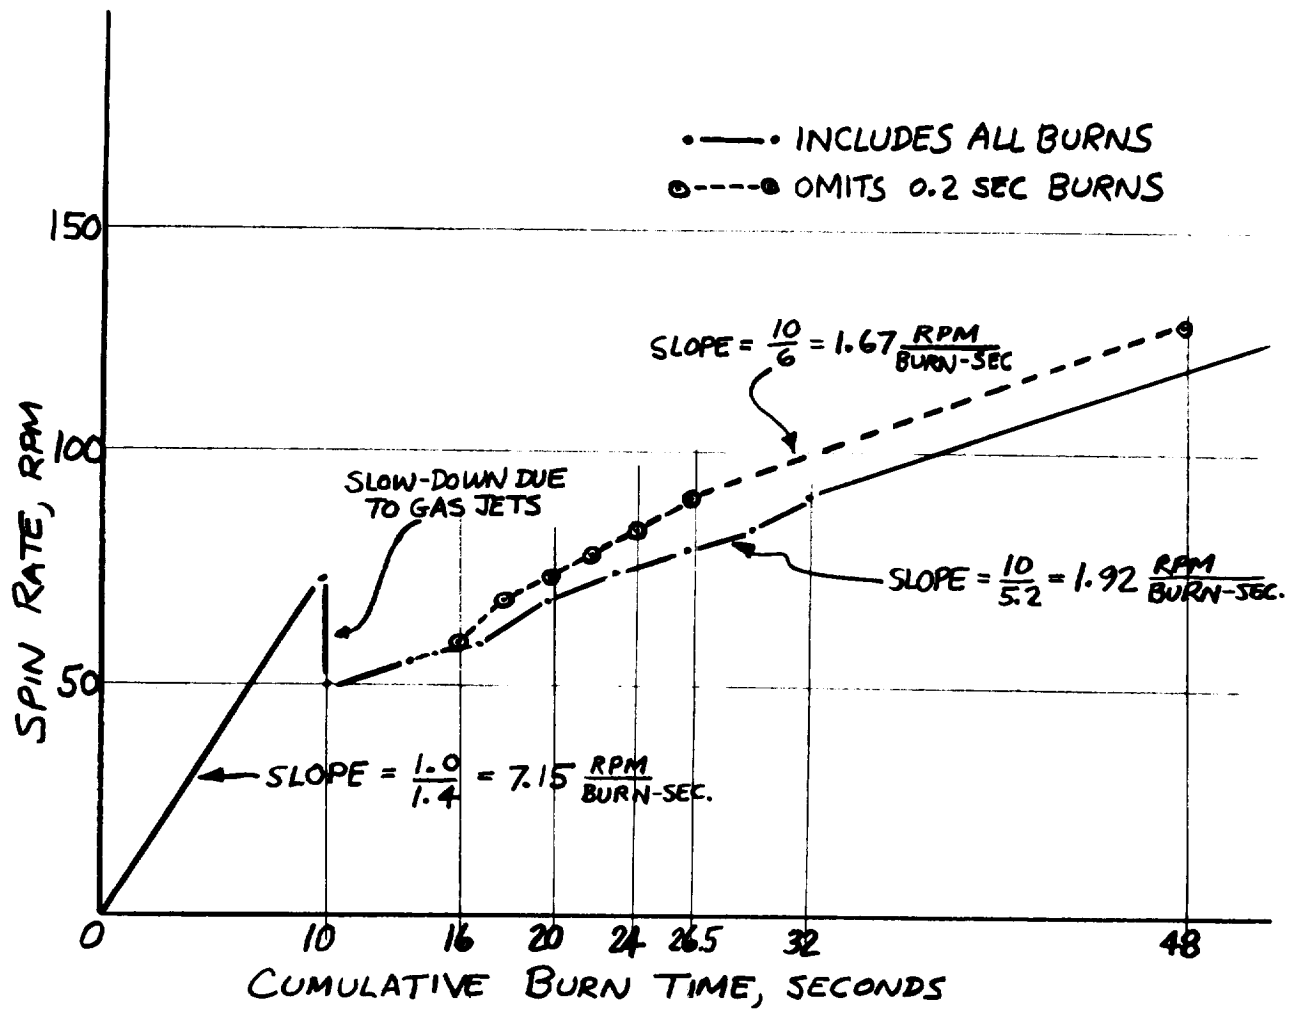
Figure 4.8-7. Spin Rate

Spacecraft rotation also produces a centrifugal acceleration on the retro accelerometer. An analysis (Reference 3) has been performed to determine the spin vector orientation which, combined with the measured spin rate (92.3 rpm), would produce the retro accelerometer output observed

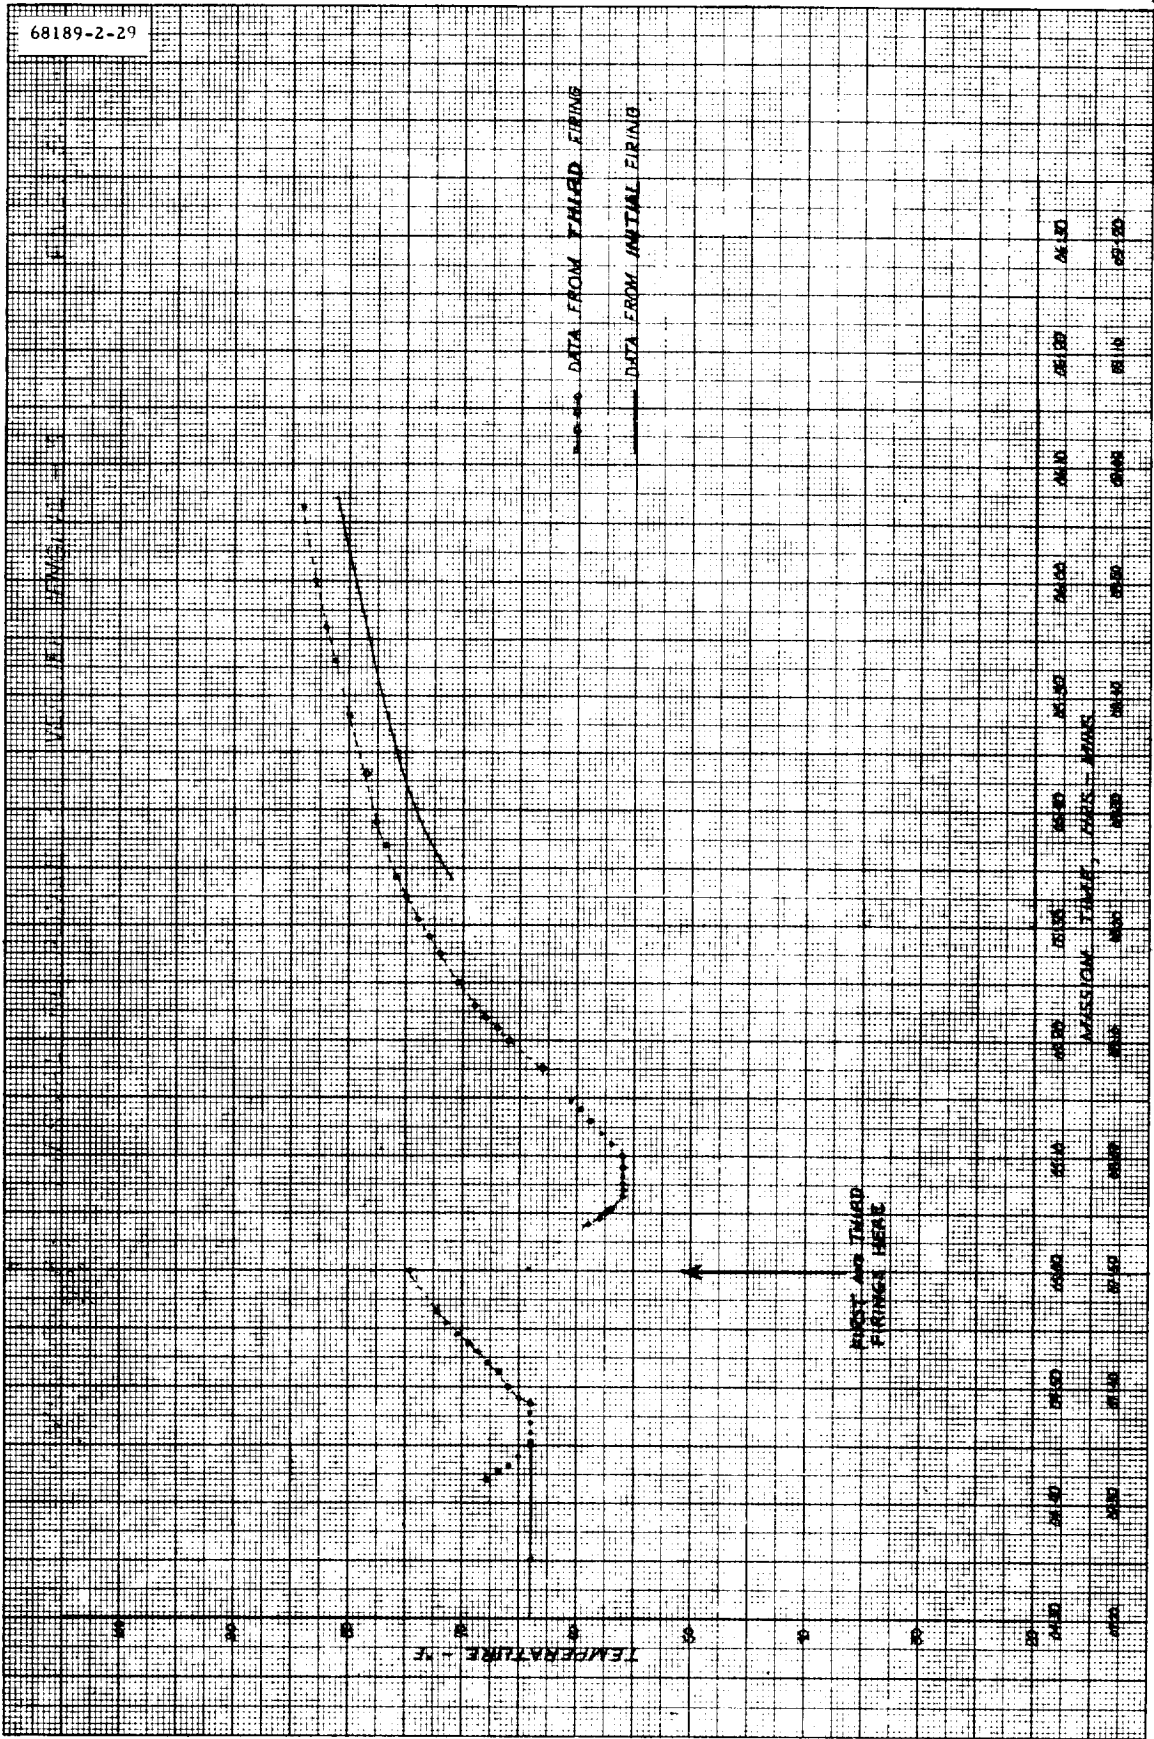
Figure 5.1-5. Vernier Engine 3 Thermal Response

The temperature of TCA 3 at initiation of the 110.6-degree yaw turn (264:04:48 GMT) was 64°F. An examination of the SC-2 solar thermal vacuum test data indicates that the maximum temperature drop of TCA 3, as indicated by the flight sensor (P-11), was 10 degrees in 12 minutes. Vernier engine 3 was not completely eclipsed prior to the initiation of engine thrusting; to the contrary, the engine was partially illuminated. Therefore, a maximum

A comparison of the engine 3 temperature profiles for the midcourse (burn 1) and third burn are presented in Figure 5.1-5. The thrust chamber barrel thermal response curves are similar for the midcourse and third burn attempts in the regions where data are available. A generalization to

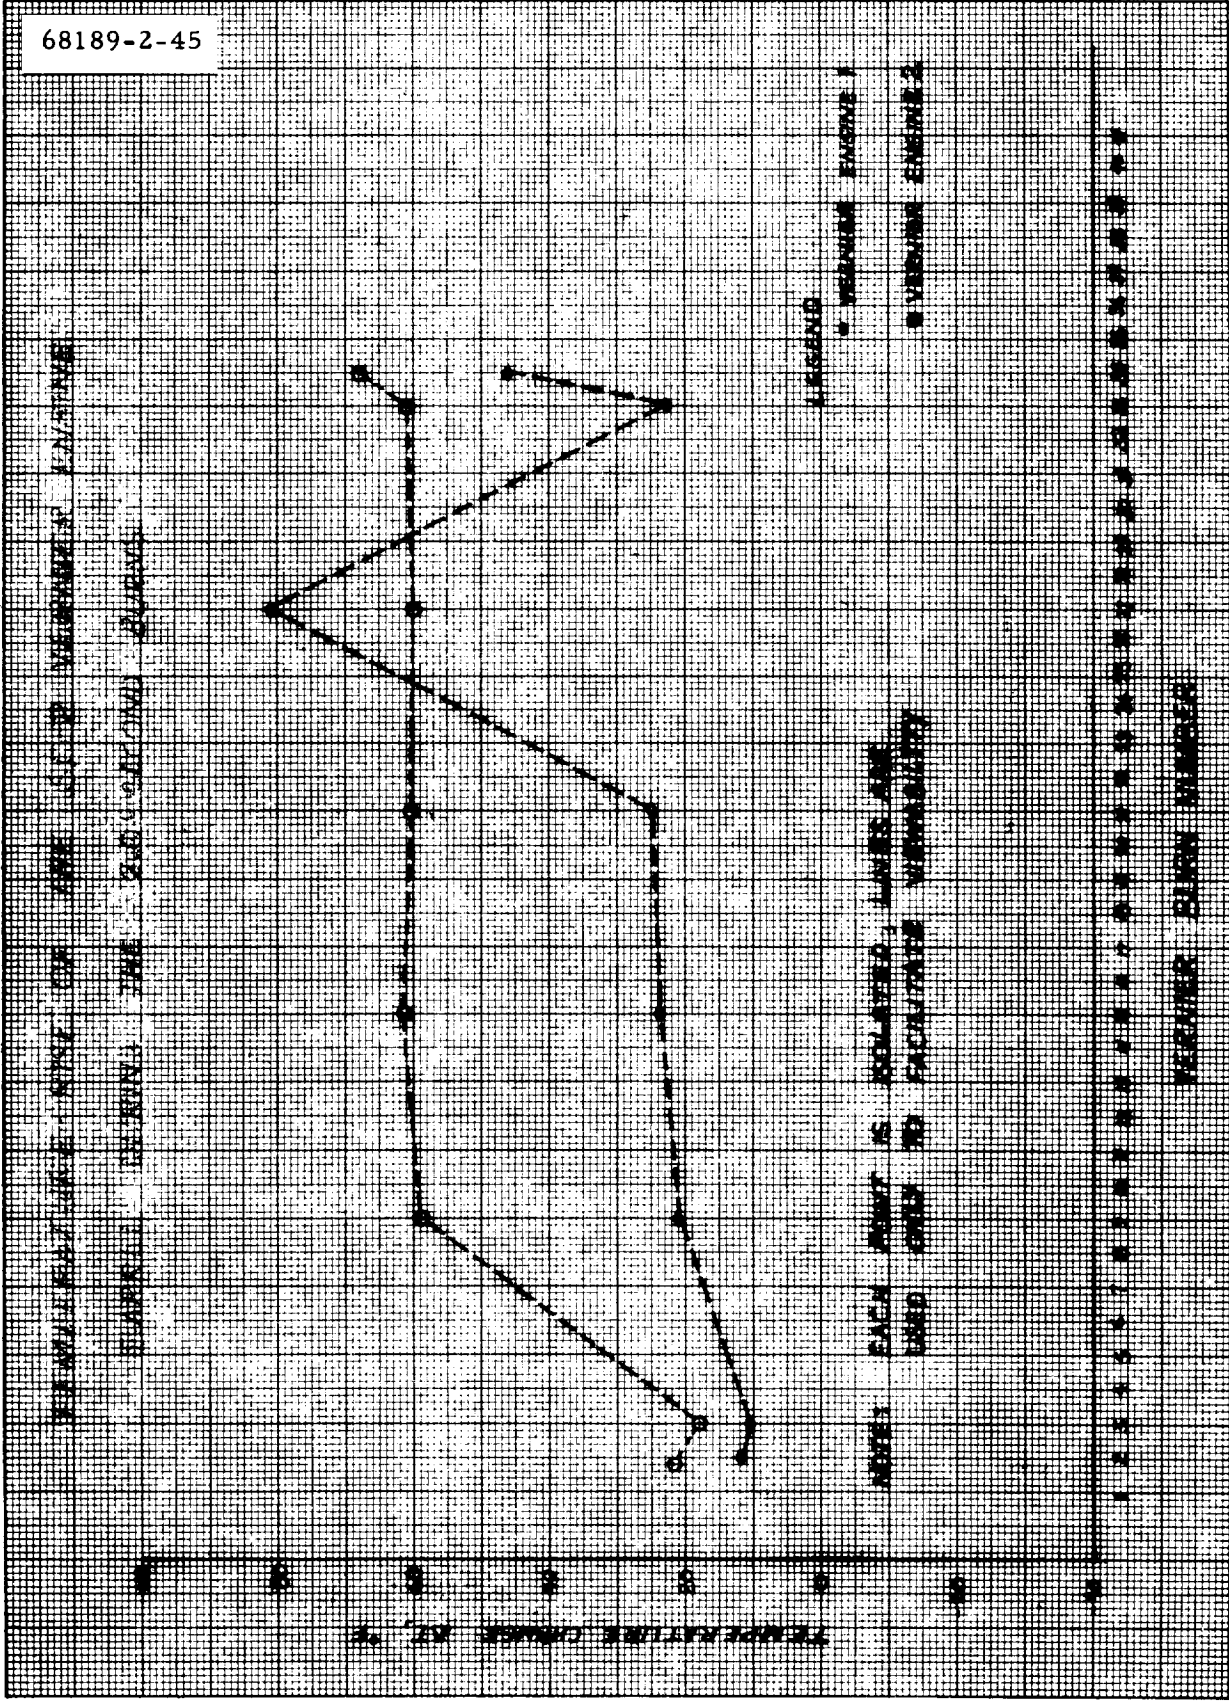
Figure 5.1-9. Vernier Engine Temperature Rise During 2.0-Second Burns

It is interesting to note and compare the temperature increases resulting from burns 2 and 3 with those for burns 9, 15, 21, 27, and 33. The data suggest that some type of irreversible change took place within engine 2 between burns 3 and 9. The data further suggest two discreet, but yet consistent, levels of operation for TCA 2 during the 2.00-second burn attempts.

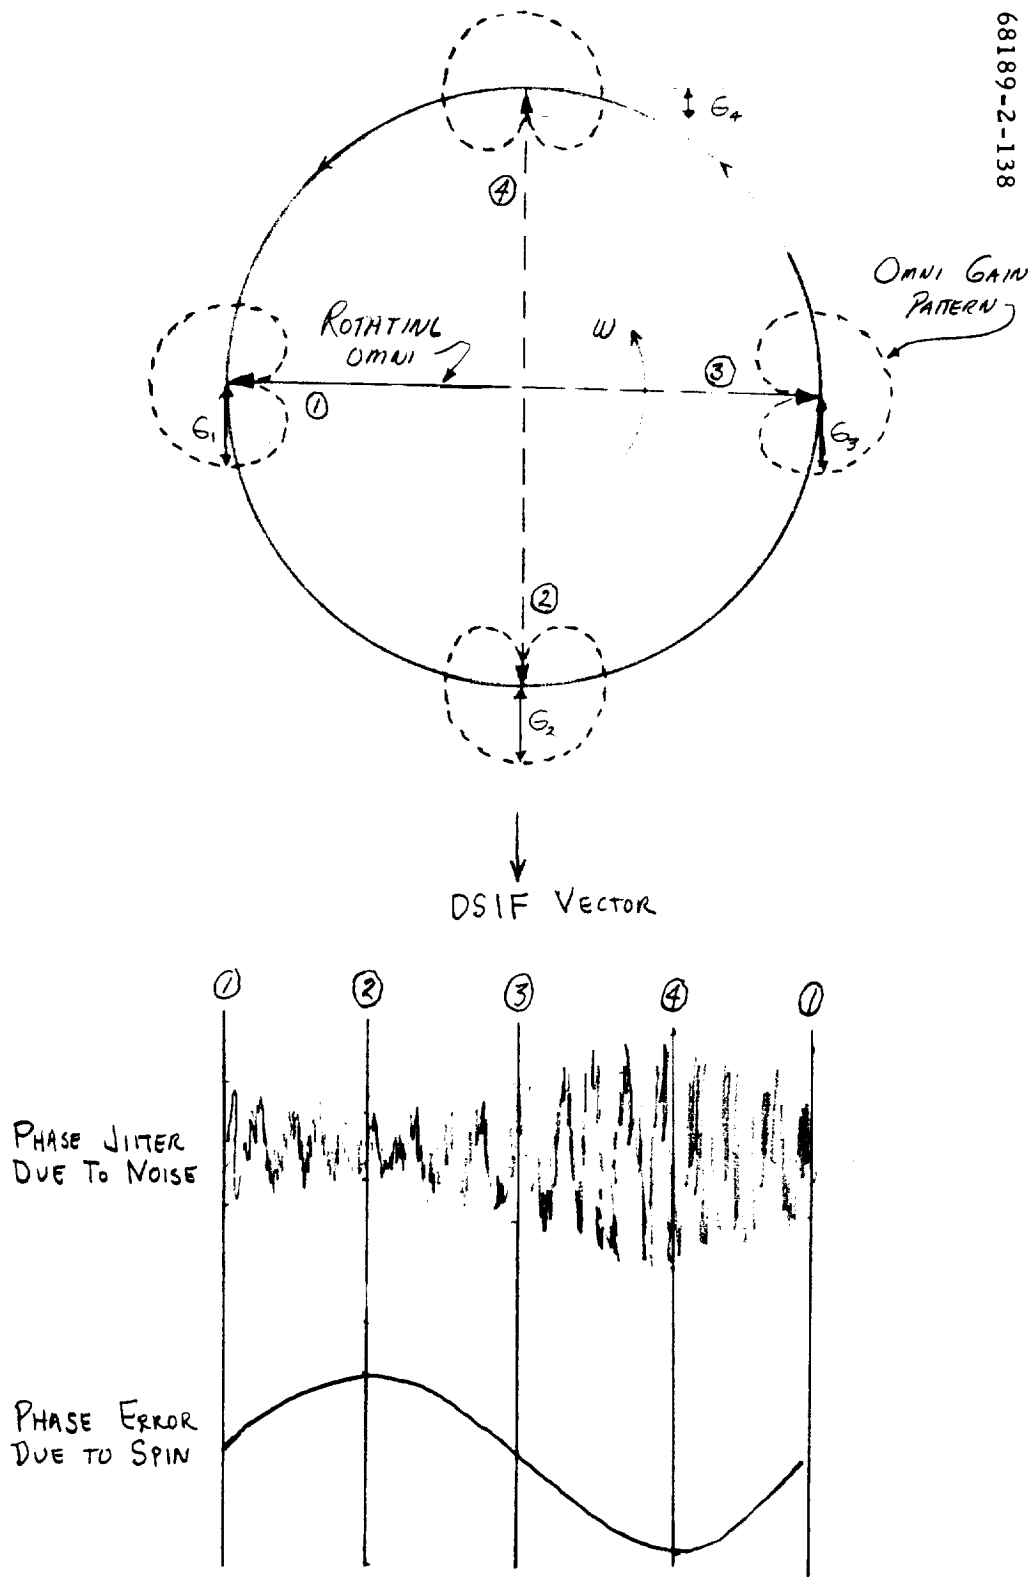
Figure 5.3-5. Carrier Tracking Loop Error

The primary loop errors are phase jitter due to noise and error caused by the sinusoidal carrier modulation resulting from the spinning omnidirectional antenna. Figure 5.3-5 shows the primary loop errors as a function of a single omnidirectional rotation. At the top of the figure, the omnidirectional antenna is shown in four positions relative to the DSIF station. The typical omnidirectional antenna gain pattern is shown at each position with the relative gain in the direction of the DSIF station as  $G_1$ ,  $G_2$ ,  $G_3$ , and  $G_4$ .

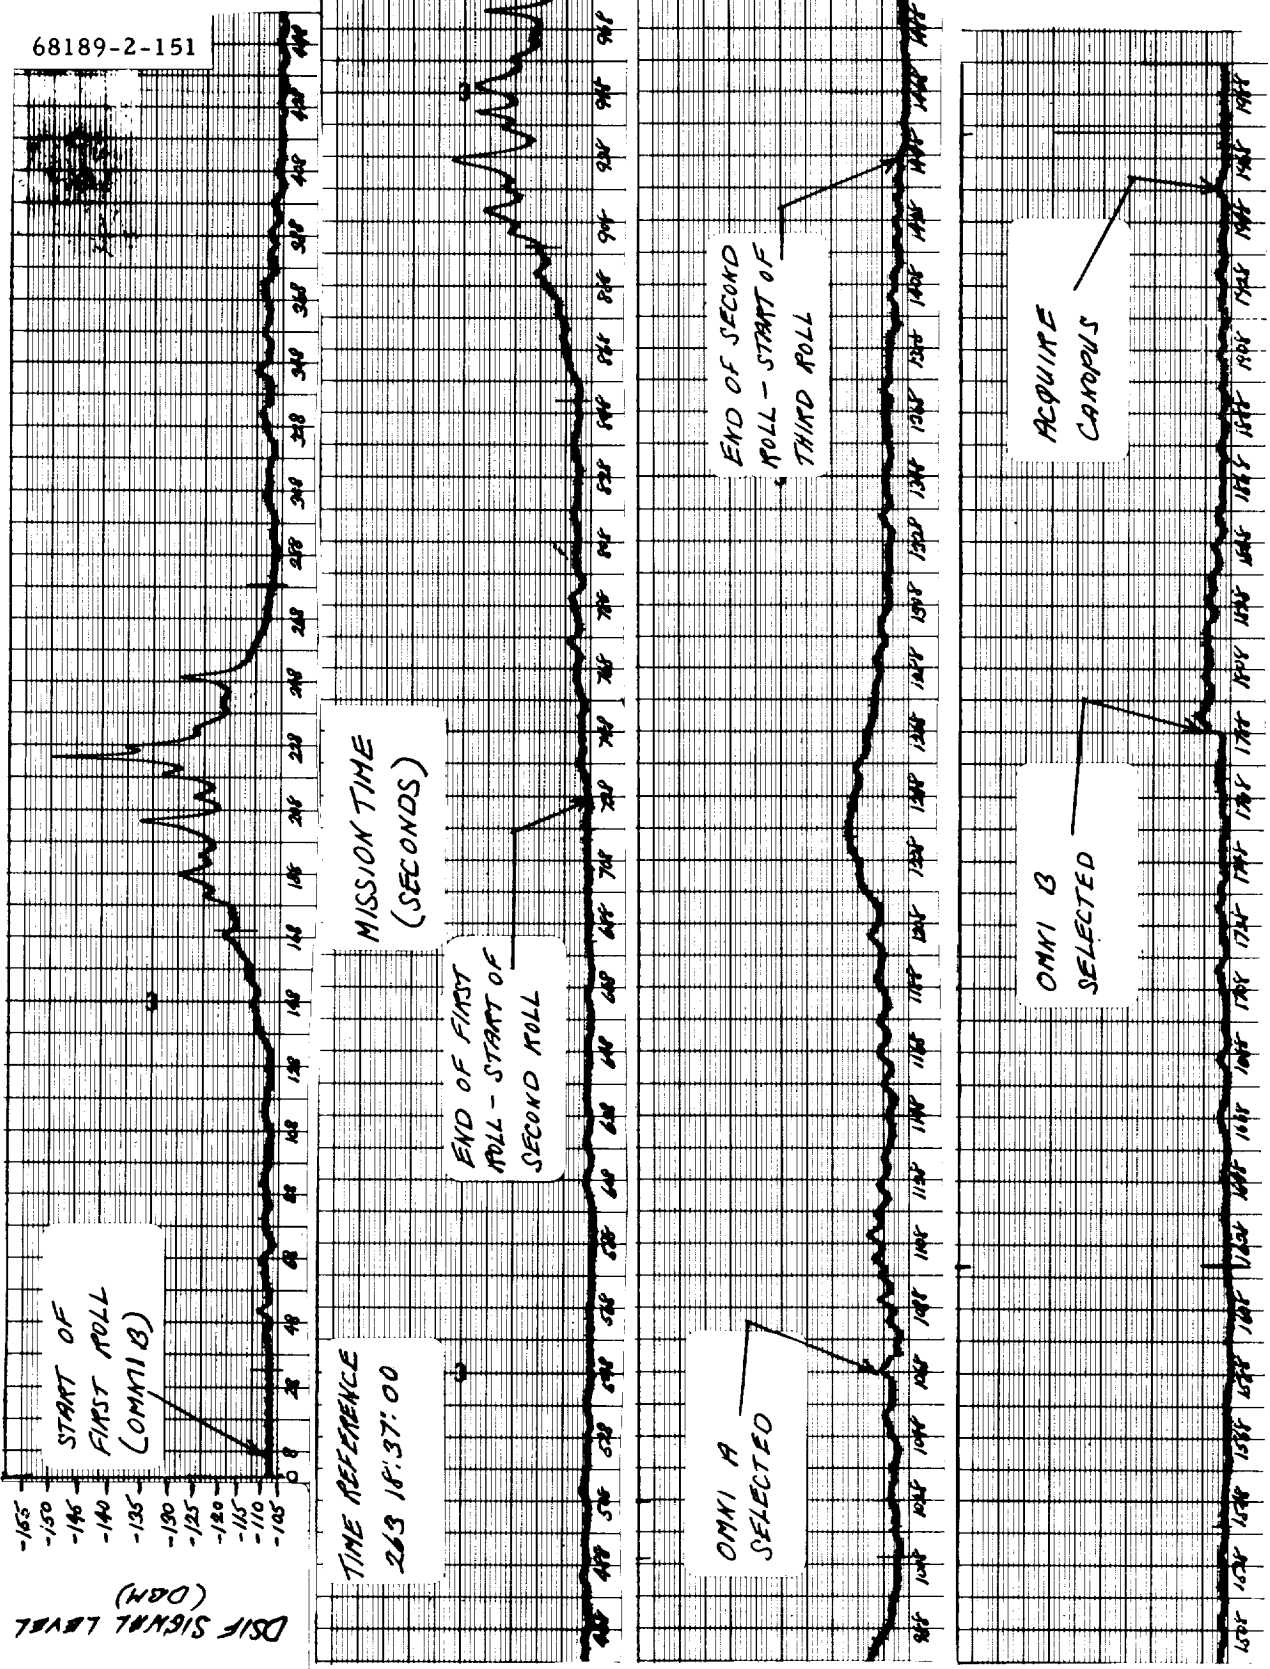
Figure 5.3-16. DSIF Signal Level During Star Maneuver

Figure 5.3-16 is a plot of the DSIF signal level during the period of the star maneuver, with significant event times noted. Figures 5.3-17 and 5.3-18 are expanded plots of the same data taken from station reports. The equivalent omnidirectional antenna gain is also shown. Since the resolution of the expanded data is relatively poor, comparative antenna gains are shown only at selected points. Signal level variations agree well with the antenna gain values, giving a high degree of confidence in the antenna patterns.

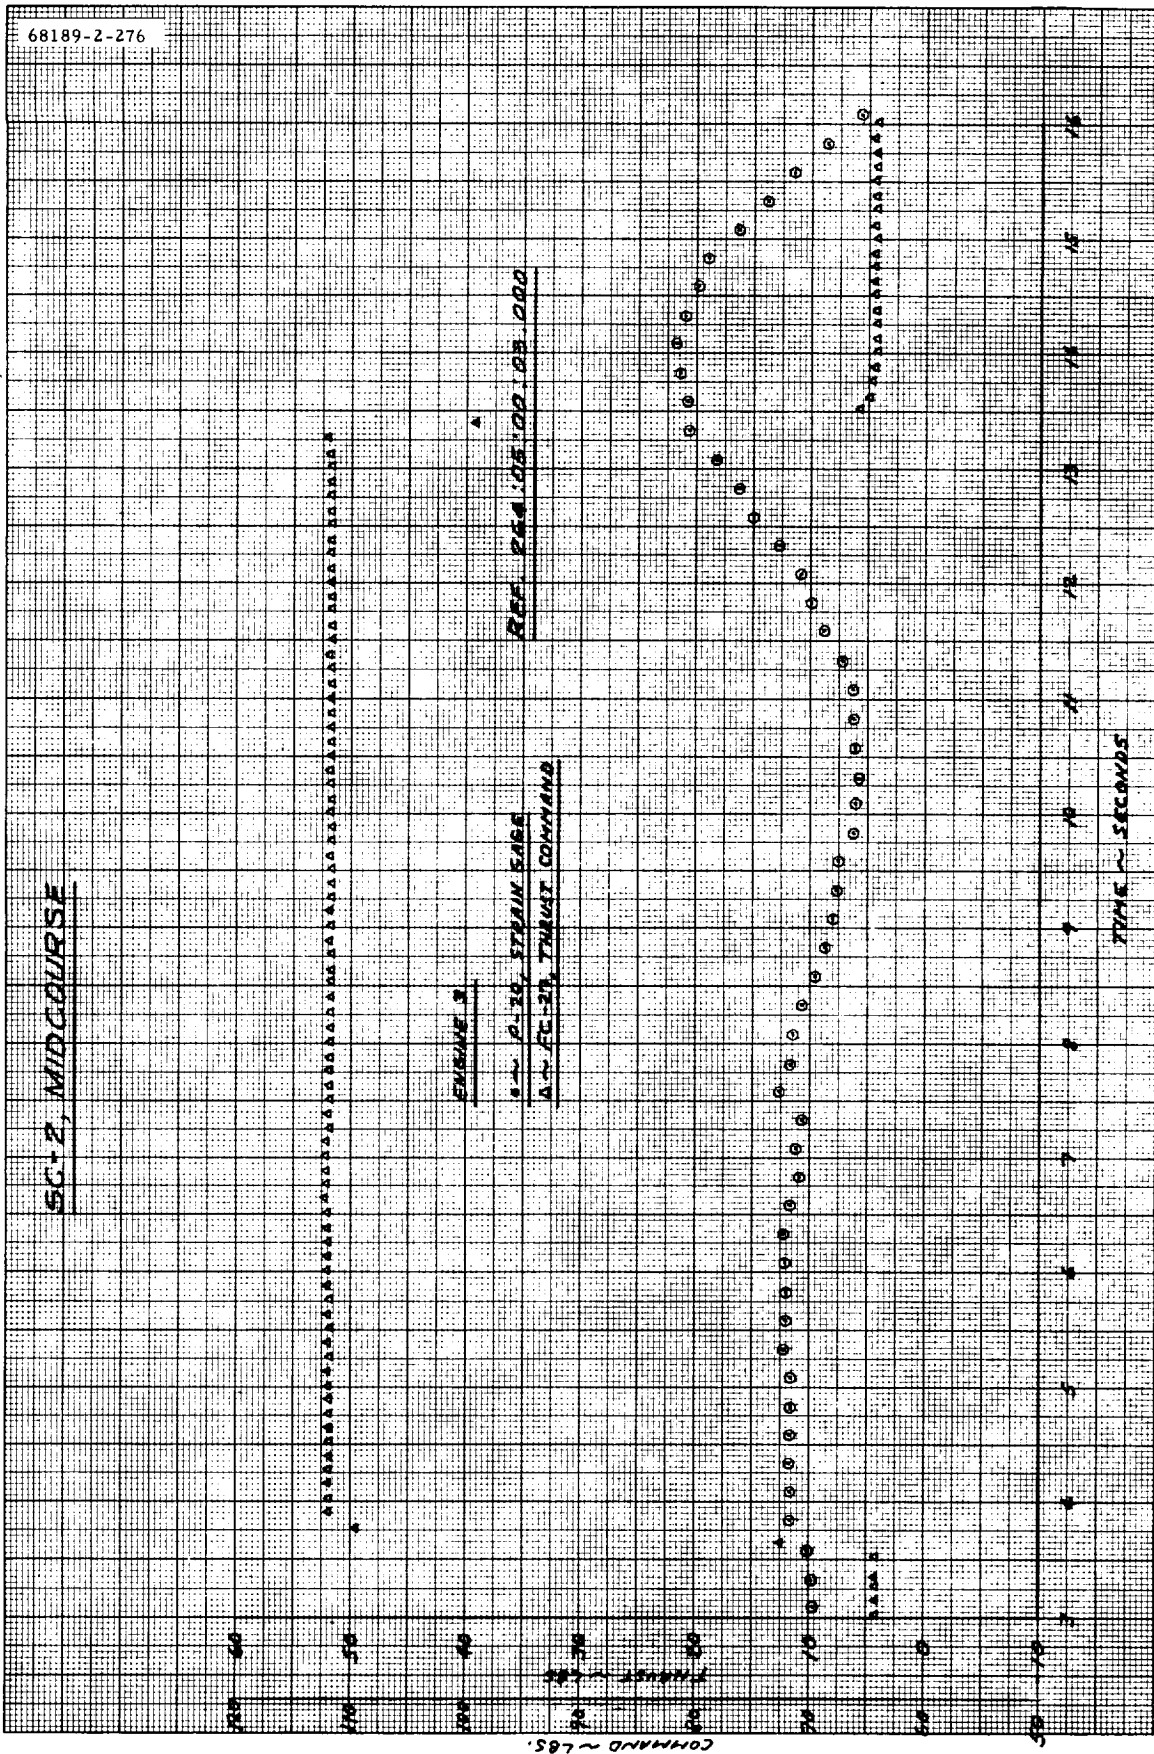
Figure 5. 5-23 (continued). Comparison of Thrust Command and Strain Gage Data, Midcourse

c) Engine 3

A summary of the longer firings (burns) ( $\geq 2. 0$  seconds) in terms of thrust commands, strain gage response, and acceleration error derived from SPAC brush recordings is presented in Figure 5. 5-22. The strain gage and thrust command data are plotted with greater resolution in Figures 5. 5-23 through 5. 5-32.
