Annual Progress Report

CONTACT ION ENGINE SYSTEM
FOR ATS SATELLITES D AND E
Contract NAS5-10380

EOS Report 7202-A-1

24 May 1968

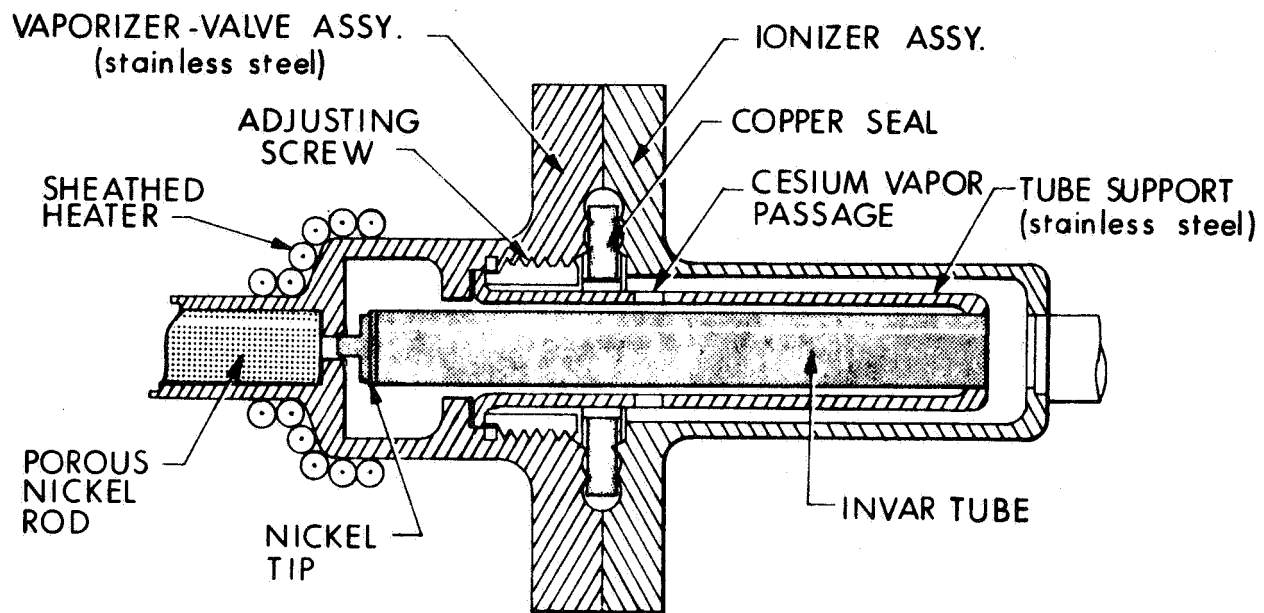
Figure 5. Bimetal Valves

The valve developed to seal the feed system operates by differential thermal expansion of dissimilar materials. It consists of an Invar tube inside a stainless steel tube. Attached to the Invar tube is a nickel tip which seats in an orifice in the vapor feed line. Power is conducted to the valve area from both the ionizer and the vaporizer. The difference in expansion between the Invar tube and the stainless tube is sufficient to move the tip away from the seat, opening the valve. Figure 5 shows a schematic of the valve. When sealed this valve has a leak rate of less than 3×10^{-10} STD cc He/sec and reseals in the presences of cesium six or more times. The valve begins to open at 60°C and reseals at 40°C; normal operation temperature is 300°C.

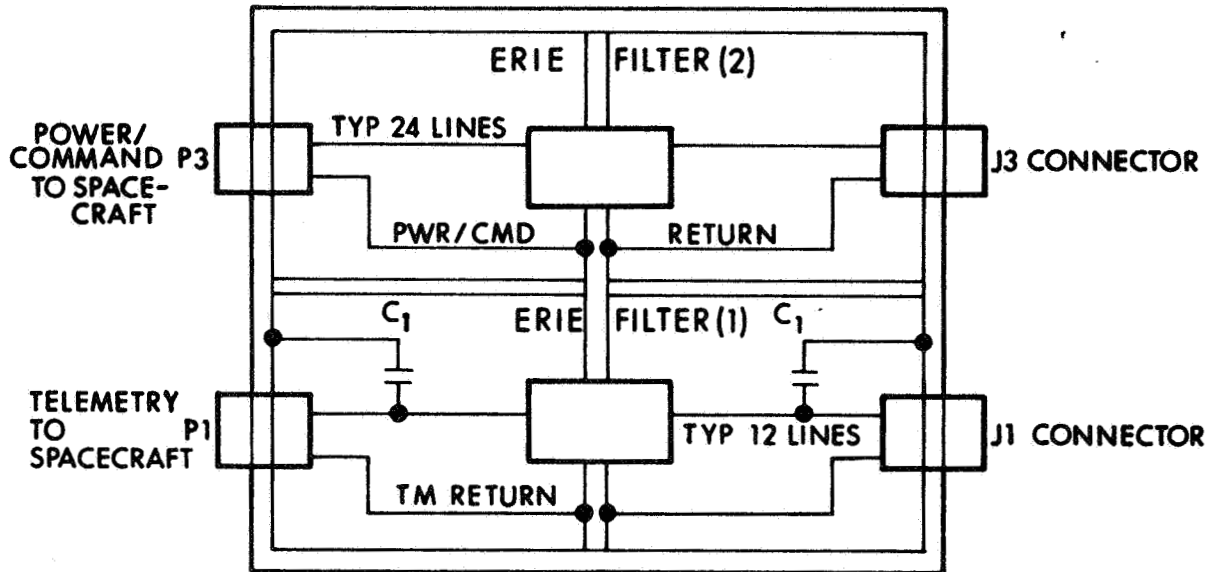
Figure 15. External RF Filter Schematic

SPECIFICATIONS:

CANNON CONNECTORS DCM-37 S/P-NM

ERIE FILTER PN 1212-502

US CAPACITOR $.01\mu\text{F}$

ATTENUATION AT 10MHz: 500V IN,
10V OUT

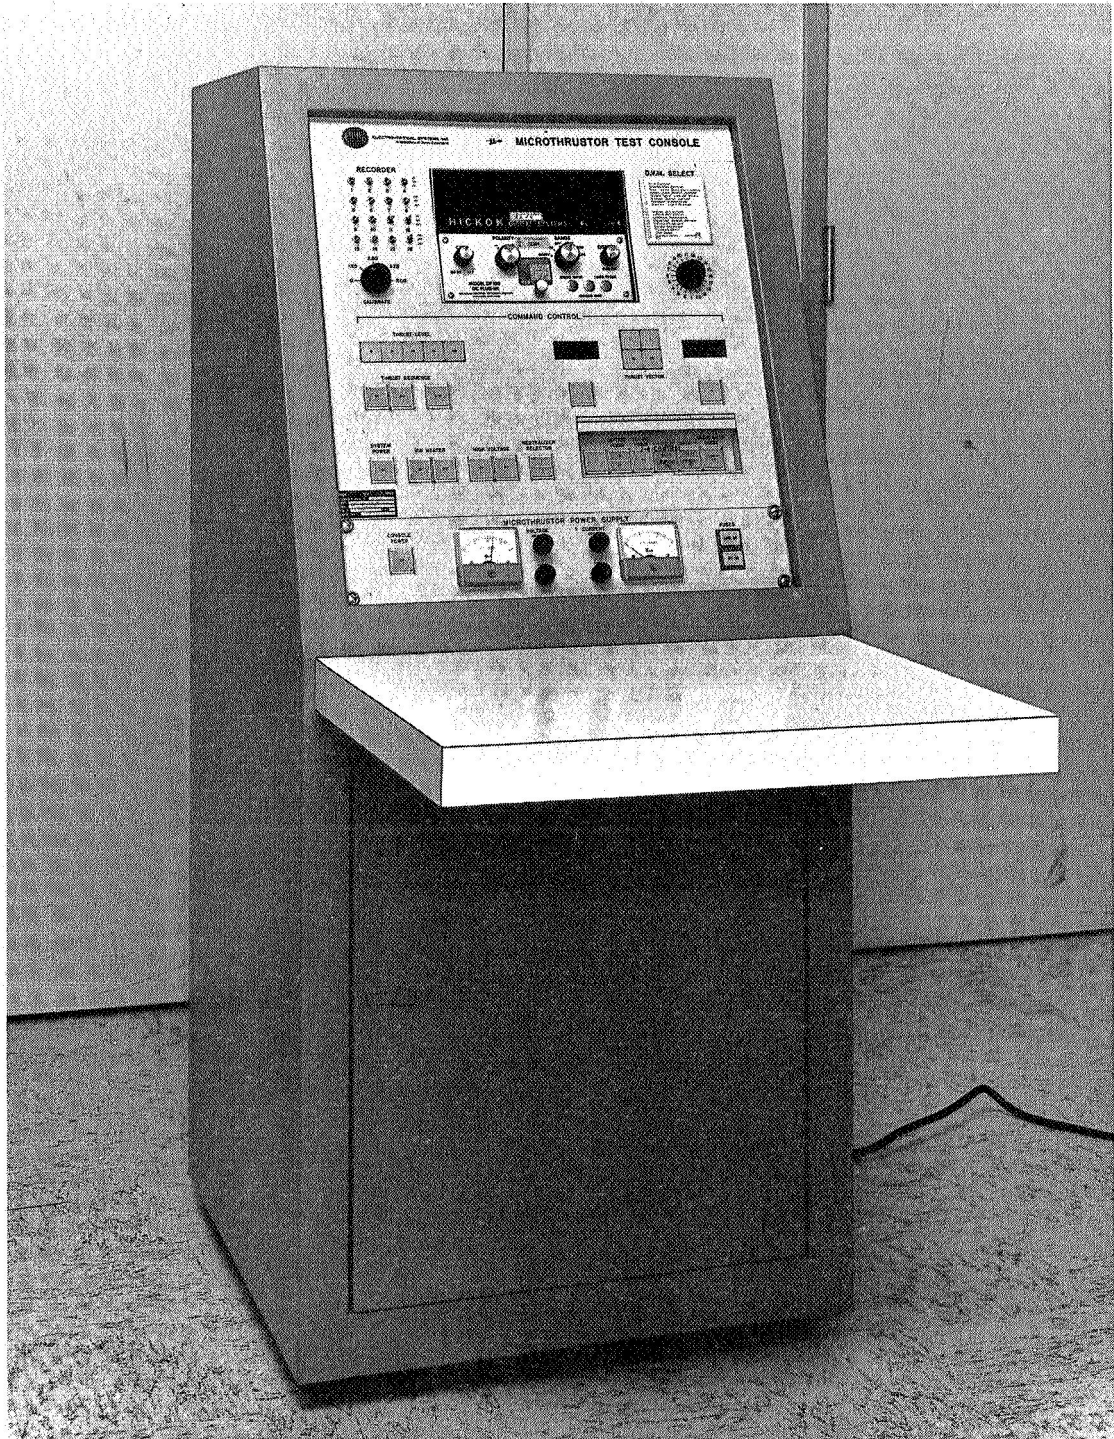
Figure 17. Test Console

In the early planning stages of the program a distinction was made between checkout consoles which would be used to verify operational readiness of the system and test consoles which would be used during full system operation. Thus, both types are specified as deliverable hardware. As the program progressed it became clear that it would be most practical to build only one type of console, one that could perform all required functions. The resulting test console is shown in Figure 17. The top portion of the panel is associated with telemetry readout. Telemetry signals from the CLPC are available for driving a strip chart recorder and may also be monitored, one at a time, by the digital voltmeter on the test console panel. Calibration signals of 1.25, 2.50, 3.75, and 5.00 volts may be substituted for any telemetry signal by means of the small toggle switches shown. The lower portion of the main panel is associated with commands and command status. Operating commands are given by depressing the buttons shown. Wherever possible, telemetry signals are used to drive indicator lamps. Thus, when the ionizer heater is on, a green lamp under the ionizer on button is illuminated. Since it is impractical to drive indicators from the x and y deflection telemetry signals, the indicators shown in the upper right hand corner of the command panel register the number of command pulses issued.

The buttons under the transparent hinged panel in the lower right corner are reserved for checkout of the fully assembled microthruster
