NASA TN D-4782

## ULTRASONIC DETECTION AND MEASUREMENT OF FATIGUE CRACKS IN NOTCHED SPECIMENS

*by Stanley J. Klima and John C. Freche*

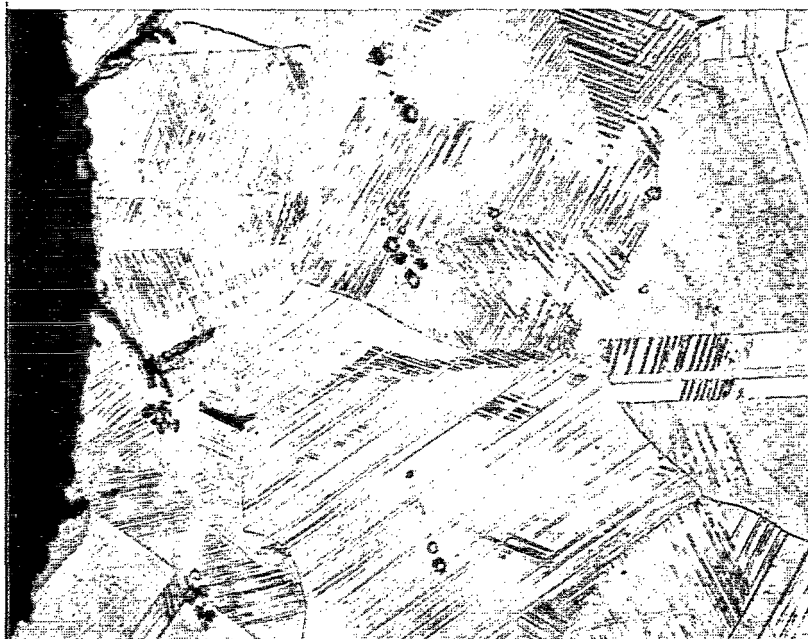
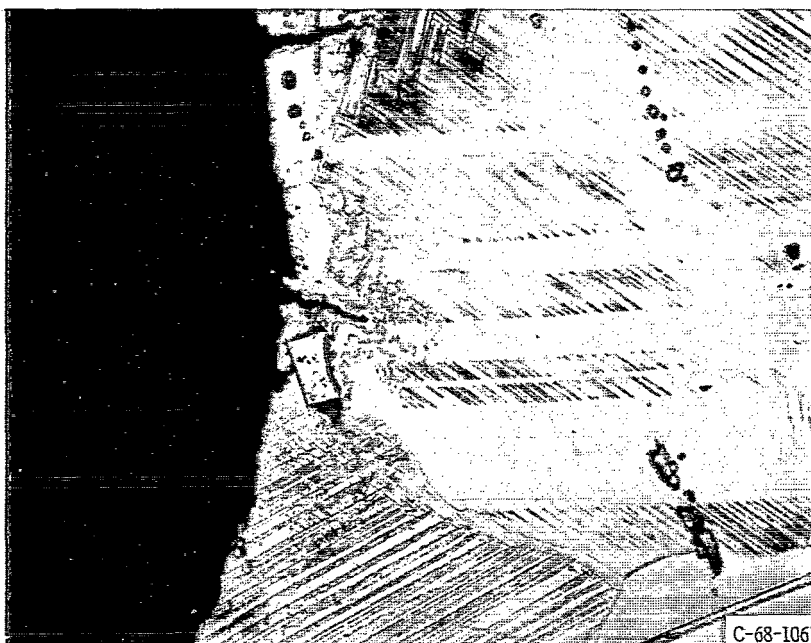
Figure 7. - Micrographs of tested fatigue specimens of each material showing first detectable cracks emanating from notch root. Longitudinal sections.

Photomicrographs of longitudinal sections of specimens tested to the initial detection of cracks for each material are presented in figure 7. Cracks emanate from the root of the notch and progress toward the center of the specimen, and cracks are generally transgranular. In most specimens, several cracks developed which began at different points along the notch root radius, as shown in figure 7. This was most commonly observed in the 5Al-2.5Sn-Ti alloy, the maraging steel, and the cobalt-base alloy L-605. Cracks were also observed to emanate from the notch root at many points around the circumference of a given specimen. As the test progressed, these small cracks grew, some of them joining together to form the crack that eventually caused fracture.

When the applied cyclic stresses corresponded to those on the inclined portion of the fatigue curve (above the fatigue limit of the notched specimens), the main crack extended all the way around the specimen circumference and was generally uniform in depth until very rapid crack growth occurred just prior to fracture. This uniform crack growth is illustrated in figure 8, which shows fracture surfaces of maraging steel specimens tested to various stages of fatigue damage. This sequential series of macrographs was obtained after the specimens were fatigue tested to various values of output voltage as indicated by the ultrasonic detection device. They were then removed from the test and broken in tension. The fatigue-cracked portion of the fracture surface is clearly distinguishable in the figure as the lightly shaded area at the periphery of the 0.3-inch- (7.6-mm-) diameter test section. The dark, rough region in the center of the specimen represents the tensile fracture. The fatigue crack is not as apparent in specimens that were not tested beyond the point of initial crack detection (fig. 8(a) and (b)). However, microscopic examination showed that the crack extended around the entire circumference and that the depth varied between 0.001 and 0.003 inch (0.025 and 0.076 mm) in both specimens shown. This represents a substantial variation, relative to the average crack depth of about 0.002 inch (0.050 mm). For larger cracks (figs. 8(c) - (h)), the crack depth was relatively uniform around the entire circumference. Note that the normalized output voltage for each specimen is the same for a given crack size, even though the number of applied cycles and the maximum cyclic stress level applied were different. These results indicate that the crack-detection system is sensitive to the crack area and independent of the way the crack was formed.
