JPL CONTRACT  
NO. 952023  
(NAS 7-100)

TRW REPORT NO.  
68.4712.2-024  
31 JULY 1968

FINAL REPORT  
**PRODUCING HOLOGRAMS  
OF REACTING SPRAYS IN  
LIQUID PROPELLANT  
ROCKET ENGINES**

**TRW**  
SYSTEMS GROUP

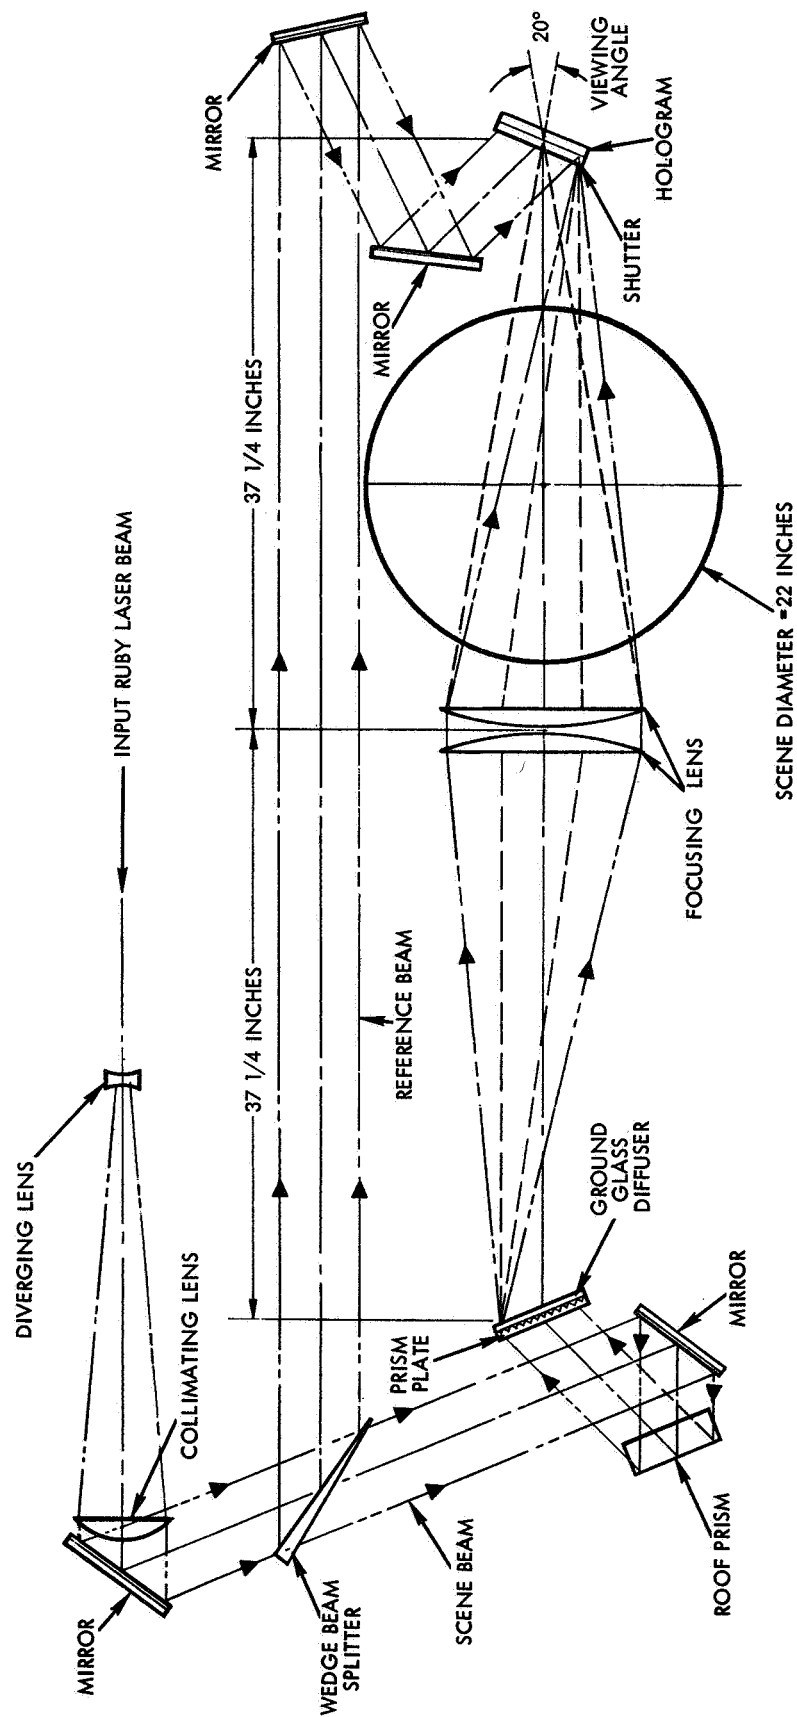
Figure 3-1. Schematic diagram of TRW focused ground glass transmission holocamera design for producing reacting spray holograms

sponsorship of the TRW Independent Research Program. Flexibility, economy, and reliability were major considerations in the design. A schematic of the system is shown in Figure 3-2. The illuminator consists of a Q-switched ruby laser oscillator with flat end mirrors (a 99 percent dielectric coated mirror and a sapphire resonant reflector), a nitrobenzene Kerr cell Q-switch, a Glan polarizing prism, and a 1/2-inch diameter by 3-3/4-inch long 60 degree ruby rod of the highest optical homogeneity.\* An aperture was placed within the laser cavity to select the best and most homogeneous area of the laser rod. The laser rod and helical flash lamp are mounted in a water-tight housing and are both cooled by water circulated from a modified drinking fountain chiller. The end mirrors are separated by a distance of ~1.5 meters, the distance being chosen to limit the peak power as well as moderate off-axis mode oscillation which could reduce the spacial coherence. The mirror separation determines the ~30-50 nanosecond pulse duration.

As can be seen from the schematic diagram of Figure 3-1, the reference beam of the holocamera is parallel to the scene beam. This design approach was selected because it eliminates the uncertainties related to the reference beam to be used in reconstructing the hologram. Further, it makes possible the projection of real images (from the hologram) which can then be examined by a high-resolution, short working distance optical microscope. An additional feature of the holocamera design is the ability to replace the condenser lens array by one of shorter focal length, thereby increasing the angular field of the recorded scene at the expense of depth.

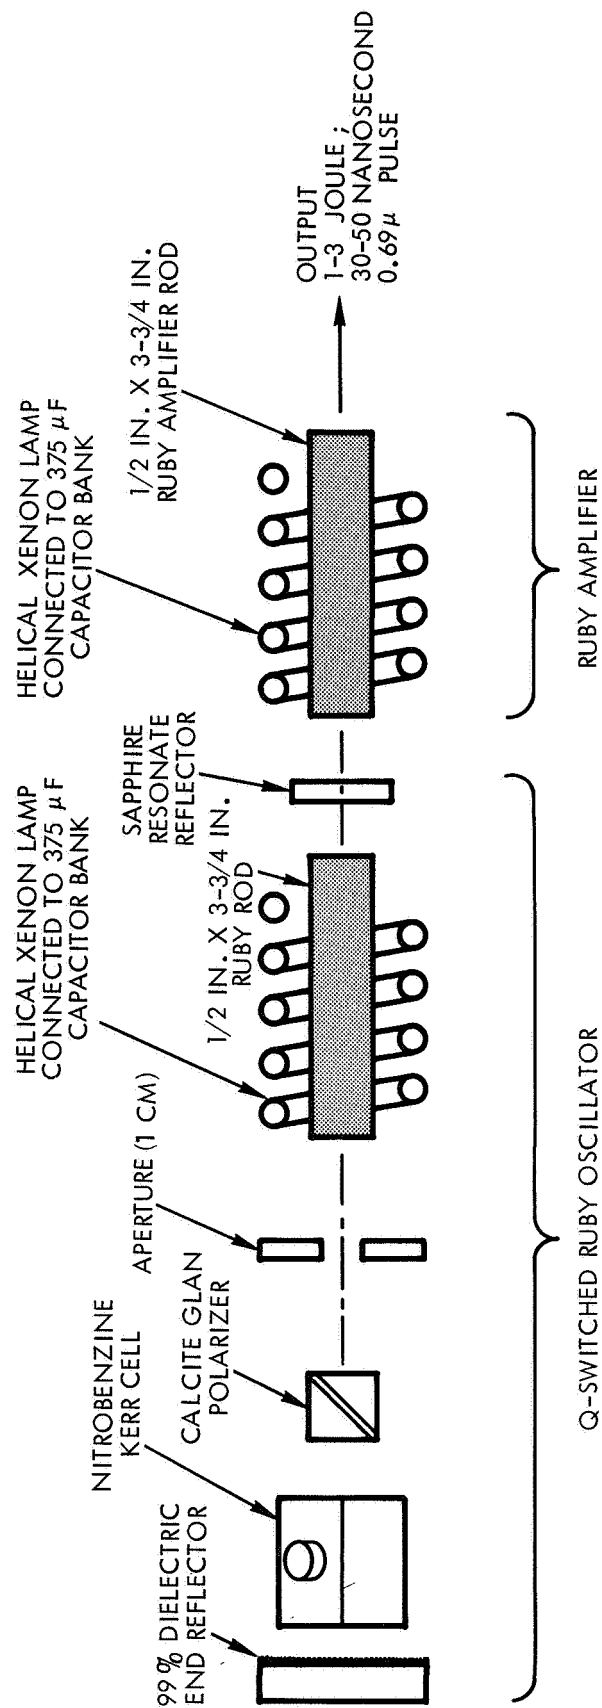
Figure 3-2. Schematic of the ruby laser illuminator used to record holograms of liquid rocket combustion phenomena

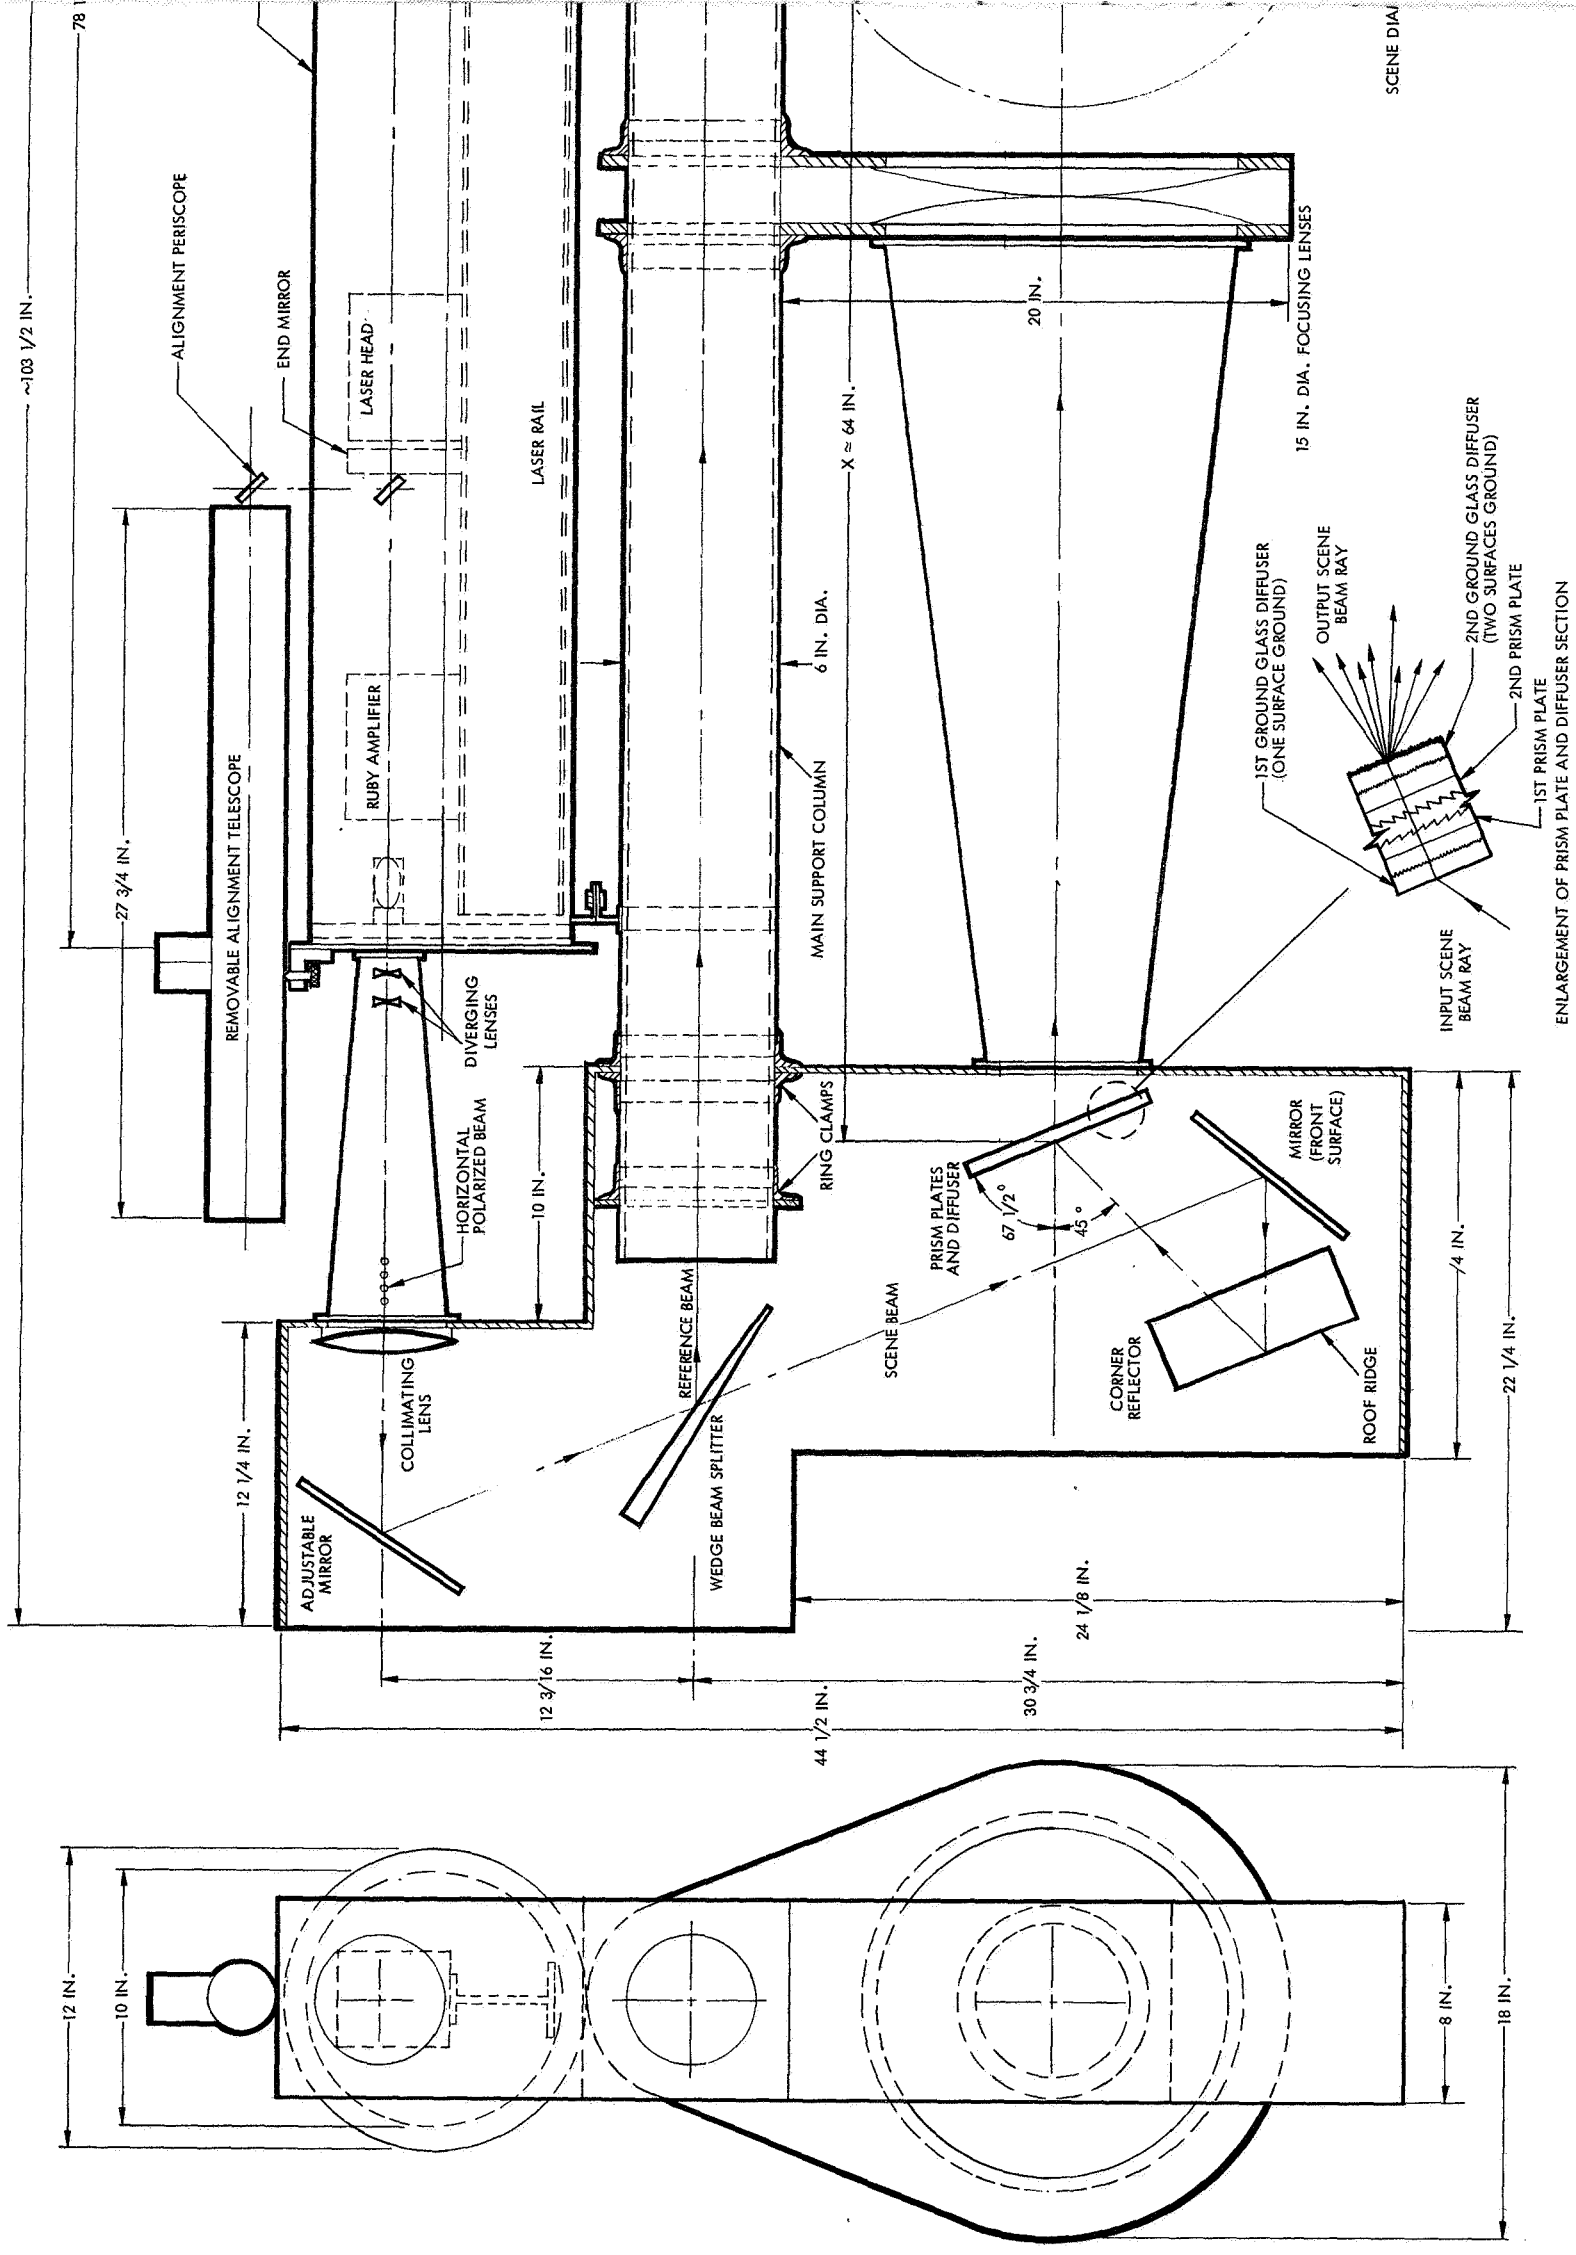
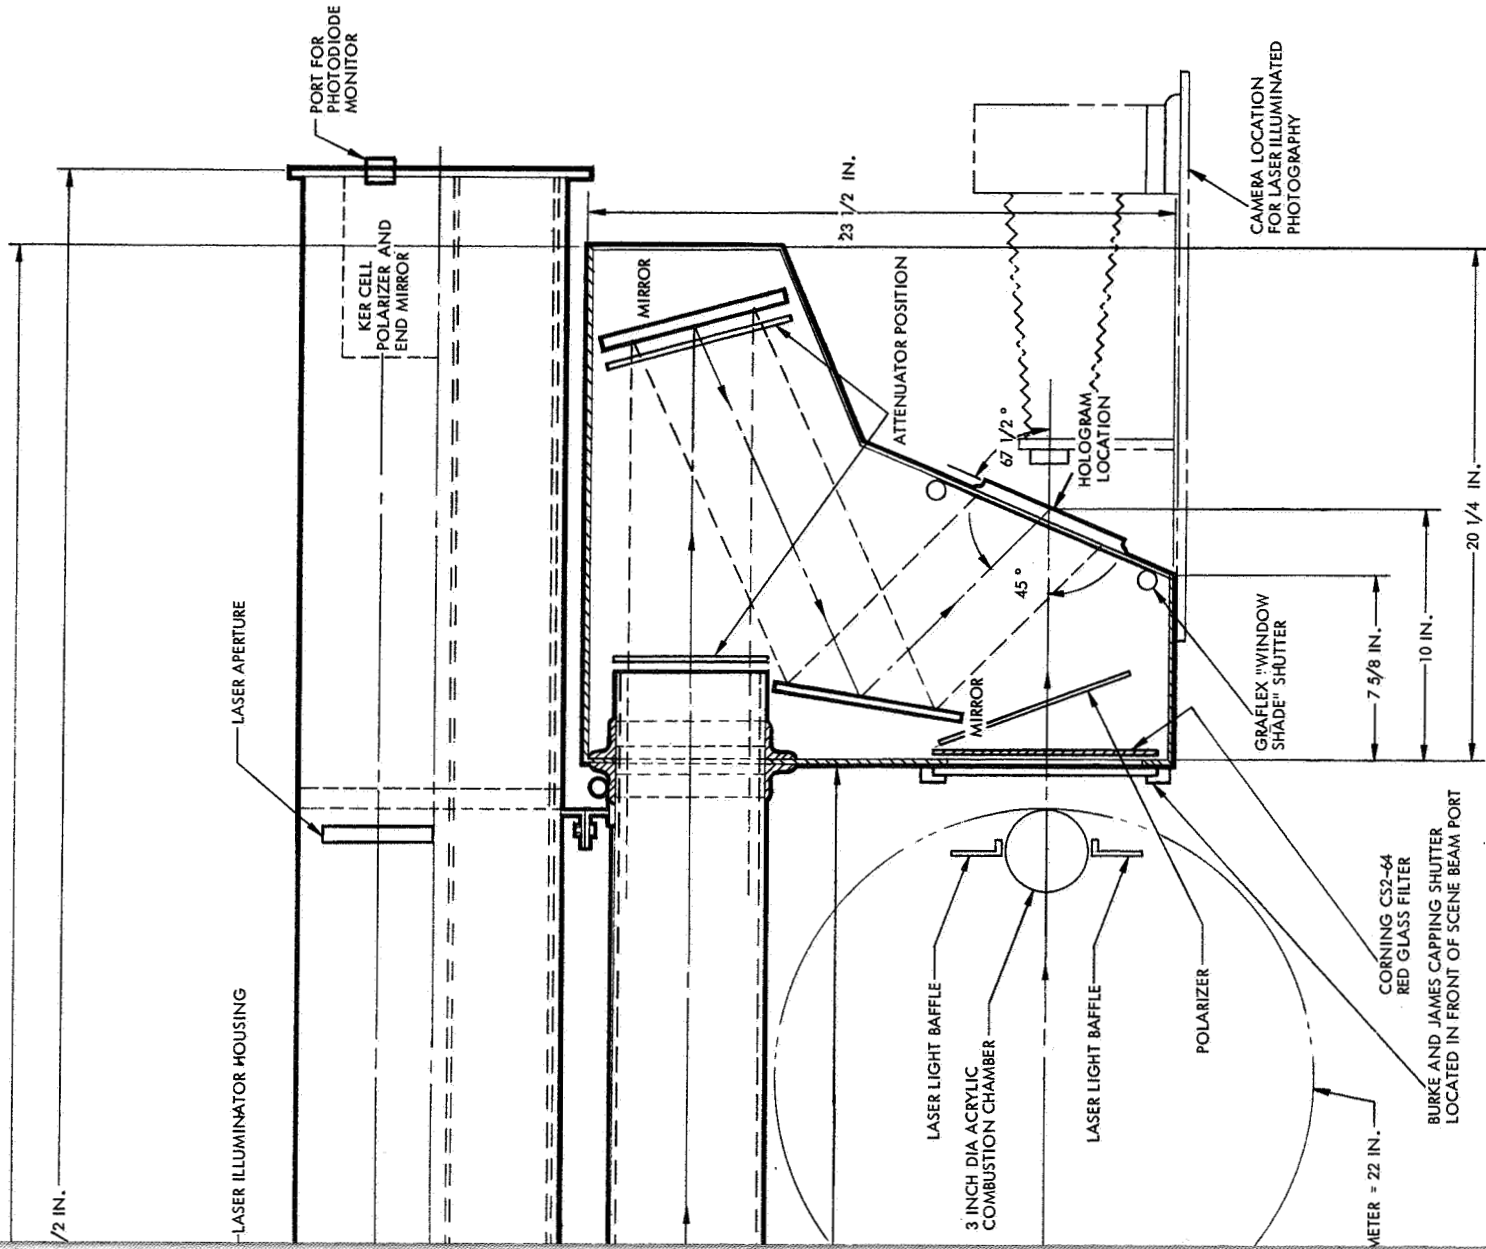
Figure 3-3. Assembly drawing of the laser holograph camera used to holograph combustion in a liquid rocket engine

Not shown in Figure 3-3 is the biplanar photodiode used to monitor the relative performance of the Q-switched ruby laser illuminator. This

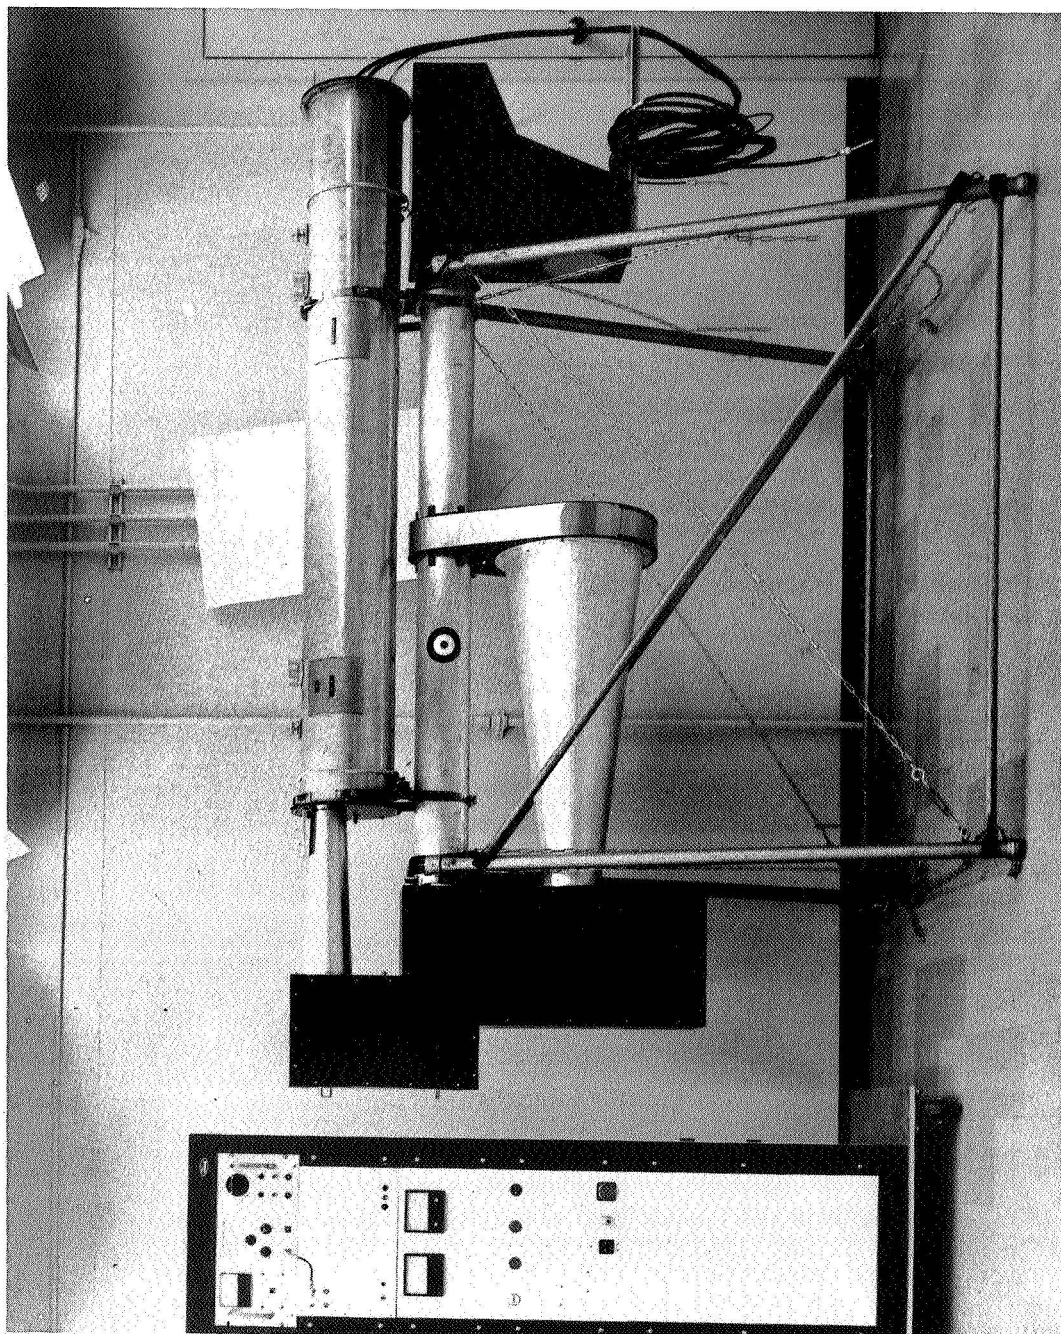
Figure 3-4. TRW laser-illuminated holocamera assembly (The laser power supply cabinet is shown at the left of the photograph.)

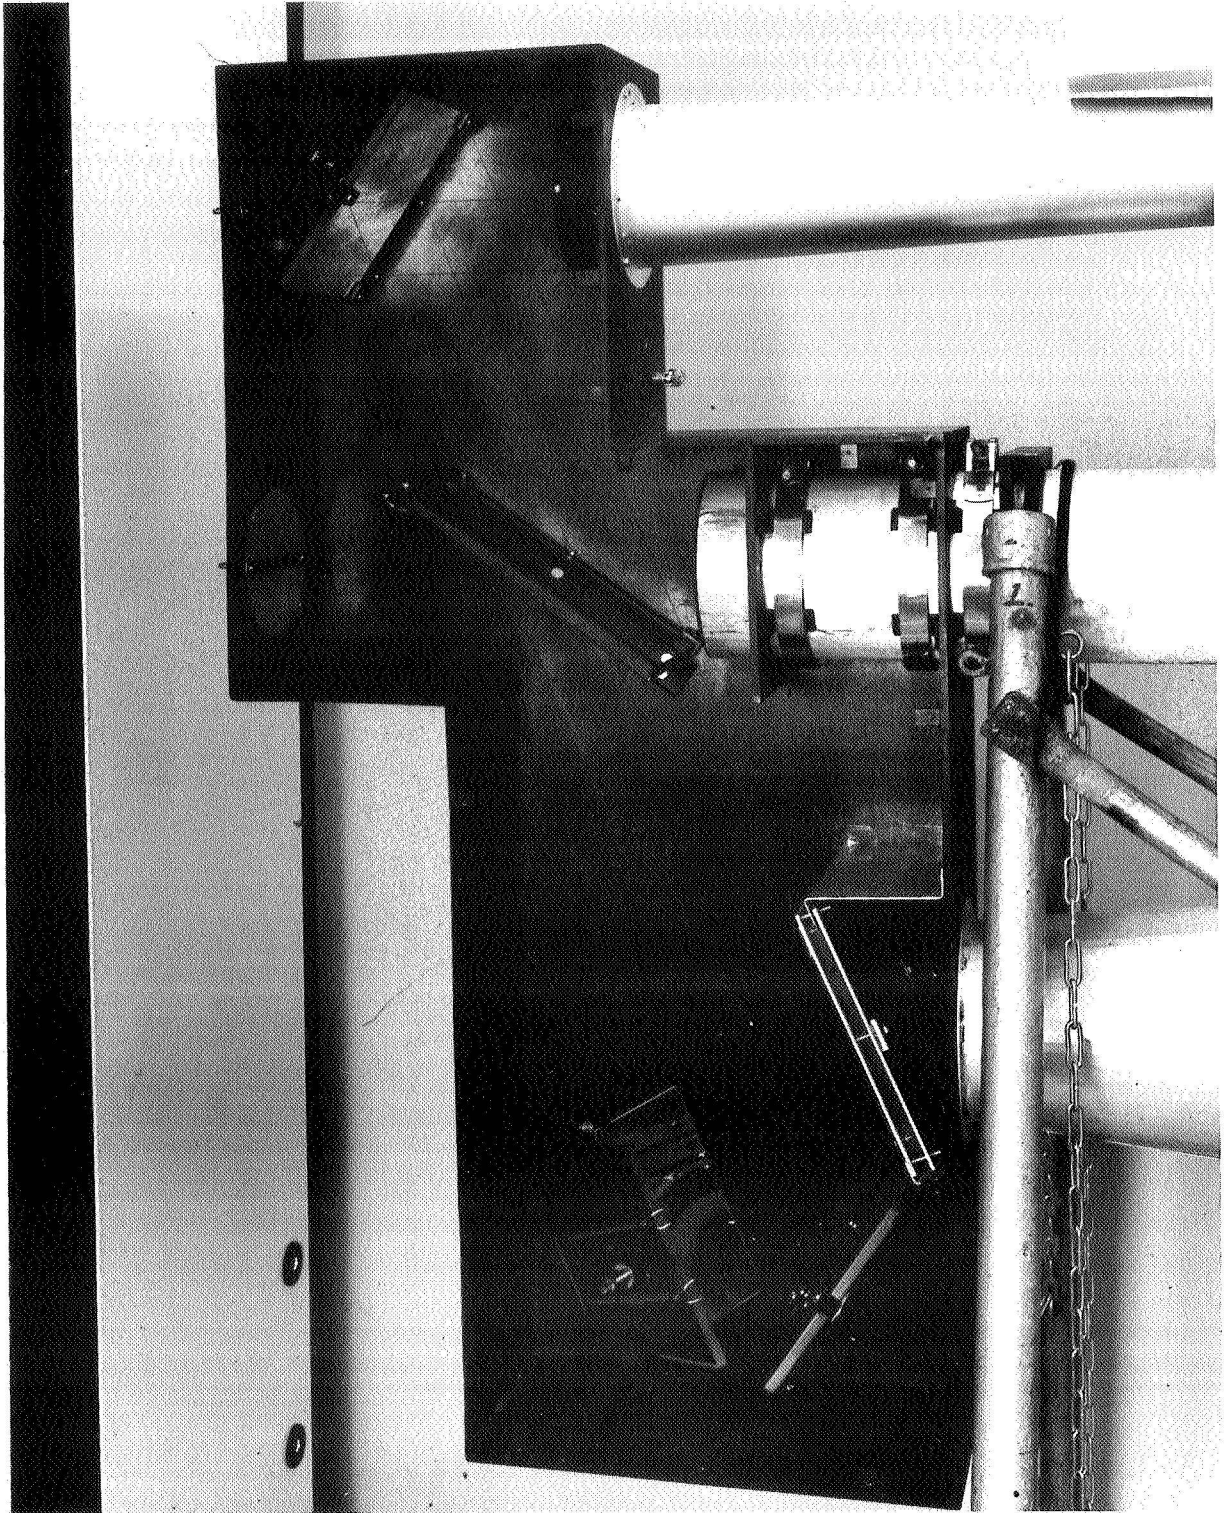
Figure 3-5. Left-hand aluminum housing containing the beam splitter and mirror installations

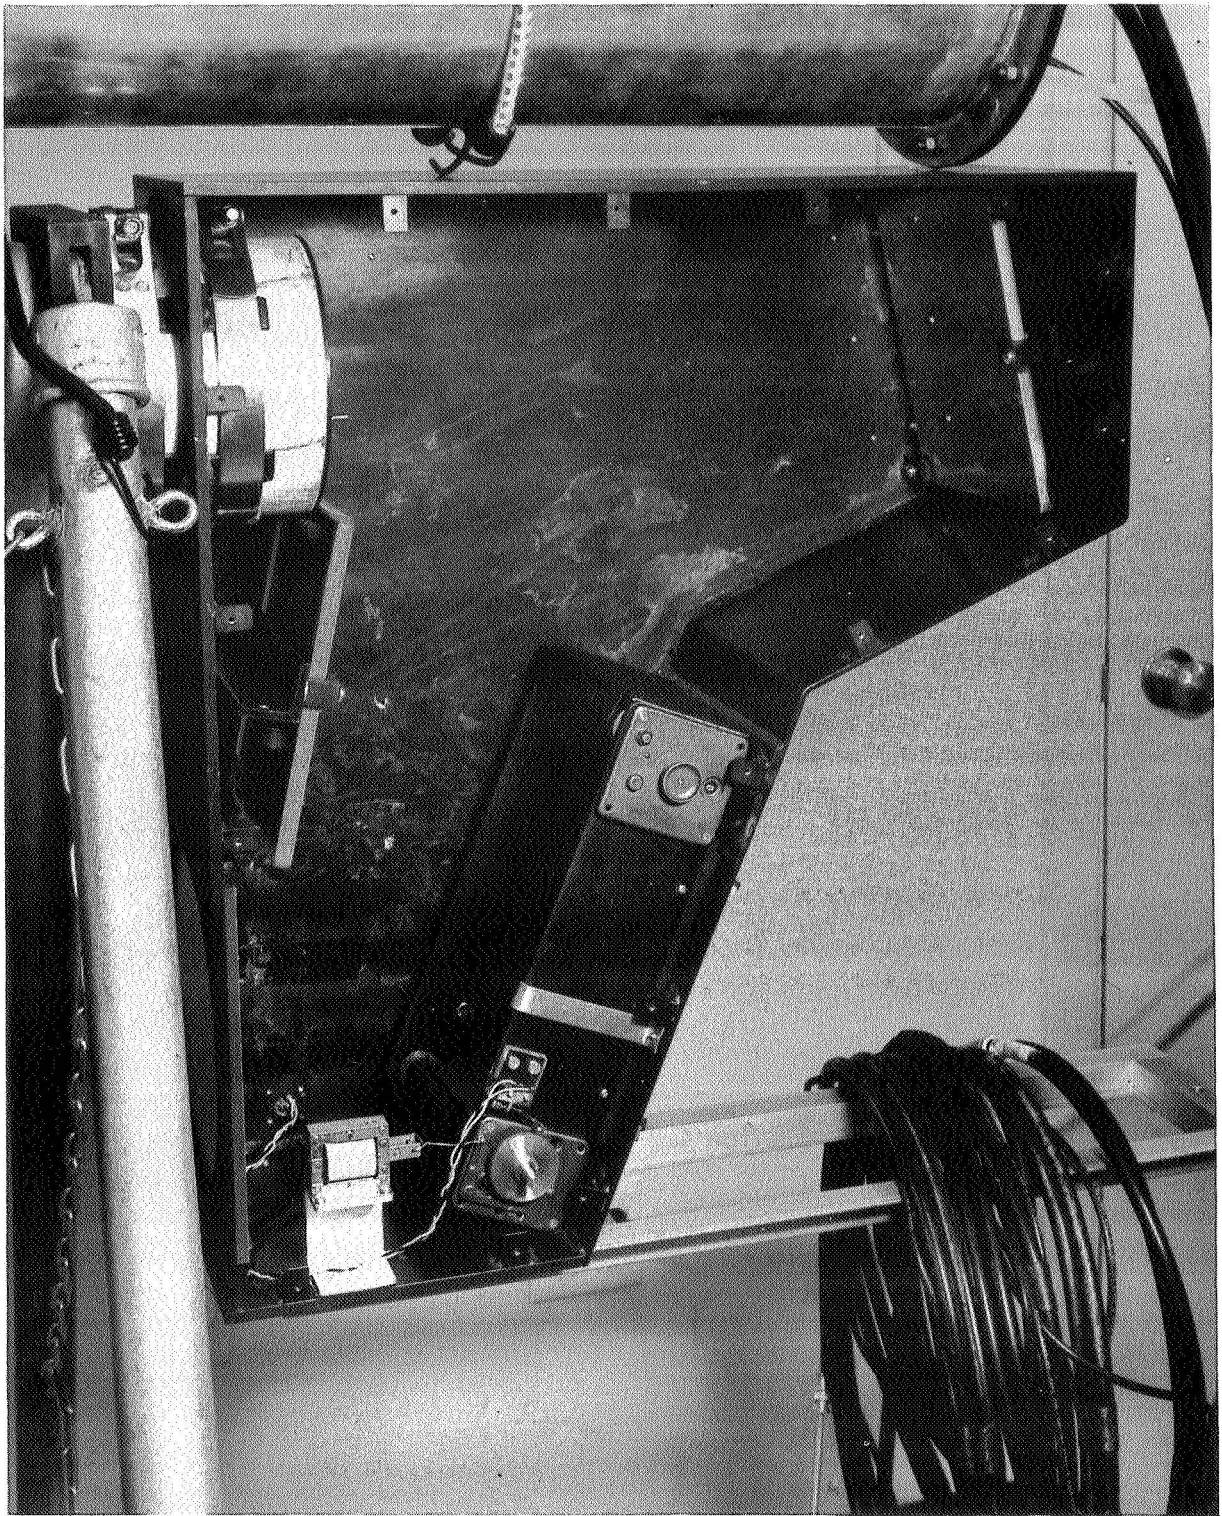
Figure 3-6. Right-hand aluminum housing containing the reference beam mirrors, shutter mechanism and film holder

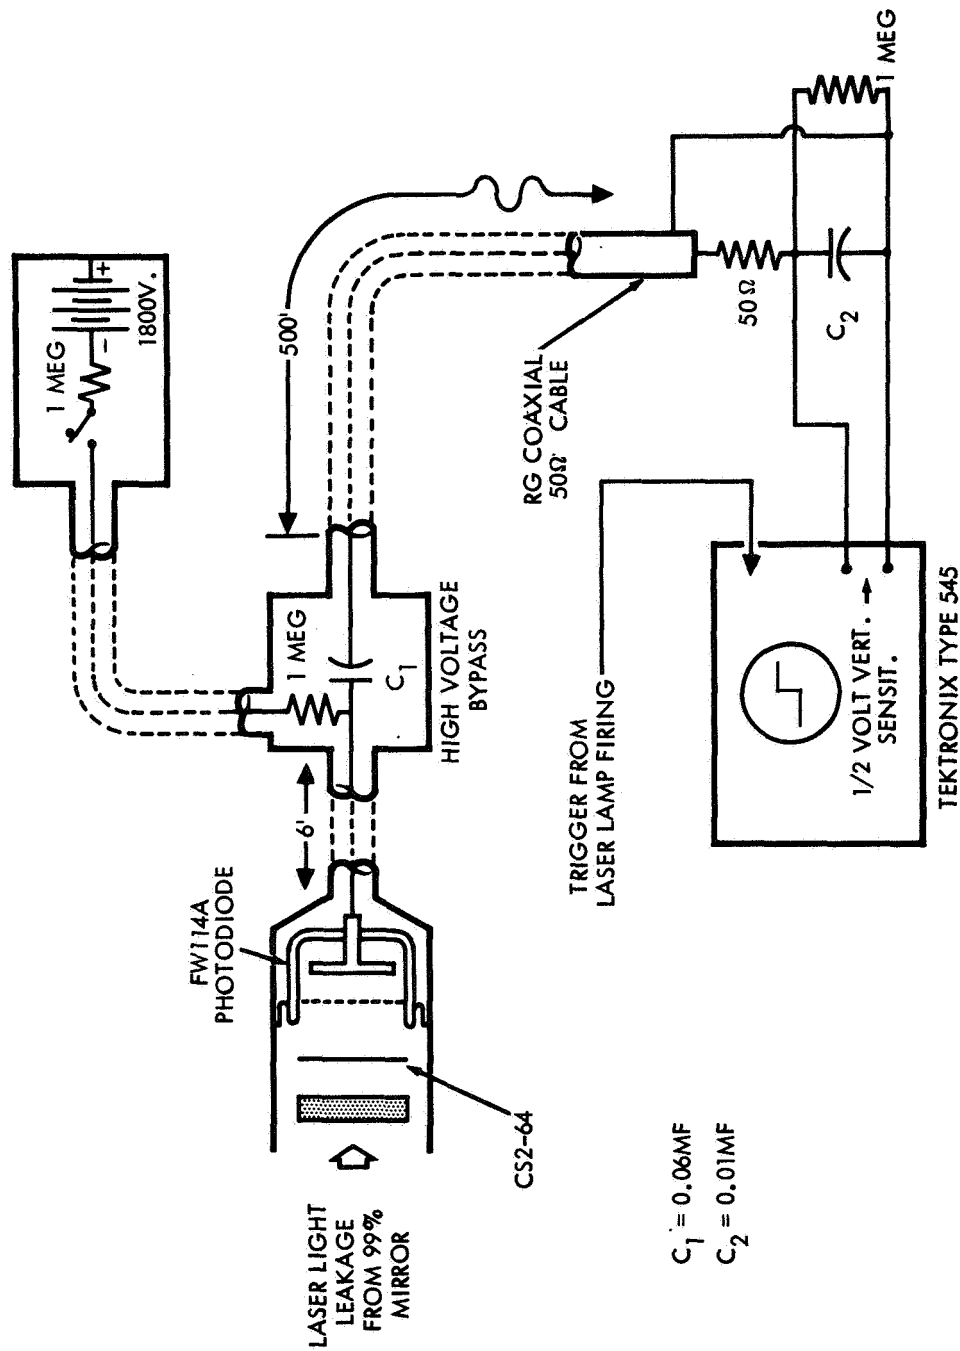
Figure 3-7. Schematic of the Photodiode Circuit; C<sub>1</sub> (0.06  $\mu$ F) is a high voltage bypass capacitor. C<sub>2</sub> (0.01  $\mu$ f) serves as an integrator, such that voltage developed across it is proportional to the integral of laser power (i.e., energy emitted by the laser). The photodiode and bypass circuit were designed to drive a traveling wave oscilloscope of 0.3 nanosecond rise time (Tektronix 519). The Tektronix 545 scope shown above was triggered by the initiation of the pump lamp current in the laser oscillator.

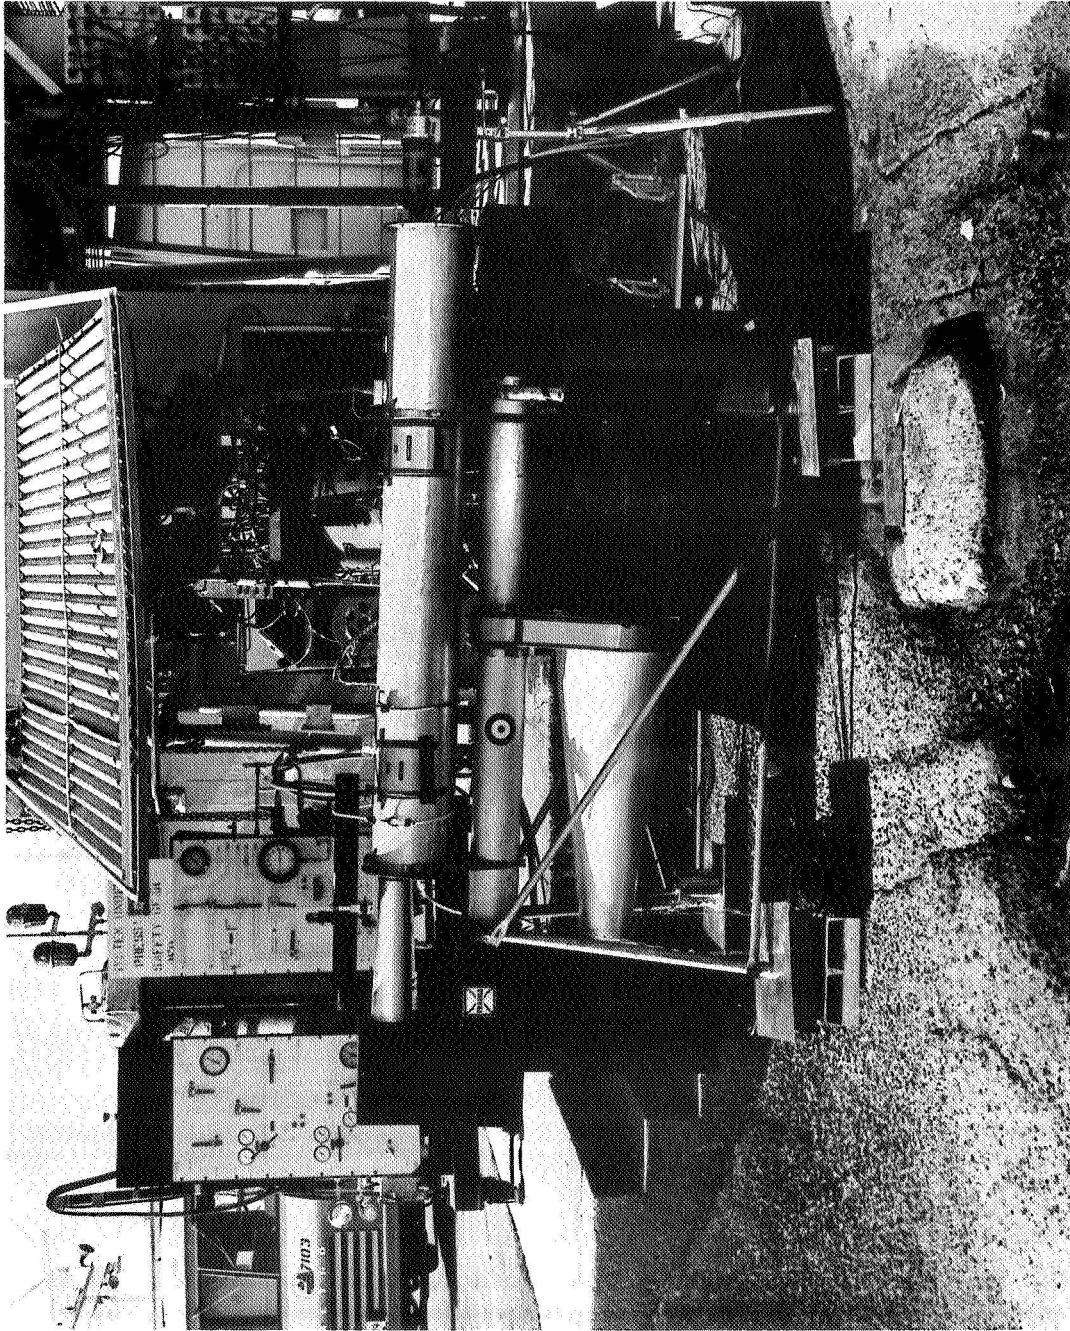
Figure 3-9. Side elevation photograph of the TRW holocamera installed at the JPL-ETS rocket test stand for Phase I open flame testing

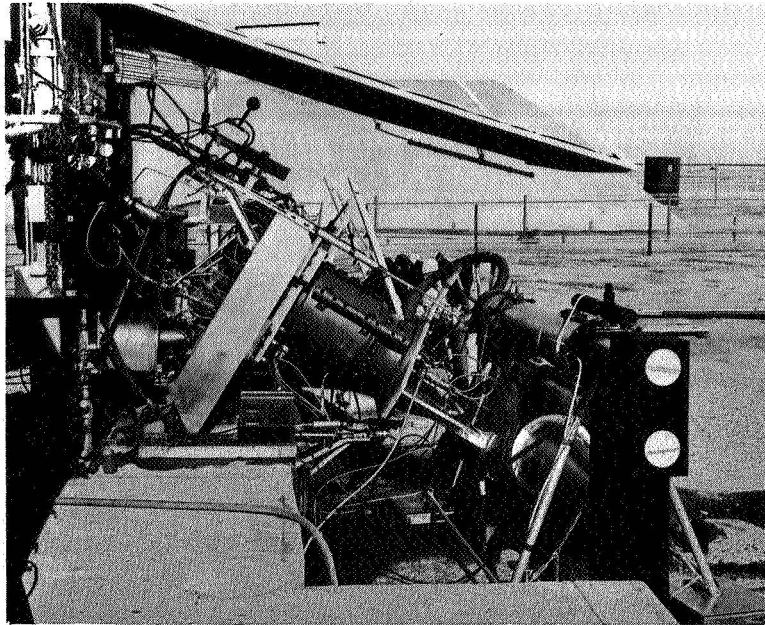
Figure 3-10. Left-side elevation photograph of the holocamera installation at JPL-ETS rocket test stand (Phase I)

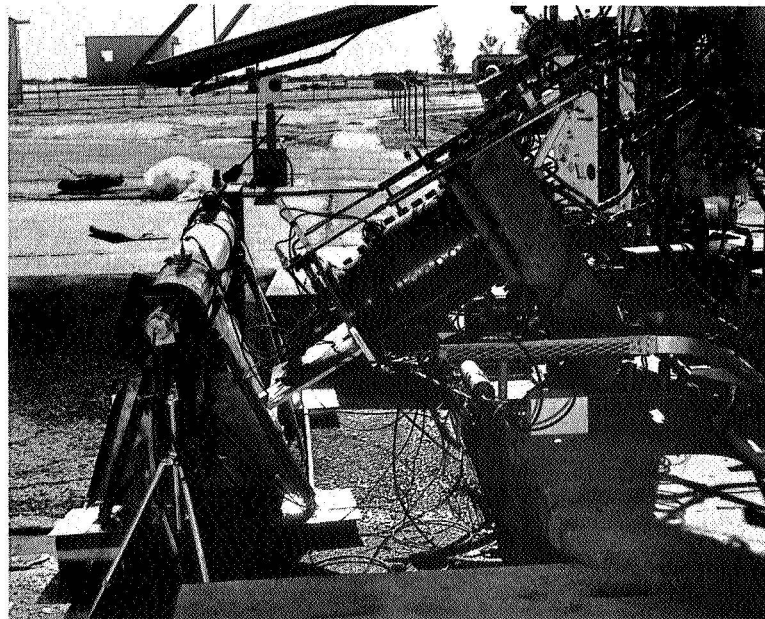
Figure 3-11. Right-side elevation photograph of the holocamera installation at JPL-ETS rocket test stand (Phase I)

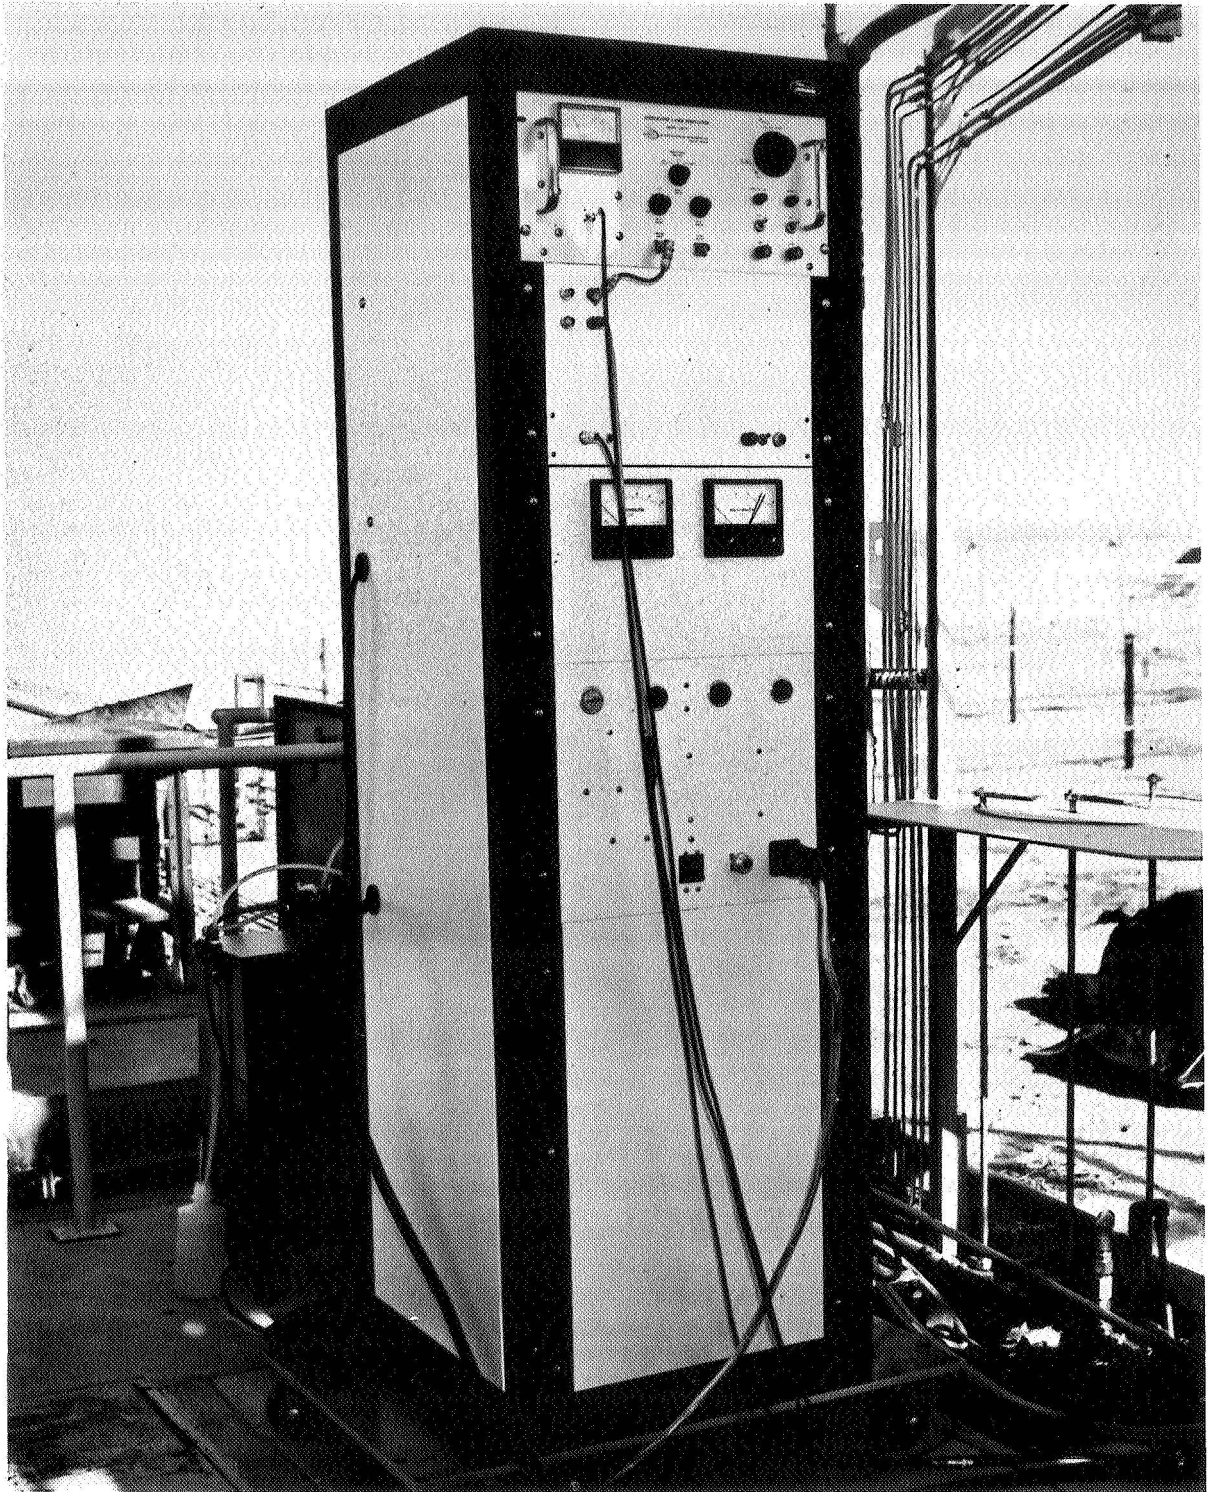
Figure 3-12. TRW power supply unit located at the rocket test stand

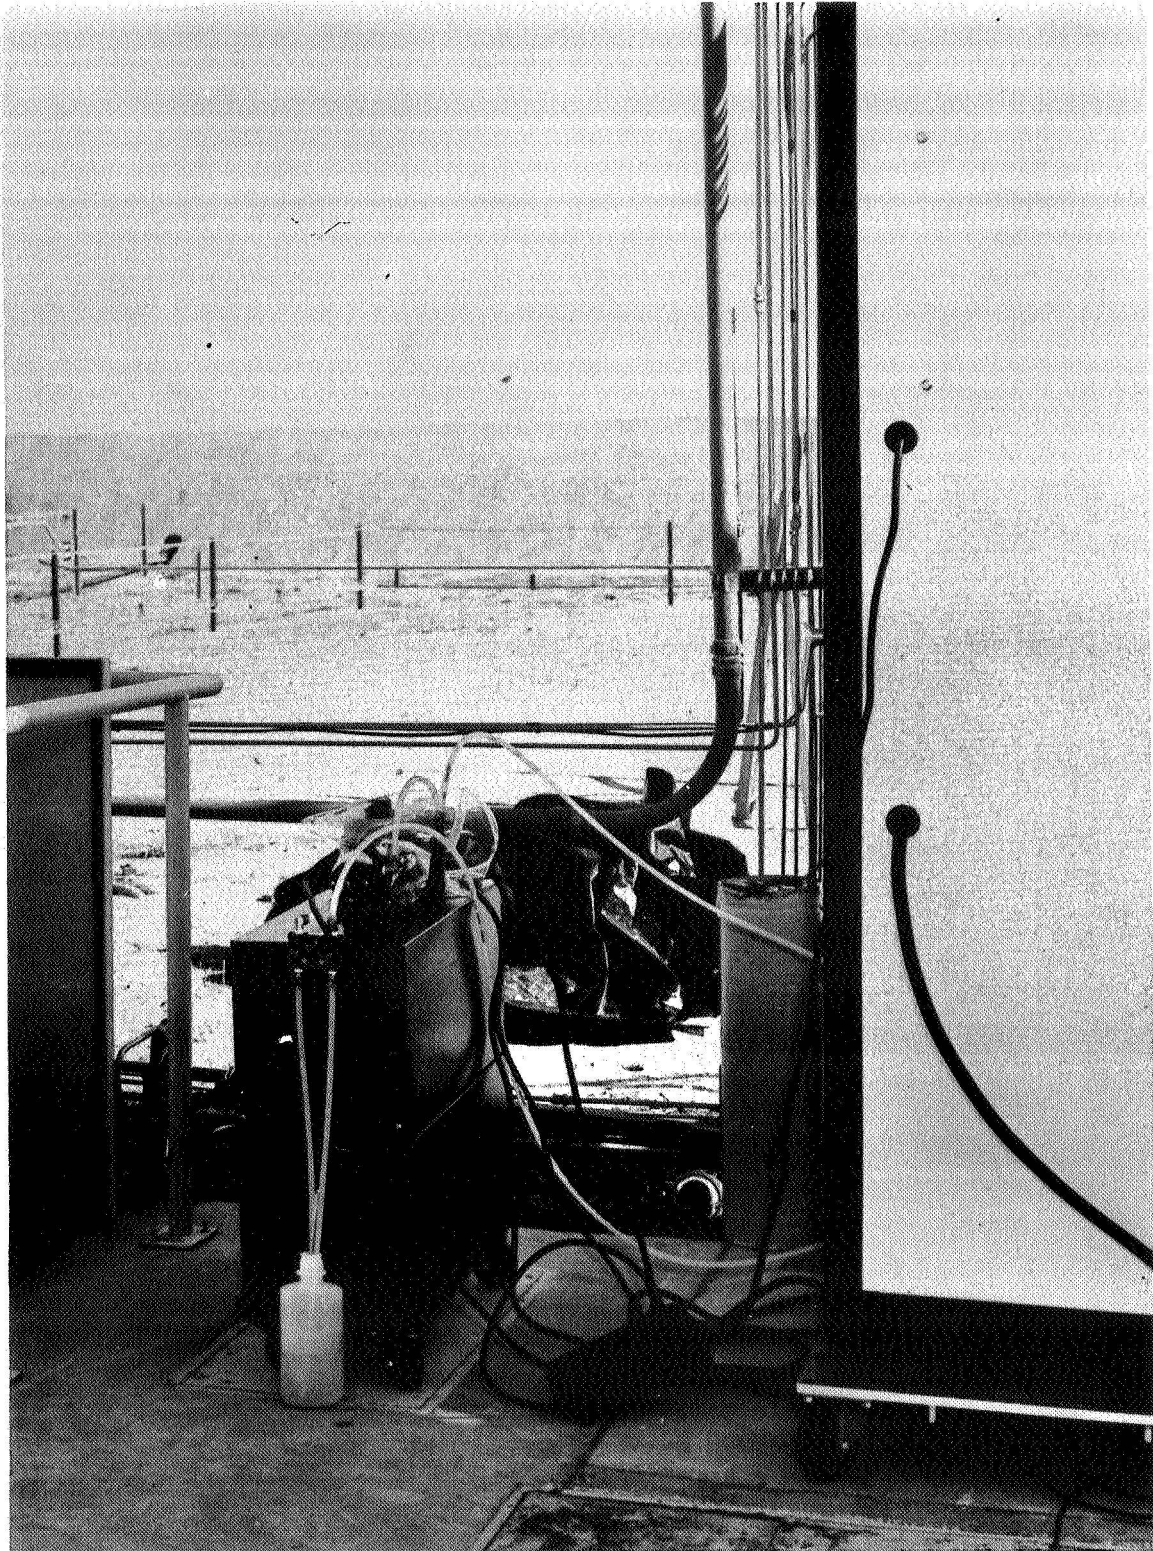
Figure 3-13. TRW portable cooling system for the laser head

A water cooling system (a part of TRW's inventory) with a circulating centrifugal pump served to cool both the oscillator and amplifier rubies. The cooling system was set to maintain 13°C water temperature.

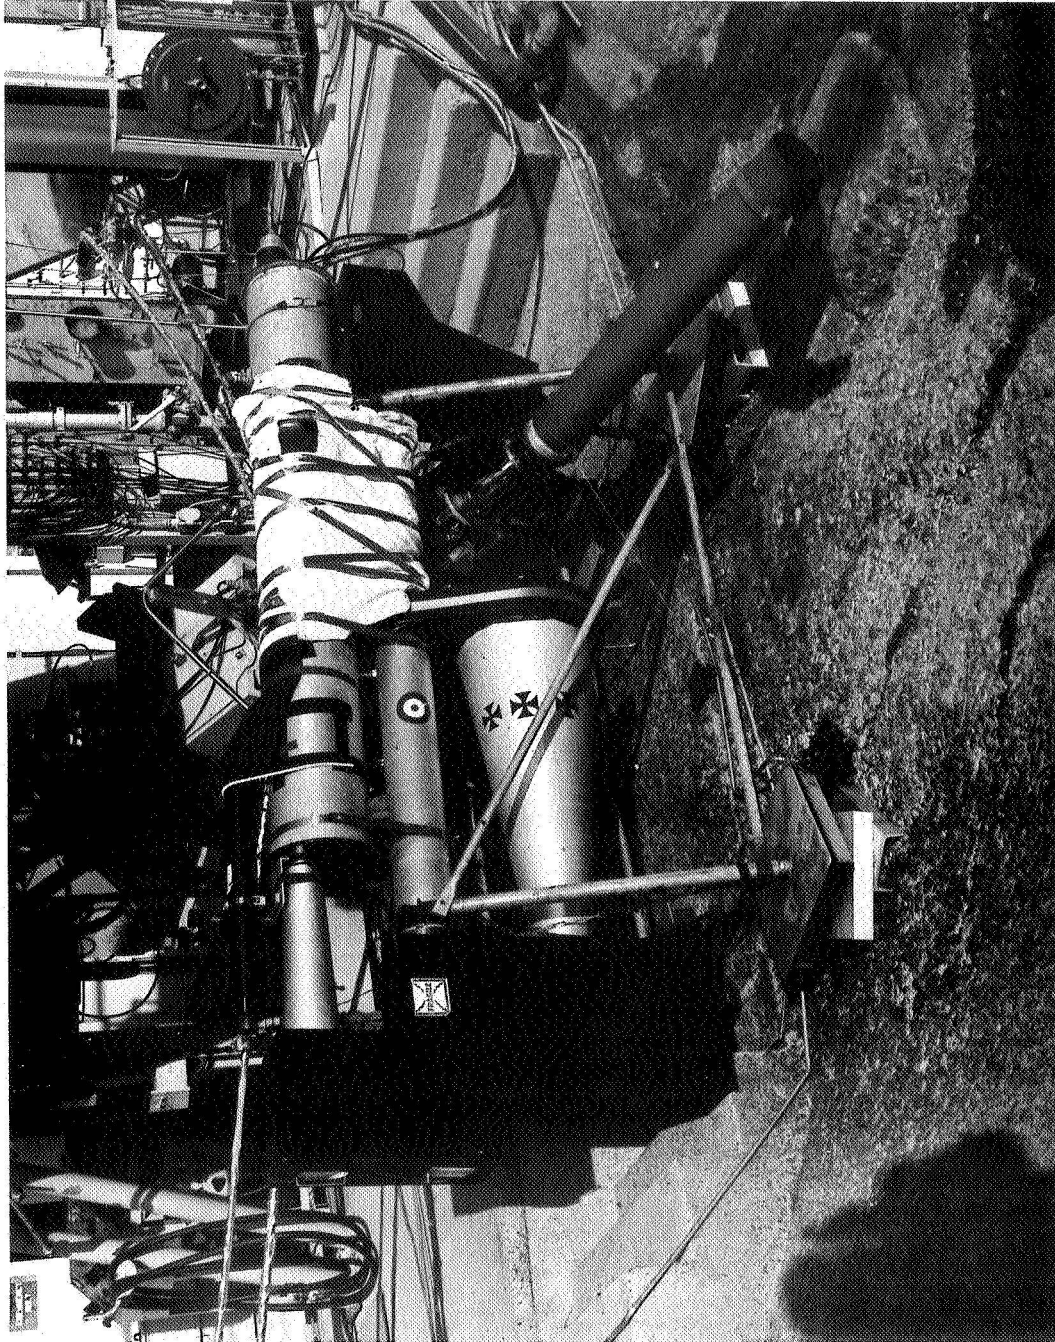
Figure 3-14. Photograph of the TRW laser holocamera installed at the JPL-ETS for the Phase II recording of combustion in a 3-inch inside diameter liquid rocket test engine
