JPL CONTRACT  
NO. 952023  
(NAS 7-100)

TRW REPORT NO.  
68.4712.2-024  
31 JULY 1968

FINAL REPORT  
**PRODUCING HOLOGRAMS  
OF REACTING SPRAYS IN  
LIQUID PROPELLANT  
ROCKET ENGINES**

**TRW**  
SYSTEMS GROUP

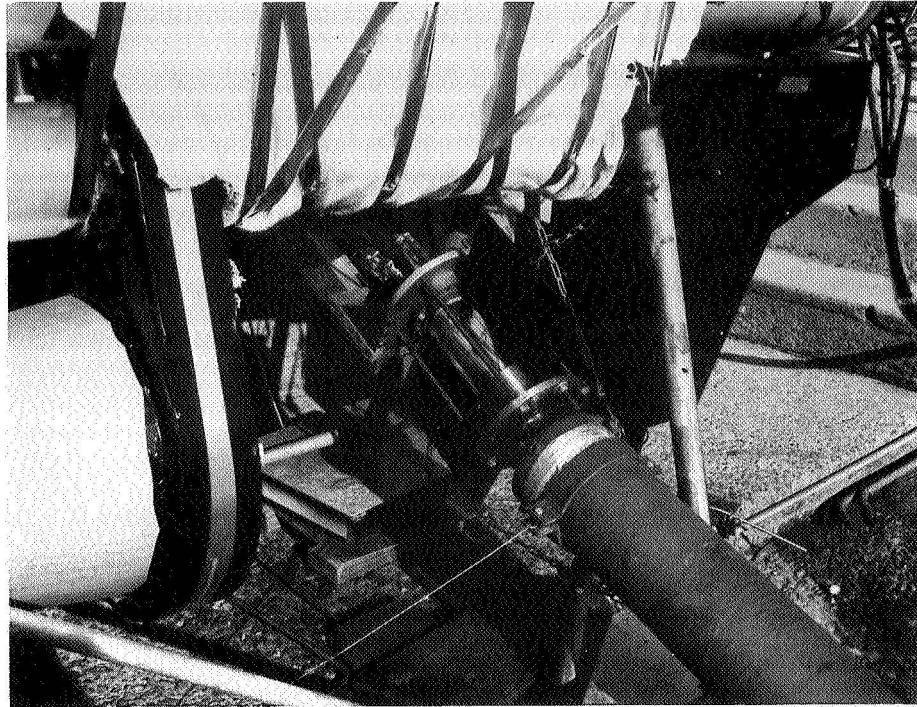
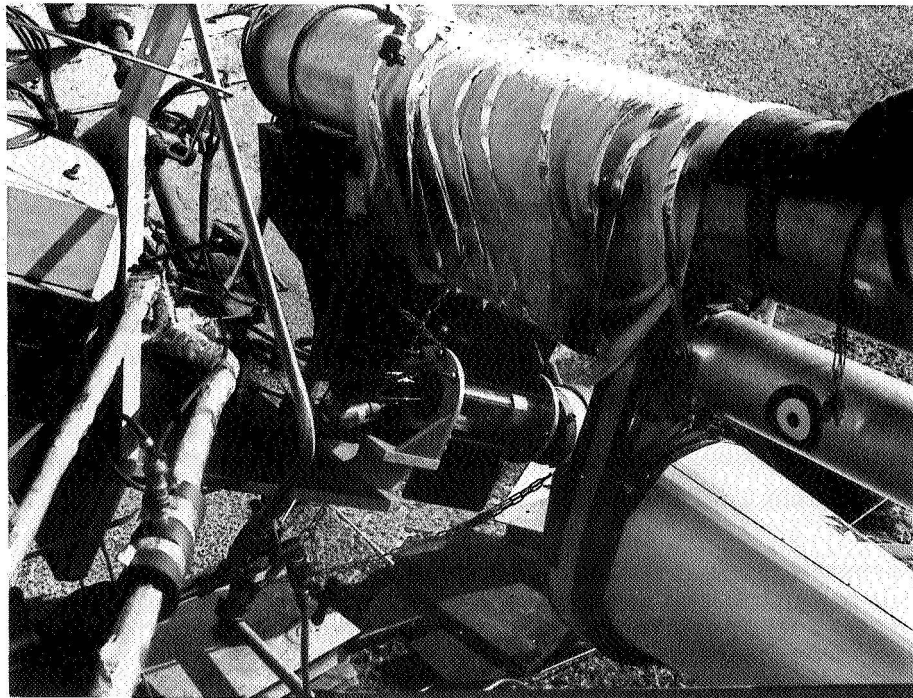
Figure 3-15. Front and rear photographs of the Phase II tests rocket engine with acrylic walls. The engine is mounted in the scene beam of the holocamera just before the electric capping shutter. Note the metal shields attached adjacent to the motor and parallel to its axis. These shields blocked excess scene light not passing through the combustion region.

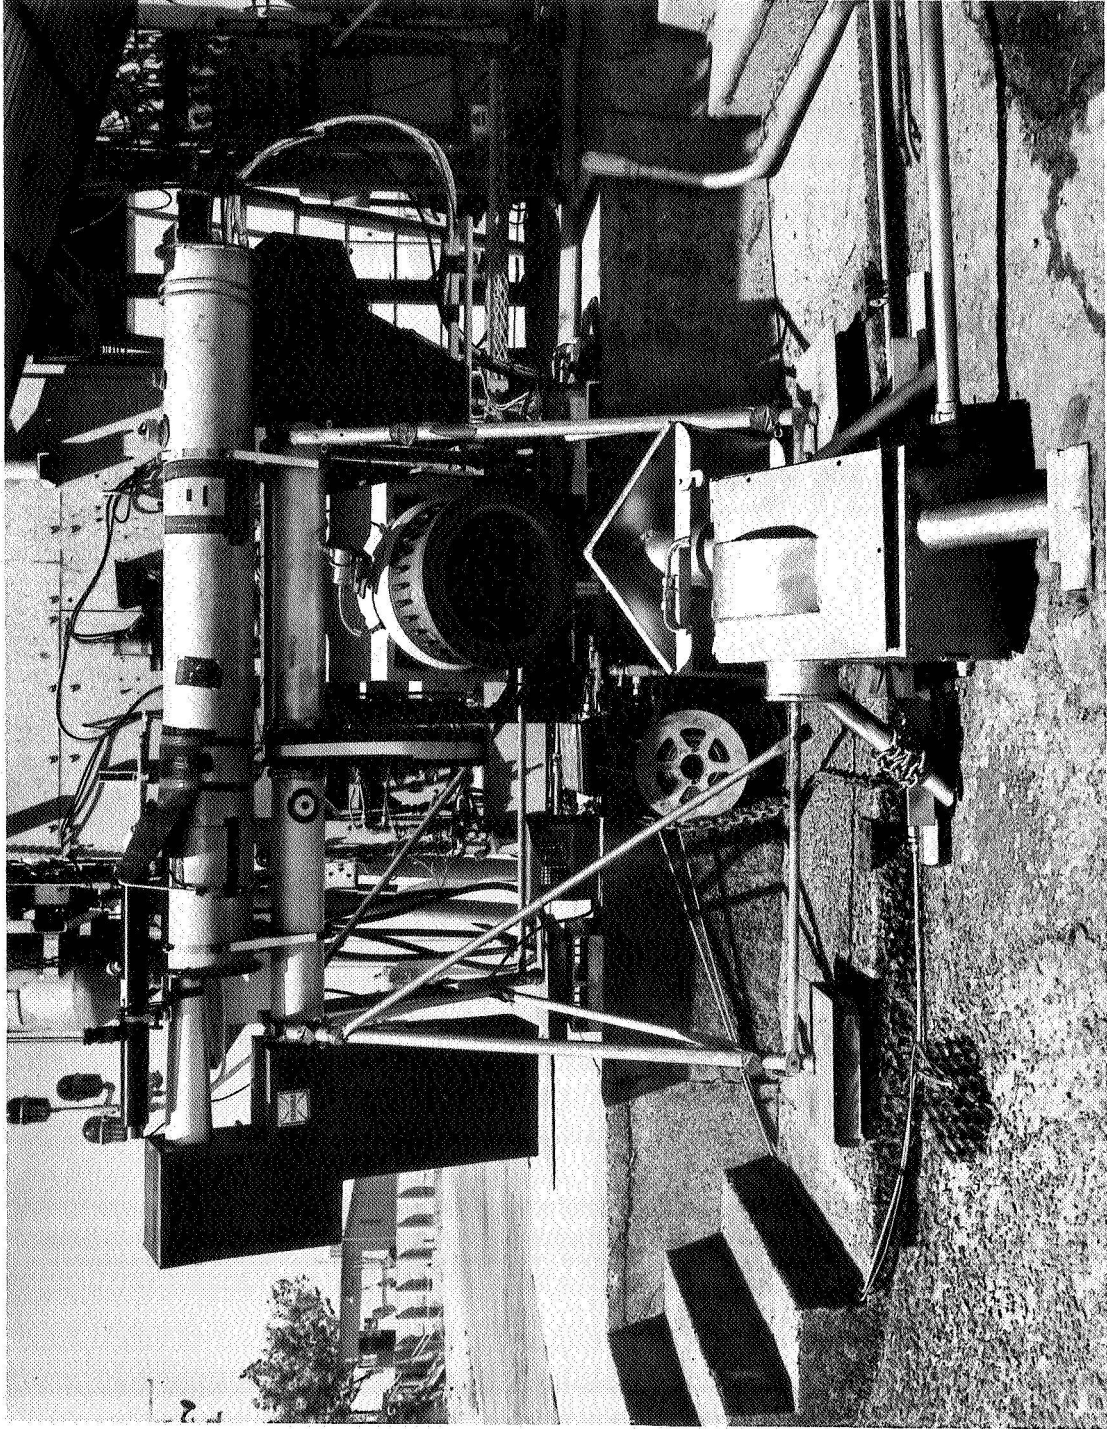
Figure 3-16. Photograph of the holocamera and 18-inch rocket test engine  
at the beginning of Phase III

Installation of the holocamera at the test stand with the 18-inch-diameter windowed engine mounted in place is shown in Figures 3-16 and 3-17. These photographs show that the entire setup was a relatively close fit with the holocamera astride the large test engine. To replace the combustion chamber windows seen in Figure 3-17 (without removing the holocamera) it was necessary to change the location of the large 15-inch-diameter focusing lenses from the original design position. This slightly defocused the ground glass diffusers at the hologram. The coherence of the ruby laser, however, was sufficient to accommodate this change.

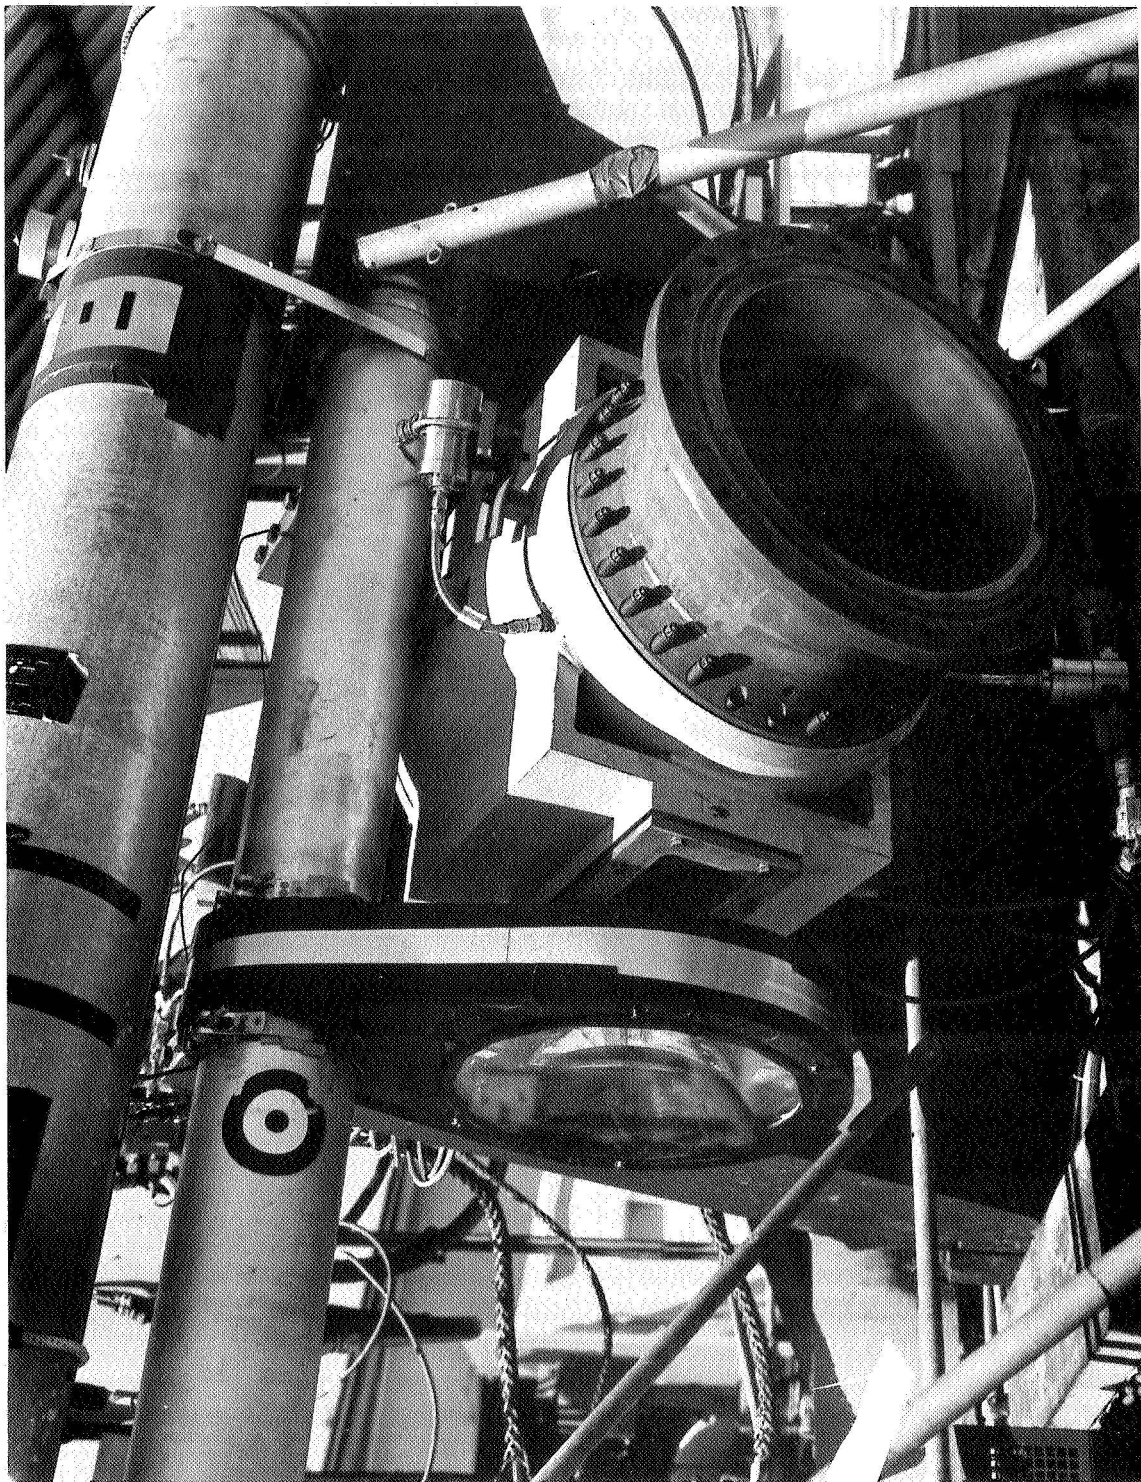
Figure 3-17. Close-up photograph of the 18-inch Phase III rocket engine with slab windows. The lens of the holocamera is on the left. Also visible is the accelerometer attached to the central support column of the holocamera (in line with the vertical axis of the motor).

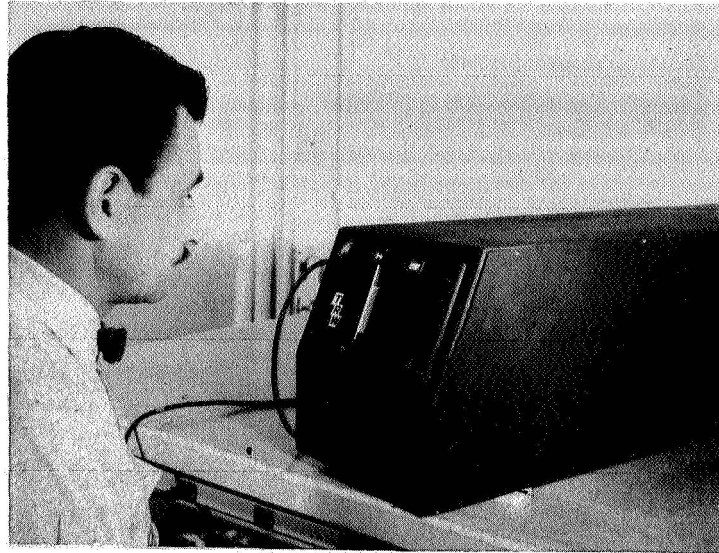
Figure 3-18. Photograph of the apparatus used to reconstruct holograms recorded in the JPL hologram camera with a 45° scene-reference beam angle

A photograph of the assembled reconstructor is shown in Figure 3-18. The observer sees the reconstructed scene within the box at an angle of 45 degrees relative to the horizontal.

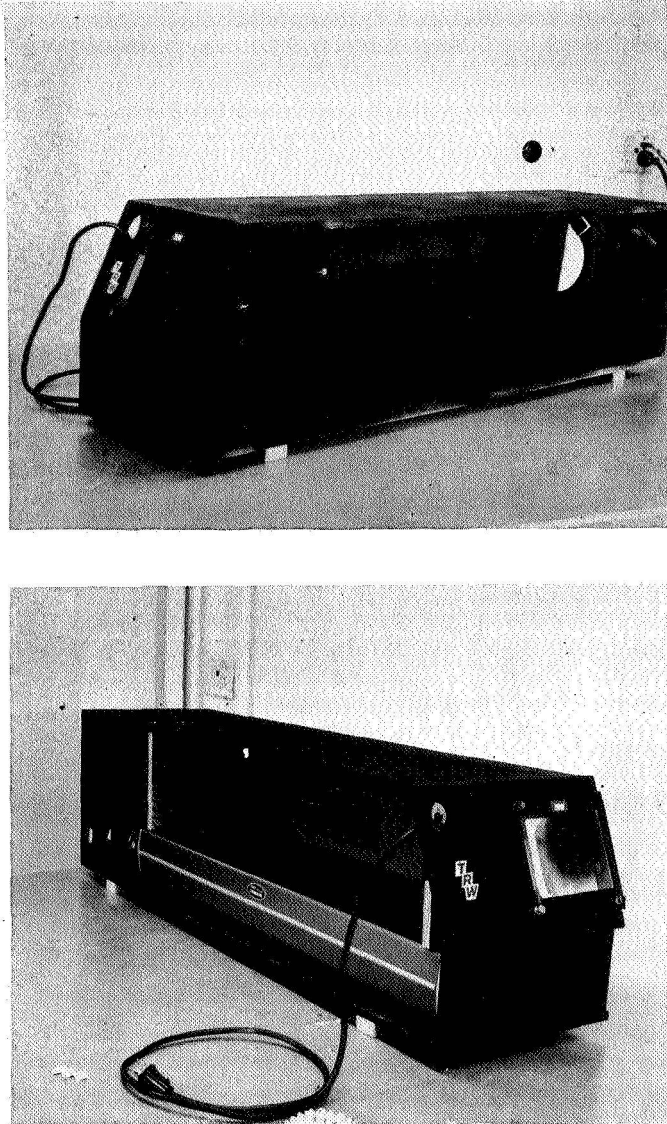
Figure 3-19. Photographs of the reconstruction apparatus with the sides removed showing the internal mounting of a Spectra Physics Model 124 helium-neon gas laser and beam-forming optics

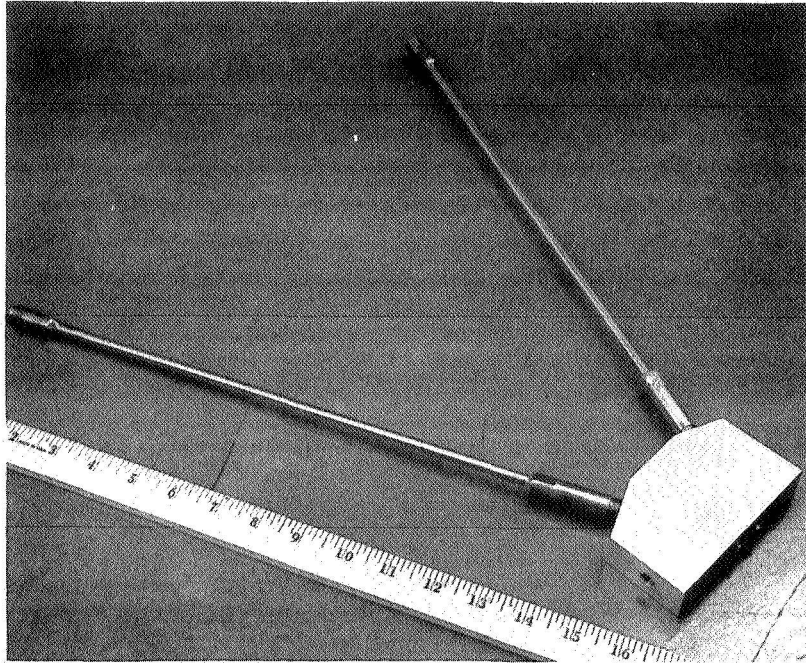
Figure 3-20. Photograph of the JPL single element impinging stream injector used for the Phase I open flame tests

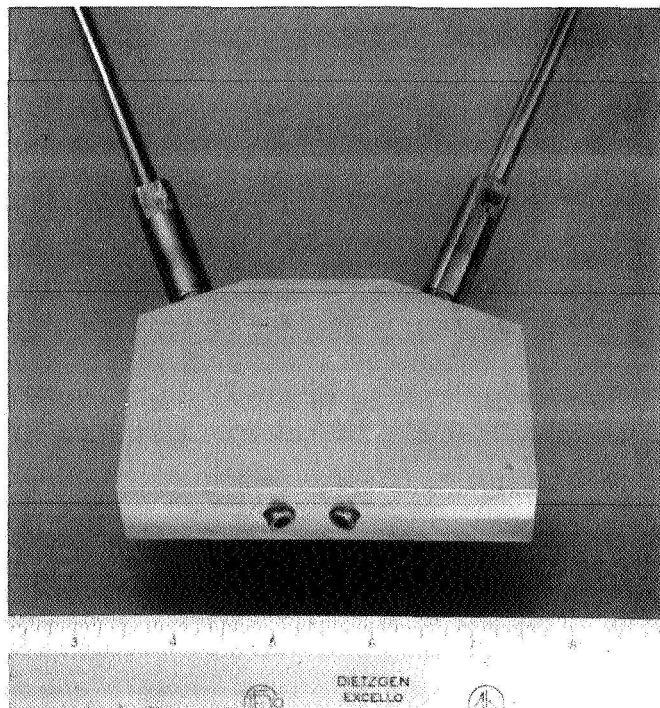
Figure 3-21. Closeup view of the JPL single element injector showing the 0.173-inch-diameter tubes extending slightly beyond the face of the aluminum injector block

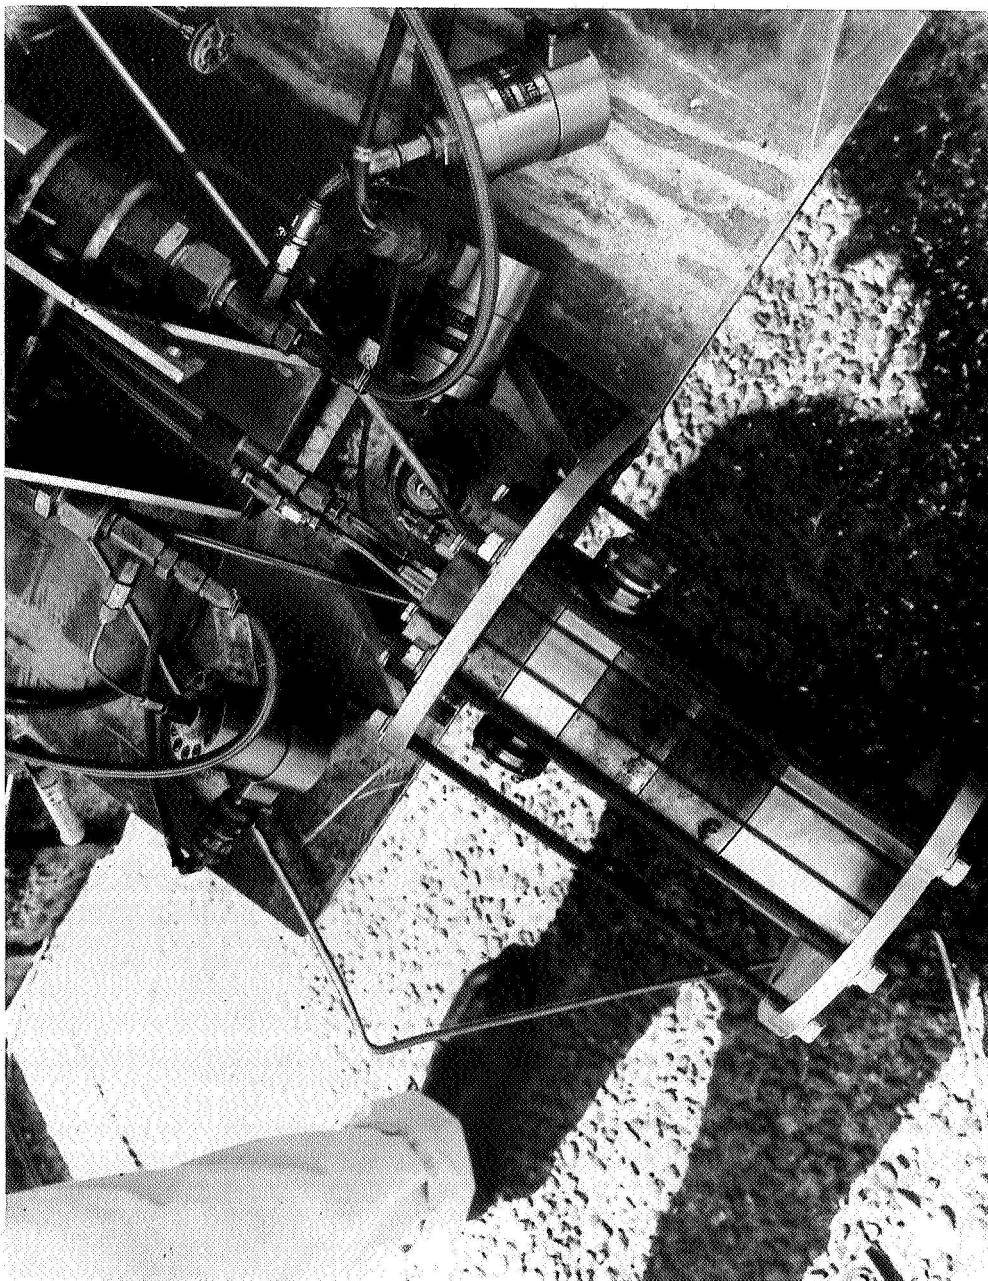
Figure 3-23. Photograph of the JPL test engine within which combustion was holographed. The engine consisted of a single doublet injector mounted within a 3-inch diameter, 6-inch long combustion chamber, followed by a nozzle throat section. In this photograph the engine had all steel walls, one section of which was fitted with bosses for 1-inch-diameter Pyrex windows.

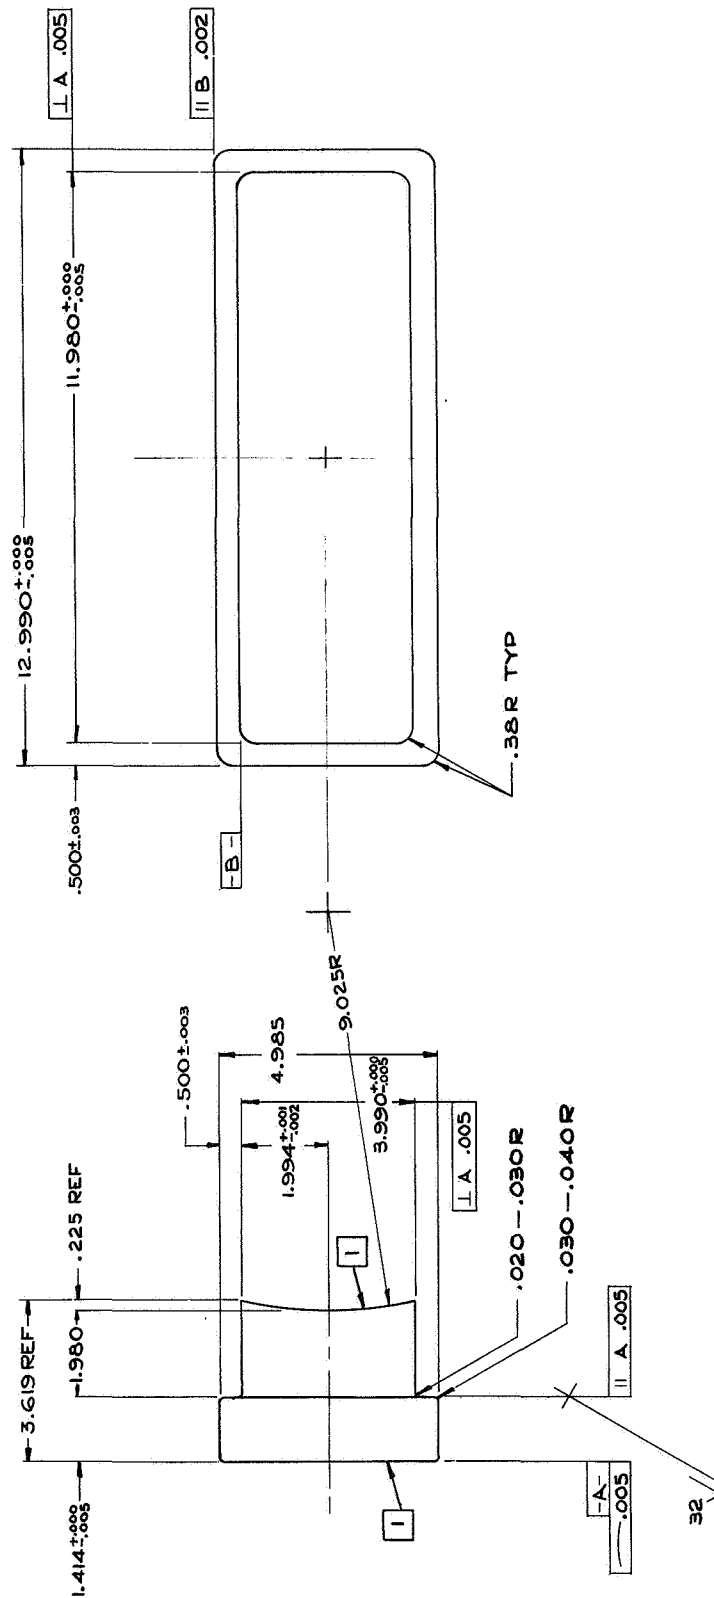
Figure 3-24. Acrylic windows used with the 18-inch-diameter chamber assembly during the Phase III test program. These windows were subsequently modified by capping the internal (chamber wall) surface with Pyrex glass to reduce thermal erosion.

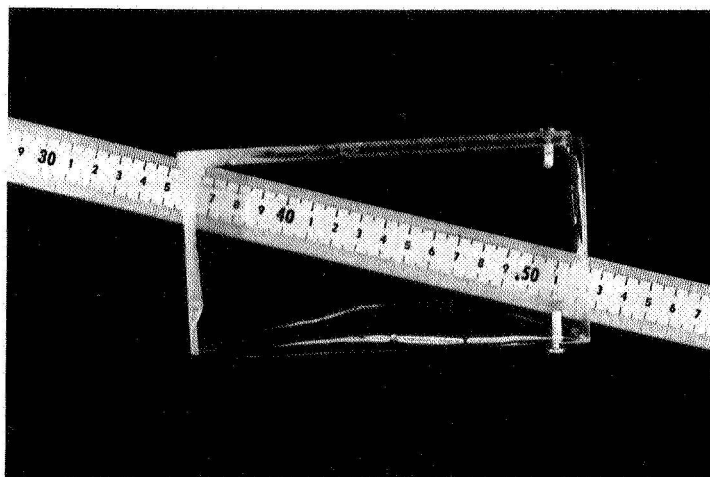
Figure 3-26. Photograph of a composite 1-inch thick acrylic test window capped with Pyrex. The materials are bonded with a clear epoxy, the mating surfaces being rough ground. The rough ground surface can be seen (in an area near the 35-36 cm portion of the scale) where no glue was placed. The windows made by this technique were used on the Phase III test program.

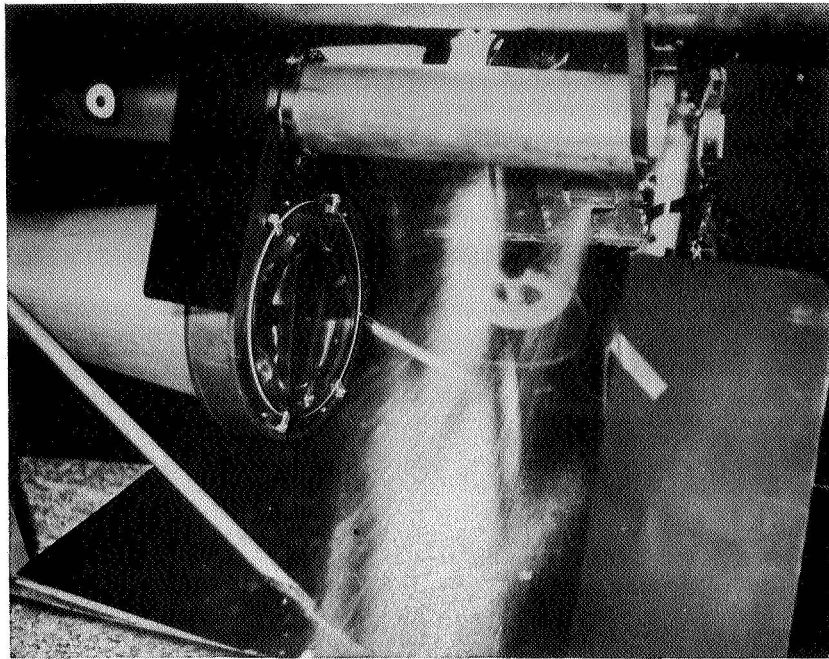
Figure 3-27. Injector water flow test with the spray fan perpendicular to the scene beam of the holocamera

Figure 3-28 illustrates the installation of the injector element 90 degrees away from the position shown in Figure 3-27. The spray fan is now horizontal within the scene beam. Note that a large piece of acrylic sheet has been placed in front of the window leading to the film

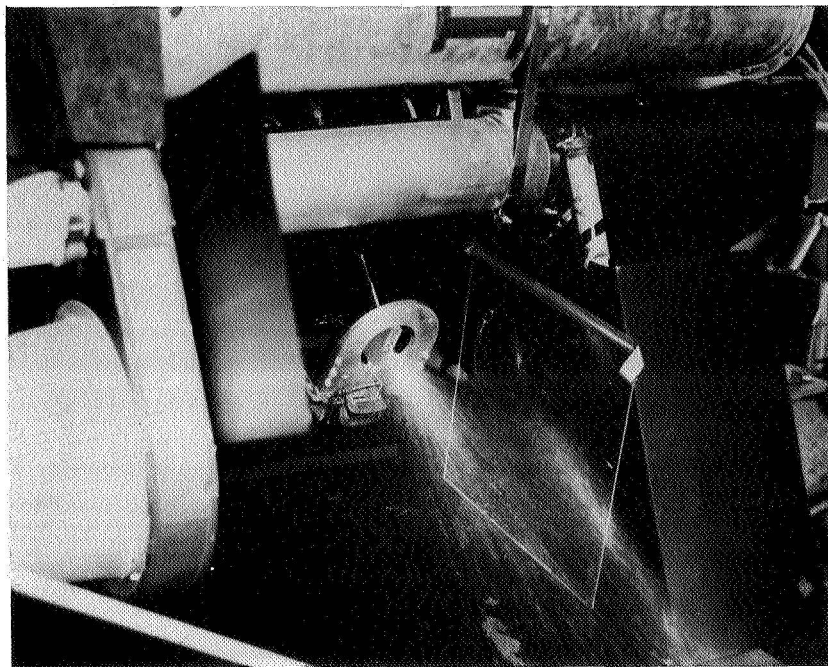
Figure 3-28. Injector water flow test with the spray fan oriented 90 degrees from that shown in Figure 3-27.

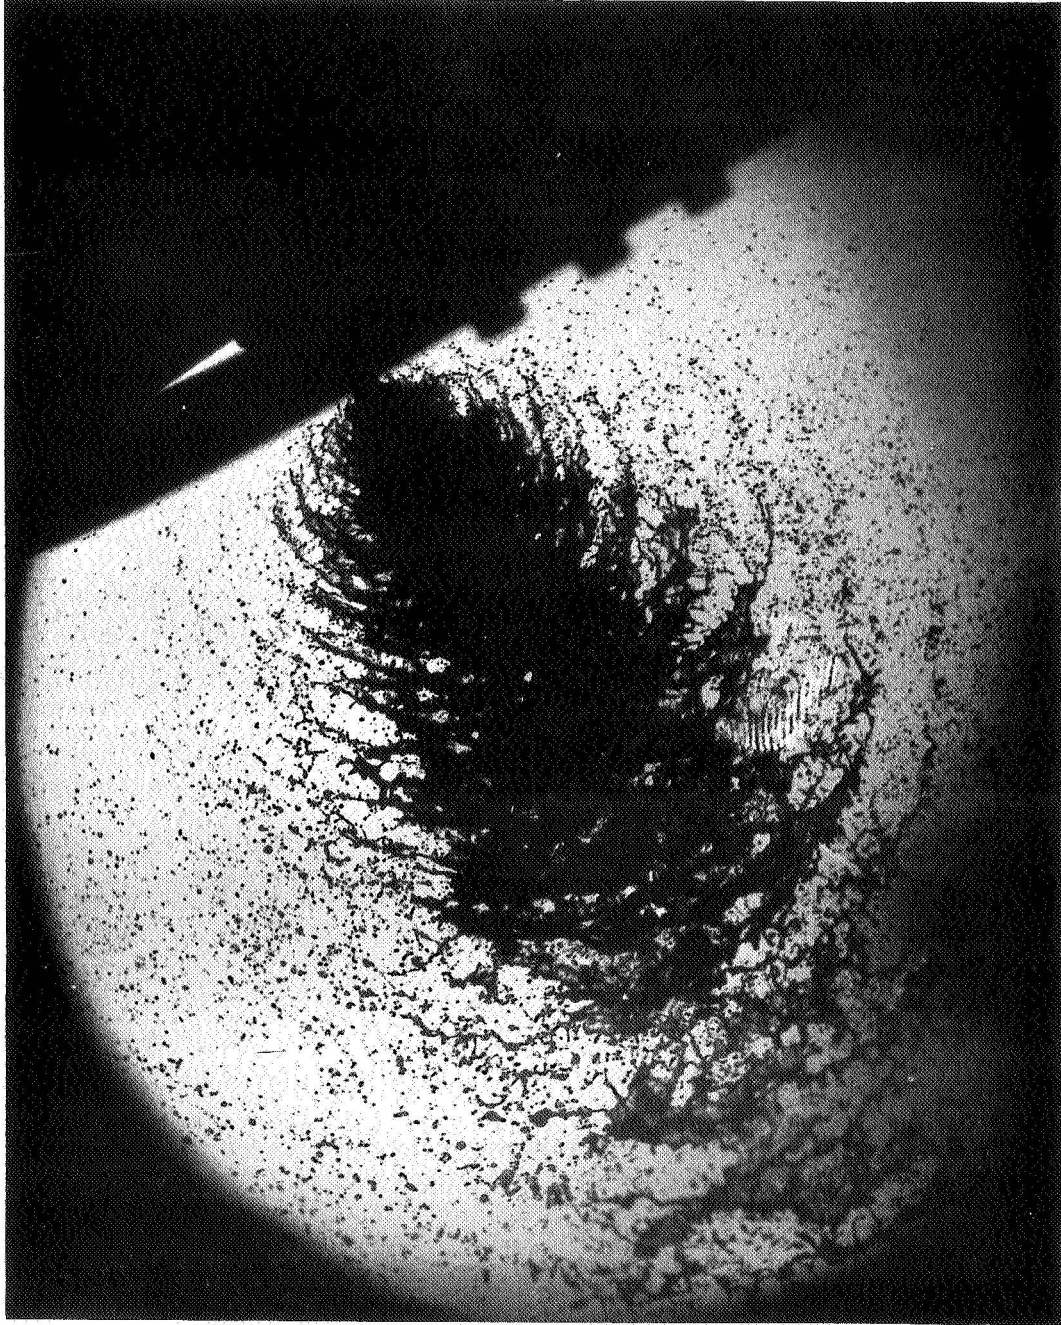
Figure 3-29. Photograph of the reconstruction of hologram B1131. This photograph illustrates the water flow spray pattern from the single element impinging stream injector operating at a pressure drop of approximately 300 lb/in<sup>2</sup> and a flow rate of 2.35 lb/sec.

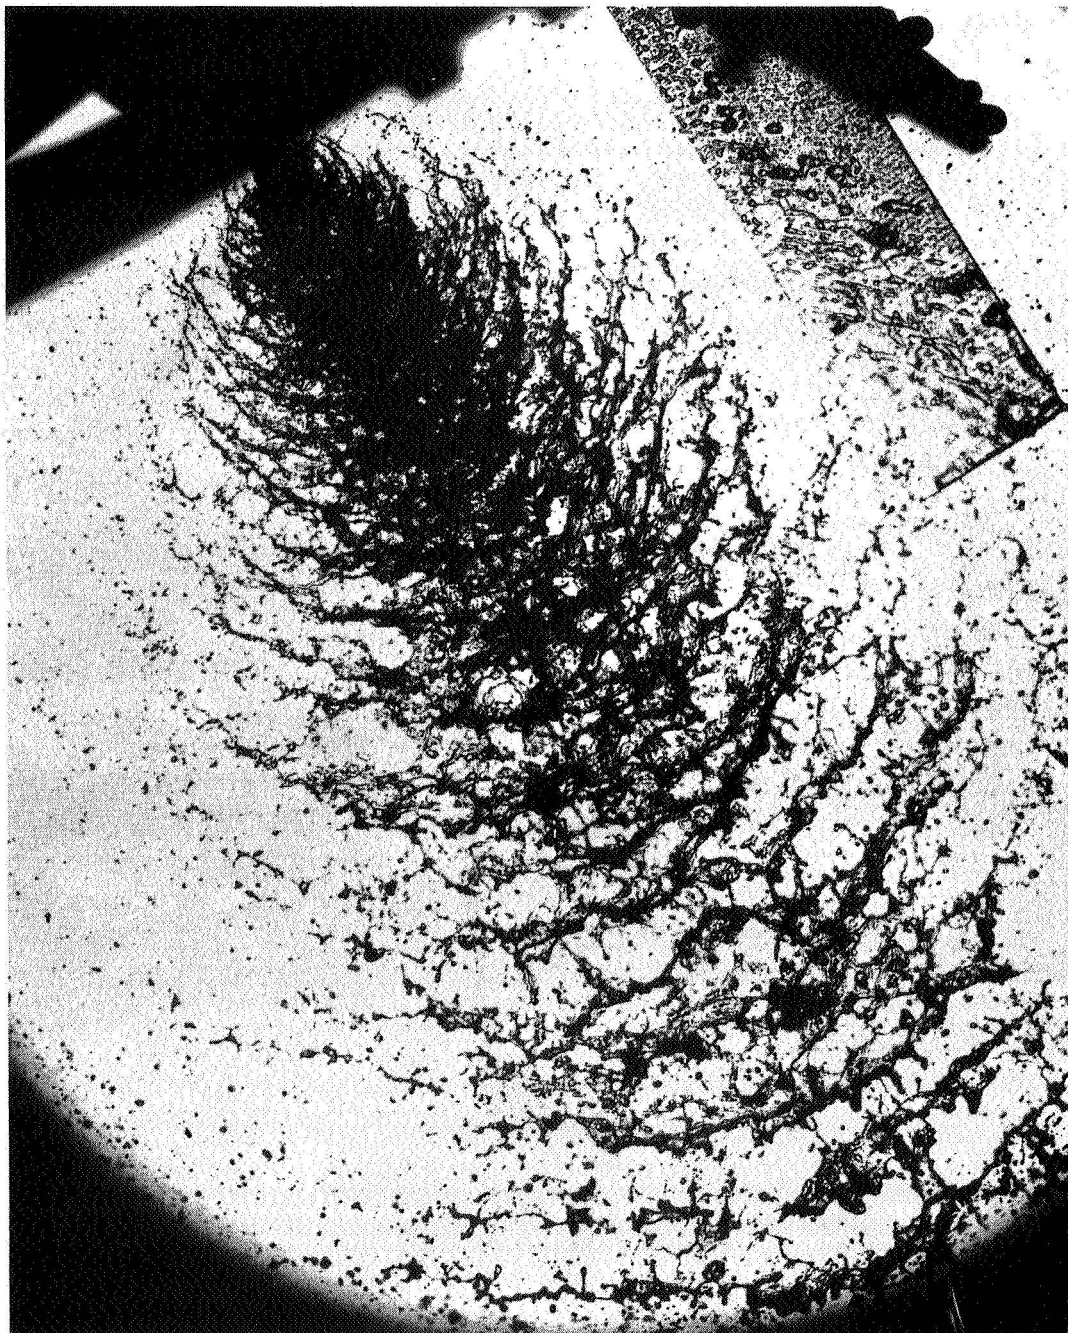
Figure 3-30. Laser-illuminated photograph of the water spray fan produced from a single element doublet during Run B113L

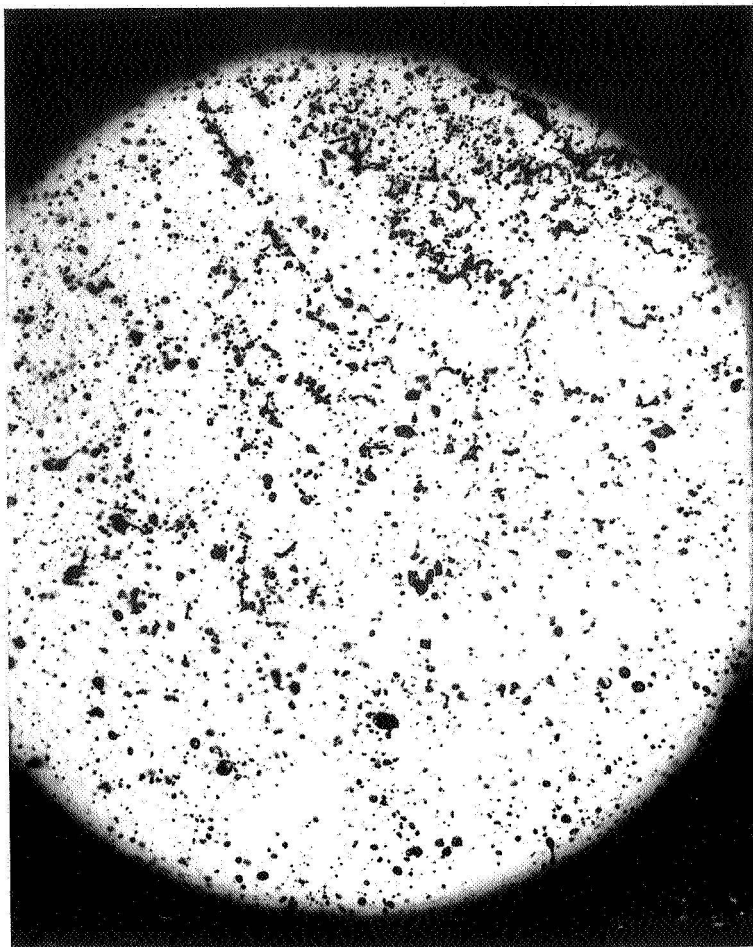
Figure 3-31. Photographic print made from a laser-illuminated photograph taken of the water flow from the JPL single element injector during test number B1113U. Direction of droplet flow is from the upper right-hand corner of the photograph to the lower left-hand portion. Examination of the Agfa 10E75 film plate (from which this print was made), under a microscope, indicated a resolution of around 25 microns.

Laser-illuminated photographs were made of the water droplet dispersion approximately 12 inches downstream from the injector element. Figure 3-31 illustrates the droplet pattern of one such test (Run No. B1113U). The photography was made on Agfa 10E75 film plate and developed for 2 minutes in HRP developer diluted 1:8 at 72°F. The

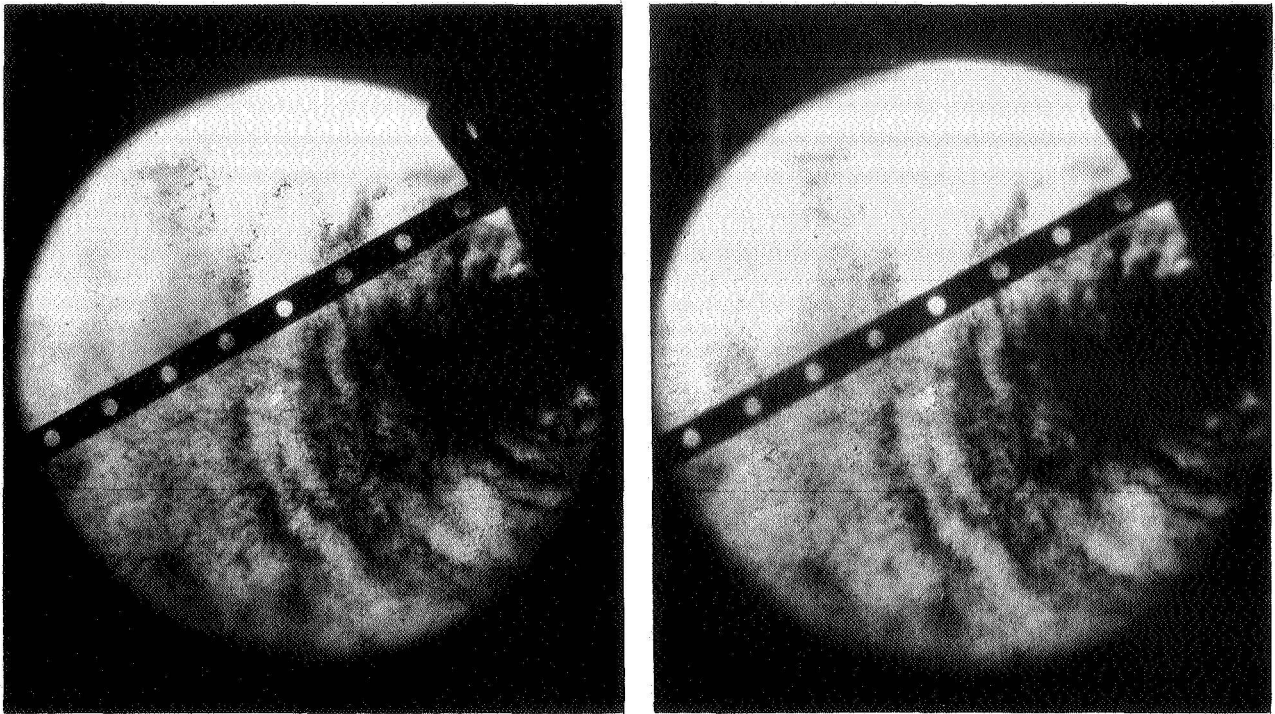
Figure 3-32. Two photographs of the reconstruction of a ruby laser hologram of the open flame combustion of  $\text{N}_2\text{O}_4$  and 50/50 mixture  $\text{N}_2\text{H}_4$  and UDMH (Run B1117G). The two differ by a slight change in focus of the f/8 150mm copy camera lens. In the left, the steel strap with 1/4-inch holes on 1-inch centers is in sharp focus. In the right, it is out of focus.

Figures 3-32 and 3-33 are reconstruction photographs of a hologram made during open flame test Run No. B-1117G. The reconstruction photographs show open flame (atmospheric) combustion of  $\text{N}_2\text{O}_4$  and 50/50

The hologram (Figure 3-32 and 3-33) was made with Agfa 10E75 film plate and developed for approximately 60 seconds in HRP developer. The hologram was reconstructed with the light from a Spectra Physics

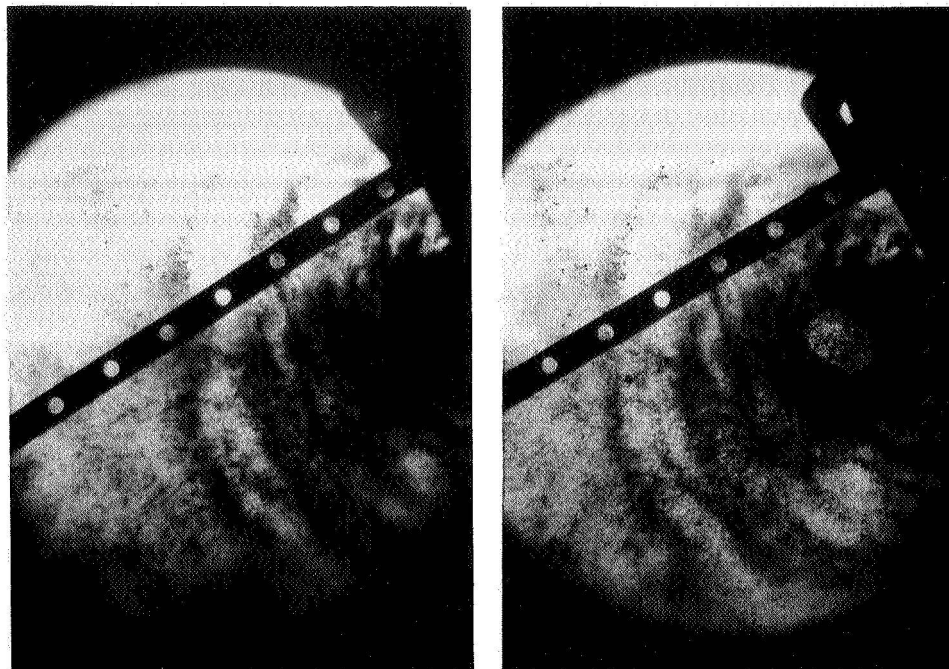
Figure 3-33. Two photographs of the reconstruction of a hologram of open flame combustion (Run B1117G). The pictures differ by the viewing angle of the copy camera. The pictures are mounted as a stereo pair, and can be so viewed with the aid of a viewer.

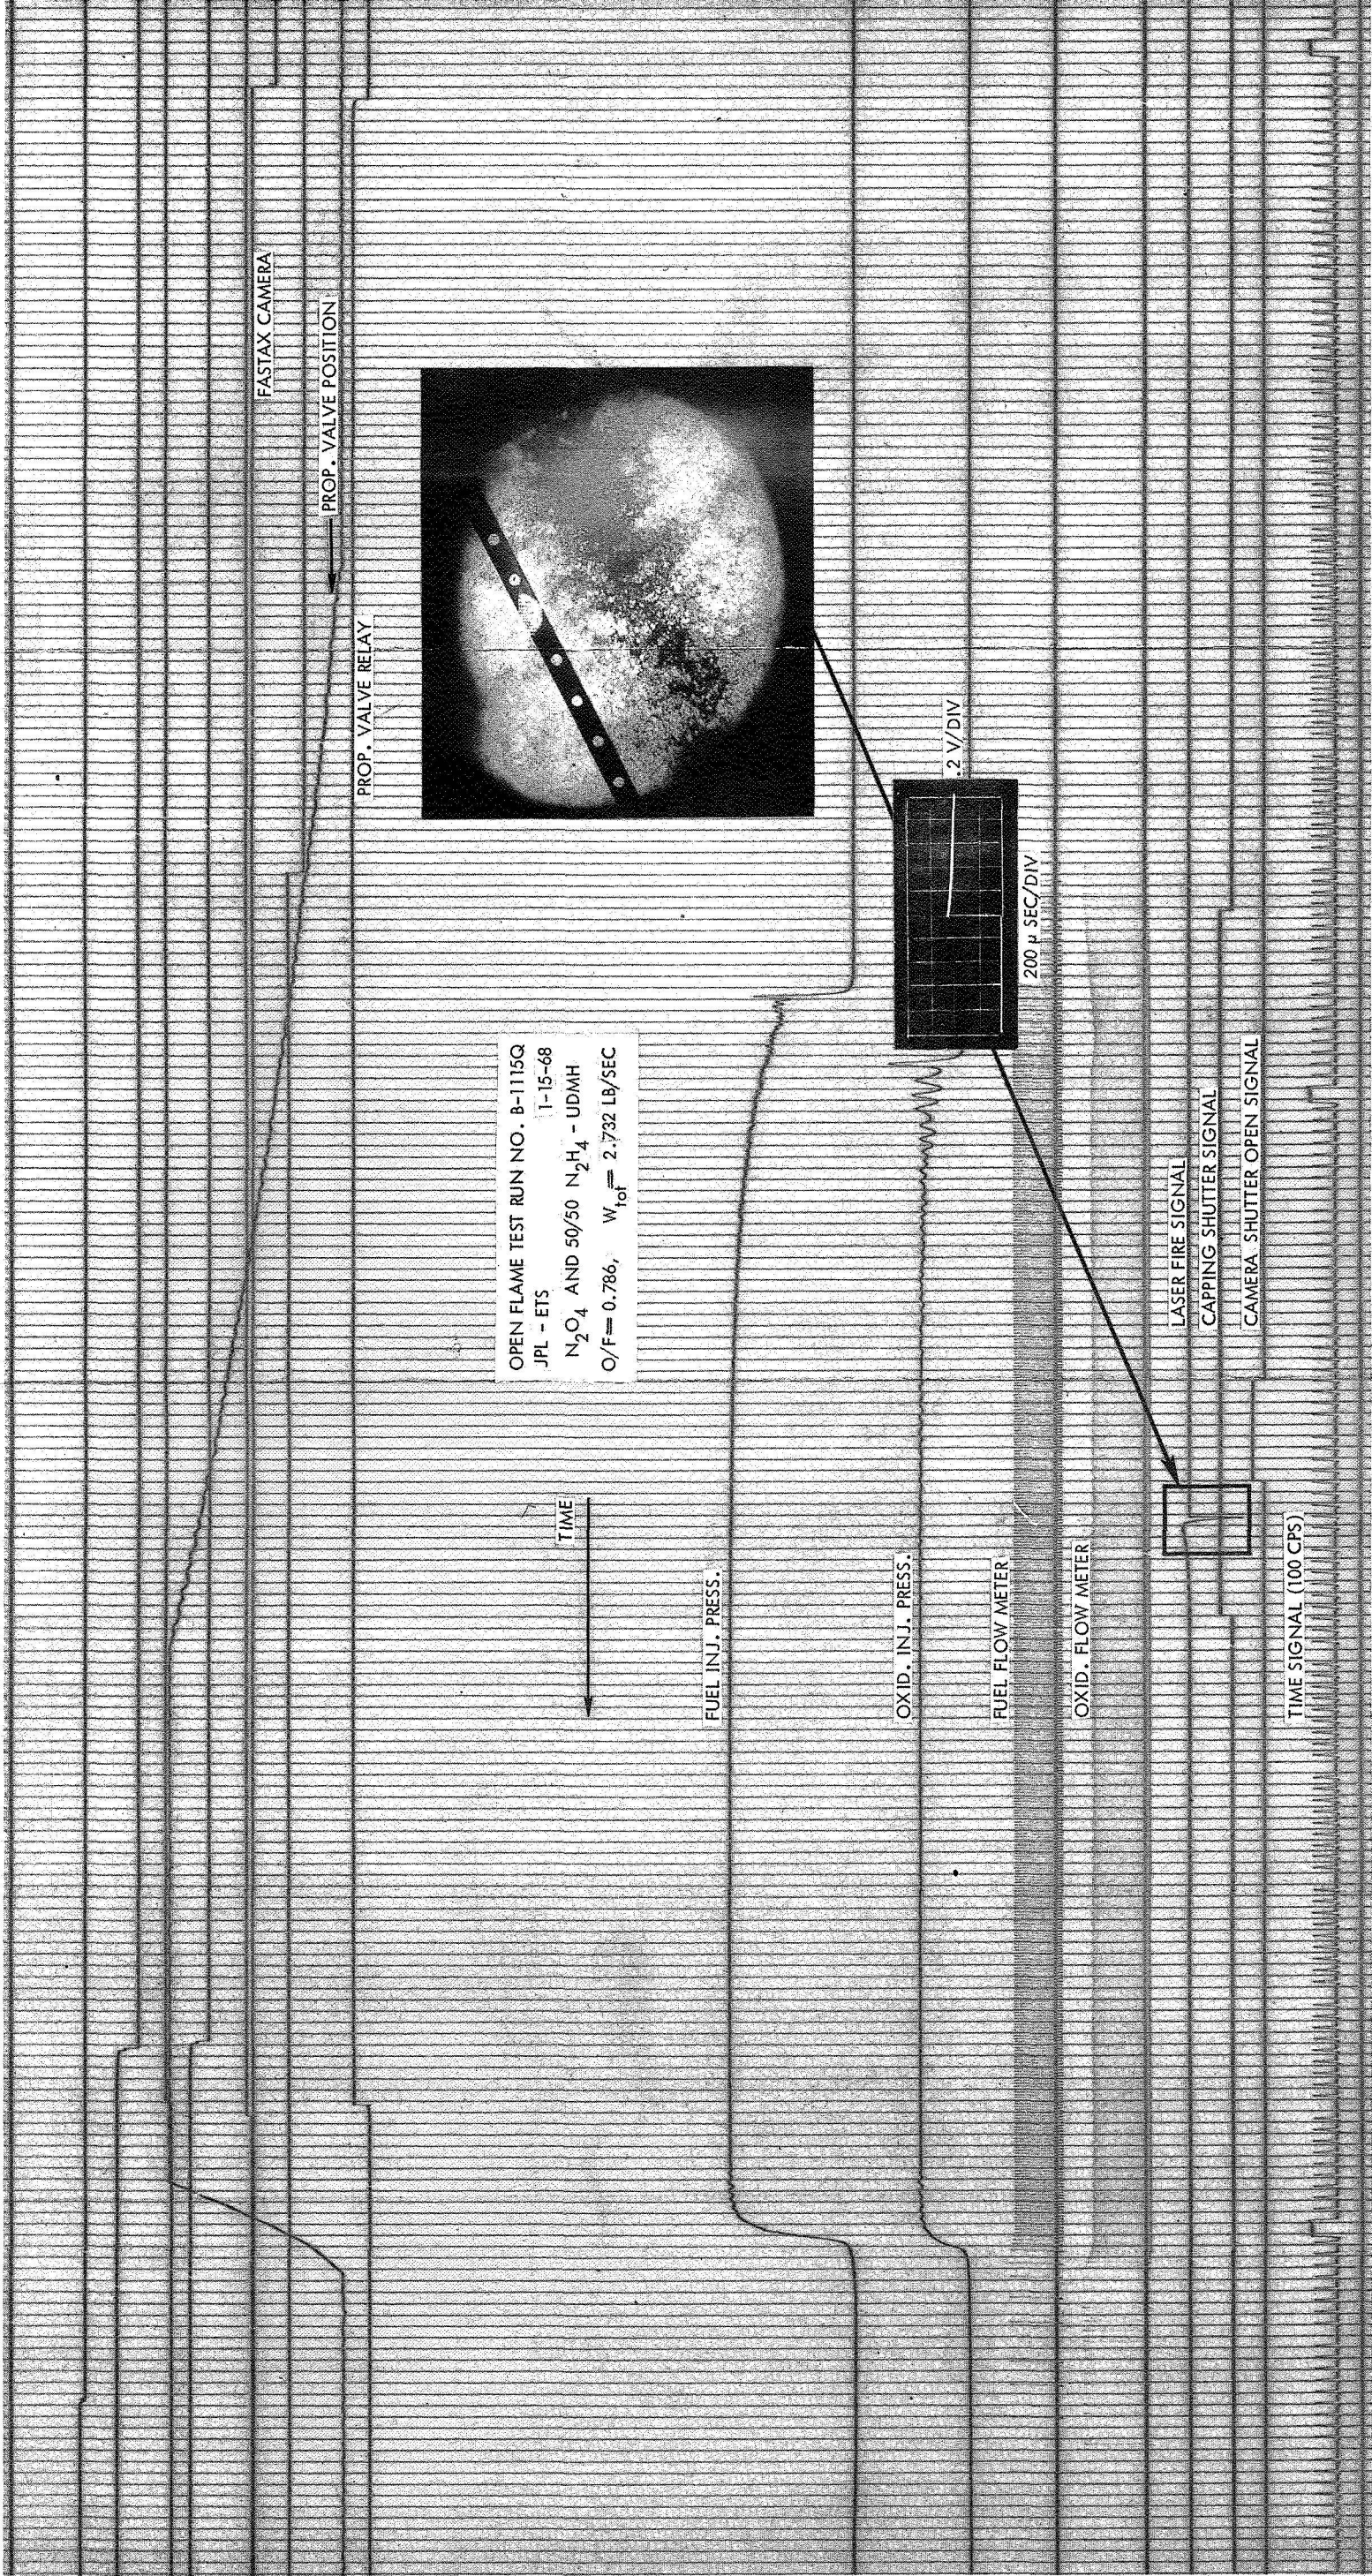
Figure 3-34. Photographic reproduction of the high speed recording oscillograph from open flame test Run No. B1115Q

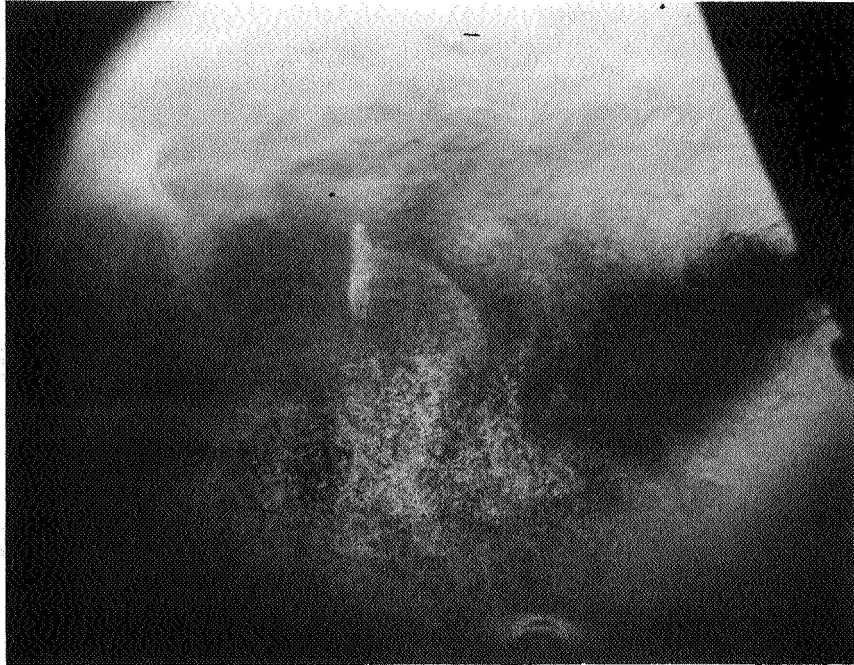
Figure 3-35. Reconstruction photograph of the edge view of the combustion spray fan recorded on  $\text{N}_2\text{O}_4$ -50/50  $\text{N}_2\text{H}_4$ -UDMH firing No. B1115I

The photograph on the right in Figure 3-35 was made by focusing a copy camera on droplets located in a plane adjacent to the acrylic window protecting the film plate housing on the right side of the holocamera scene volume. The central opaque portion of the initial part of the reacting spray fan appears as a blur located behind these droplets. Conversely, the photograph on the left was made by focusing the copy camera on the droplets at the extreme opposite side of the scene volume. In this photograph, the opaque part of the spray fan is again blurred and out of focus, since it is now in the foreground of the scene. Also in sharp focus in this photograph is the 1/2-inch grid which was scribed on the acrylic plate attached to the 15-inch-diameter field lenses.

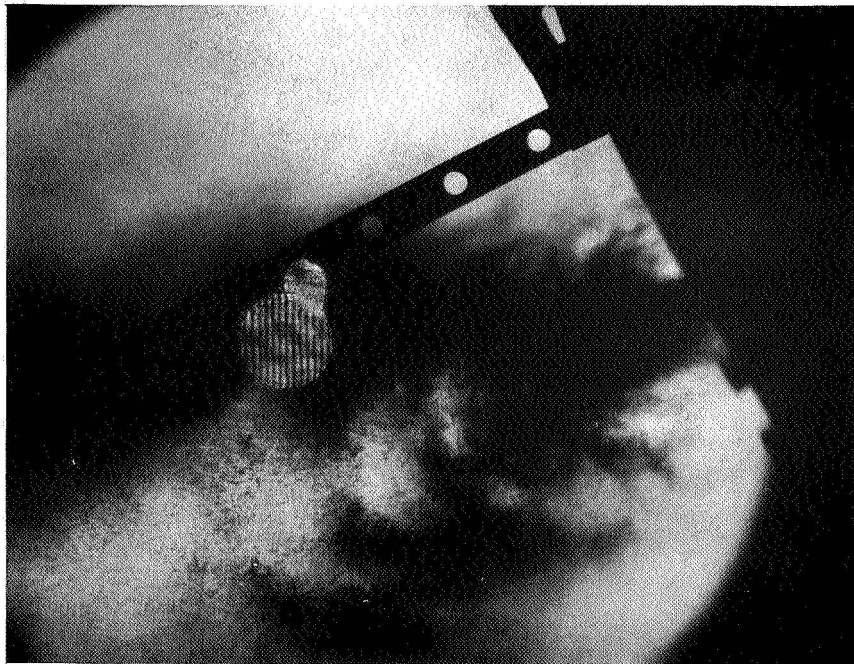
Figure 3-36. Reconstruction photograph of the edge view of the combustion spray fan recorded on  $\text{N}_2\text{O}_4$ -50/50  $\text{N}_2\text{H}_4$ -UDMH firing No. B1115R
