JPL CONTRACT  
NO. 952023  
(NAS 7-100)

TRW REPORT NO.  
68.4712.2-024  
31 JULY 1968

FINAL REPORT  
**PRODUCING HOLOGRAMS  
OF REACTING SPRAYS IN  
LIQUID PROPELLANT  
ROCKET ENGINES**

**TRW**  
SYSTEMS GROUP

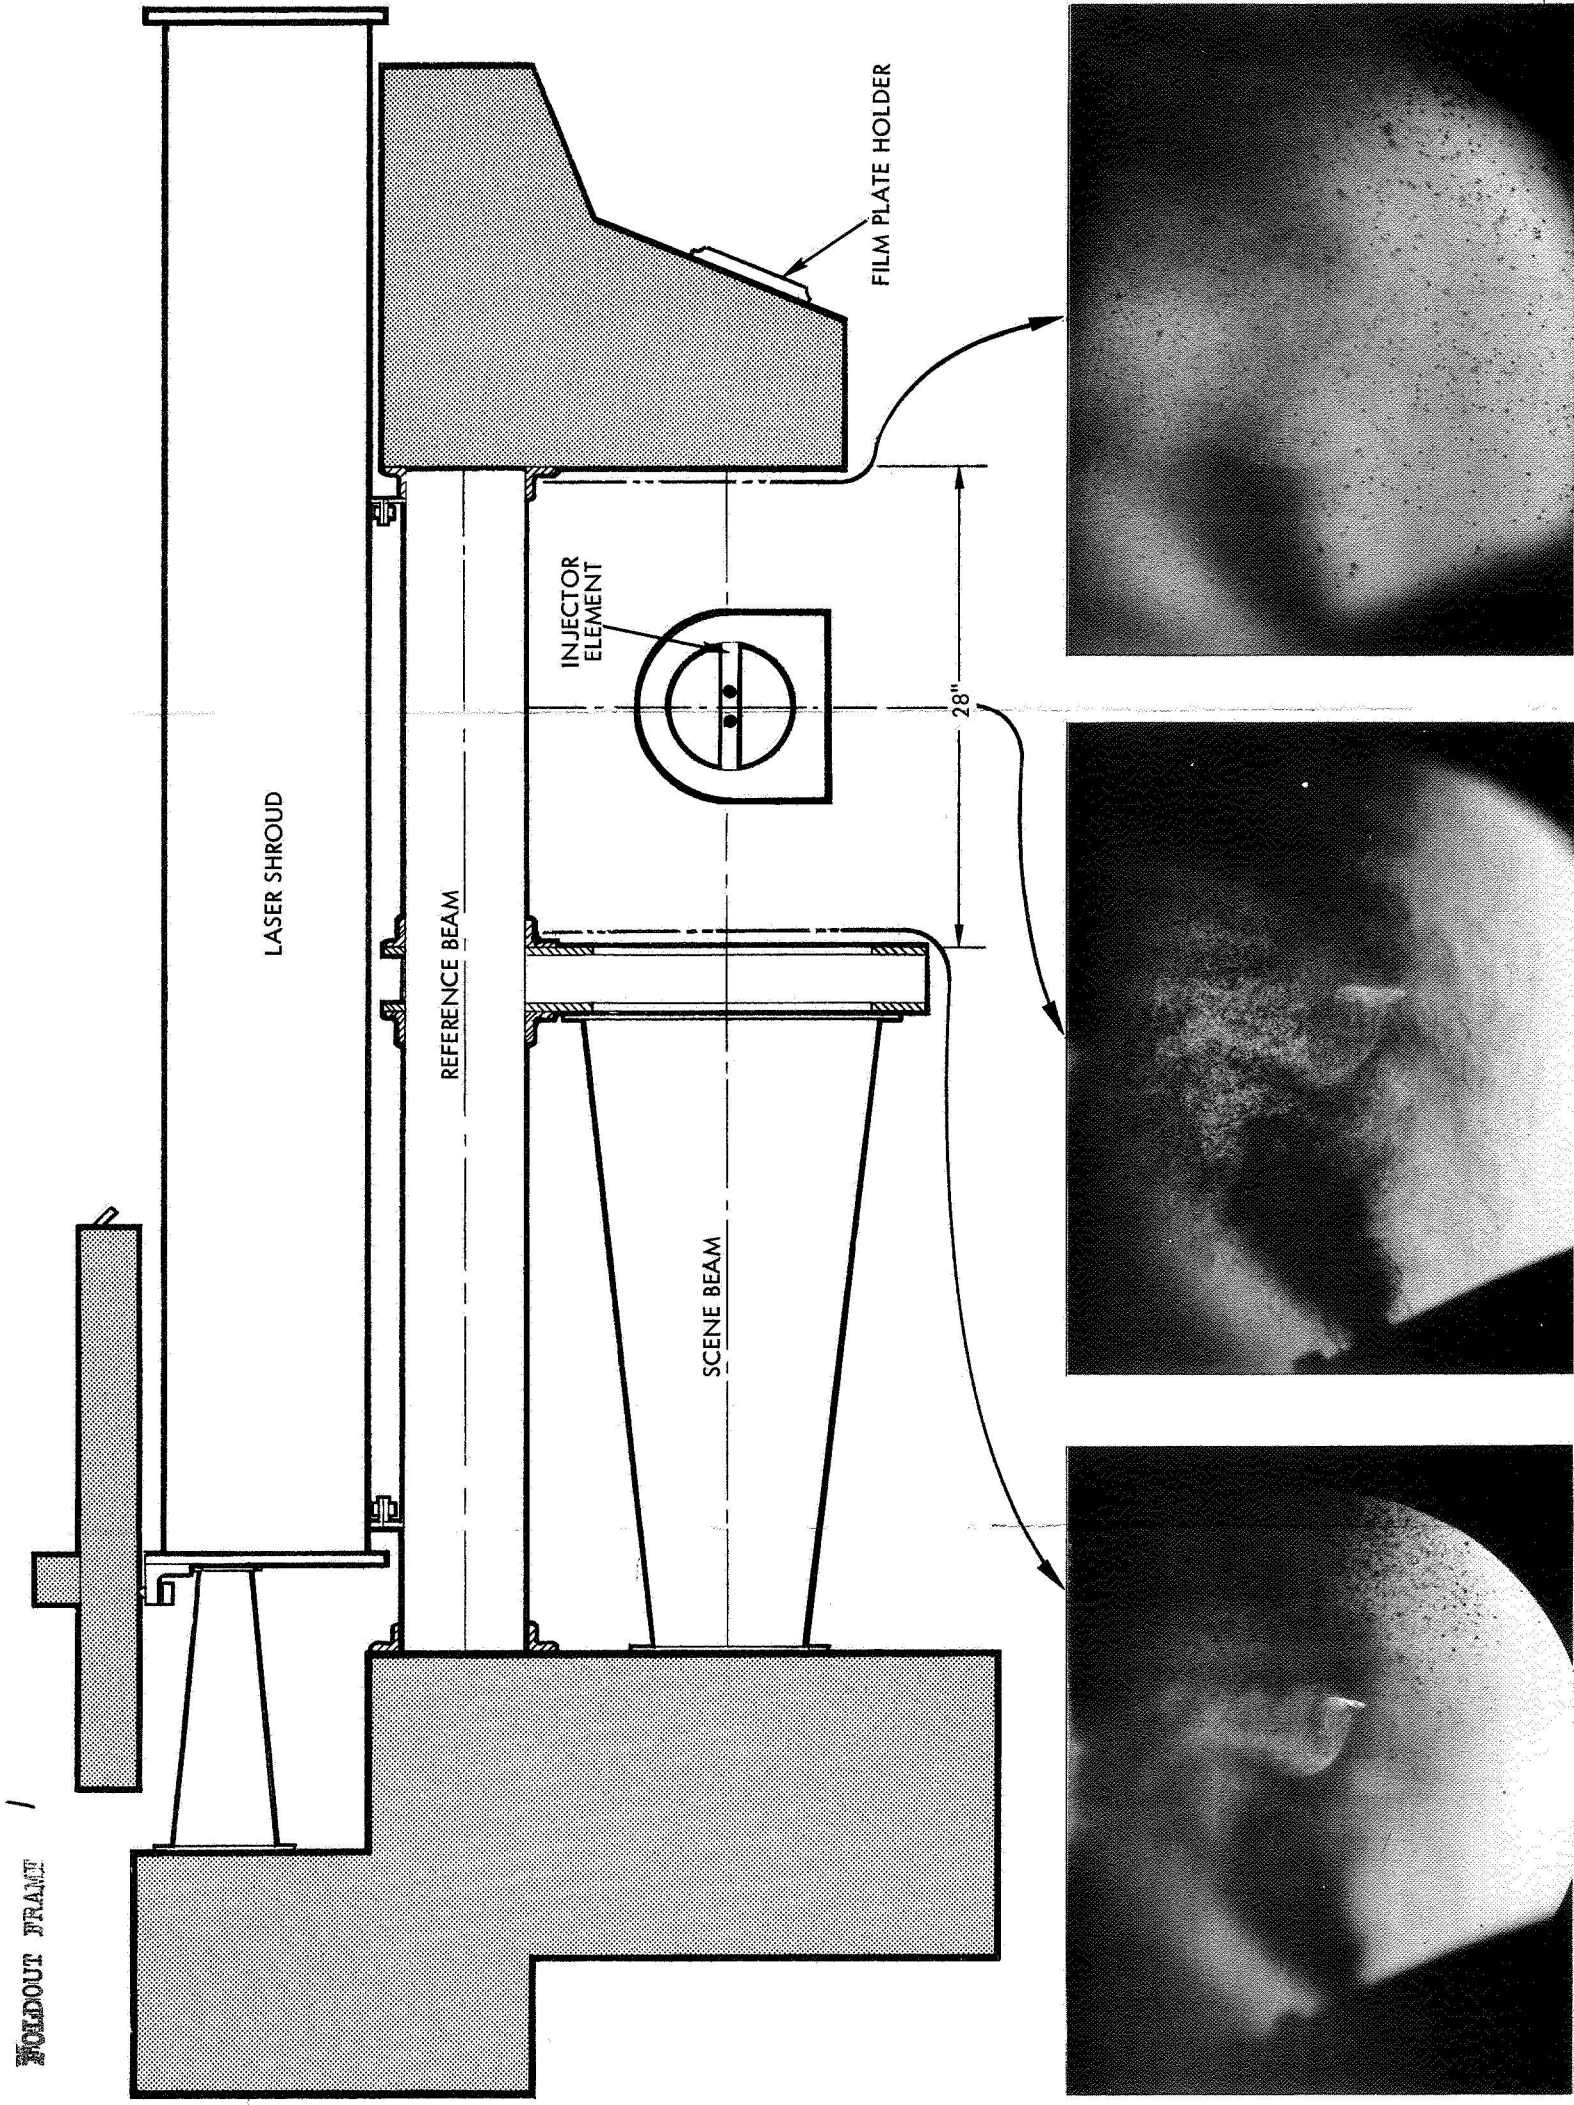
Figure 3-37. Reconstruction photographs made from open flame test B41151 illustrating three-dimensional characteristics of a hologram

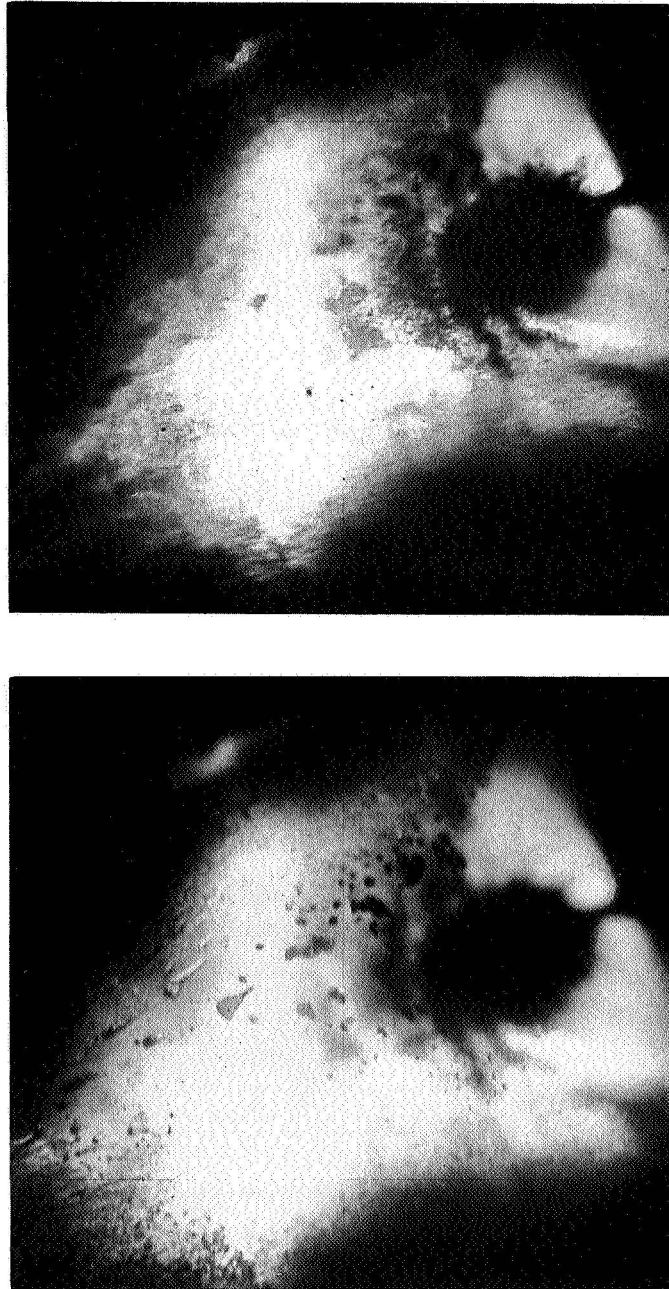
Figure 3-38. Two photographs of the reconstruction of a hologram of hypergolic propellant combustion in a 3-inch inside diameter combustion chamber with 0.099-inch injector orifices. The photographs correspond to different focal settings of the copy camera. The photographs are of Run B1149 using  $N_2O_4$  and 50/50  $N_2H_4$ -UDMH propellants

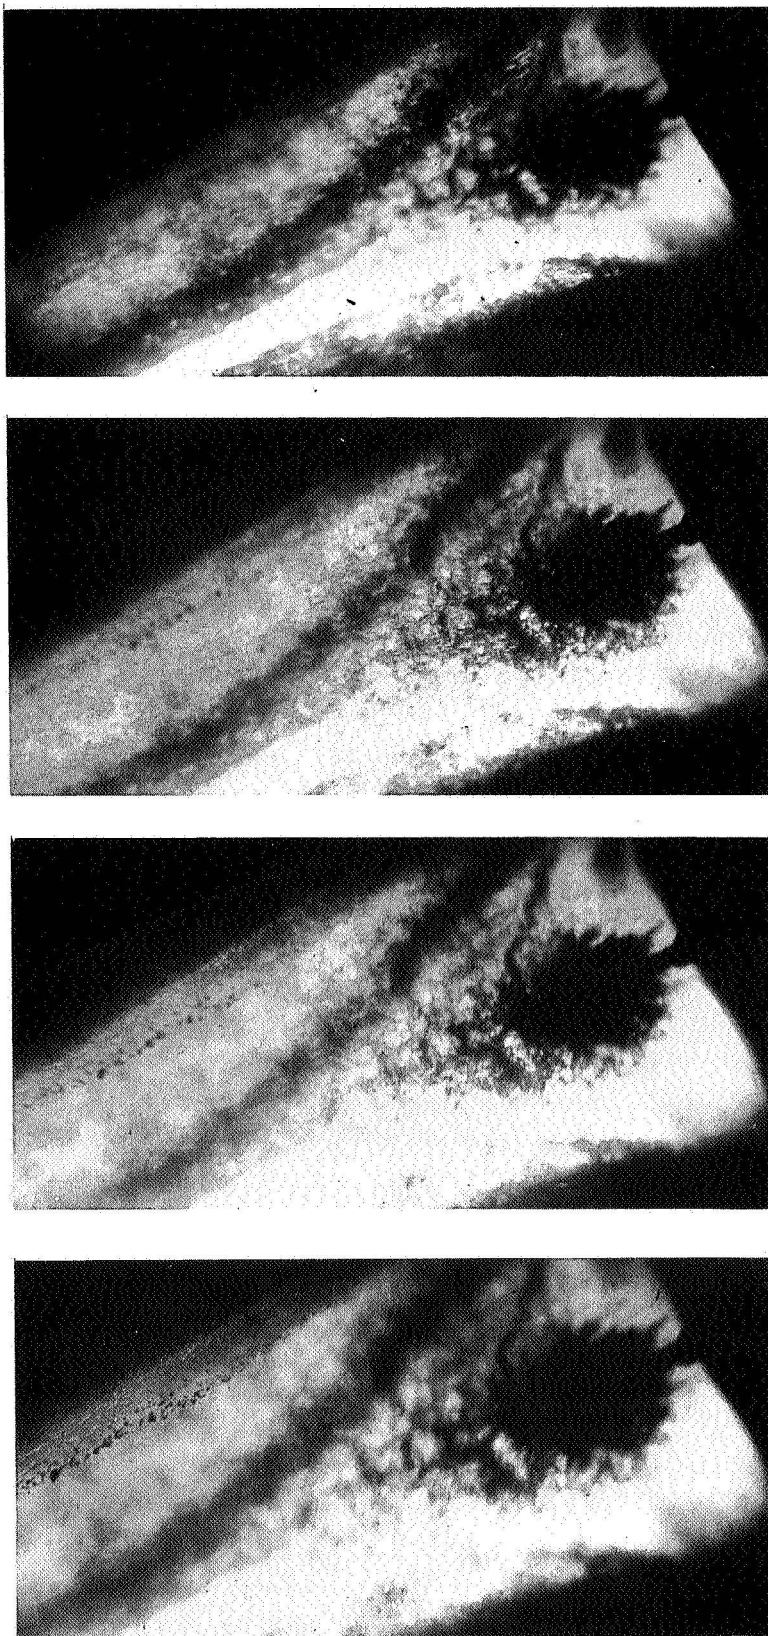
Figure 3-39. Four photographs of the reconstruction of a hologram of combustion within a rocket engine. The four photographs correspond to different focusing of the camera throughout the reconstruction volume. For the left picture, the camera is focused on the near inner wall. For the right picture, the camera was focused on the far inner wall. The other photos were at intermediate locations in the region of the fan. The hologram was No. B1162 and was the best of the Phase II series. The propellant was FNA and UDMH.

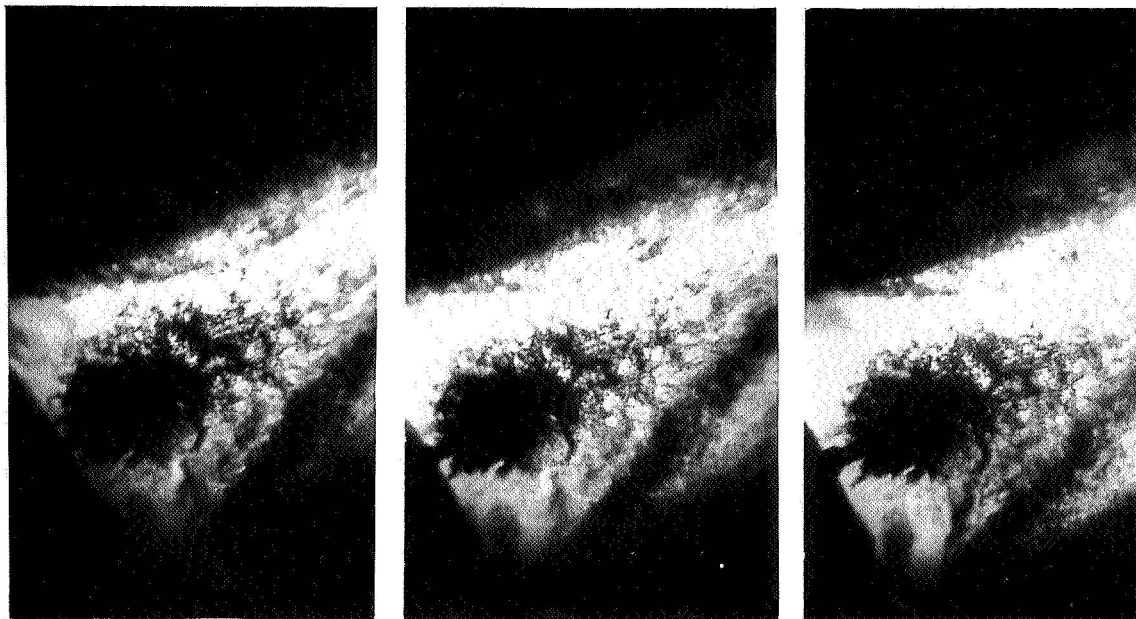
Figure 3-40. Three photographs of the B1162 hologram taken at different viewing angles. Adjacent photographs can be viewed stereoptically.

As indicated previously, run B1162 was made with FNA-UDMH propellants. Chamber pressure ( $P_c$ ) in the 3-inch I.D. chamber was 106 psia and the overall mixture ratio was 1.40. Propellant inlet temperatures were in excess of 100°F.

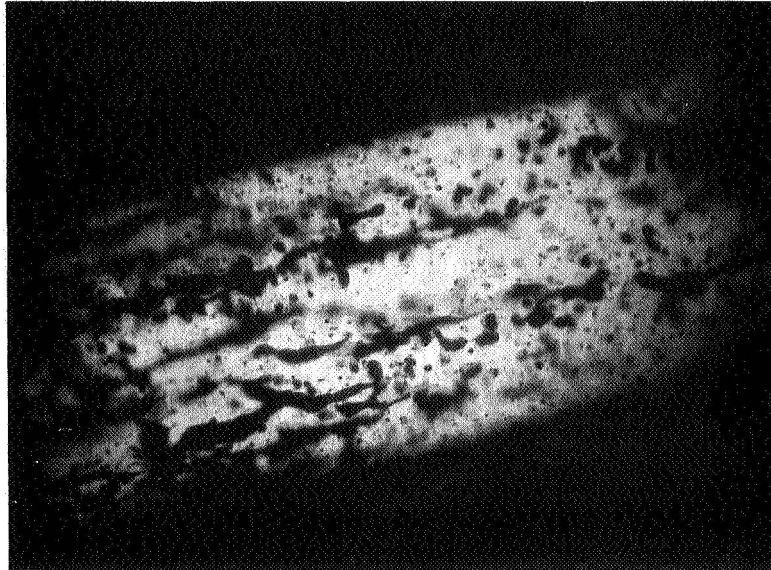
Figure 3-41. Photograph of the reconstruction of a ruby laser hologram made during the Phase III effort. The hologram corresponded to Run B1178, and is a recording of the engine shutdown with the air-nitrogen purge in operation.

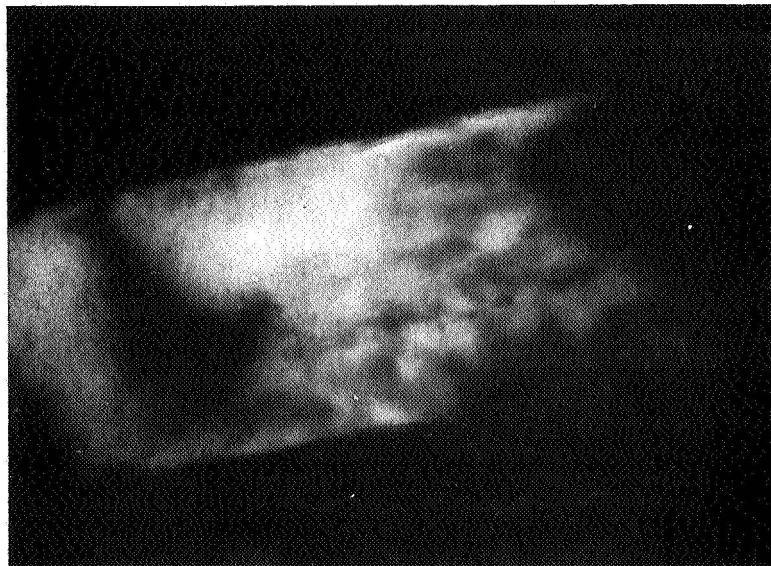
Figure 3-42. Photograph of the reconstruction of a hologram of the 18-inch engine combusting N<sub>2</sub>O<sub>4</sub> and 50/50 mixture. The photograph corresponded to Run B1184.

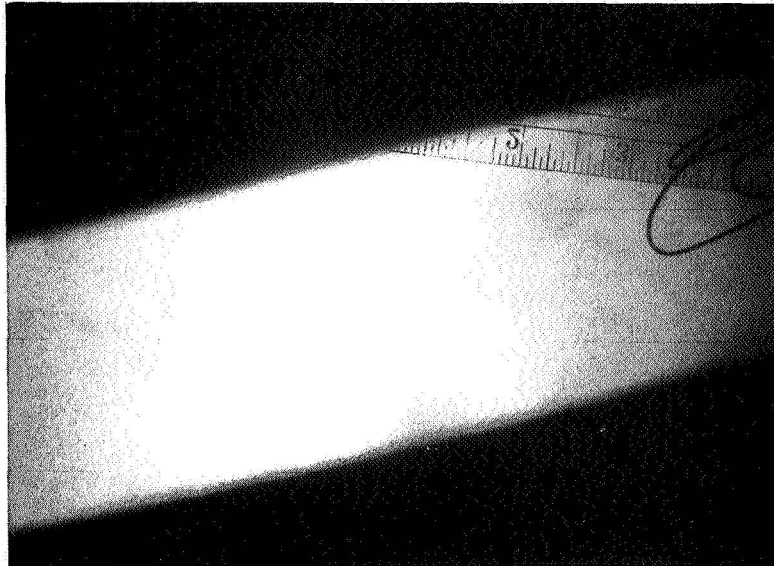
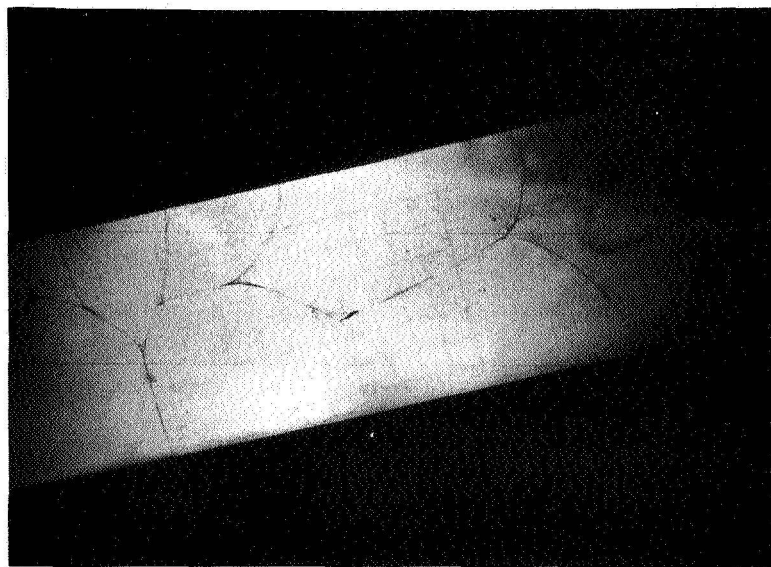
Figure 3-43. Photographs of the reconstruction of a test hologram made between firings of the engine. A transparent scale was mounted on the midplane of the holocamera. In the upper photograph, the copy camera was focused on the ruler; in the lower, on the cracked surface of the rear window. The size of the previous figures can be estimated from these two photos.

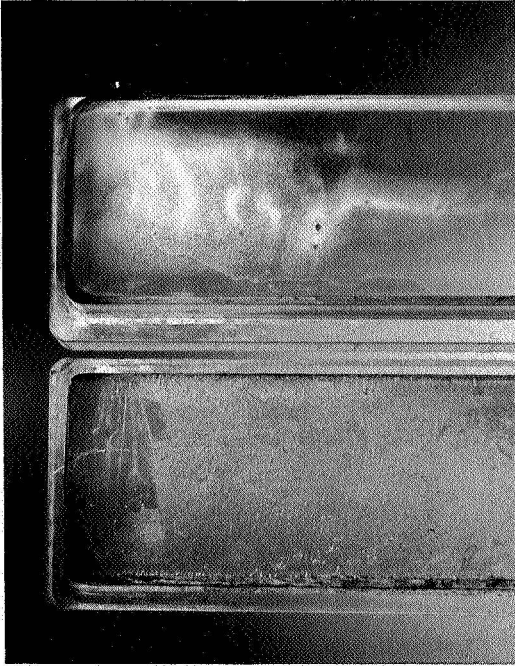
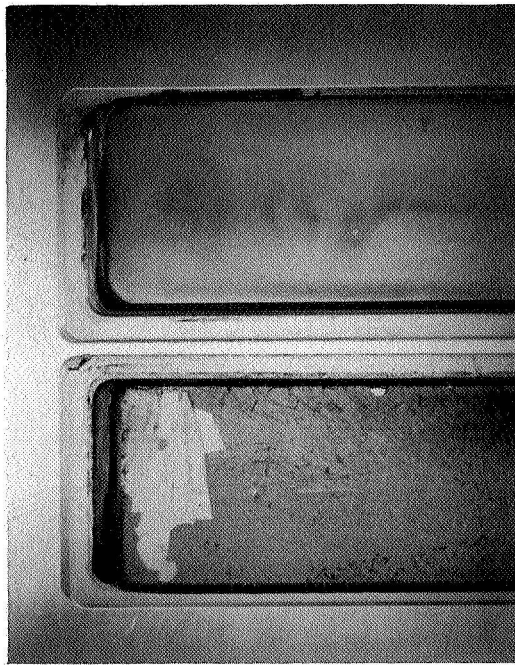
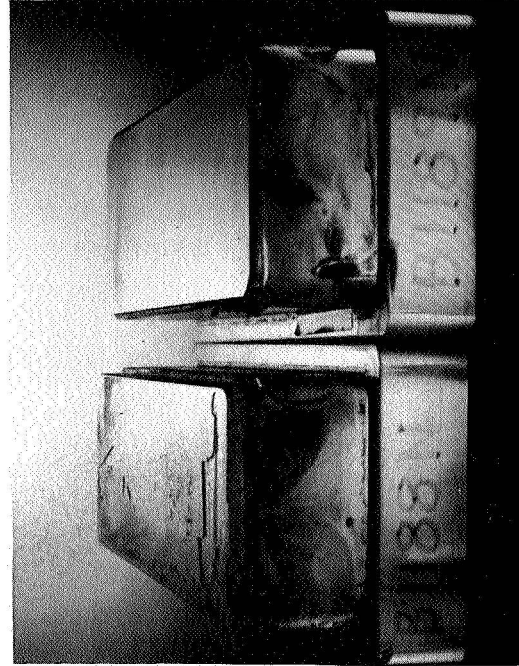
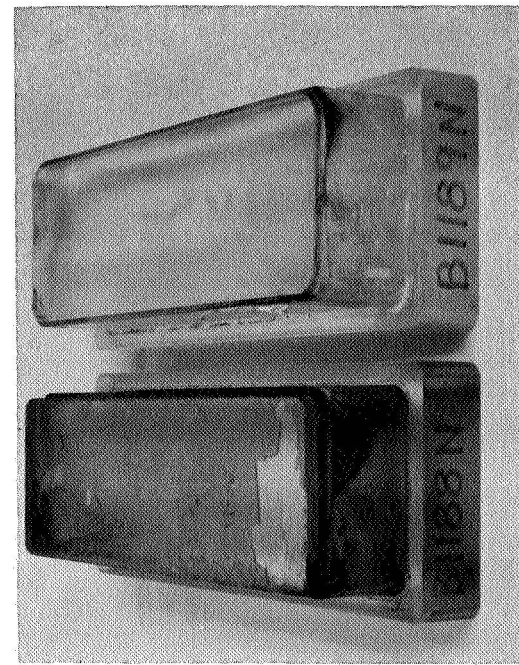
Figure 3-44. Four photographs of the Pyrex and Vycor capped acrylic window after use. The surface of the glass was blistered but did not fail in the bond. The Vycor surface survived, but the bond blistered.

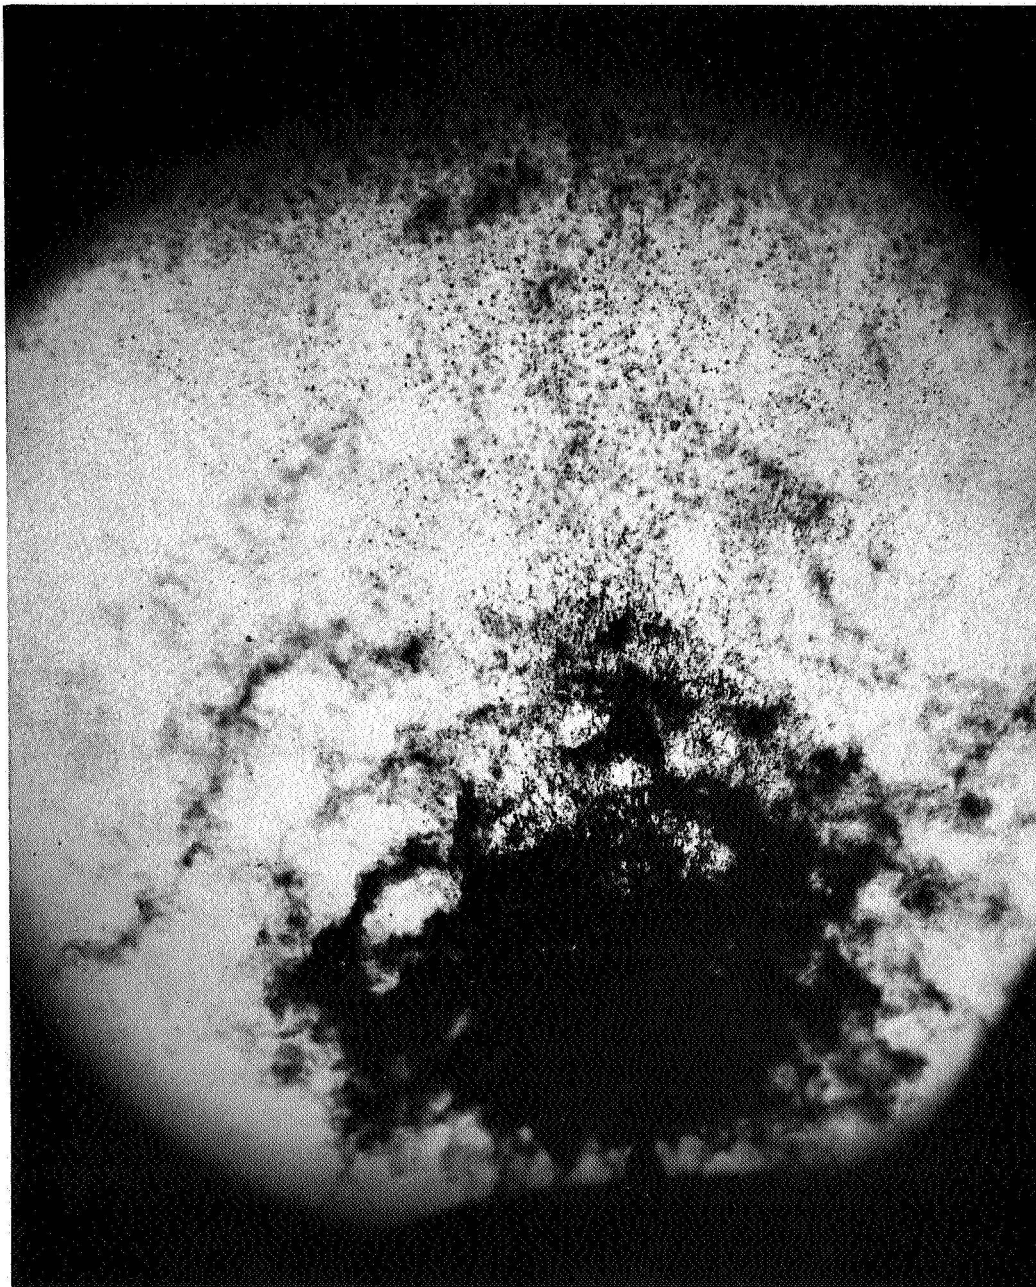
Figure 3-45. Direct laser photograph of open flame combustion using FNA and UDMH (Run B1172). The camera used a Schneider Kreuznach Xenar  $f/1.4$ , 150 mm lens.
