UNITED STATES  
DEPARTMENT OF THE INTERIOR  
GEOLOGICAL SURVEY

INTERAGENCY REPORT NASA-123

AERIAL INFRARED SURVEYS AT THE GEYSERS  
GEOTHERMAL STEAM FIELD, CALIFORNIA\*

R. M. Moxham\*\*

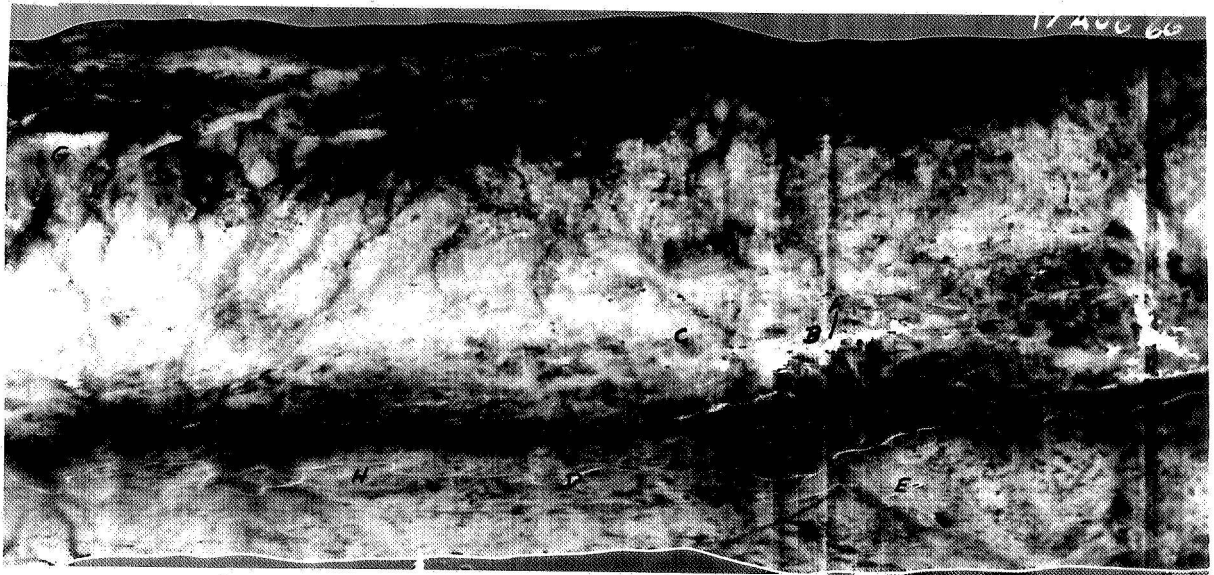
FIG 12C

Figure 12C. A=temperature monitoring station no. 1; B=station no. 2;  
C=station no. 3; D=Geyser Road; E=Healdsburg-Geyser Road;  
F=Big Sulphur Creek; G=jeep trail; H=Eagle Rock.

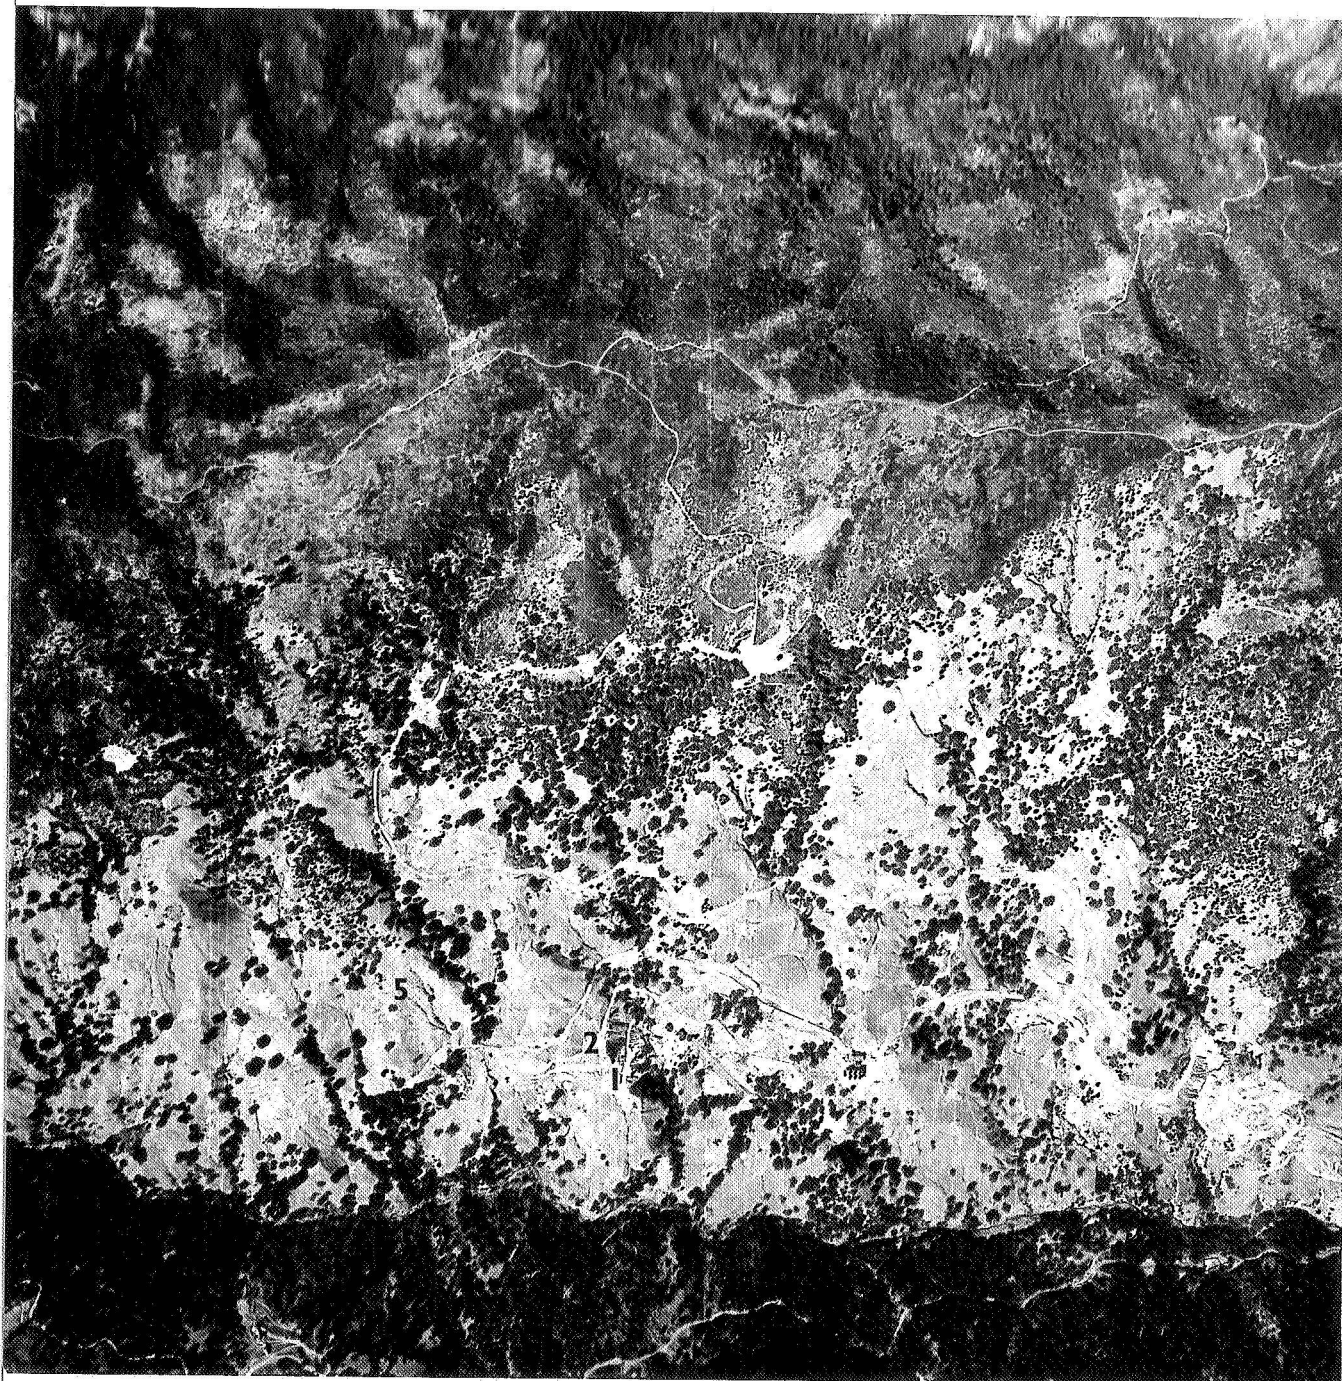
FIG. 13

Figure 13. 1966 aerial photo of the Sulphur Banks. Power plant no. 2 is in the lower center. Temperature monitoring stations are indicated by the numbers 1, 2, and 5.

The increase in temperature difference between anomaly and background from afternoon to pre-dawn is borne out by ground temperature measurements at the Sulphur Banks (fig. 13 and 14). Three thermistors were emplaced at random in a warm alteration zone at station 1. Another three-thermistor array was established at station 2 on a flat bare soil surface about 500 feet NW of the anomaly at station 1. The results (fig. 14) show that during the day the background is at about the same temperature as the anomaly, whereas in the pre-dawn hours the average temperature at the anomaly is about 10° greater than the background.

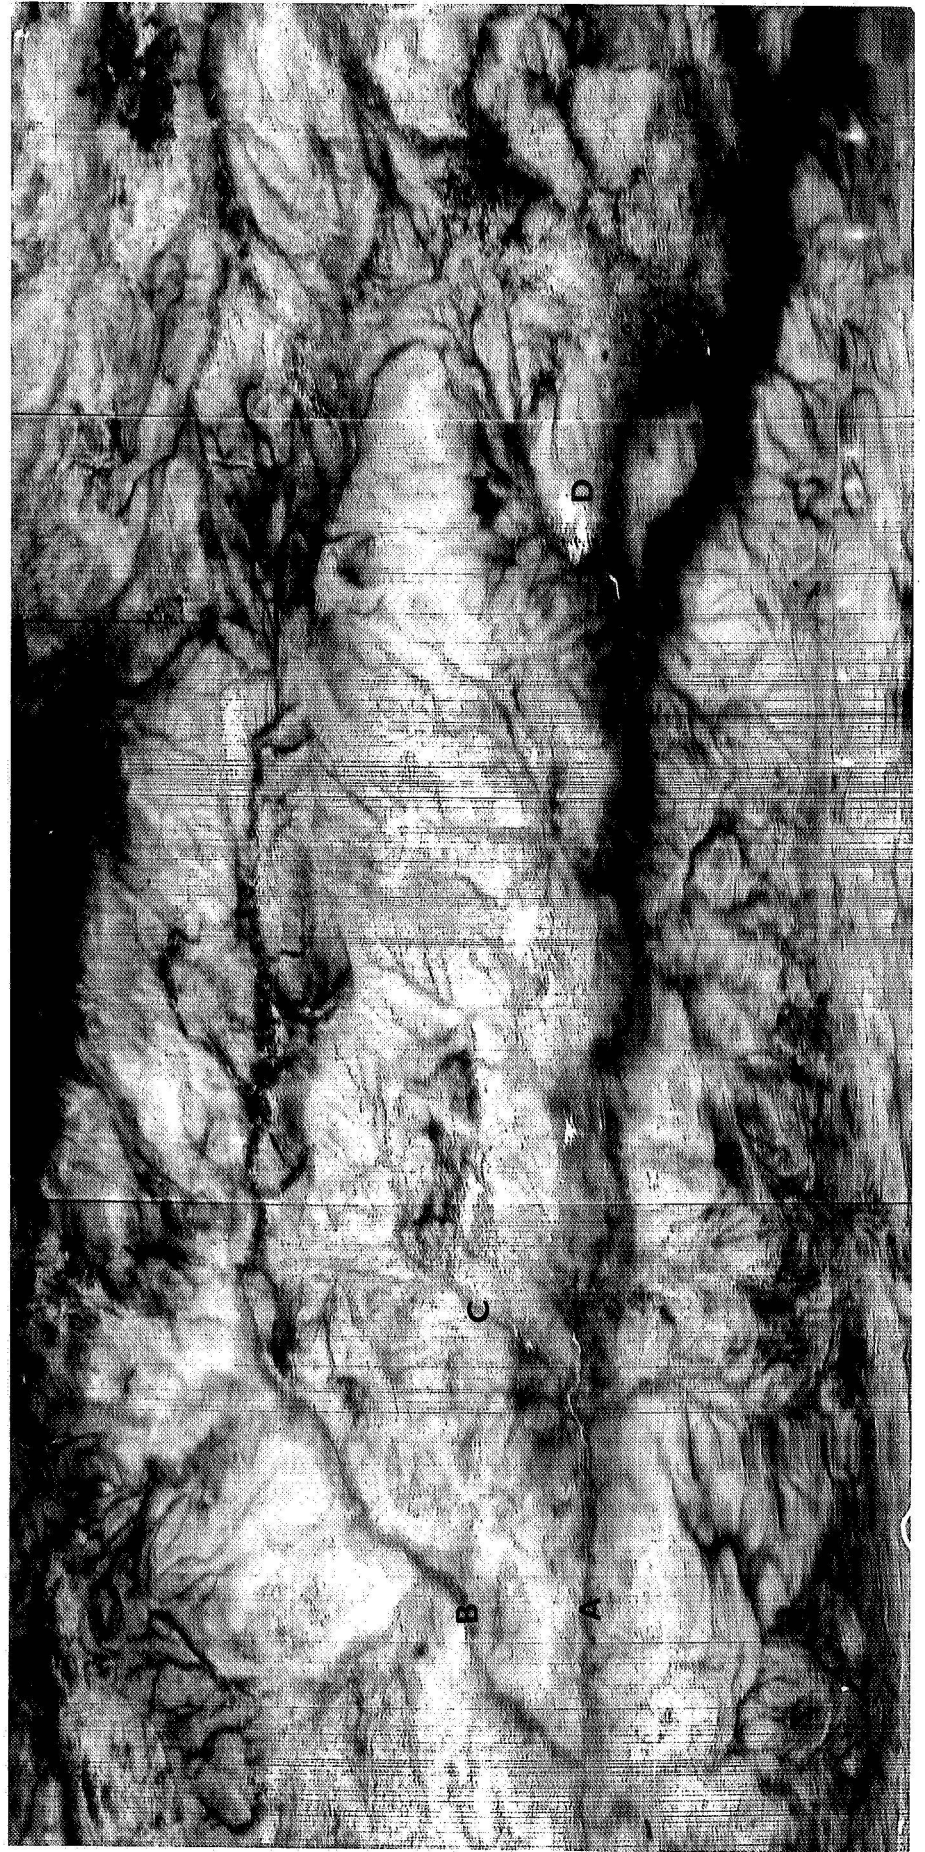
Fig. 16

Figure 16. Infrared image of the Little Geysers area (04:00, 8/17, no filter). A=Big Sulphur Creek, B=Cobb Creek; C=Hot Springs Creek; D=Little Geysers. Figure 16 is an enlargement of the SE part of figure 15.

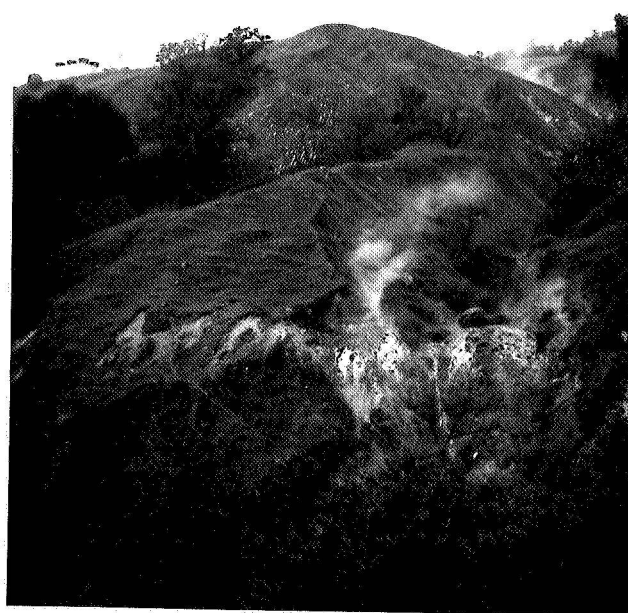
FIG. 17

Figure 17. Steaming fracture along Big Sulphur Creek. Power plant no. 2 is in the background on the upper left.

The two most intense anomalies lie between powerhouse 1 and Geyser Canyon. They are in the area's largest alteration zone and it is here that steam development first began. Natural steam vents at 90°C are common, and on the westernmost of the two anomalies steam from the cracked drilling pad of a wild-blowing well adds to the thermal signal. The southwest limit of the anomalous zone is a thermal lineament which extends along the north bank of Big Sulphur Creek from the powerhouse nearby to the mouth of Geyser Canyon. A similar WNW linear thermal zone lies along the creek from near the mouth of Geyser Canyon downstream along Big Sulphur Creek for several hundred yards. This zone likewise forms the southern limit of a zone of hot spots in the valley next west of Geyser Canyon. The image suggests and field examination tends to confirm that the linear thermal zone contains two steaming fracture zones, one about at creek level, the other 20 feet or so above the creek (fig. 17).

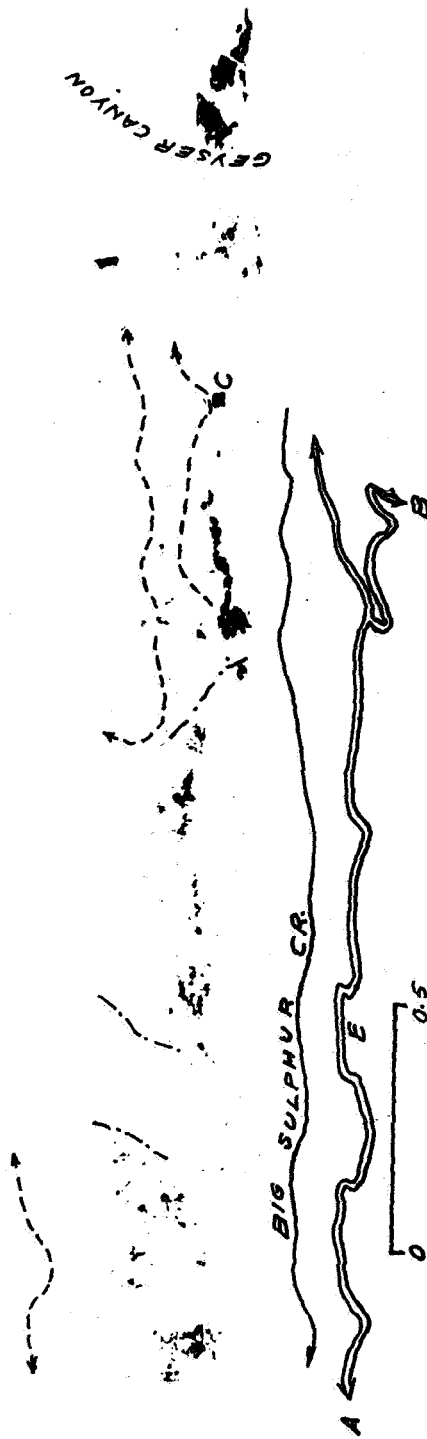
FIG. 19

Figure 19. Enlargement of part of figure 18B with landmarks superimposed. Dashed lines are jeep trails. A=Geyser Road; B=Healdsburg-Geyser Road; C=power plant no. 2; E=Eagle Rock. Segments of stream valleys have been shown where they can be identified.

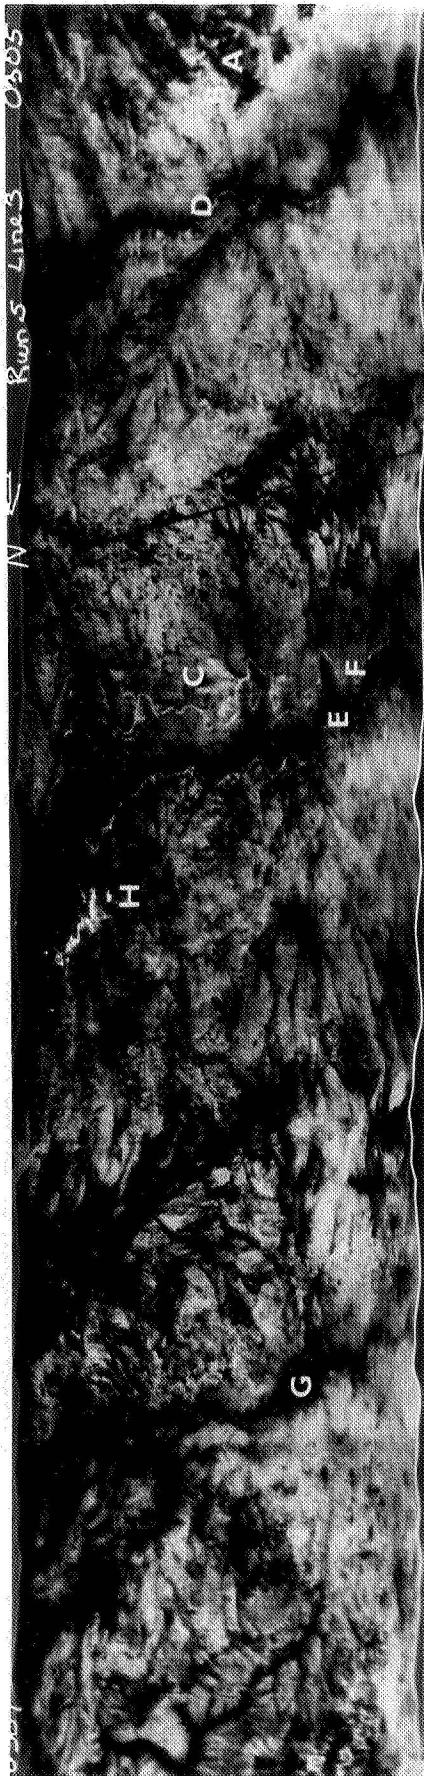
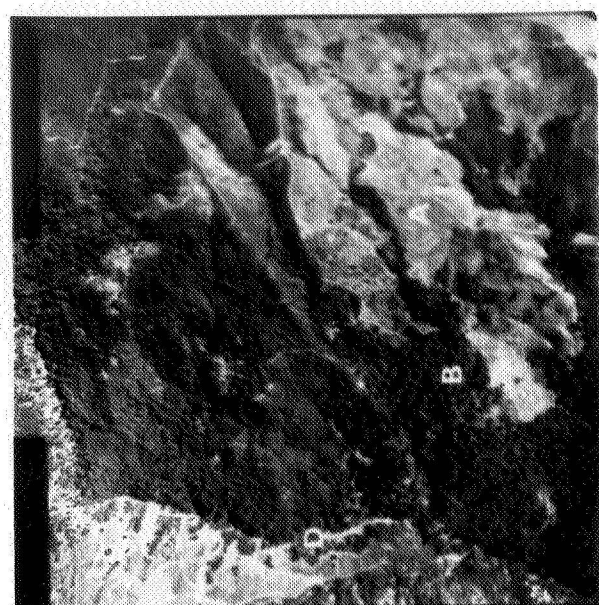
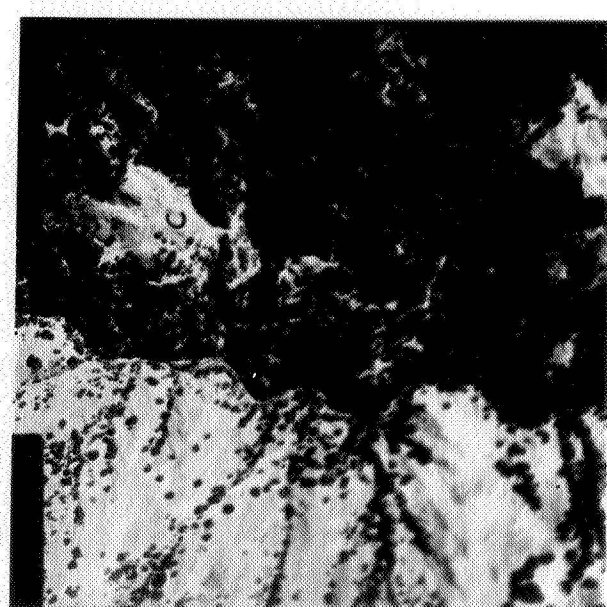
FIG 25

Figure 25. Aerial photos (bottom) and IR image (top) across the regional structure. Some apparent contradictions are illustrated. Barren area (A) and adjacent heavily forested area (B) west of the north branch of Little Sulphur Creek appear to have radiances reversed from similar barren area (C) and adjacent heavily forested area on the west slope of Big Sulphur Creek. E=Big Sulphur Creek; F=Geyser Road; G=Squaw Creek at the mouth of Cold Water Canyon; H=the Sulphur Banks. Arrows indicate position of arcuate radiance feature.
