# A BRAZING PROCESS FOR Cb-1Zr HEAT RECEIVER TUBES

by C. E. Smeltzer and W. A. Compton

Prepared under Contract No. NAS3-10603 by  
SOLAR DIVISION, INTERNATIONAL HARVESTER COMPANY  
San Diego, Calif.

A two-phase program was conducted to develop a suitable braze process for attaching internal fins of Cb-1Zr foil to Cb-1Zr heat receiver tubes. Phase I was concerned with the selection, development, and evaluation of candidate braze systems, as well as with the determination of fabrication feasibility and brazing studies upon subscale heat receiver tube modules. Phase II involved actual fabrication and vacuum brazing of two full scale heat receiver tubes employing the optimum braze alloy, Zr-28V-16Ti-0.1Be.

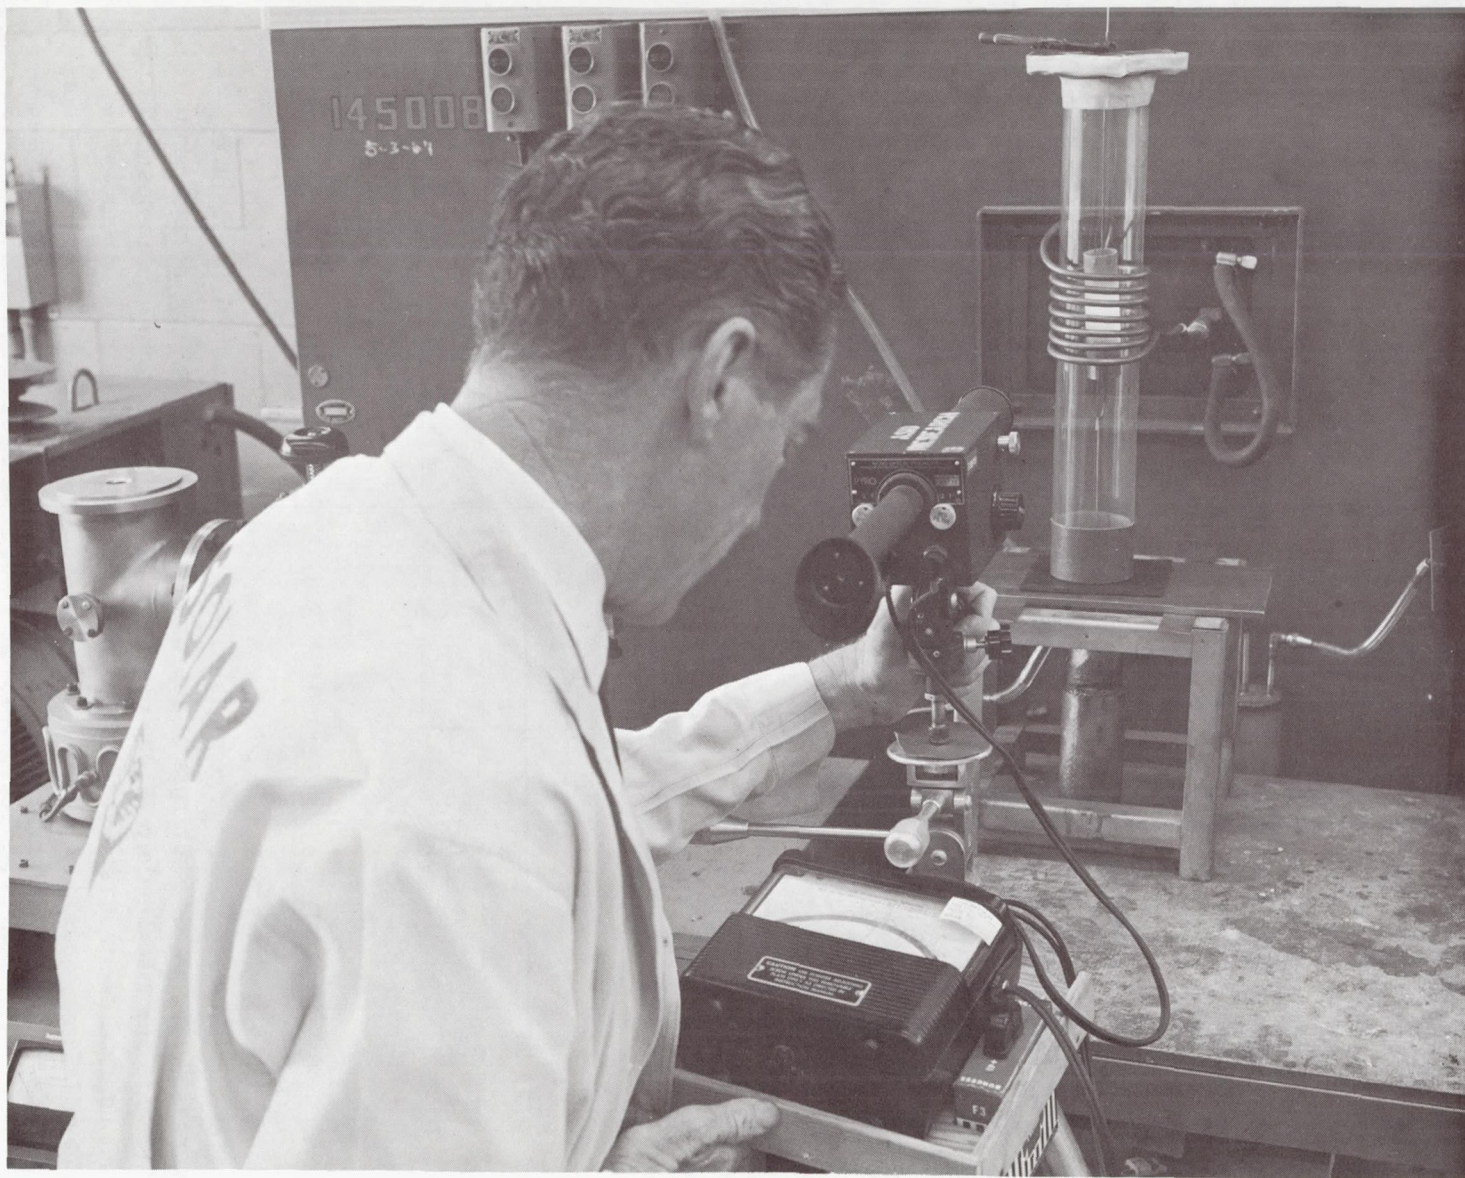
FIGURE 6. APPARATUS FOR BRAZE SEPARATION (REMELT) TEST AND 1750°F TENSILE TESTS OF SHEAR SPECIMENS

Tensile-shear tests were conducted at room temperature with a Riehle Universal Tester, at a strain rate of approximately 0.005 inch/inch/minute (or a loading rate of approximately 75,000 psi/min). The shear specimen was designed so that nominal shear stress at the joint and nominal uniaxial tensile stress in the parent metal are equal at all applied loads. Tensile-shear tests at 1750°F were conducted in a Vycor vertical-tube furnace, by dead-weight loading specimens heated inductively in an argon atmosphere (Fig. 6). Lead shot was used to load the specimens progressively - approximately 5000 psi/minute. Specimens were held five minutes at the test temperature before loading to permit temperature equalization.

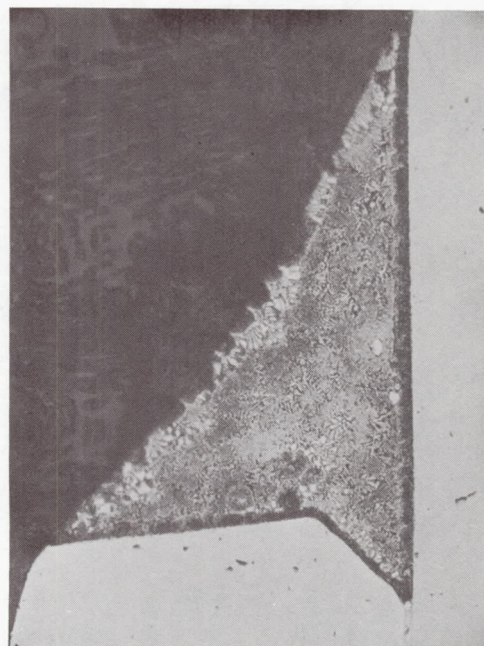
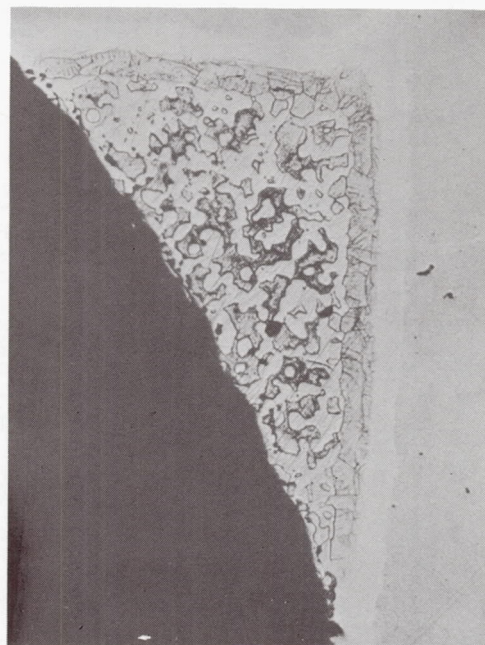
FIGURE 22. LAP-JOINT BRAZEMENTS OF Zr-28V-16Ti BRAZE ALLOY
