NASA TM X-1803

**PERFORMANCE AND STALL LIMITS
OF A YTF30-P-1 TURBOFAN ENGINE
WITH UNIFORM INLET FLOW**

by Willis M. Braithwaite and William R. Vollmar

*Lewis Research Center
Cleveland, Ohio*

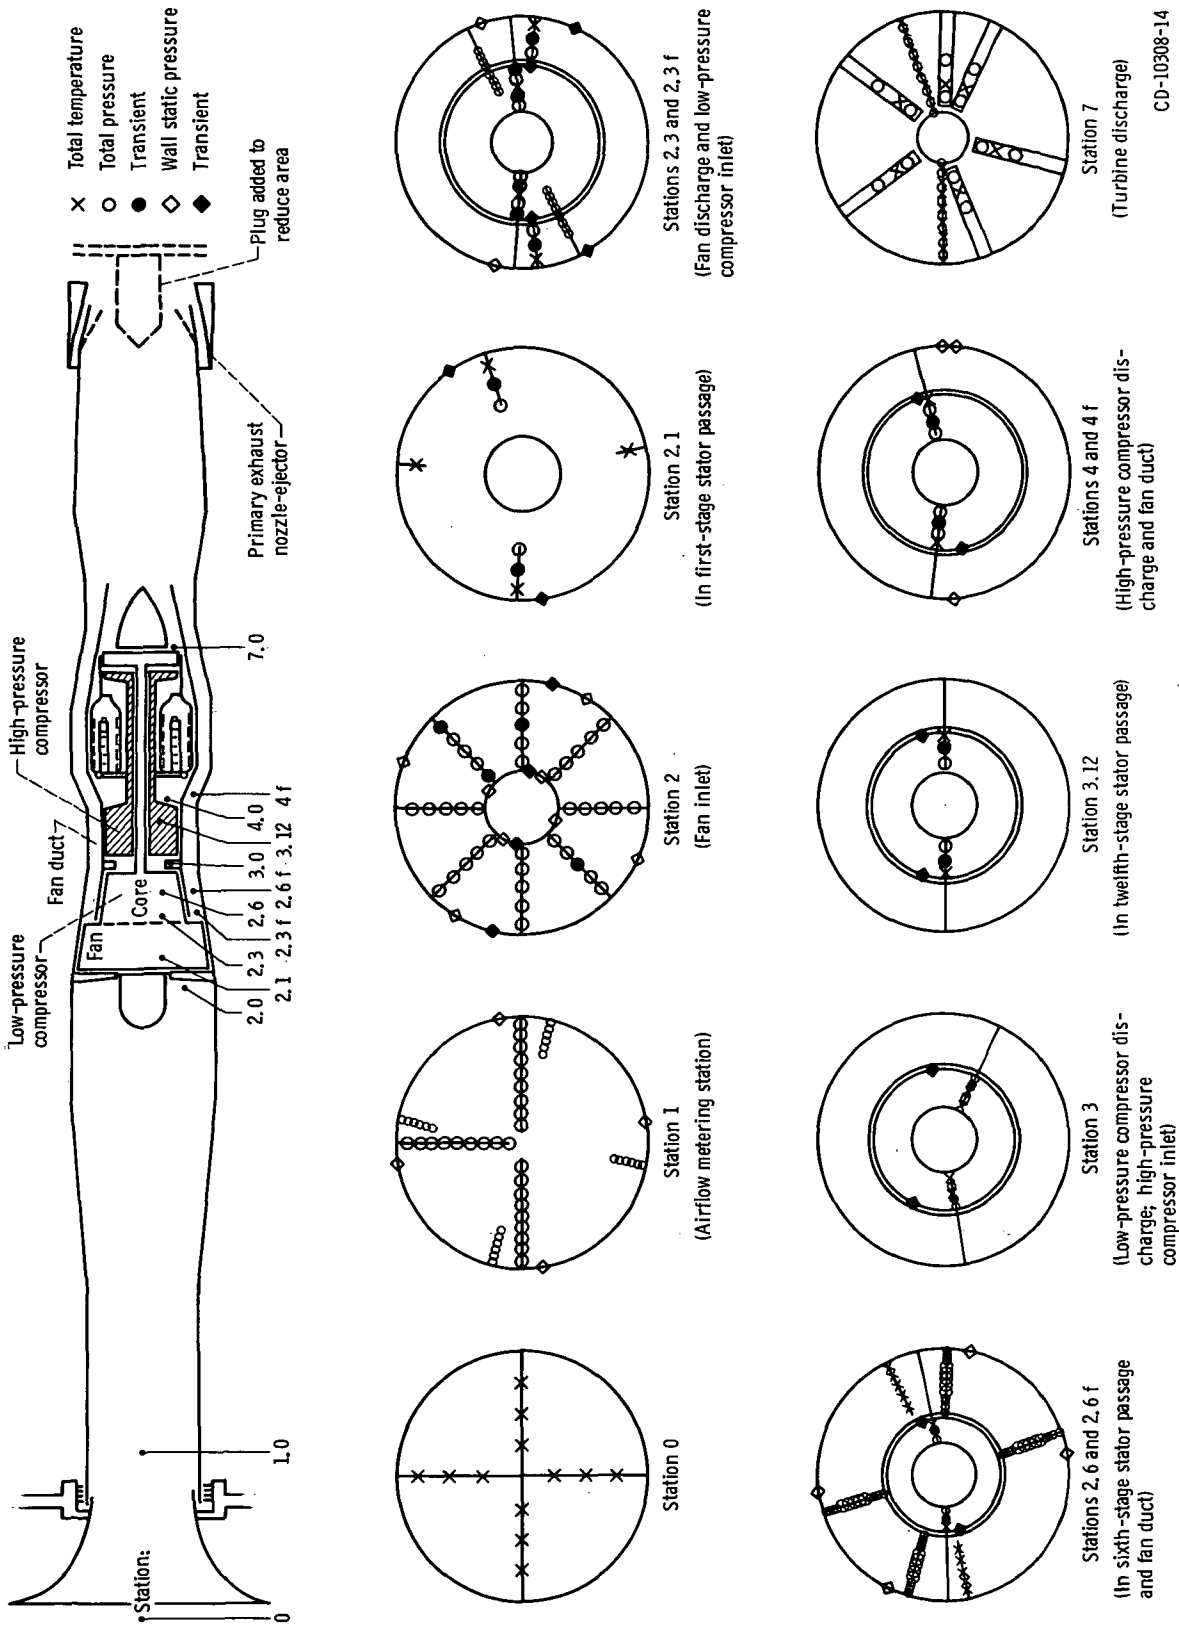
Figure 2. - Instrumentation layout for YTF30-P-1 turbofan engine.

schematically in figure 2, consists of a three-stage axial-flow fan mounted on the same shaft with a six-stage, axial-flow, low-pressure compressor. This unit is driven by a three-stage, low-pressure turbine. A seven-stage, axial-flow compressor driven by a single-stage, air-cooled turbine make up the high-speed spool. The nominal overall pressure ratio of the compressor system is 17:1 with a fan bypass ratio of 1. The fan duct airflow is diverted from the core flow by a splitter ring at the exit of the third-stage stators. It then passes through an annular passage surrounding the core engine and is combined with the turbine discharge gases at the afterburner inlet. The total flow is then discharged through a variable-area exhaust nozzle. An ejector nozzle having aerodynamically operated blow-in doors and exit leaves (also called tail feathers) is a part of the normal engine-afterburner configuration. The ejector prevents over-expansion of the primary jet and provides cooling and purging for the engine compartment.

The location of the instrumentation used in this investigation is also shown in figure 2. The station identification is shown on this engine schematic and the location and number of measurements at each station are shown on each station sketch. The station locations were selected to divide the compressor into groups of three to four stages each.

High-response transient instrumentation. - The location of the high-response pressure transducers is also shown in figure 2. One of the objectives of this program was to have the capability of determining the location of the initiation of stall, to trace its progression through the compressor, and to determine the phase relation between various locations in the compressor. It was estimated that a frequency response of 500 hertz with a maximum of ±5 percent error in amplitude was required. To meet this requirement, the transducer must be located within 1 to 2 inches from the sense point. The presence of the fan duct annulus greatly complicated the instrumentation design and

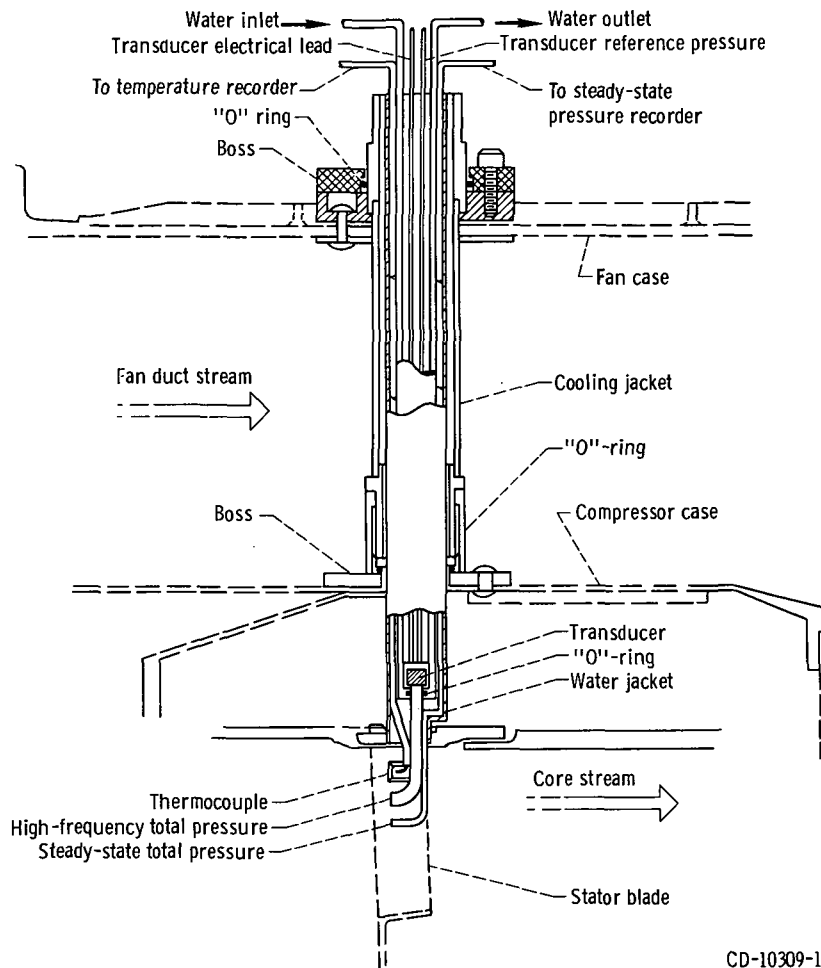
Figure 4. - Typical probe installation.

in some cases only a 300- to 350-hertz frequency response was obtainable. Typical probes are shown in figure 3, and a cross section of a typical rake is shown in figure 4. Miniature transducers, 1/4 inch in diameter, were used and were located in the probes at a point that was in, or adjacent to, the gas stream. Because the transducers were limited to a 170° F (76.5° C) operating temperature and had significant calibration shifts with temperature, water cooling was employed. The transducers, mounted in the water jackets, could be removed for repair without removing the complete rake from the engine.

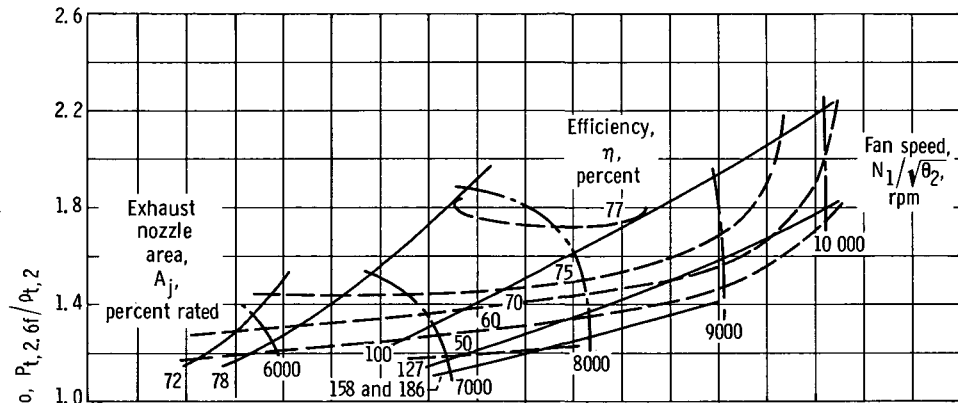
(a) Twelfth-stage bleeds closed.

(b) Twelfth-stage bleeds open.

Figure 6. - Fan map for outer annulus of YTF30-P-1 turbofan engine at Reynolds number index of 0.5.

Fan performance. - Fan performance is presented in the form of maps in figure 6 for the outer annulus and in figure 7 for the inner annulus. Separate maps are presented for the 12th-stage bleeds closed and open.

For both the inner and outer parts of the fan, increasing the exhaust nozzle area at a given corrected fan speed resulted in an increase in the corrected inlet total fan flow and a decrease in total-pressure ratio. In general, opening the 12th-stage bleeds resulted in only small changes in the pressure ratio and total airflow for a given speed. The peak isentropic efficiency was lower for the fan outer annulus (about 78 percent compared to approximately 95 percent for the inner annulus) and occurred at lower corrected speeds when the 12th-stage bleeds were opened. These results are based on rather limited instrumentation which was incapable of evaluating the radial profile at the fan exit.

Comparison of the outer and inner fan maps (figs. 6 and 7) indicate that the total-pressure ratio decrease with increasing exhaust nozzle area was greater for the outer annulus than for the inner annulus. The constant corrected speed lines of the inner annulus indicated a constant total-pressure ratio for exhaust nozzle areas below rated and only a slight decrease above rated.

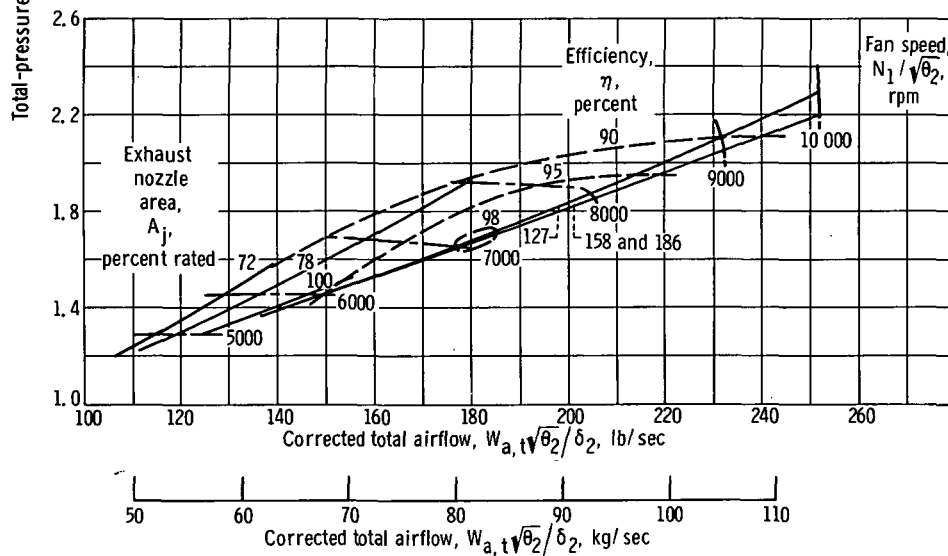
(a) Twelfth-stage bleeds closed.

(b) Twelfth-stage bleeds open.

Figure 7. - Fan map for inner annulus of YTF30-P-1 turbofan engine at Reynolds number index of 0.5.

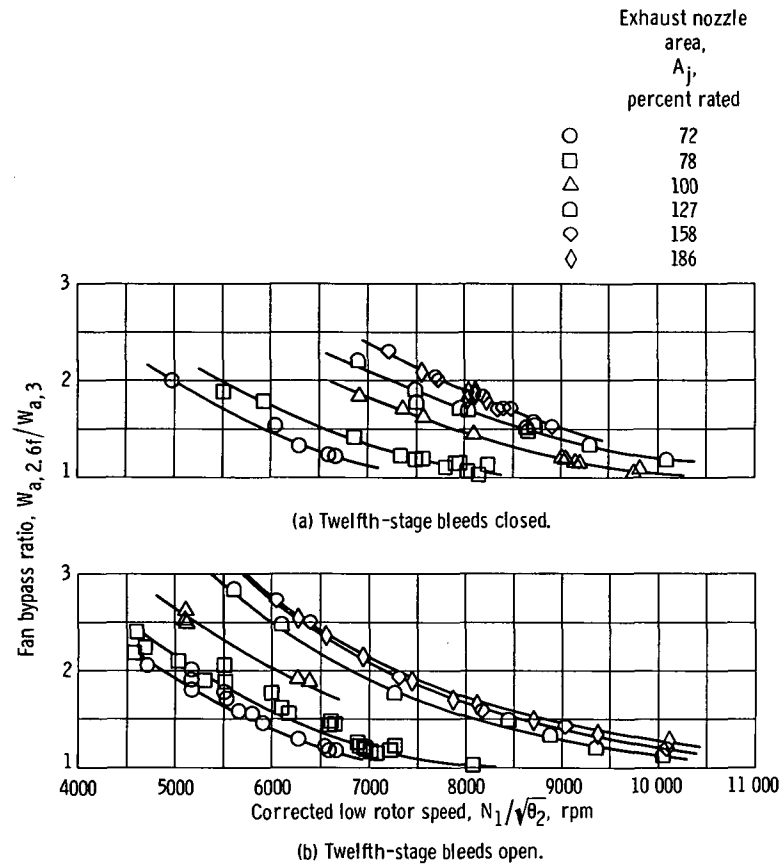
Figure 8. - Fan bypass airflow characteristics for YTF30-P-1 turbfan engine at Reynolds number index of 0.5.

The boundary assumed between the core and fan duct flow in the fan is somewhat arbitrary due to the lack of a physical flow separator until after the flow has left the third stage. The fan includes the first three stages, and the low-pressure compressor the next six. However, the performance of the outer annulus of the fan is a different function of the exhaust nozzle area than is that of the inner annulus. Therefore, the fan performance is presented by means of two sets of maps. The performance of the outer fan annulus is presented as the pressure ratio $P_{t,2.6f}/P_{t,2}$ (fan duct total pressure to inlet total pressure) as a function of corrected total airflow $W_{a,t}\sqrt{\theta_2}/\delta_2$ and corrected fan speed $N_1/\sqrt{\theta_2}$ (fig. 6). The inner annulus performance is defined by the pressure ratio $P_{t,2.3}/P_{t,2}$ (fourth stage inlet to engine inlet total pressure) as a function of corrected total airflow and corrected fan speed (fig. 7). The bypass ratio, the ratio of fan duct airflow to core airflow, is presented in figure 8.

Bypass ratio (fig. 8) increased as exhaust nozzle area was increased at a given corrected low rotor speed and as corrected low rotor speed was reduced at a given exhaust nozzle area. As bypass ratio increased, the fraction of total airflow increased through

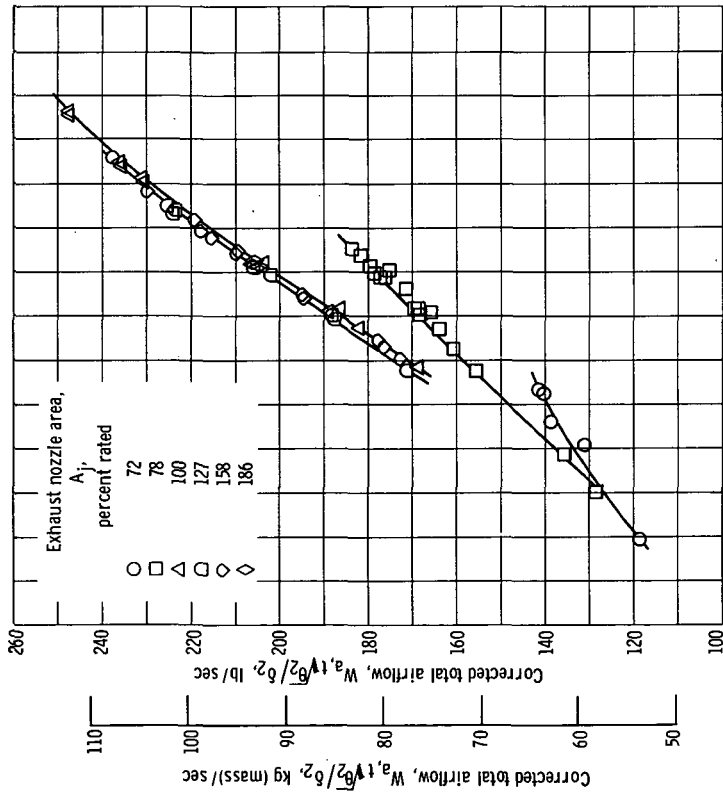
Figure 17. - Performance of fan of YTF30-P-1 turbofan engine at Reynolds number index of 0.5, 12th-stage bleed closed.

The basic performance data obtained for the YTF30-P-1 turbofan engine, serial number P-647218, are presented as corrected airflow, total-pressure ratios, and compressor efficiencies as functions of corrected rotor speed and exhaust nozzle area in figures 17 to 24. Separate curves are included for the 12th-stage bleeds open.

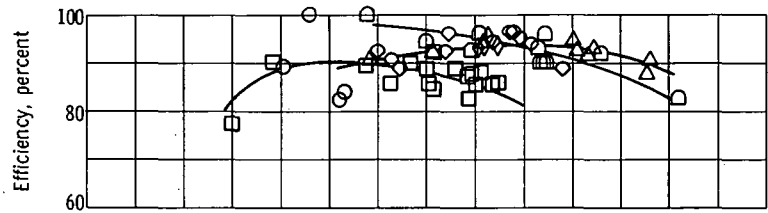
Figure 19. - Performance of core stages 1 to 3 of YTF30-P-1 turbfan engine at Reynolds number index of 0.5, 12th-stage bleed closed.

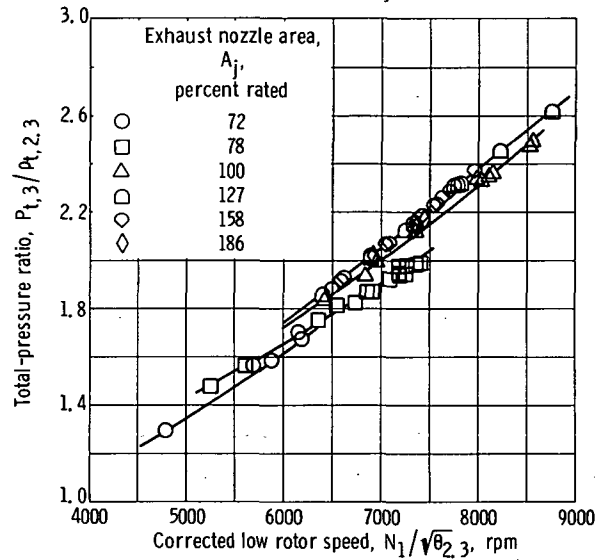
Figure 21. - Performance of core stages 4 to 9 of YTF30-P-1 turbofan engine at Reynolds number index of 0.5, 12th-stage bleed closed.

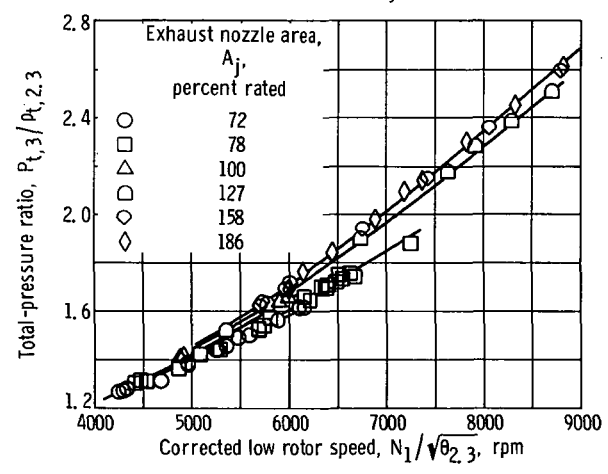
Figure 22. - Performance of core stages 4 to 9 of YTF30-P-1 turbofan engine at Reynolds number index of 0.5, 12th-stage bleed open.
