FINAL REPORT

VOLUME 2

APOLLO SM-LM RCS ENGINE DEVELOPMENT  
PROGRAM SUMMARY REPORT

Contract NAS 9-7281

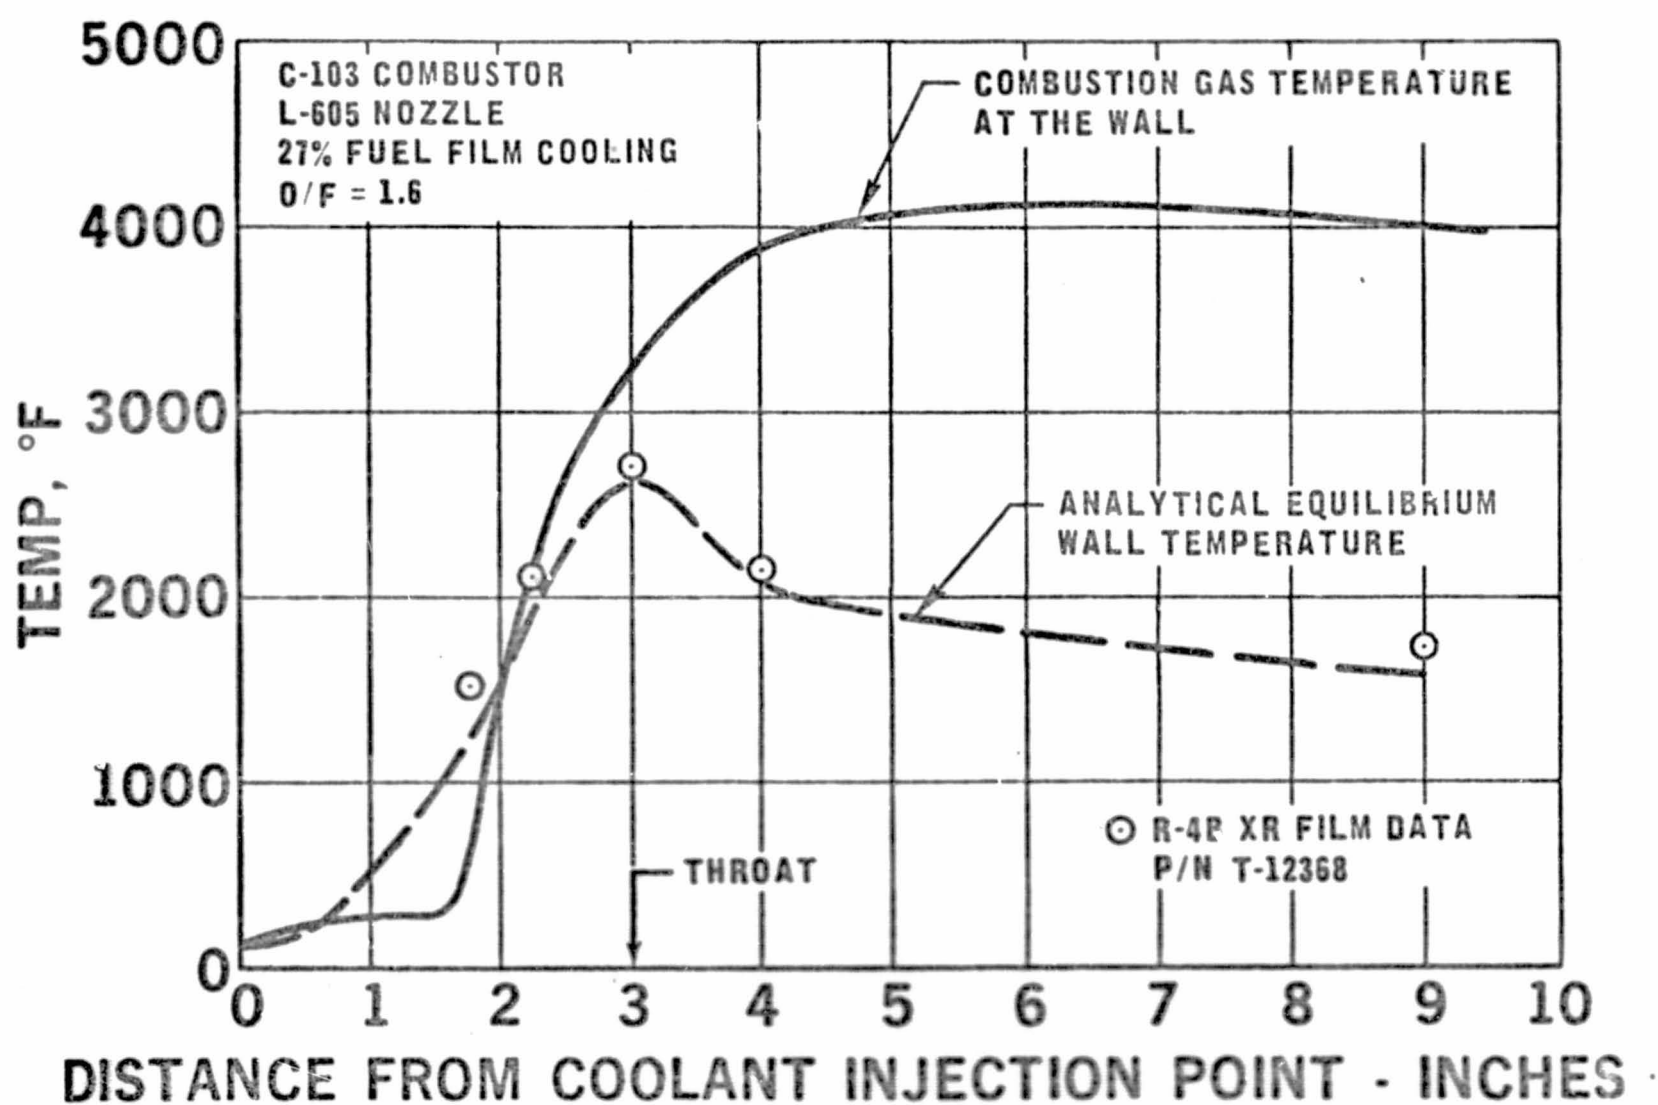
# 100 POUND THRUST RADIATION COOLED ENGINE TEMPERATURE CHARACTERISTICS

In addition to the hot firing tests which were conducted during the development program, a series of tests were conducted to determine the engine characteristics during cold soak (radiation to deep space) operation. During space operation the engine usually radiates to space vacuum ( $-460^{\circ}\text{F}$ ), but during ground tests the engine was tested in vacuum test cells where the surroundings were ambient ( $70^{\circ}\text{F}$ ). Since the temperature of the combustor is in the  $1000-3000^{\circ}\text{F}$  range, the effect due to the temperature difference of the surroundings is negligible. During the time when the engine is not operating, i.e., cold soak, and the engine must be maintained at temperatures above the freezing point of the propellants, it was necessary to simulate the space environment. This was accomplished by locating the engine in the test cell where the surrounding test cell walls are cooled with liquid nitrogen. The engine was then heated by a resistance heater and the power required to maintain the engine at various temperature levels was obtained. These data were then compared to the thermal model results. Figure 11 shows the power requirements for the R-4D engine vs. injector temperature based on the experimental results and the analytical model.

The data show that the analytical methods used to calculate the thermal characteristics of the R-4D engine can adequately predict the actual temperature during both hot firings and cold soak conditions. As will be shown later, the analytical methods which evolved from this program were used in successful supplementary programs to provide the necessary thermal design criteria.

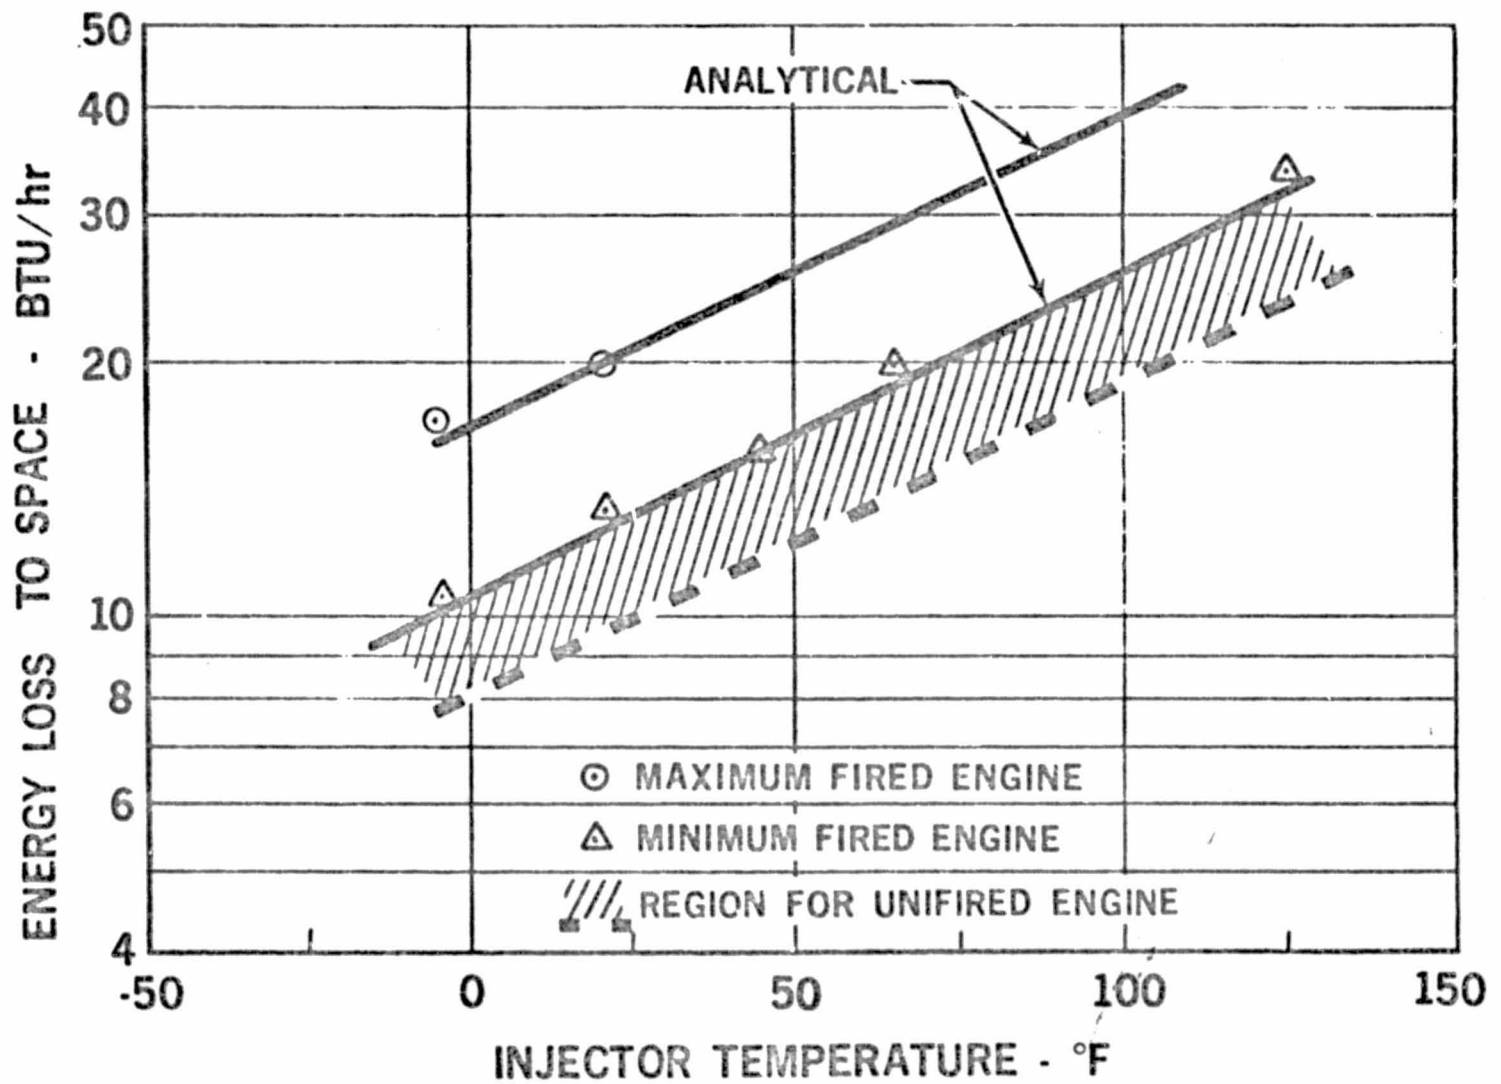
# POWER REQUIREMENTS RADIATION TO DEEP SPACE R-4D 100 LB. THRUST ROCKET ENGINE

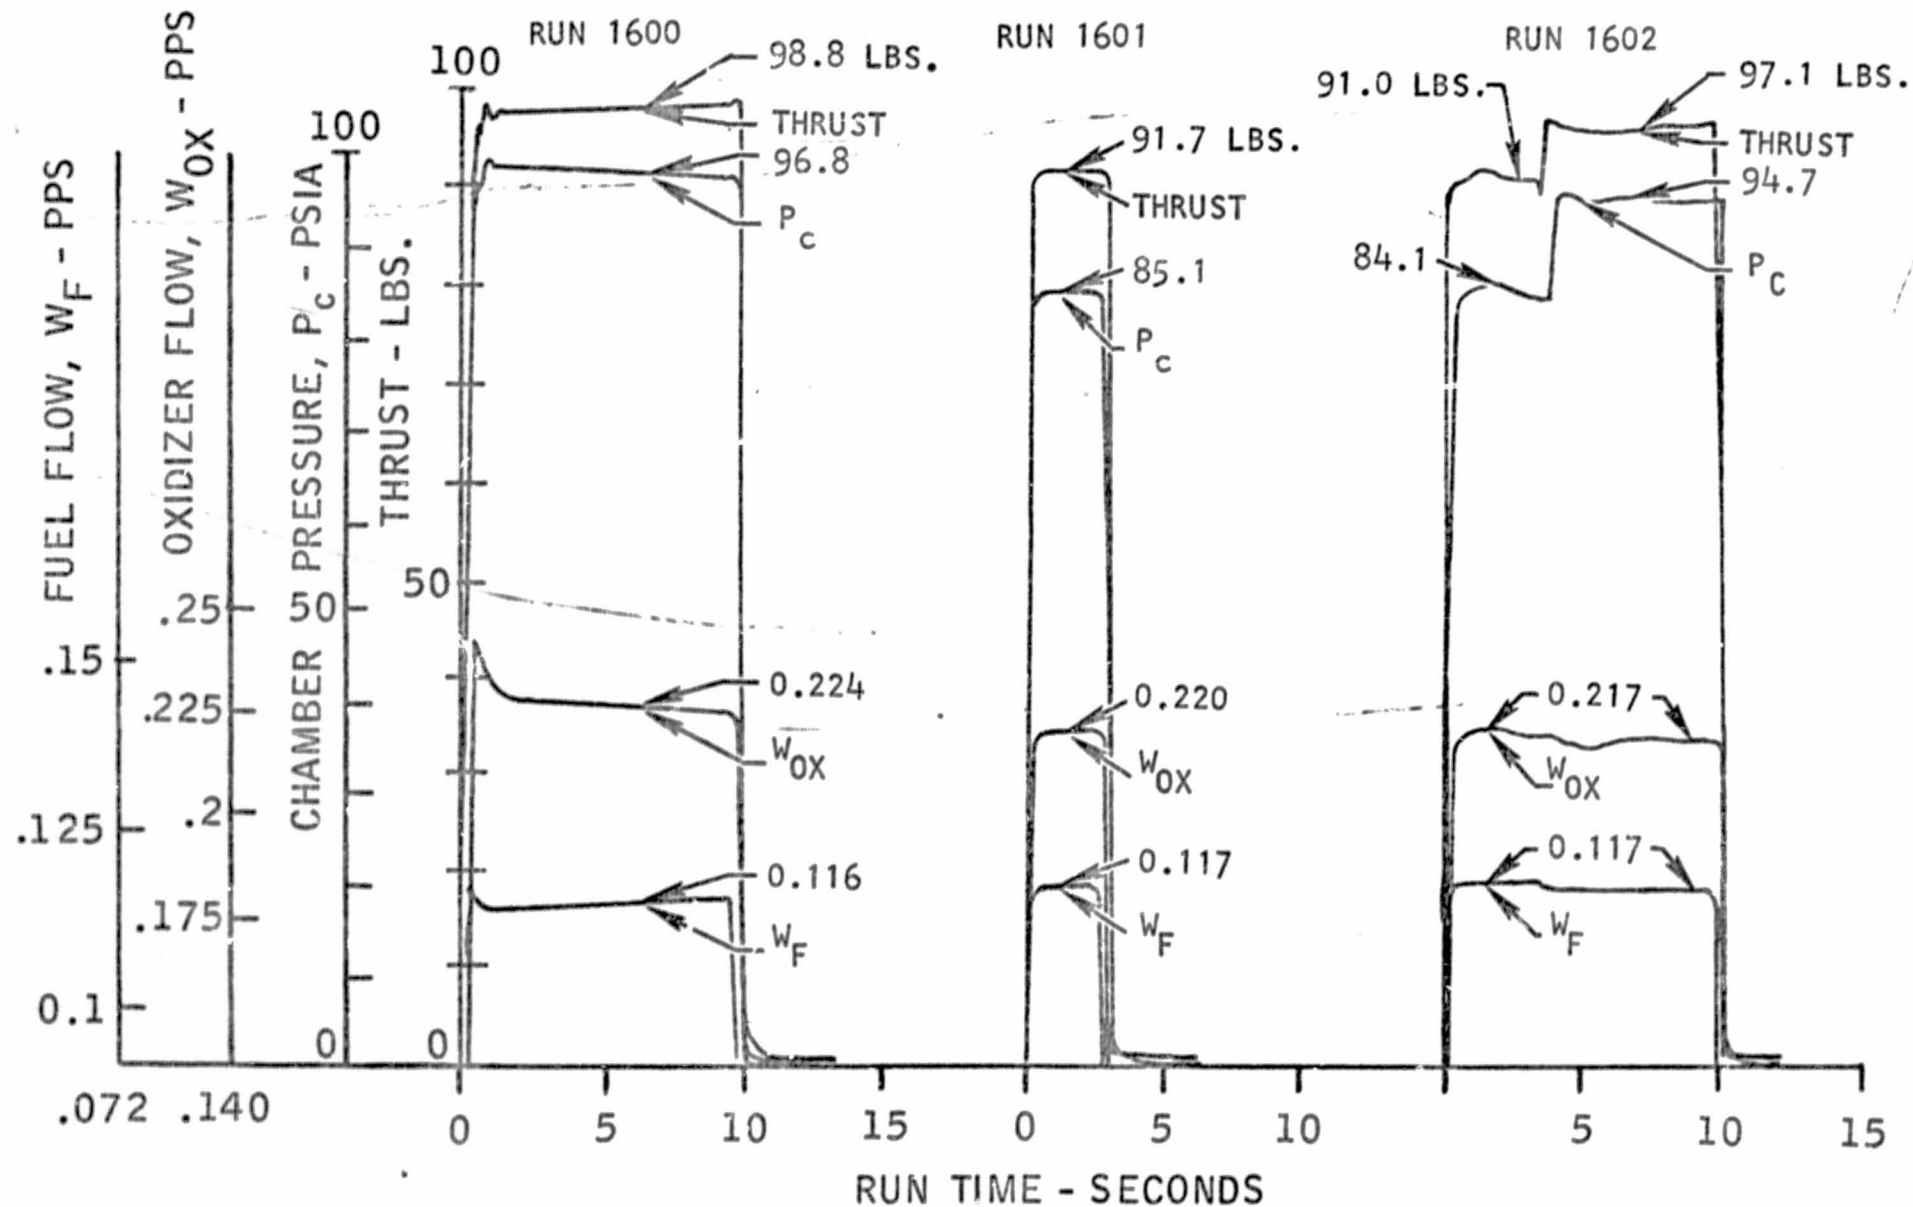
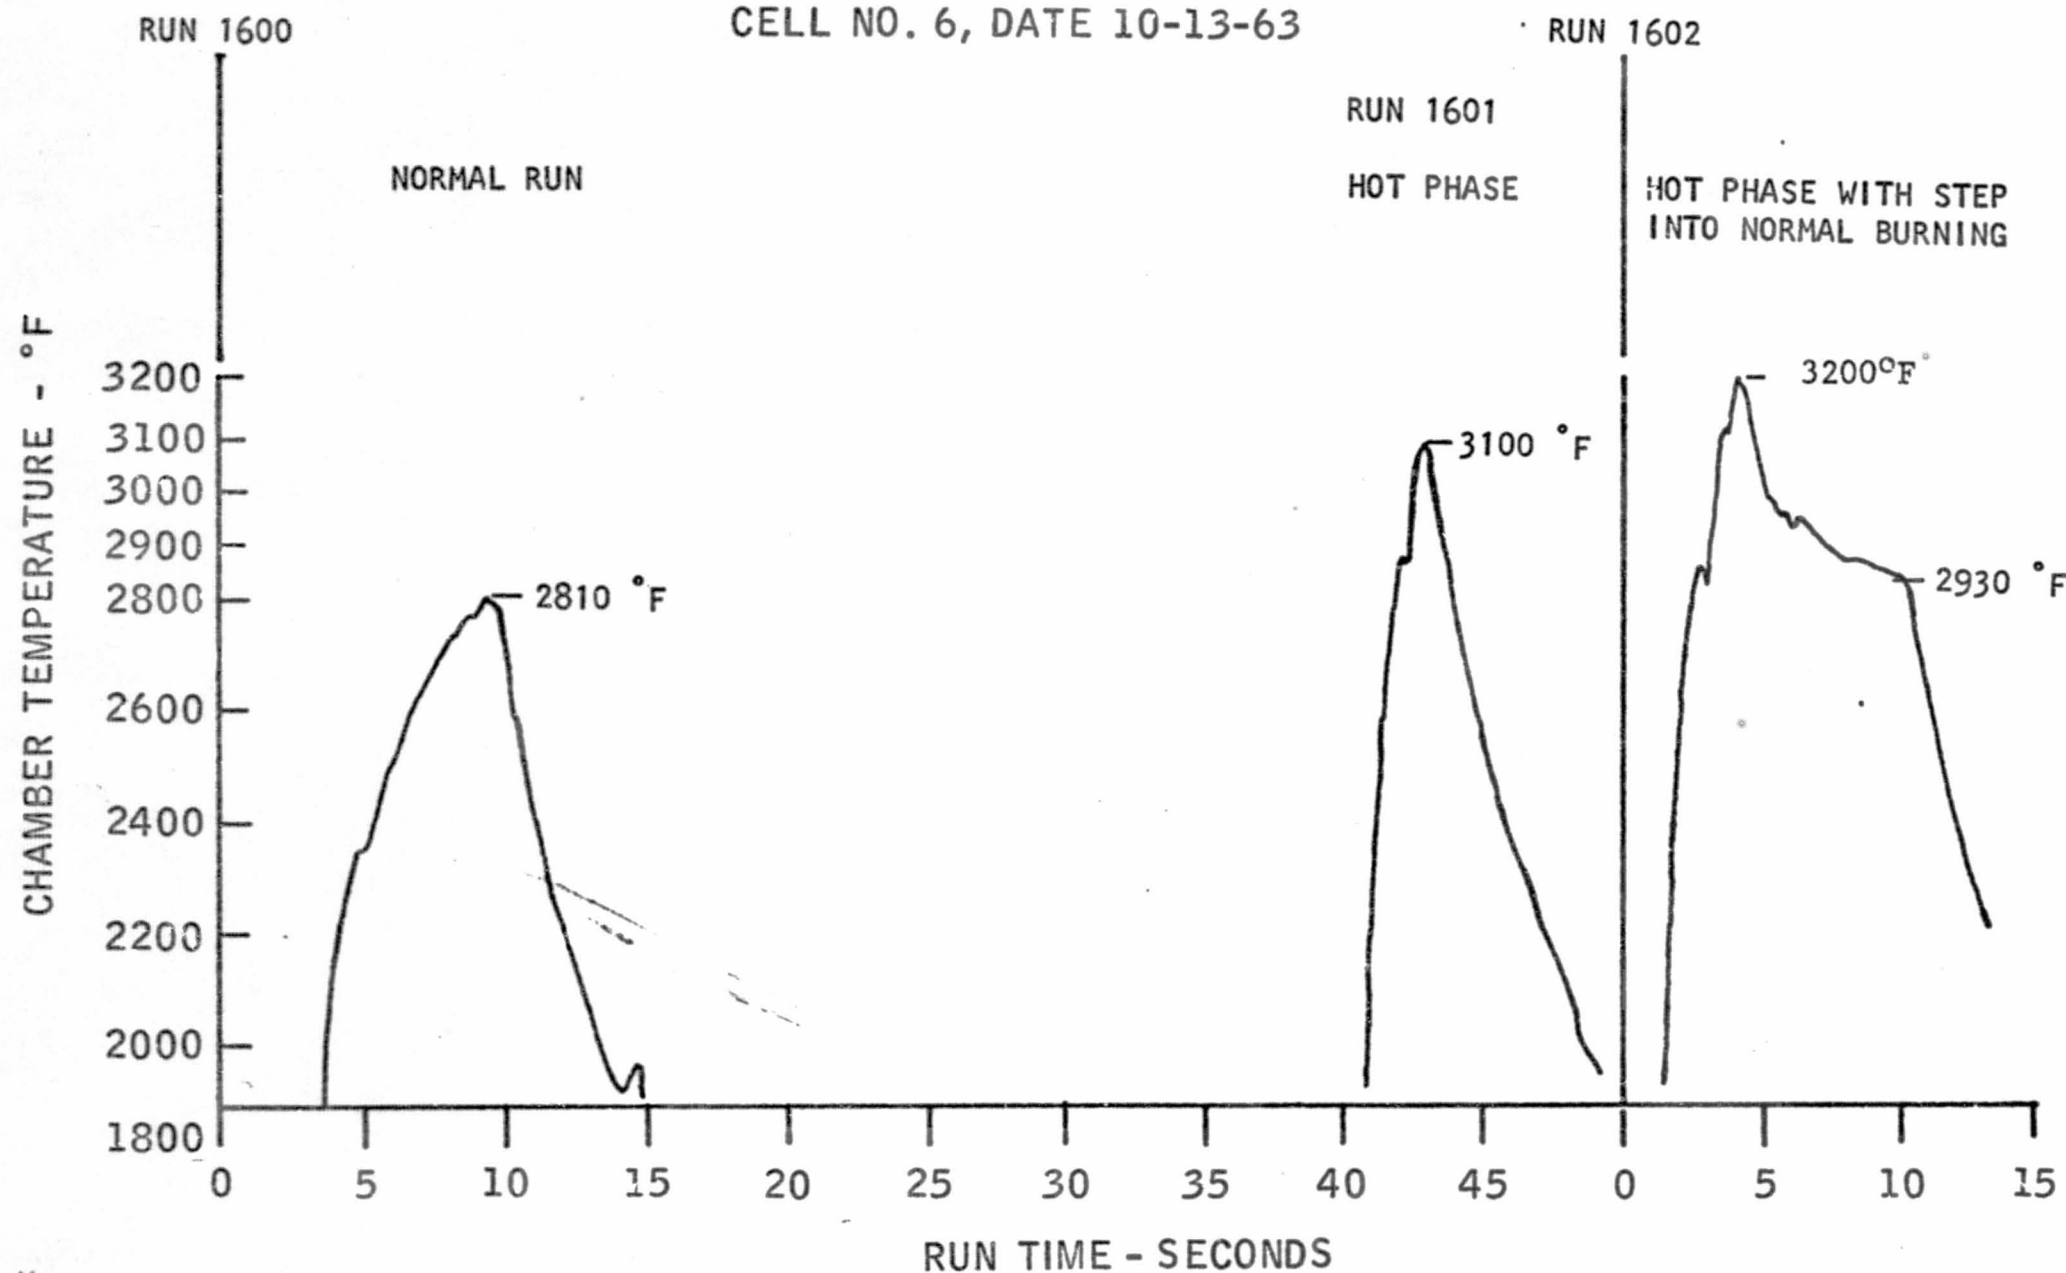
Figure 13

# COMPARISON OF CHAMBER WALL TEMPERATURE RISE DURING NORMAL & HHTB RUNS

MANEUVER NO. 1  
ENGINE P/N 20560-503, S/N 0001  
CELL NO. 6, DATE 10-13-63

During execution of the above cycle, a peculiar behavior of the thrust and chamber pressure, and an extremely rapid heating of the chamber was observed. Typical data traces are shown in Figures 12 and 13.

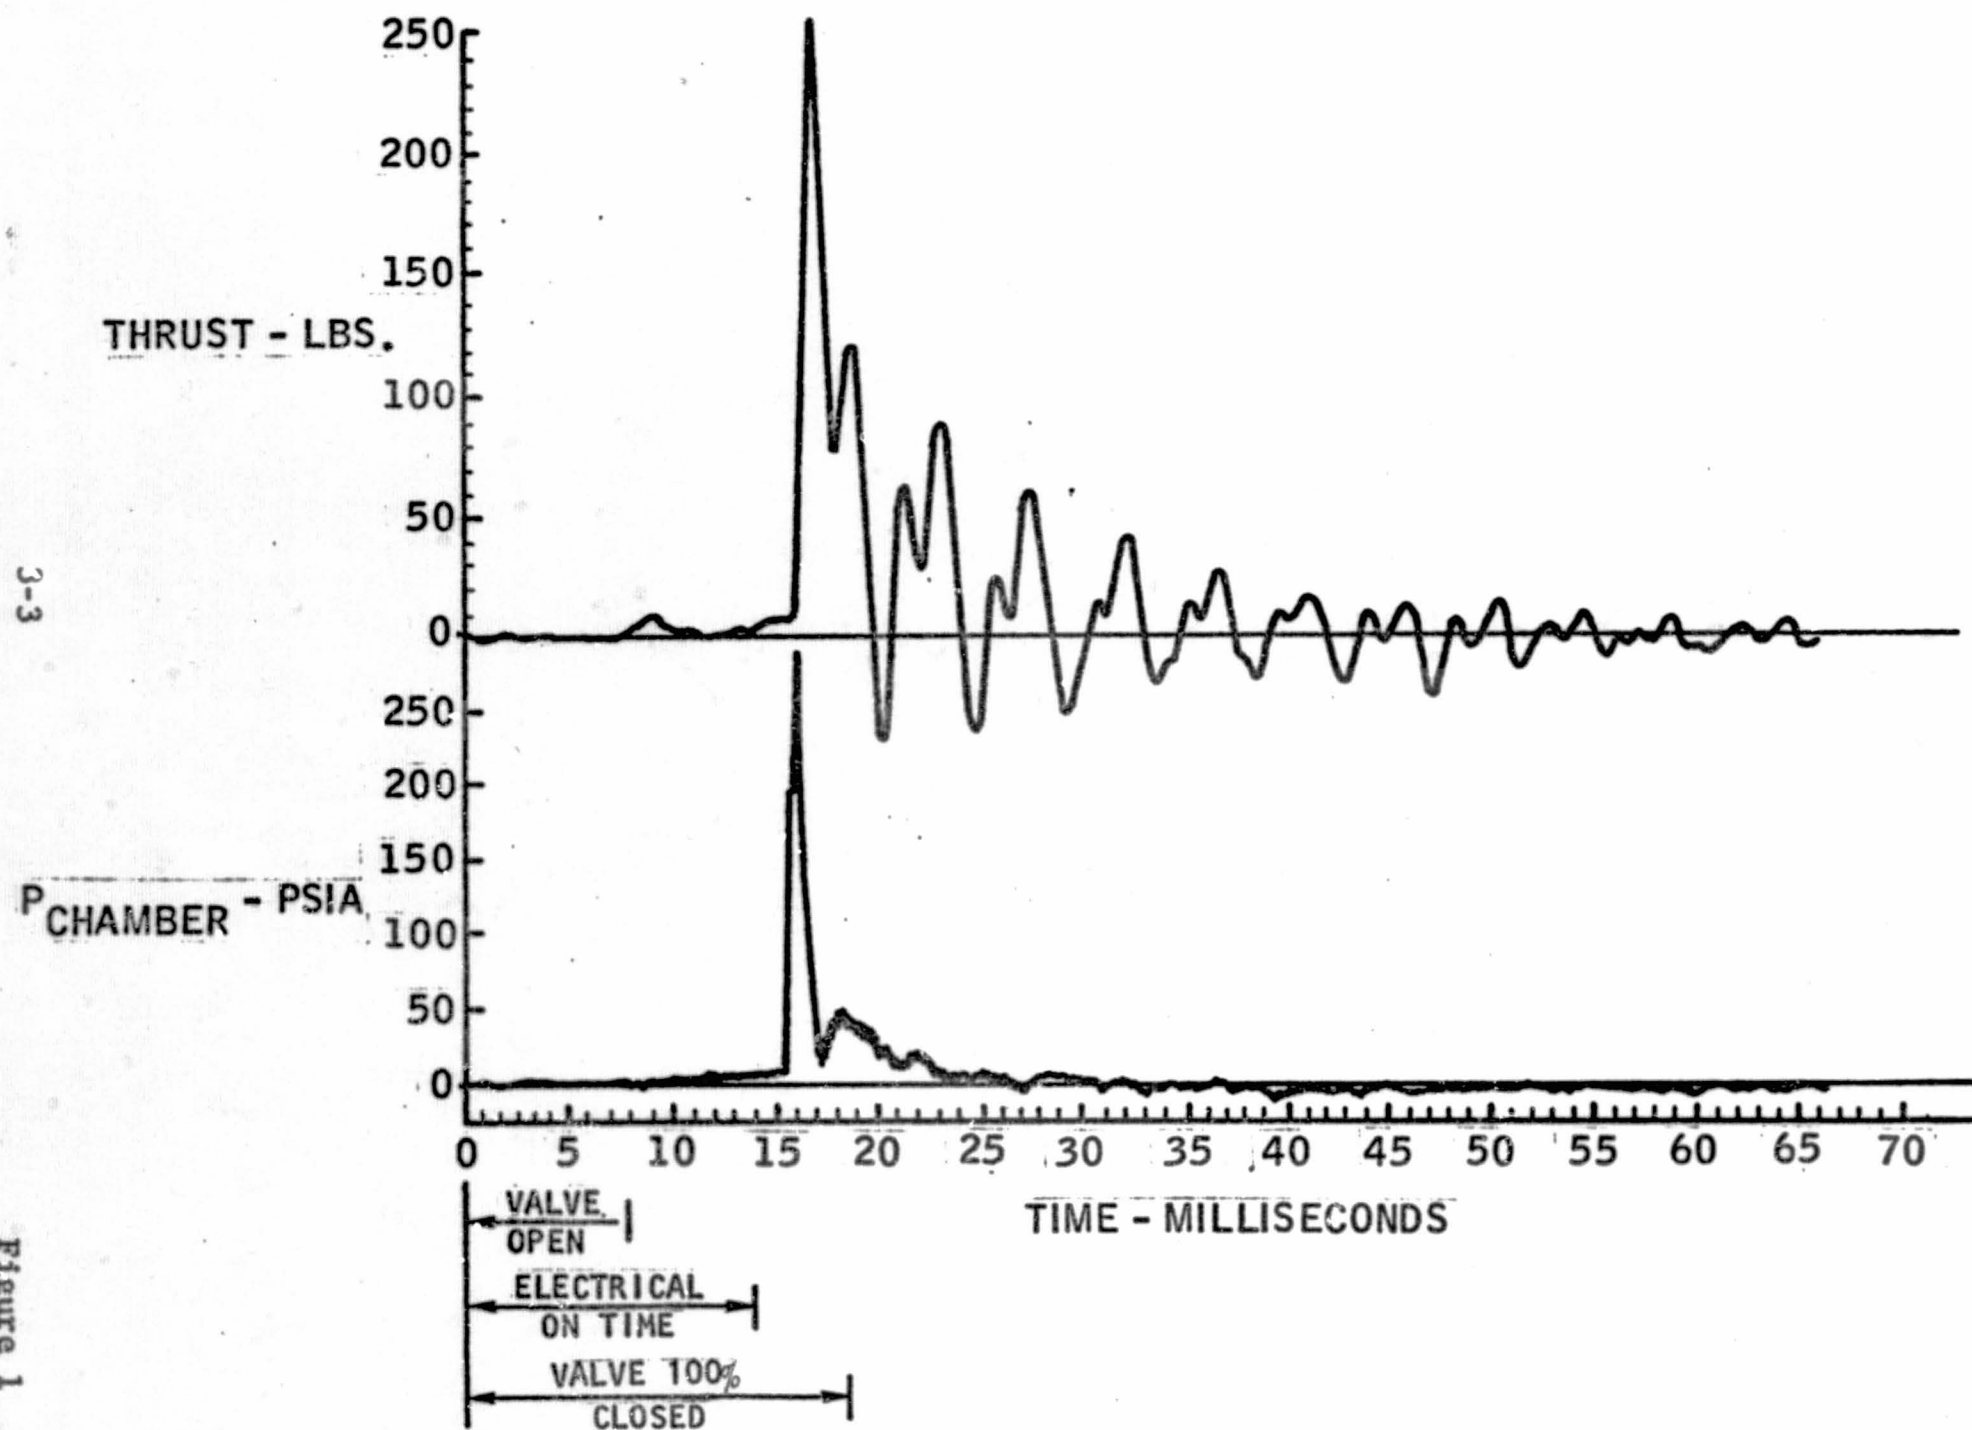
Figure 1

# THRUST AND CHAMBER PRESSURE VS TIME

During one of these tests in the ATL facility, three firings of 11, 10 and 5 seconds duration were made. The combustion chamber failed at the start of a planned 5 second run and subsequent examination of the engine showed that about two-thirds of the combustion chamber was missing.

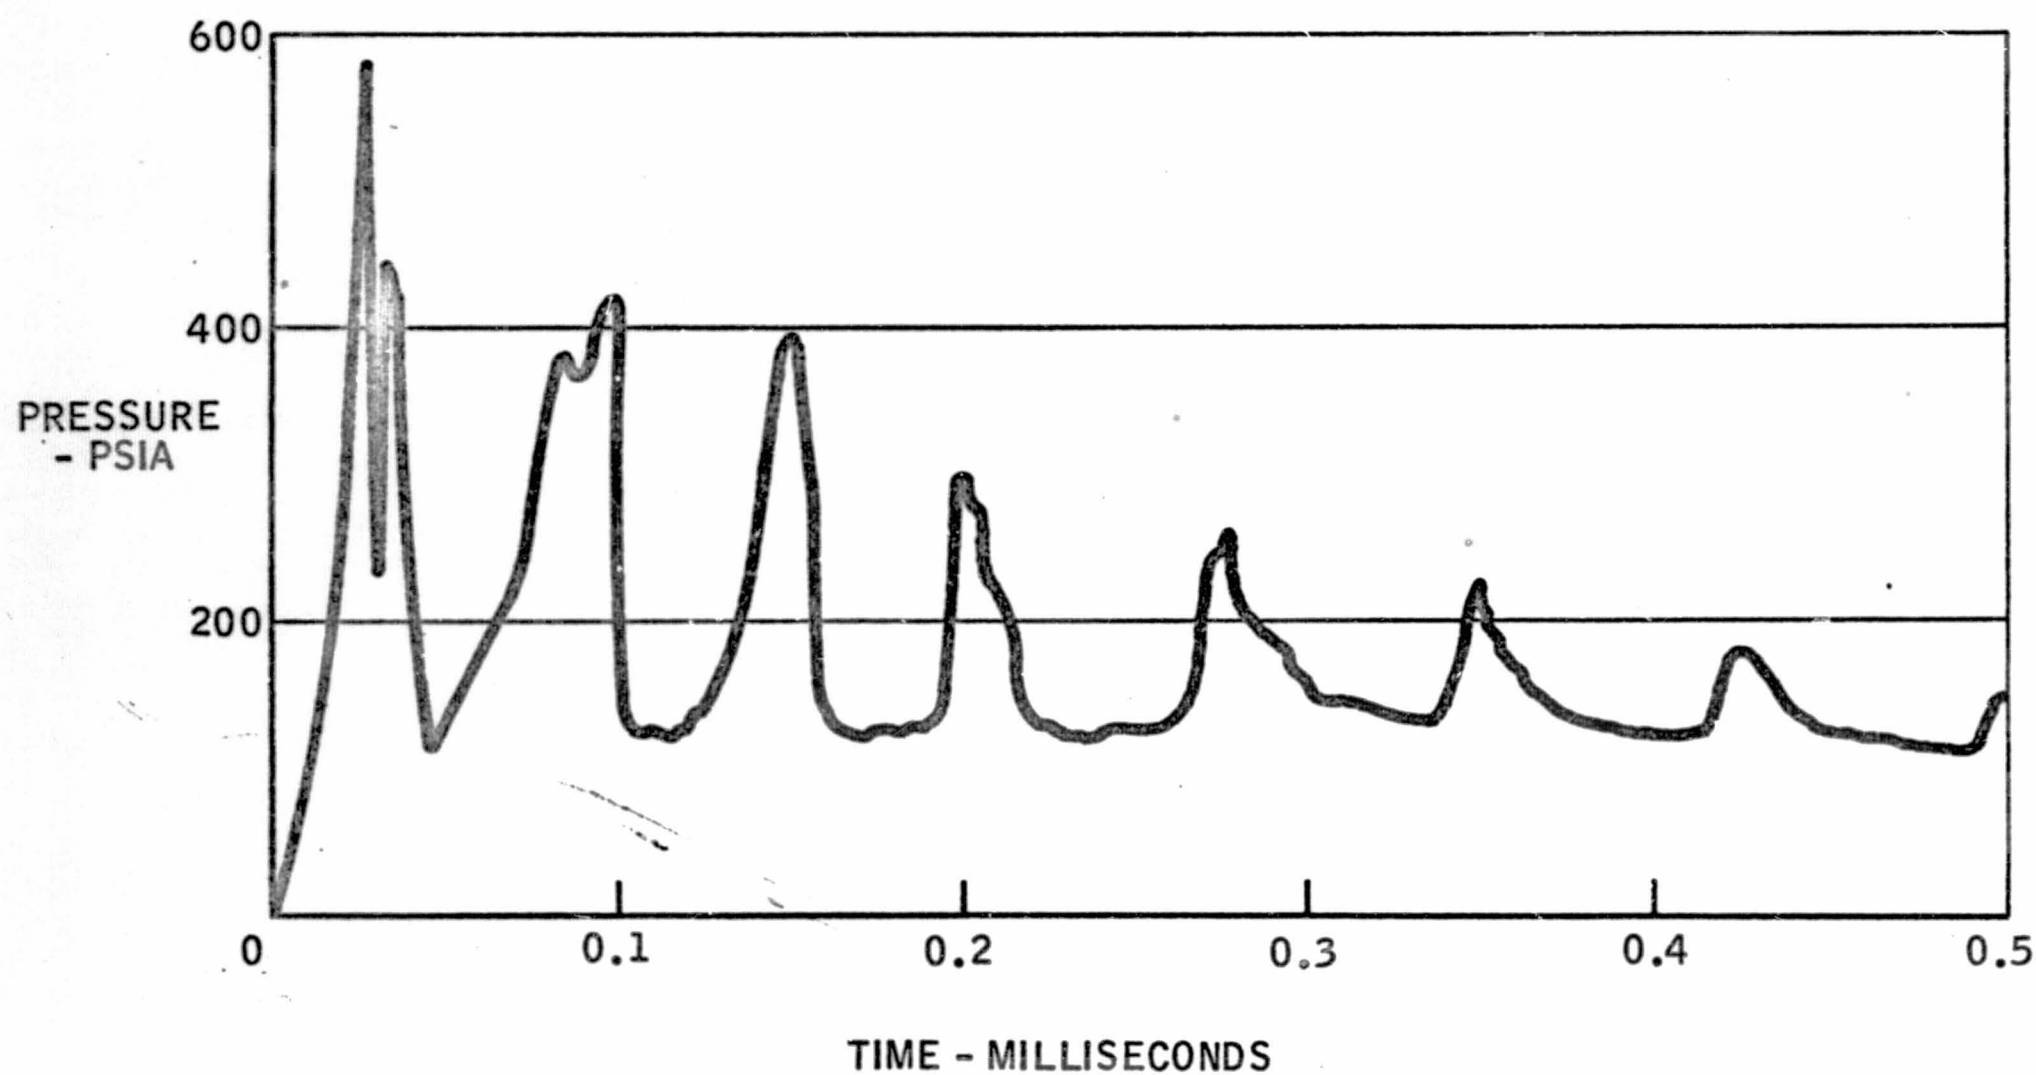
Figure 2

# TYPICAL PRESSURE HISTORY AT A POINT ON THE CHAMBER WALL

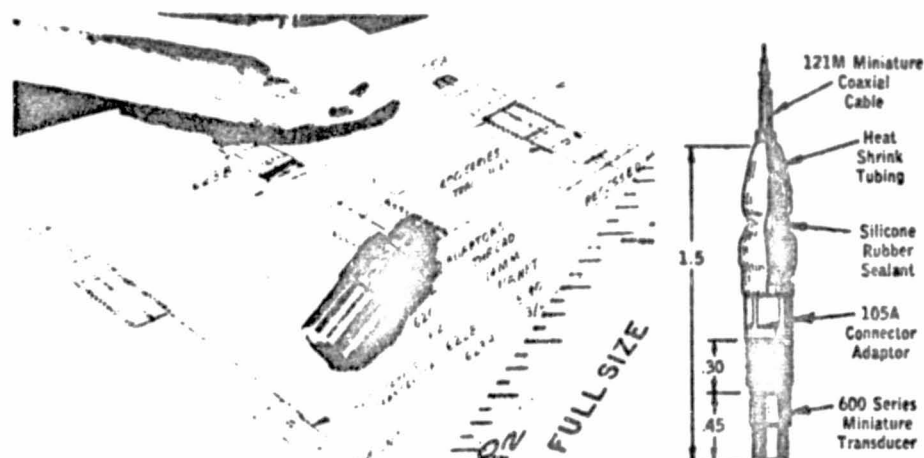
model 601H

### FAST RESPONSE TRANSDUCER MEASURES HIGH LEVEL DYNAMIC PRESSURES

Model 601H heavy diaphragm, fast response, miniature quartz transducer measures dynamic pressure up to 15,000 psi, with limited application to 20,000 psi, in blast, explosion, combustion, hydraulic and pneumatic applications. Mounting adaptors facilitate installation and protect transducer against extreme environments. Electrostatic systems, utilizing quartz transducers, charge amplifiers and low-noise cable, feature short-term static response and static calibration.

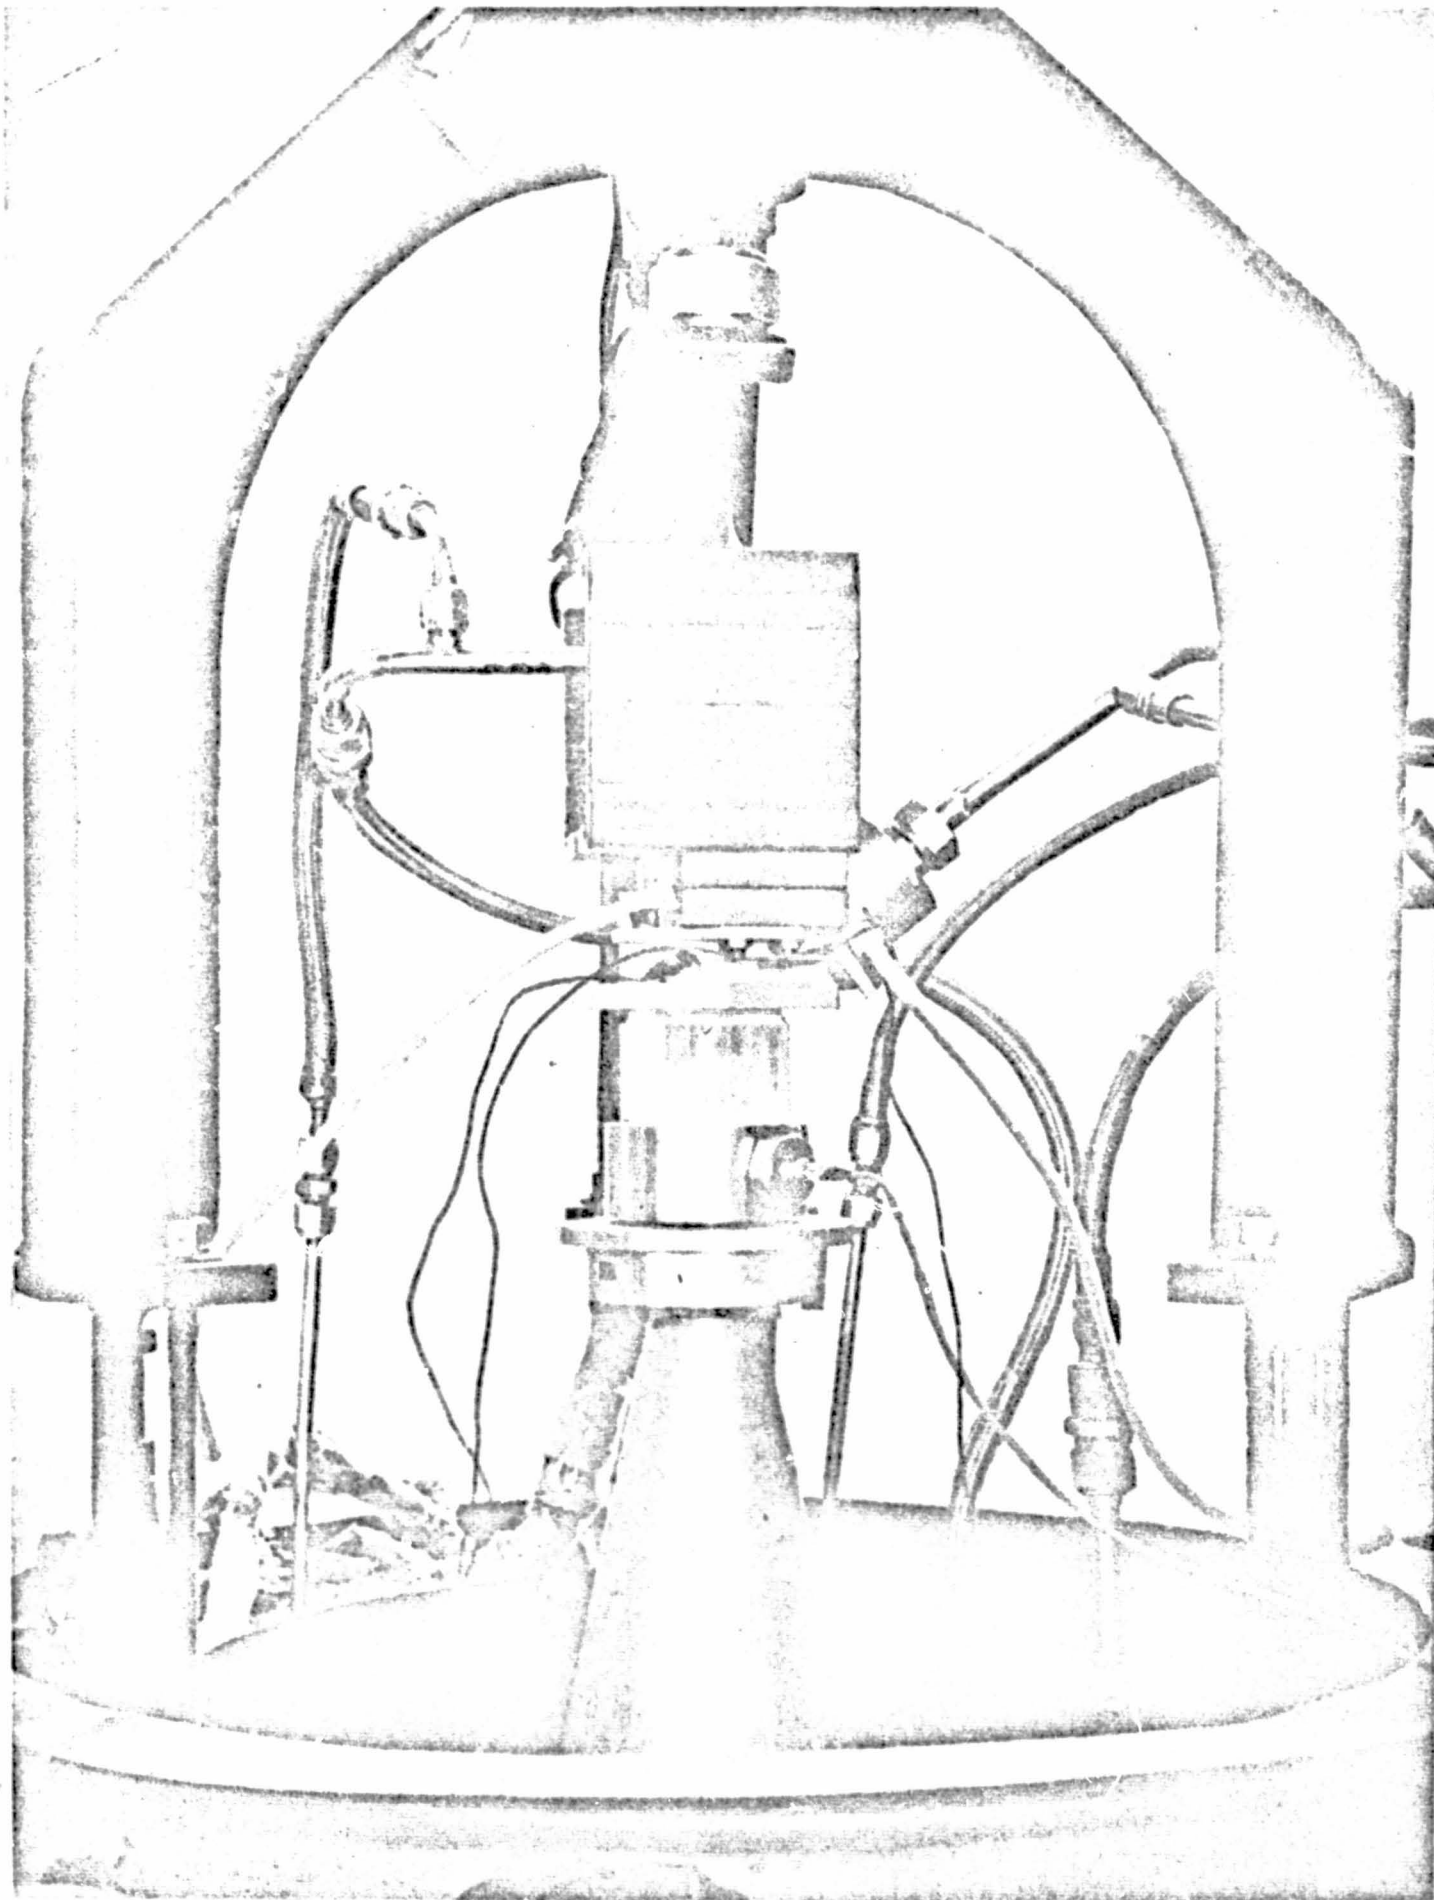
NEG. C6334-2

Engine with Transparent Combustor

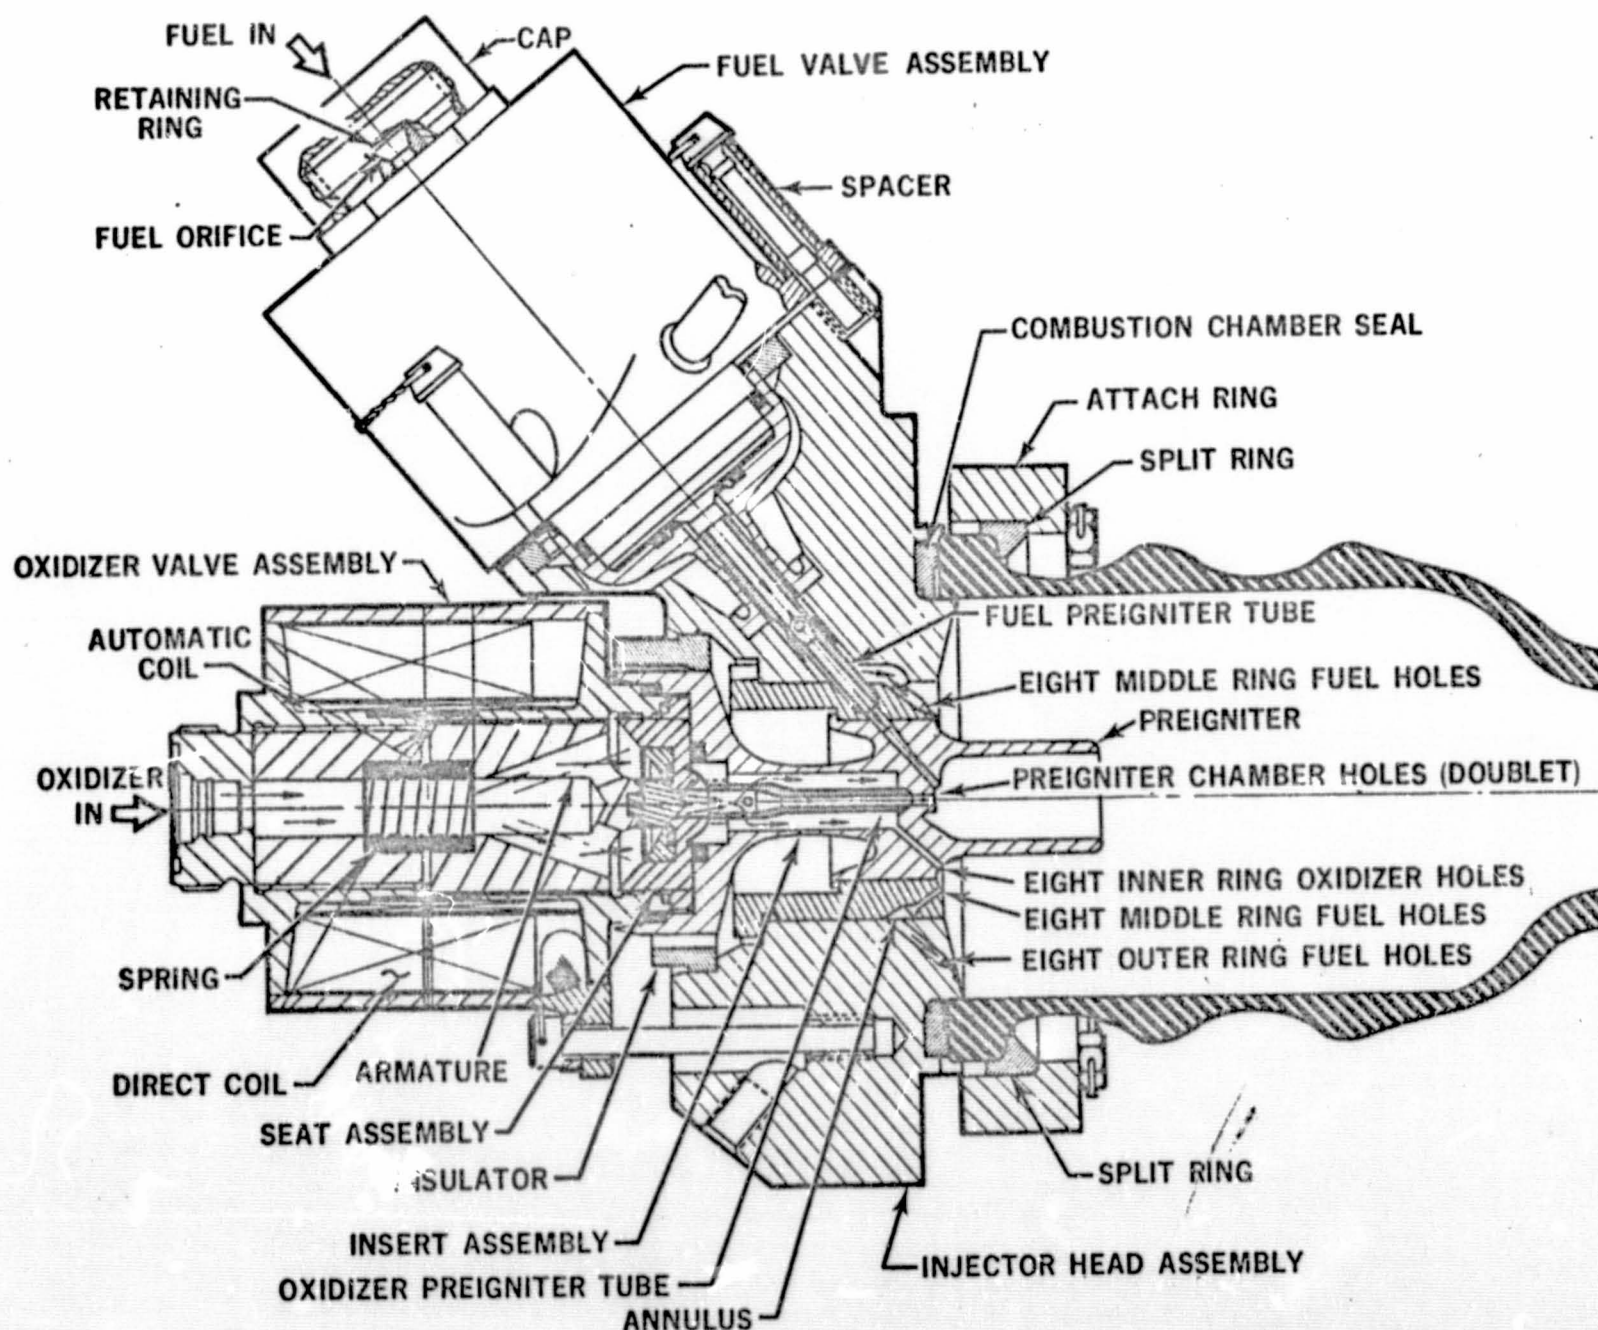
FIGURE 4. HEAD AND VALVE ASSEMBLY - MODEL R-4D ROCKET ENGINE

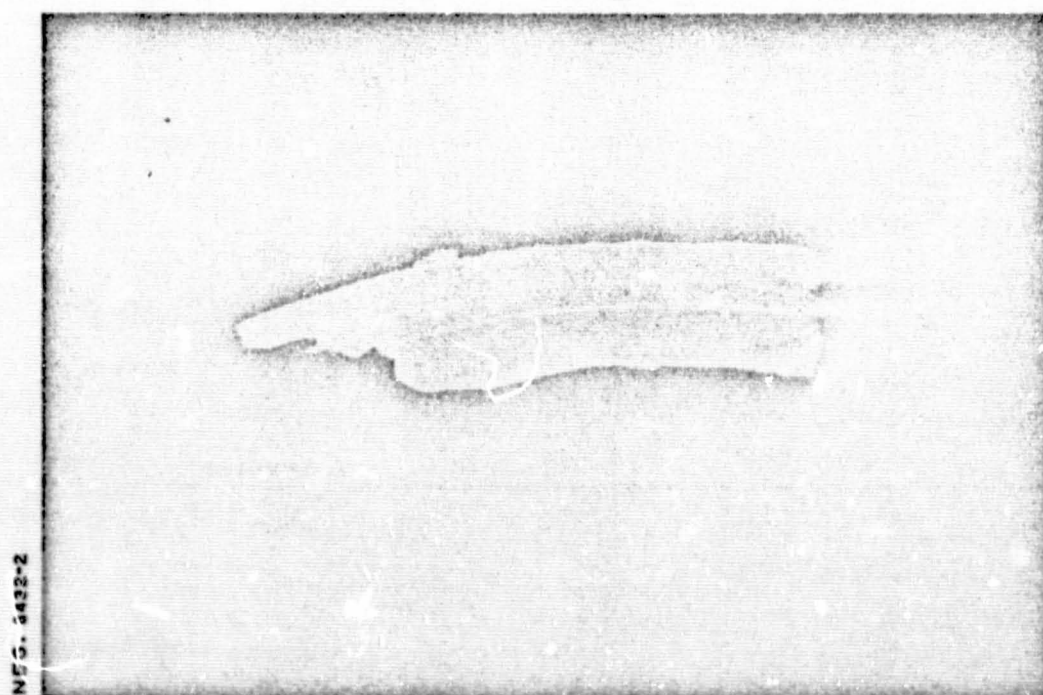
FIGURE 5B. PARTICLE THAT BLOCKED CHAMBER  
COOLING HOLE (14X)

Large particle contamination of the injector assembly has been a problem in a few instances. One such problem was experienced when a chamber cooling hole was found partially blocked by a piece of Teflon. Figure 5 shows the blocked hole and the particle. Other large particle contamination problems are discussed in Section D, Engine contamination problems.

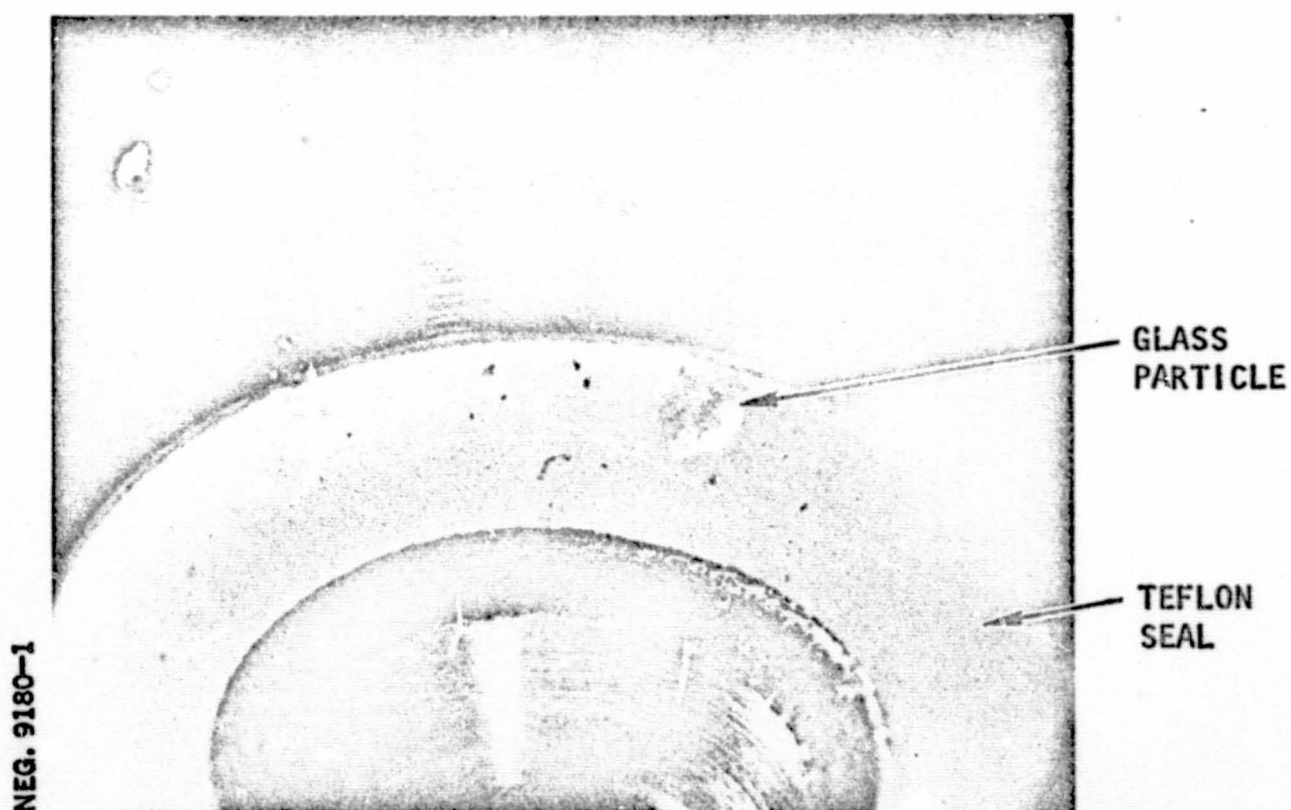
FIGURE 6. 600 MICRON (0.024 IN.) GLASS PARTICLE INBEDDED  
IN VALVE TEFLON SEAL (18X) (IR&D ENGINE TEST)

The first significant engine contamination problem which occurred to an engine delivered to the customer was during check-out of Quad "A" Engines on Apollo S/C 009 at John F. Kennedy Space Center. Investigation of leakage from two of the engines resulted in finding excessive contamination in all four of the engines. The contaminants were varied in identity including sand, metal, human hair, Teflon, wood, rutile, RTV rubber, corrosion products, and other unidentified contaminants. It was concluded that the source of the contaminants was both internal and external to the quad engine system. Recommended action of the NASA investigation team included; 1) provisions for protecting the engines from contamination through the combustor exit bell during test and check-out; 2) checking engines at all levels of manufacture and test to determine and eliminate the sources of contamination; and 3) provide filters immediately upstream of each valve to entrap any internal foreign particles.

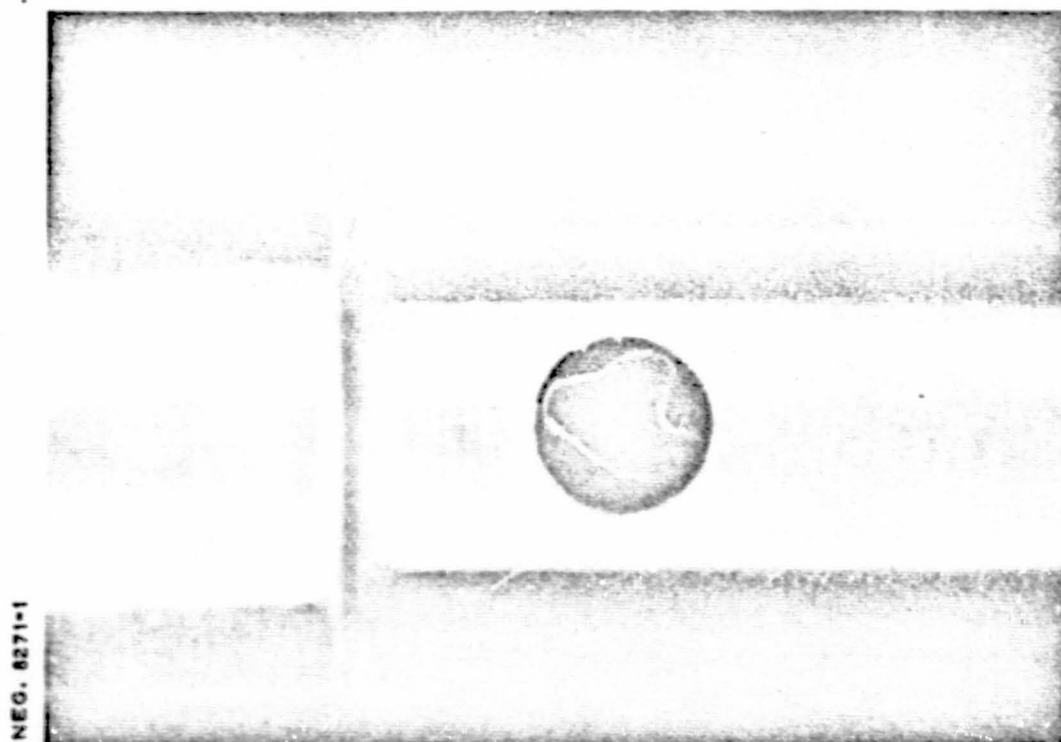
FIGURE 7A. PLASTIC IN PREIGNITOR TUBE (8X)

FIGURE 7. INJECTOR CONTAMINATION (REF. FAILURE/MALFUNCTION  
REPORT CR-056)
