FINAL REPORT

VOLUME 2

APOLLO SM-LM RCS ENGINE DEVELOPMENT  
PROGRAM SUMMARY REPORT

Contract NAS 9-7281

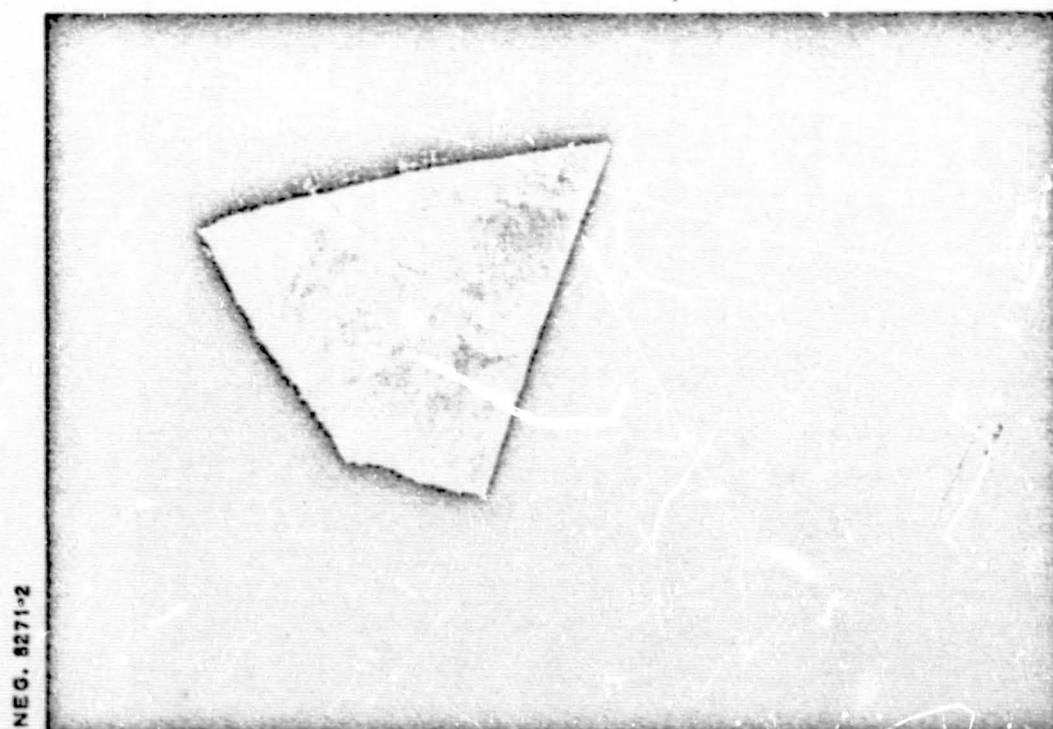
FIGURE 7B. PLASTIC AFTER REMOVAL FROM  
PREIGNITOR TUBE (8X)

FIGURE 7. INJECTOR CONTAMINATION (REF. FAILURE/MALFUNCTION  
REPORT CR-056)

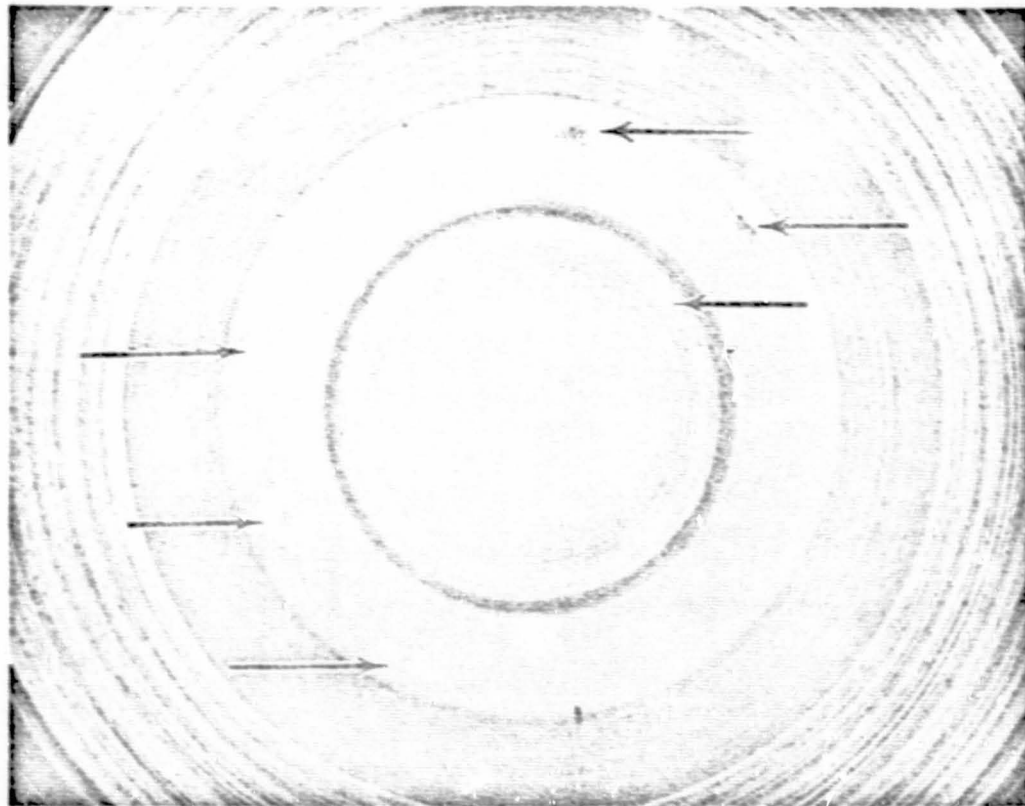
FIGURE 8A. WHITE PAINT ON VALVE TEFLON SEAL FACE (11X)

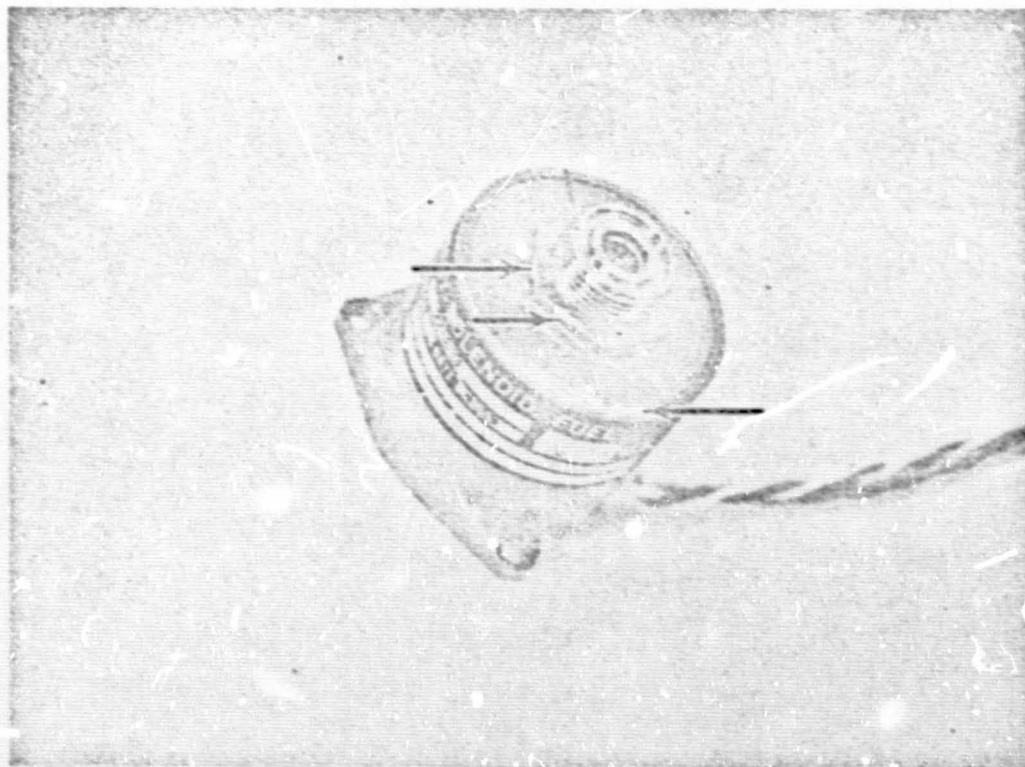
FIGURE 8B. WHITE PAINT ON THE TOP OF VALVE

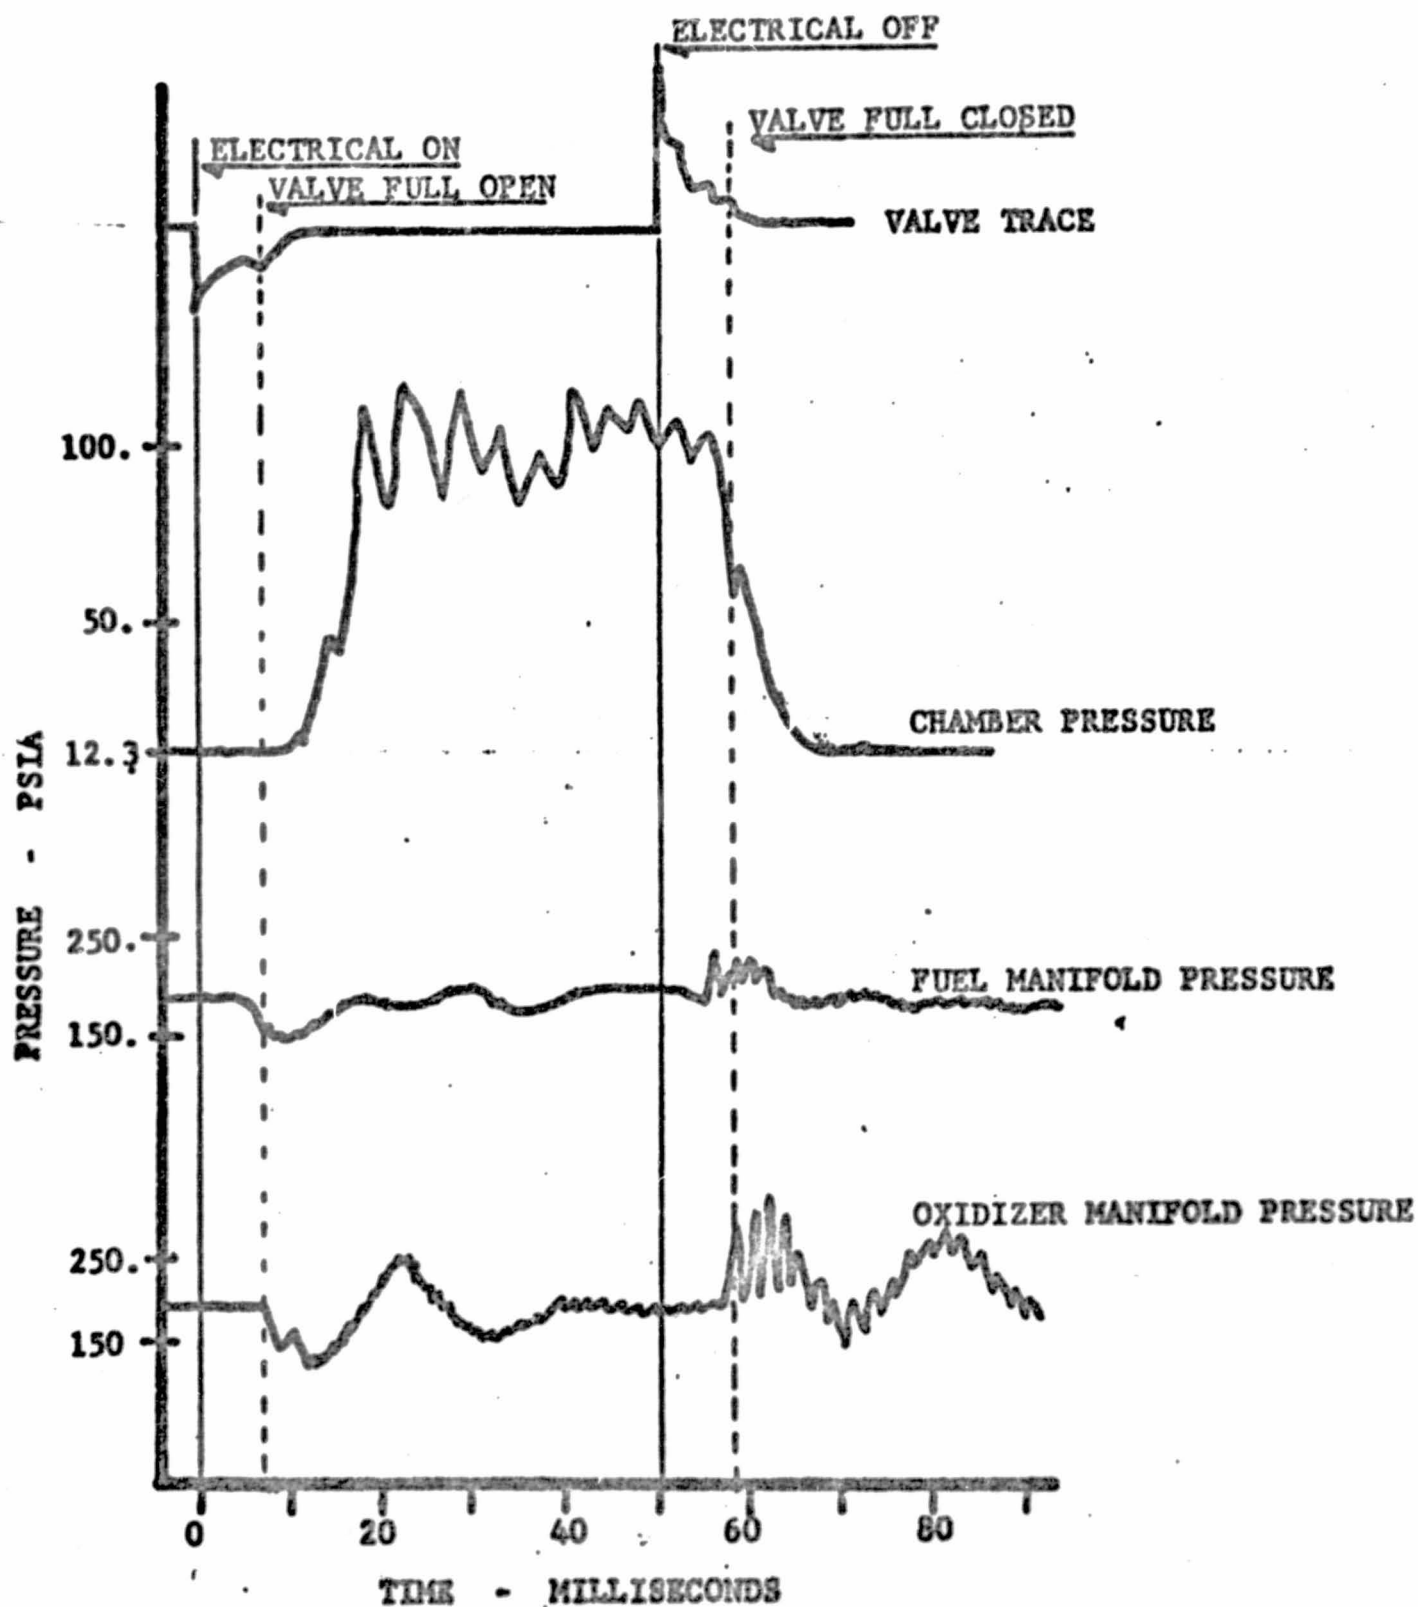
TYPICAL PRESSURE TRANSIENT OF BI-PROPELLANT ENGINE

system pressure is caused by friction and fluid damping. In a typical RCS installation the propellant lines feeding the engine take a number of turns (bends) and changes in cross sectional area, these impedance changes all affect the wave propagation of the distributed flow. A detailed treatment of the pressure-time transient associated with both the valve closing and opening are presented in References 1 and 2.

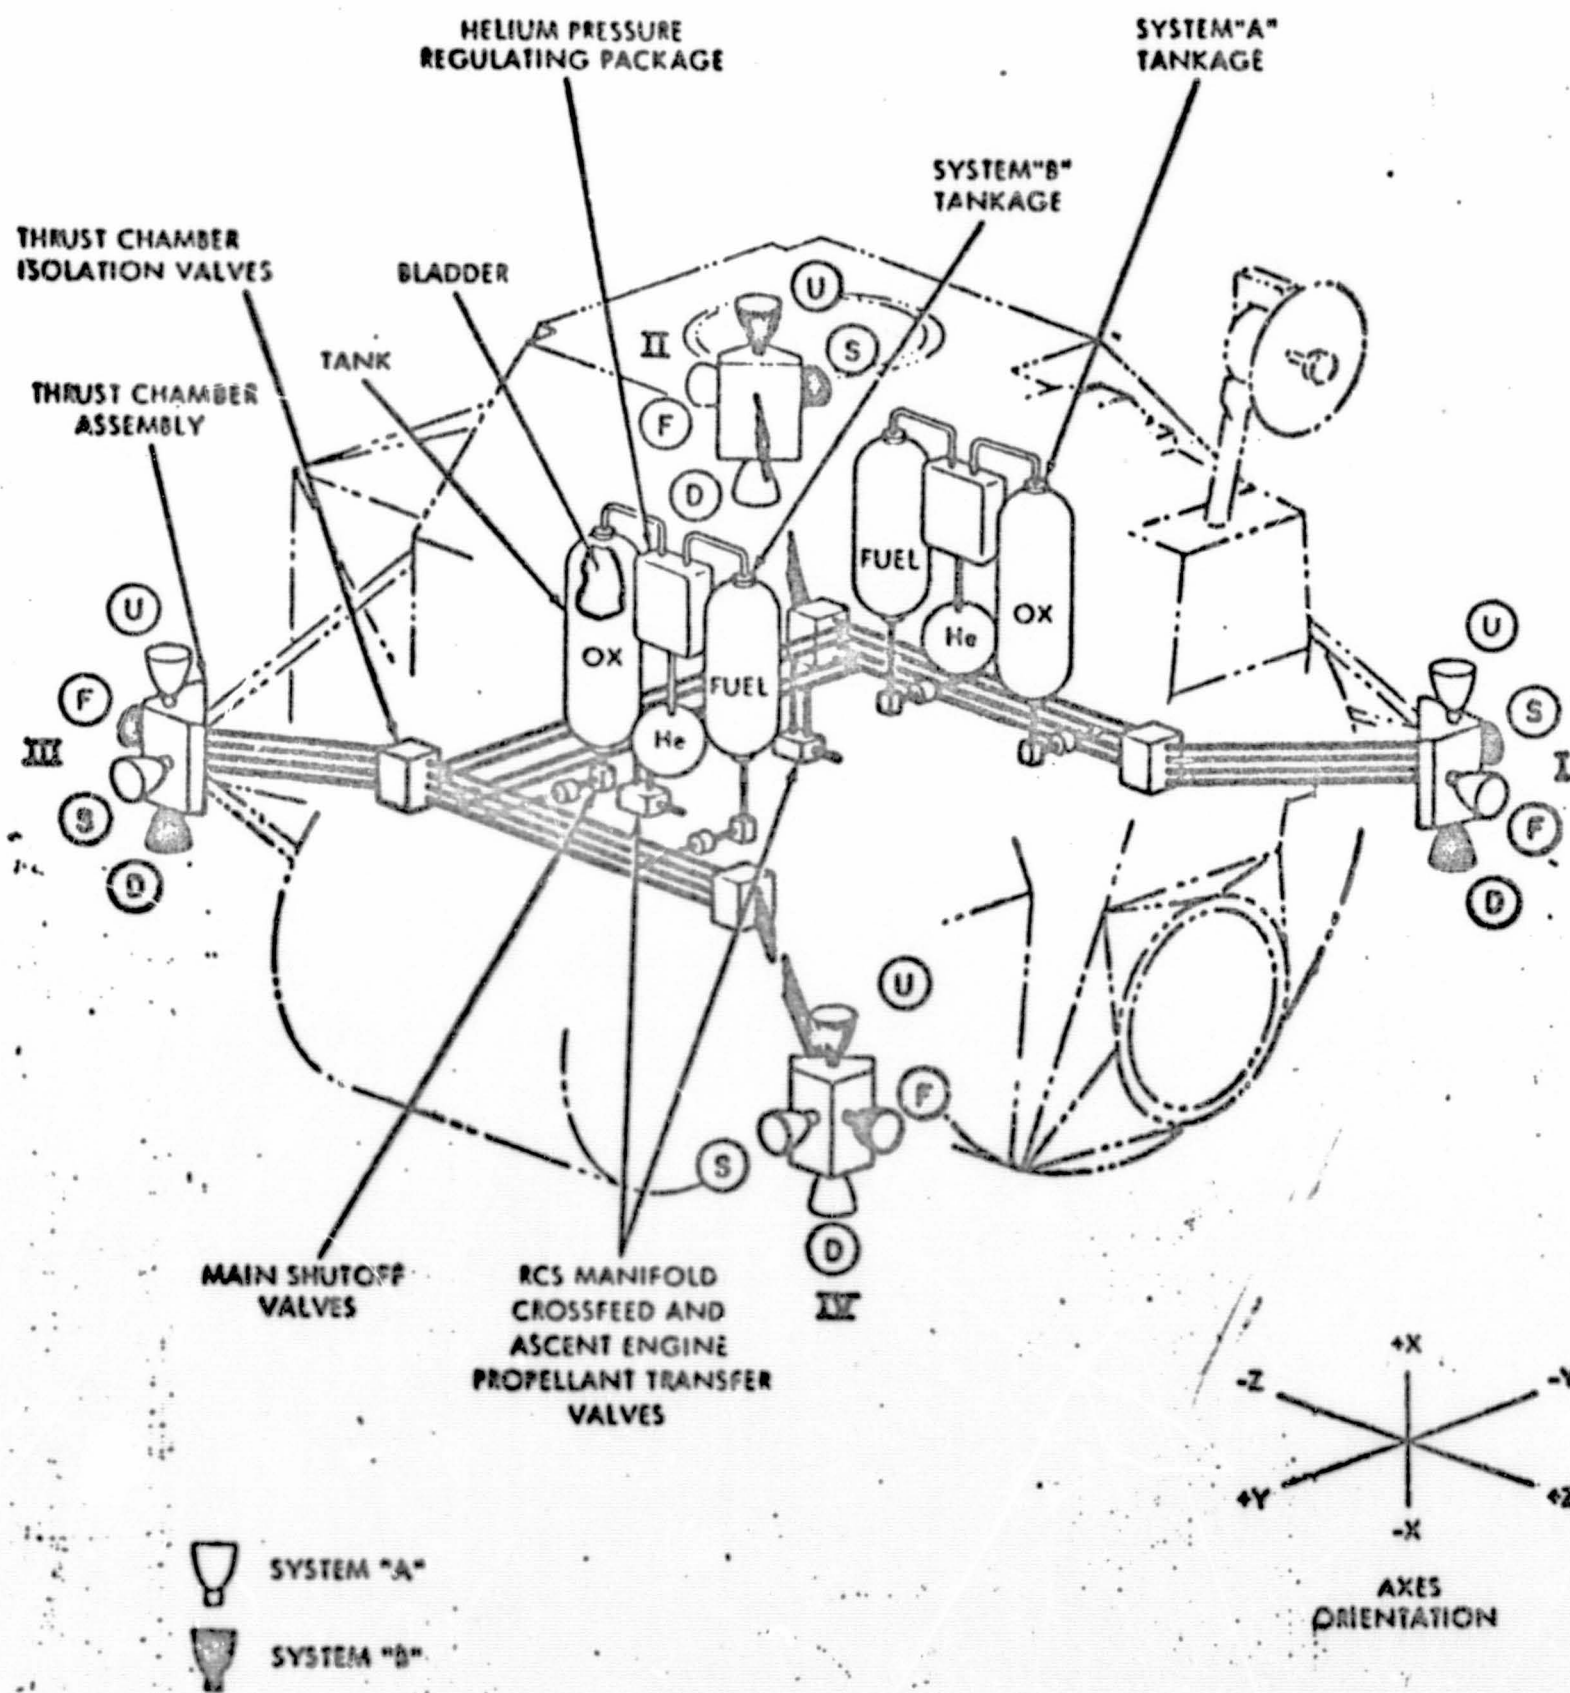
LM System Pictorial

Sixteen identical Marquardt 100 lb thrust R-4D engine assemblies are arranged in clusters of four and mounted on four outriggers at the corners of the LM vehicle. Spatially, the clusters are located at the corners of an ap-

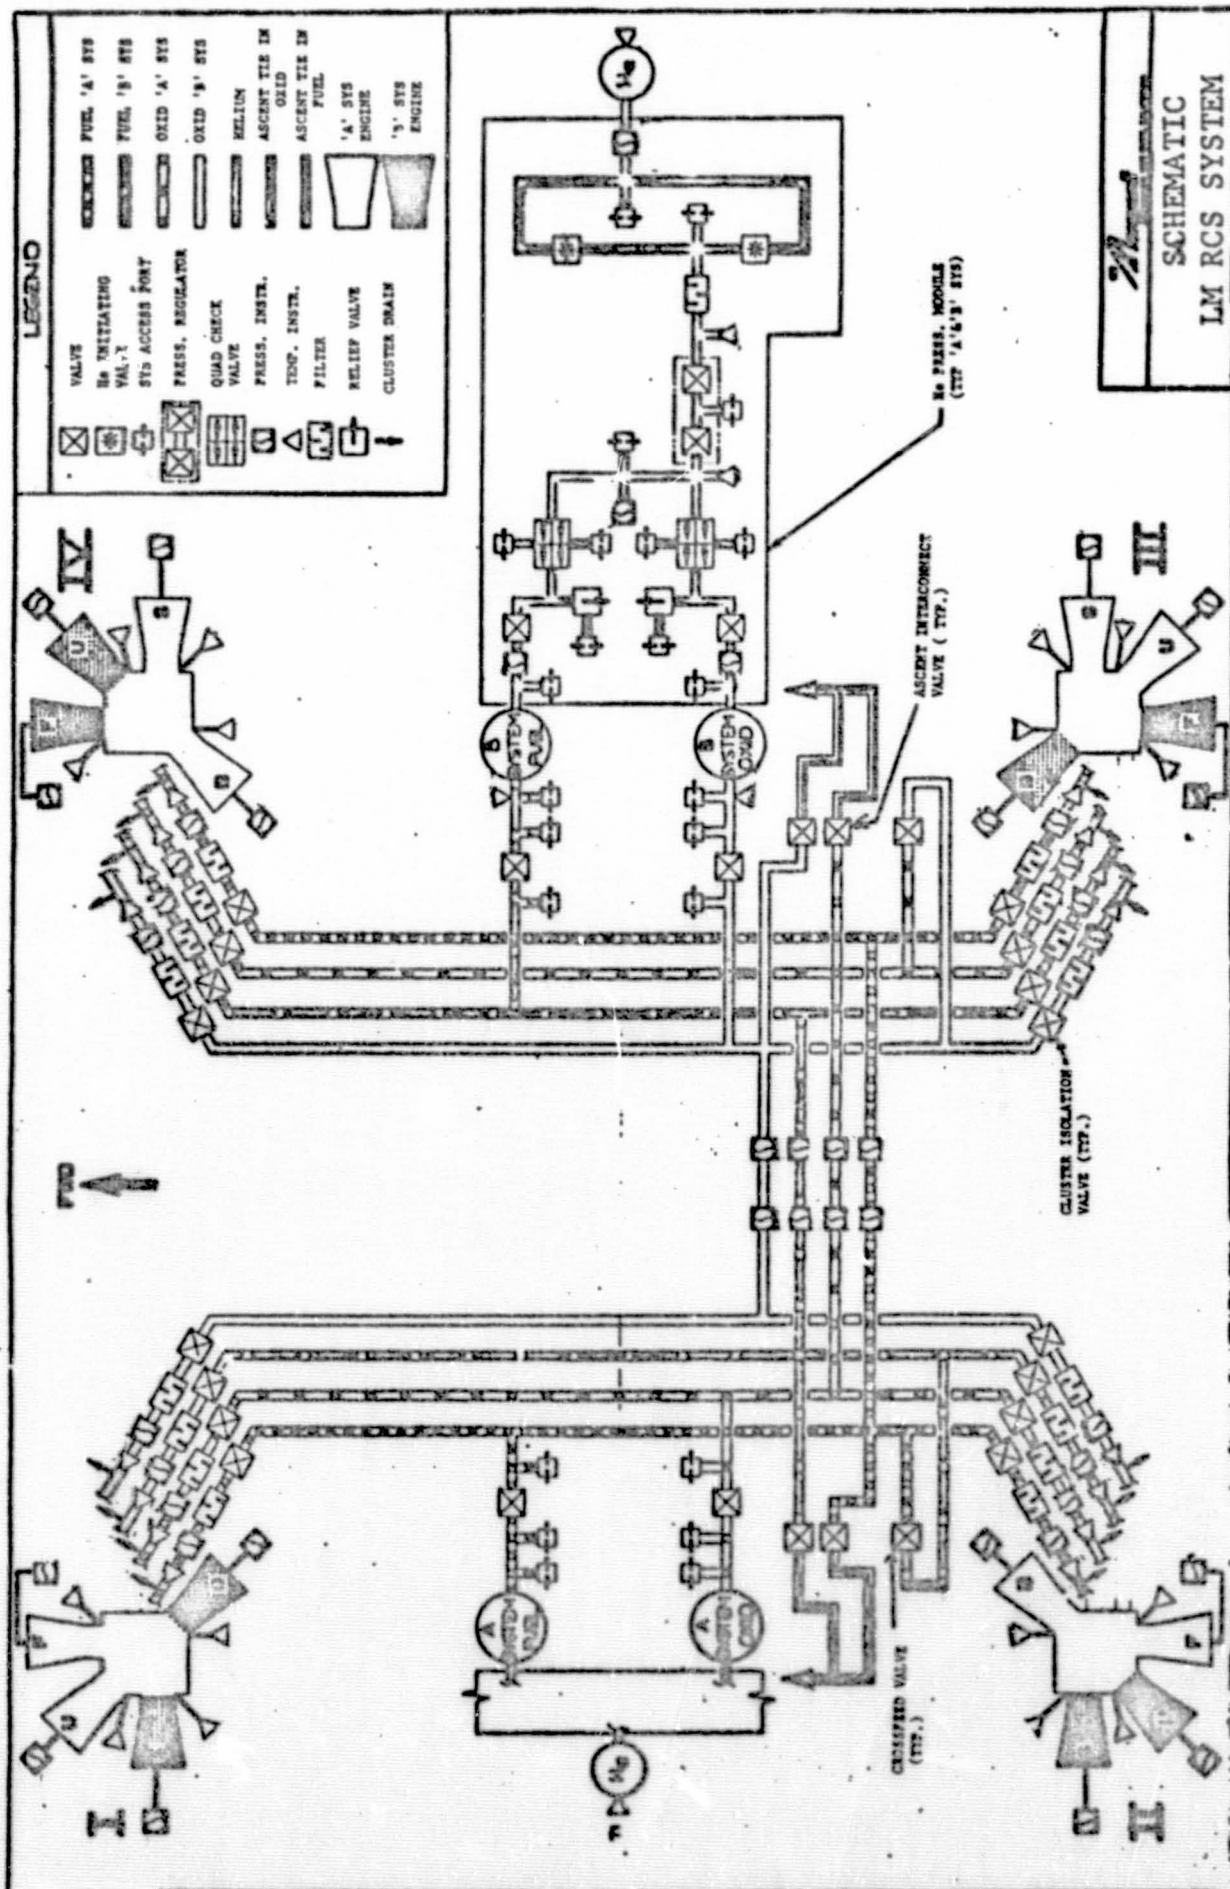
FIGURE 4

SCHEMATIC - LM RCS SYSTEM

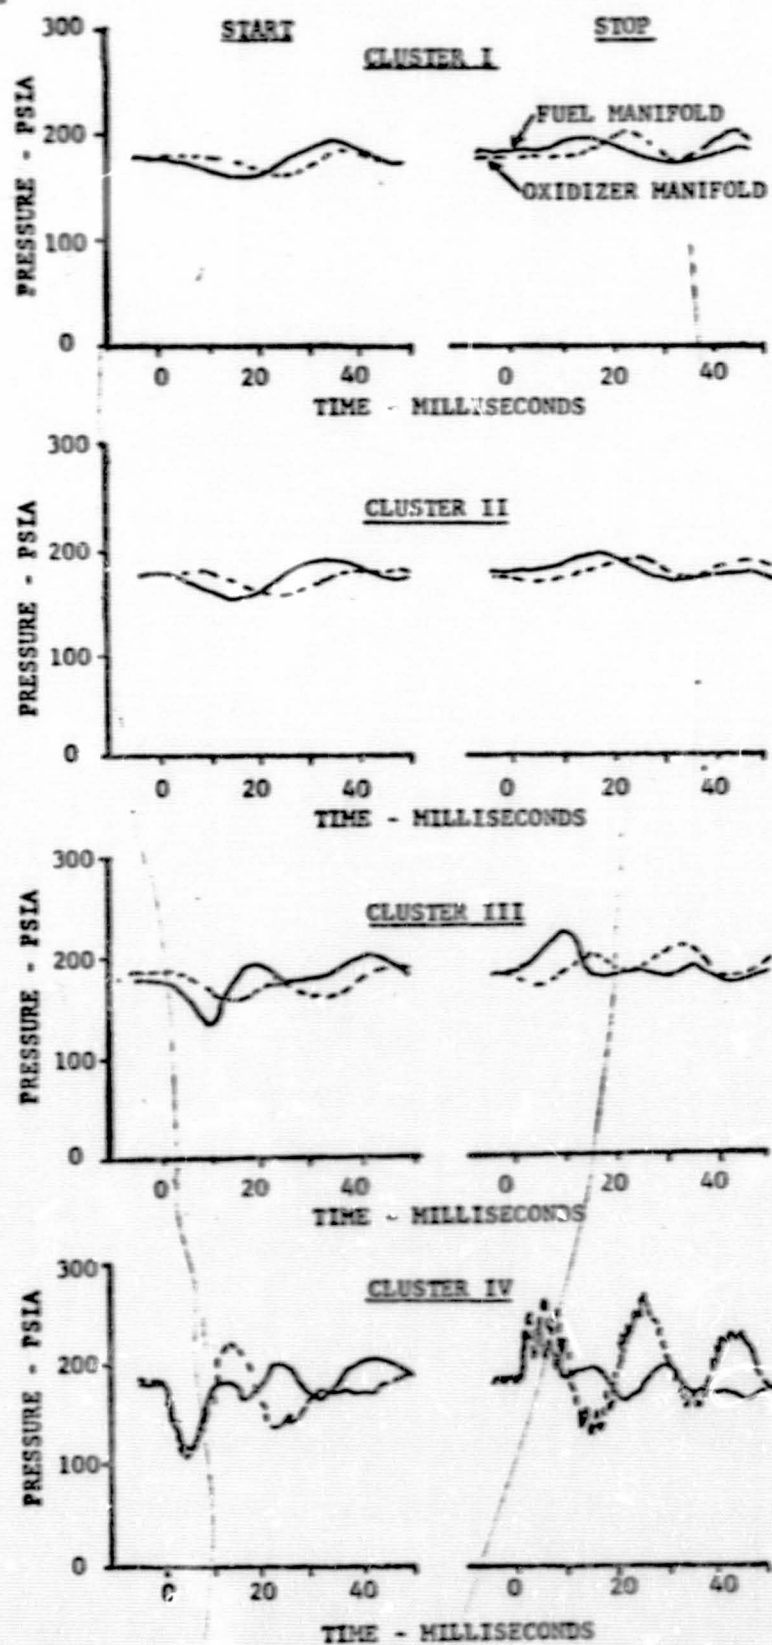
# PROPELLANT SYSTEM MANIFOLD PRESSURE TIME HISTORY SYSTEM A, ENGINE IVD FIRING

The firing of engine couples indicated that the initial transient of chamber pressure is affected by the location of the supply tankage. If the tankage to a particular engine is located far from the engine the initial chamber pressure rise is followed by a lower drop in pressure before recovery to its steady state value. Table V presents typical integrated chamber pressure data for engines of System A when fired as a couple at different pulse width. Also shown on the table, for comparison purposes, is the integrated chamber pressure of the engine when fired as a single engine in the system. The loss of impulse for engines located furthest from the supply tankage (Engines 3S and 4D) may be noted in Table V. The decrease in impulse is primarily attributed to the behavior of the initial transients; as the engine couples are fired for longer periods of time (as in the case of vehicle translation maneuvers) the percentage change in impulse is less.
