SUPER INSULATION SYSTEMS FOR  
CRYOGENIC TEST TANK

FINAL REPORT

CONTRACT NAS 8-11740  
AND  
CONTRACT NAS 8-24567

C. R. Lindquist  
Linde Division  
Huntsville, Alabama - 35801

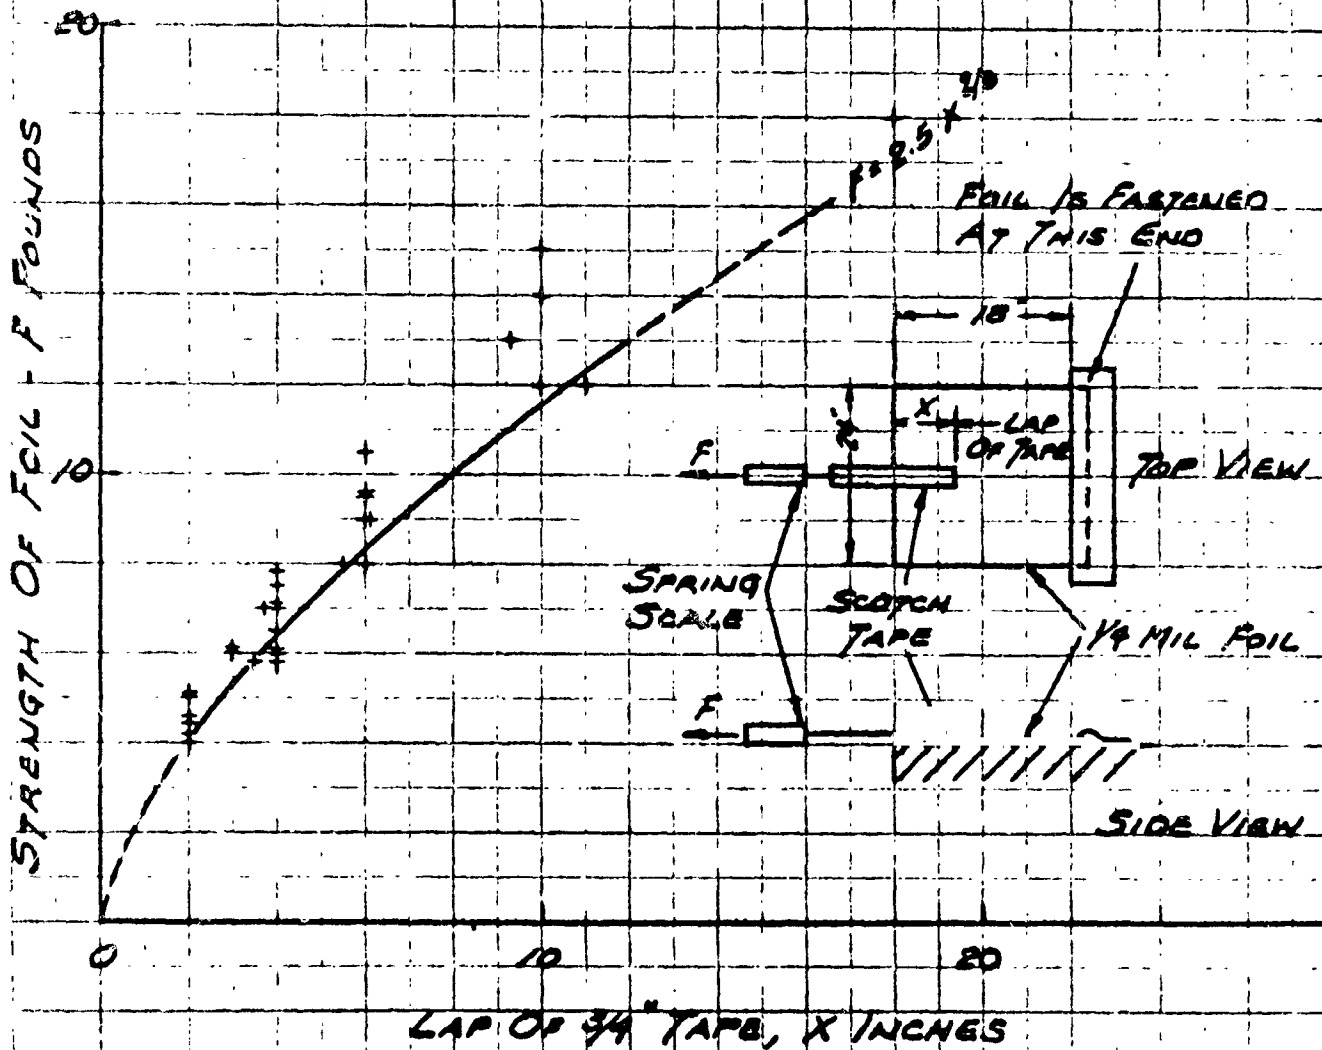
# STRENGTH OF $\frac{1}{4}$ MIL ALUMINUM FOIL LOADED BY $\frac{3}{4}$ " WIDE "SCOTCH NO. 600" TAPE

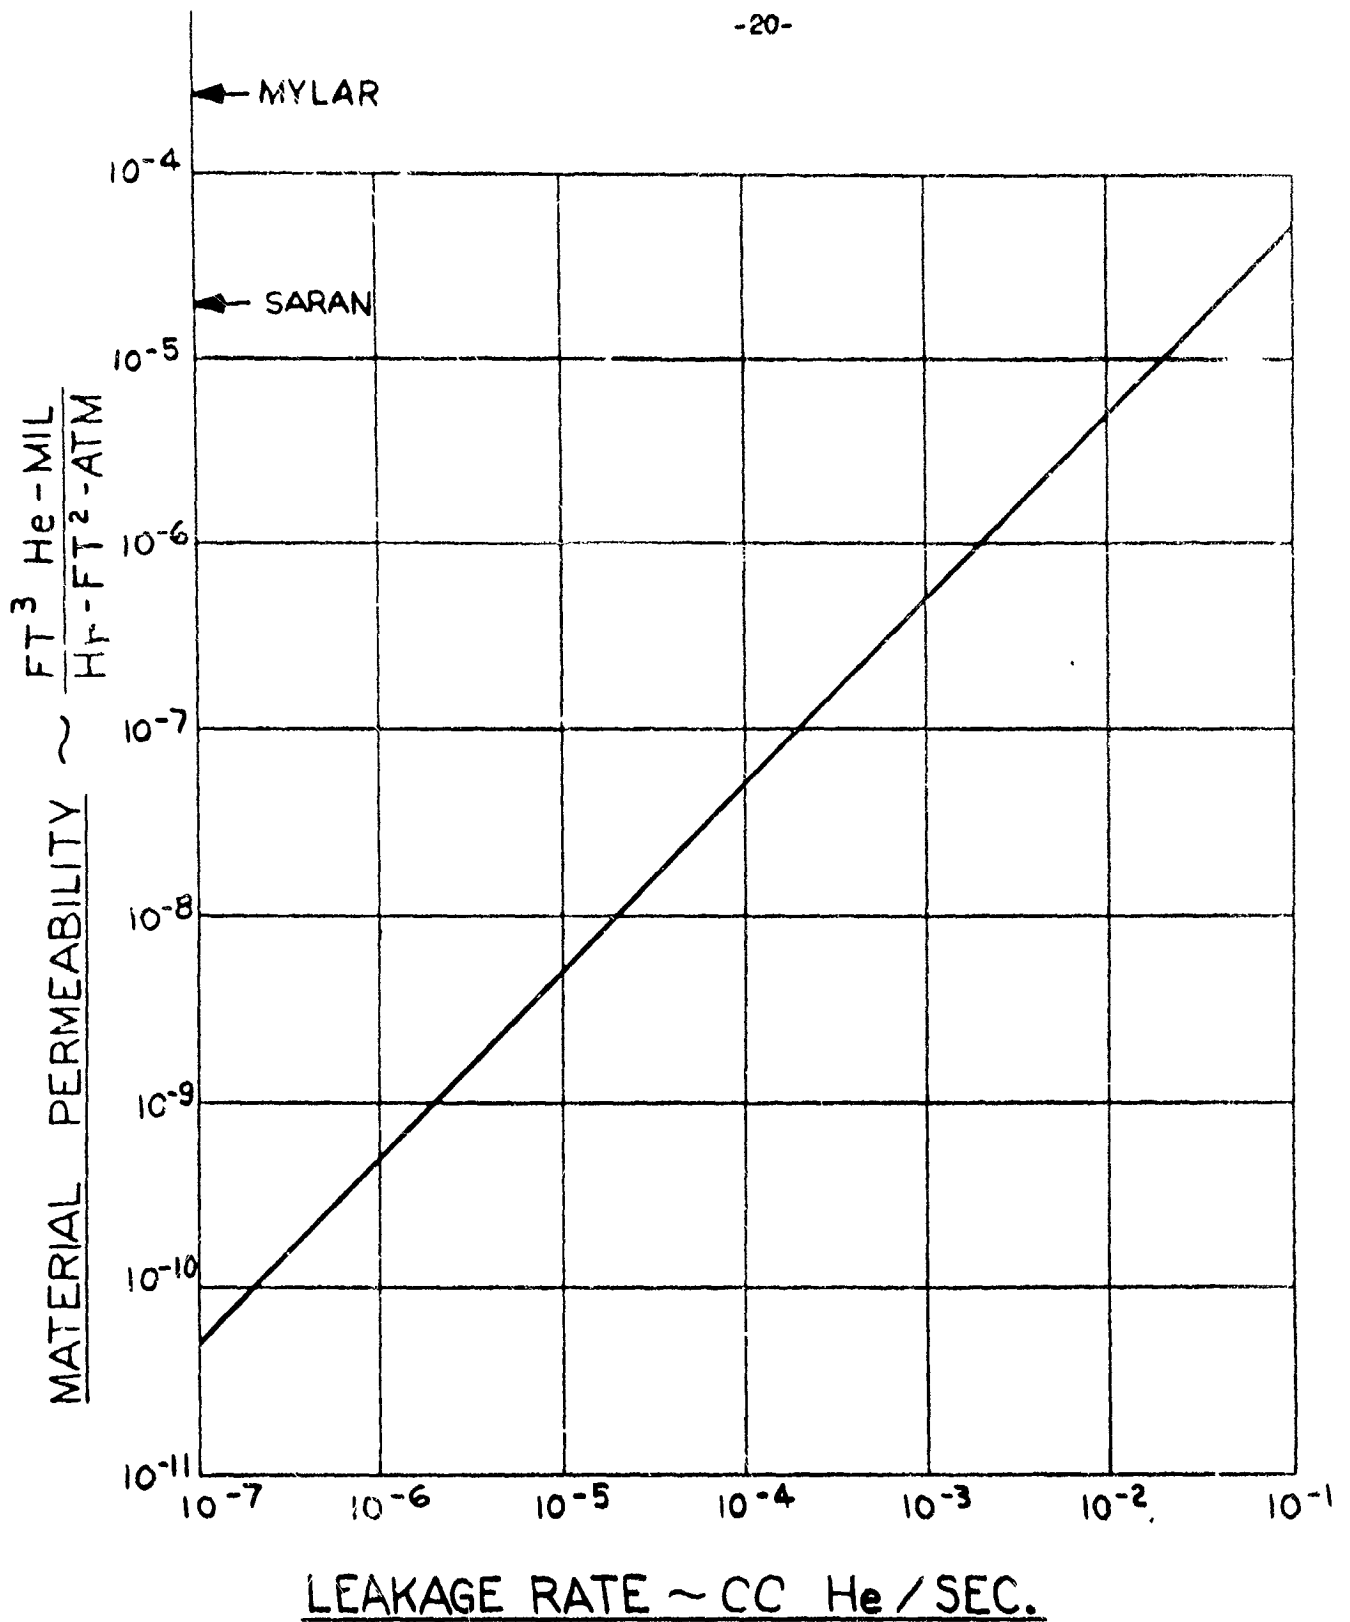
FIGURE 8

PERMEABILITY vs EQUIVALENT LEAKAGE  
105 INCH TANK

The purpose of the vacuum jacket is to maintain vacuum on the launch pad from the time the evacuation equipment is cut off until lift-off. It was determined that a period of fifteen hours vacuum hold time is acceptable. The leakage rate then becomes a function of the amount of adsorbent and the allowable pressure level at lift-off. In order to enhance evacuation and be conservative, a permeability after flexing of less than  $10^{-9} \text{ ft}^3 \text{He/hr.-ft}^2$  was taken as the goal. A plot of permeability versus overall helium leakage rate for the 105-inch diameter tank

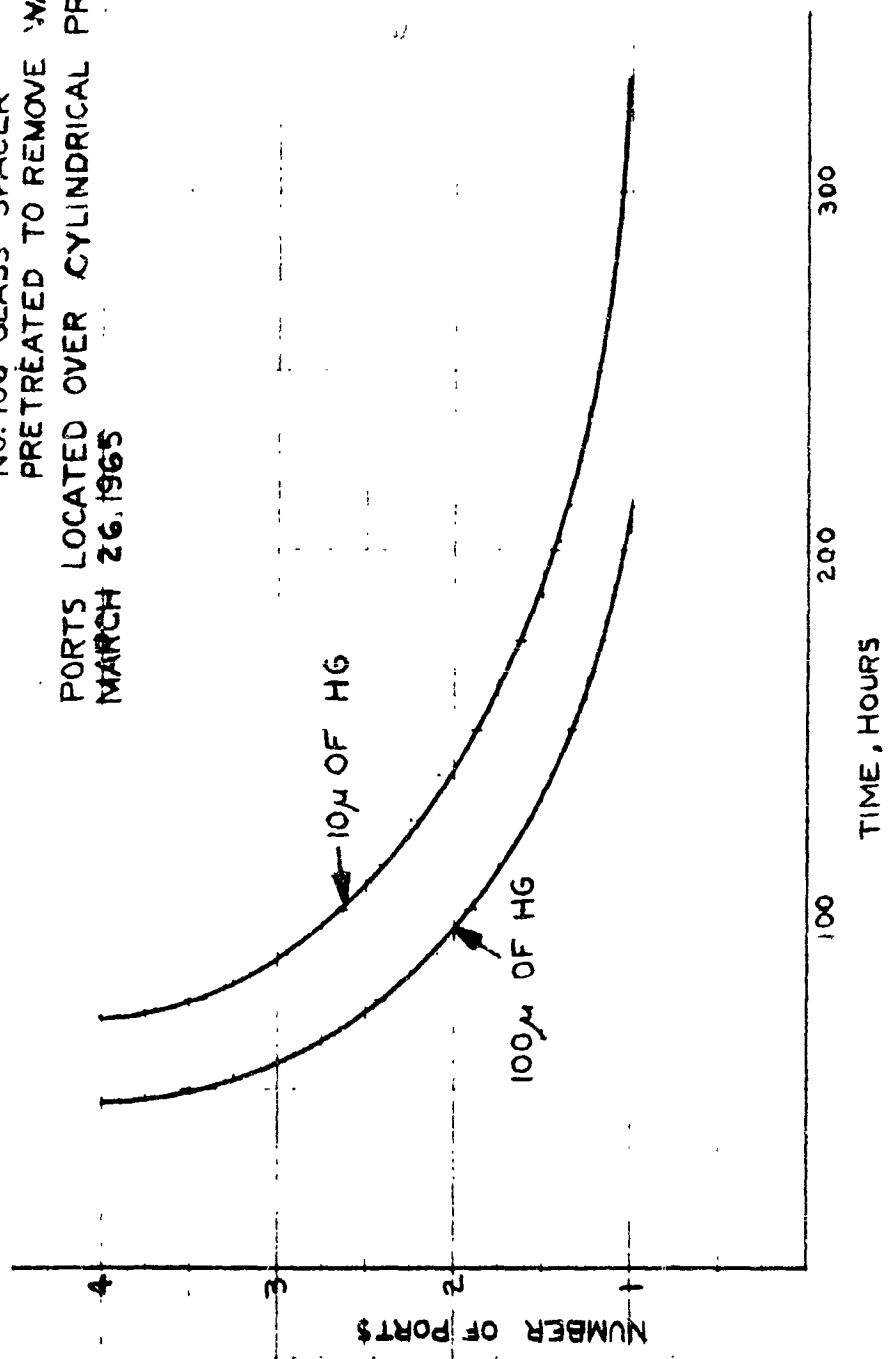
FIGURE 19

TIME TO EVACUATE 105 INCH DIA. TANK  
INSULATION: 70 LAYERS OF  
0.25 MIL. ALUMINUM FOIL AND  
NO. 106 GLASS SPACER  
PRETREATED TO REMOVE WATER  
PORTS LOCATED OVER CYLINDRICAL PROTRUSIONS  
MARCH 26, 1965

conductance for this system is 0.09 cfh. As discussed above, the time required to evacuate the insulation to 100 microns of mercury with these four evacuation ports, and assuming that leakage is insignificant, is 45.7 hours.

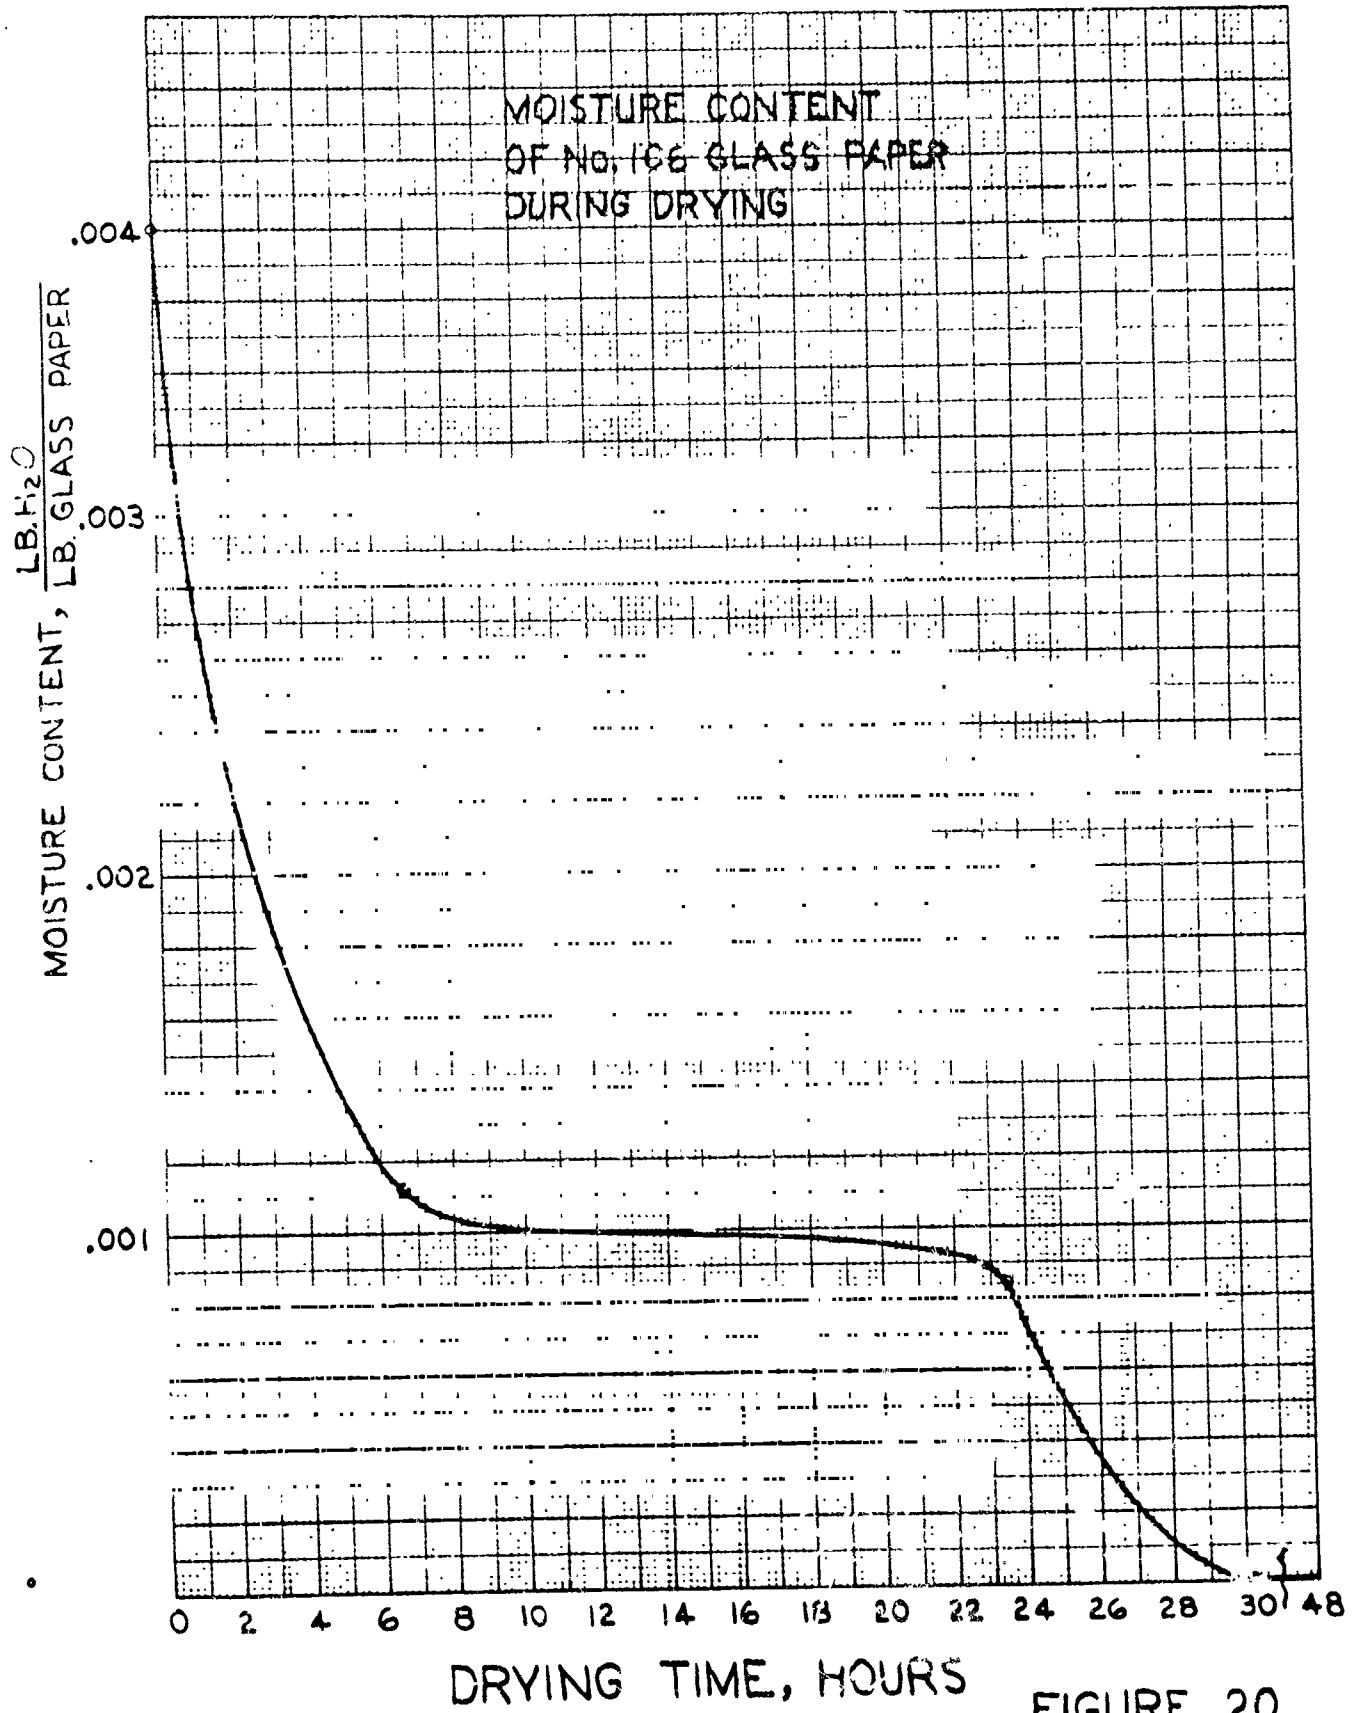
FIGURE 20

In order to determine the rate of moisture adsorption of No. 106 glass paper, two samples were first dried in a furnace at 300°F for forty-eight hours. Moisture adsorption was calculated from the progressive increase

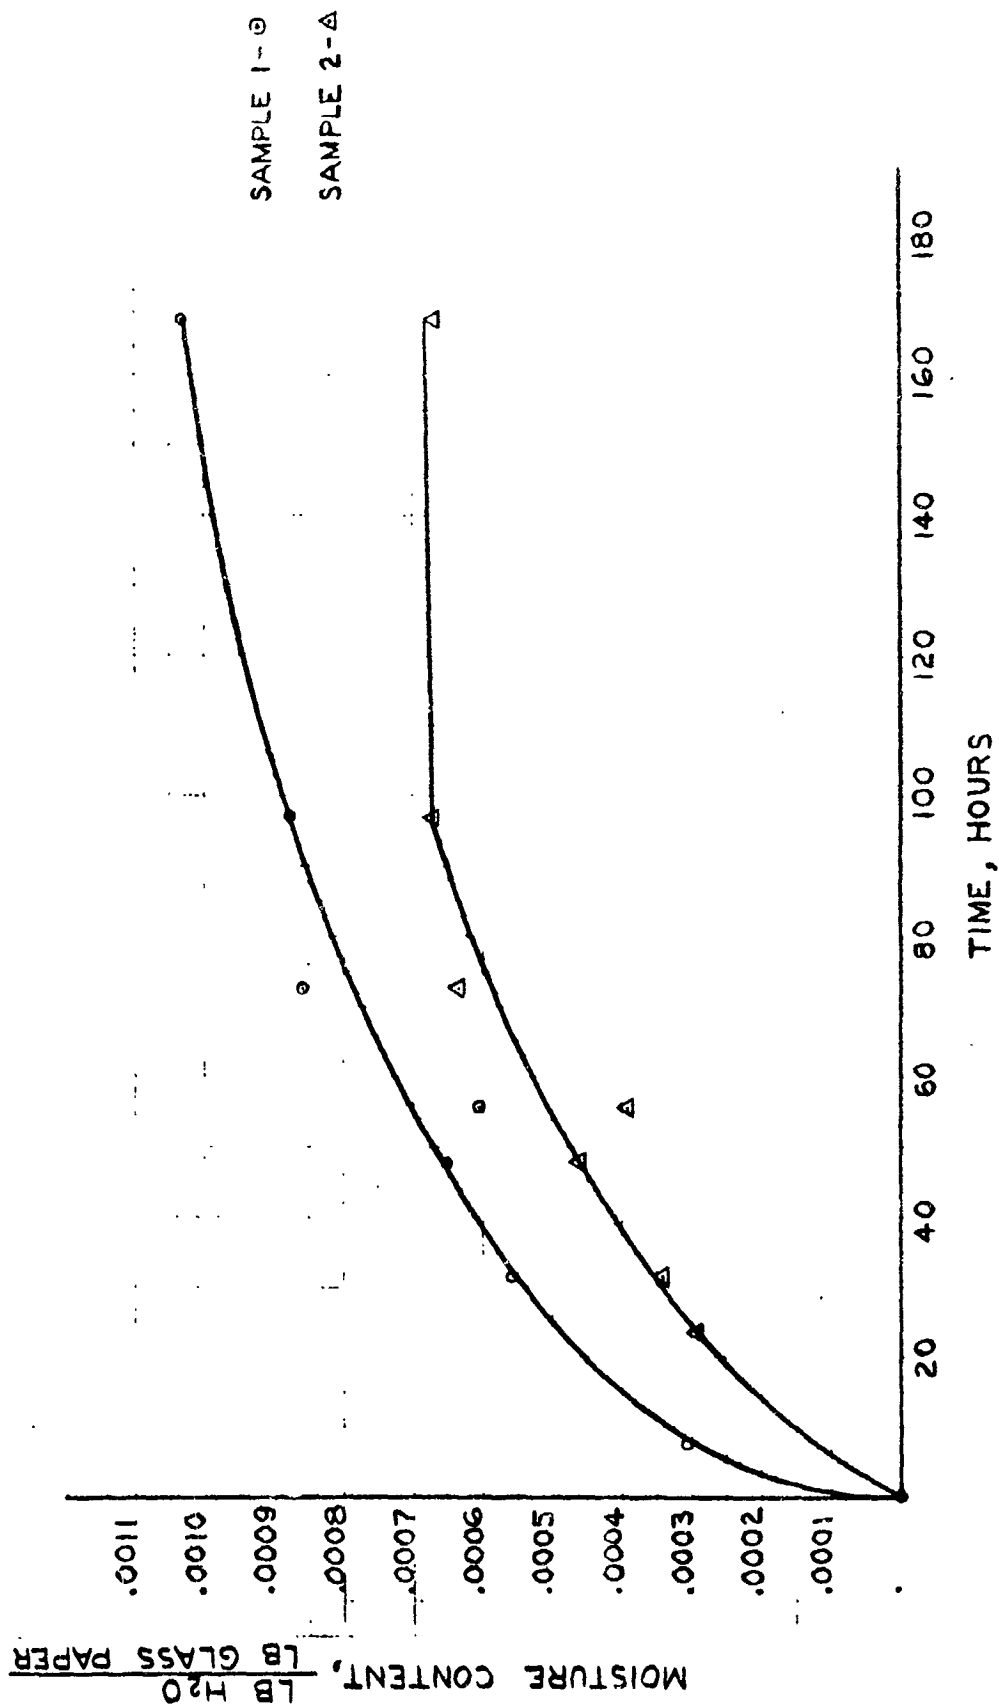
FIGURE 21

# MOISTURE ADSORPTION OF No. 106 GLASS PAPER

in weight of the samples after exposure to the air. Figure 21 shows a plot of moisture content as a function of exposure time for a one-week period. After one week's exposure, in a room with an average relative humidity of 36 per cent, Sample 1 contained 0.00104 lb-water/lb-glass and Sample 2 seemed to level off at 0.000675 lb-water/lb-glass.

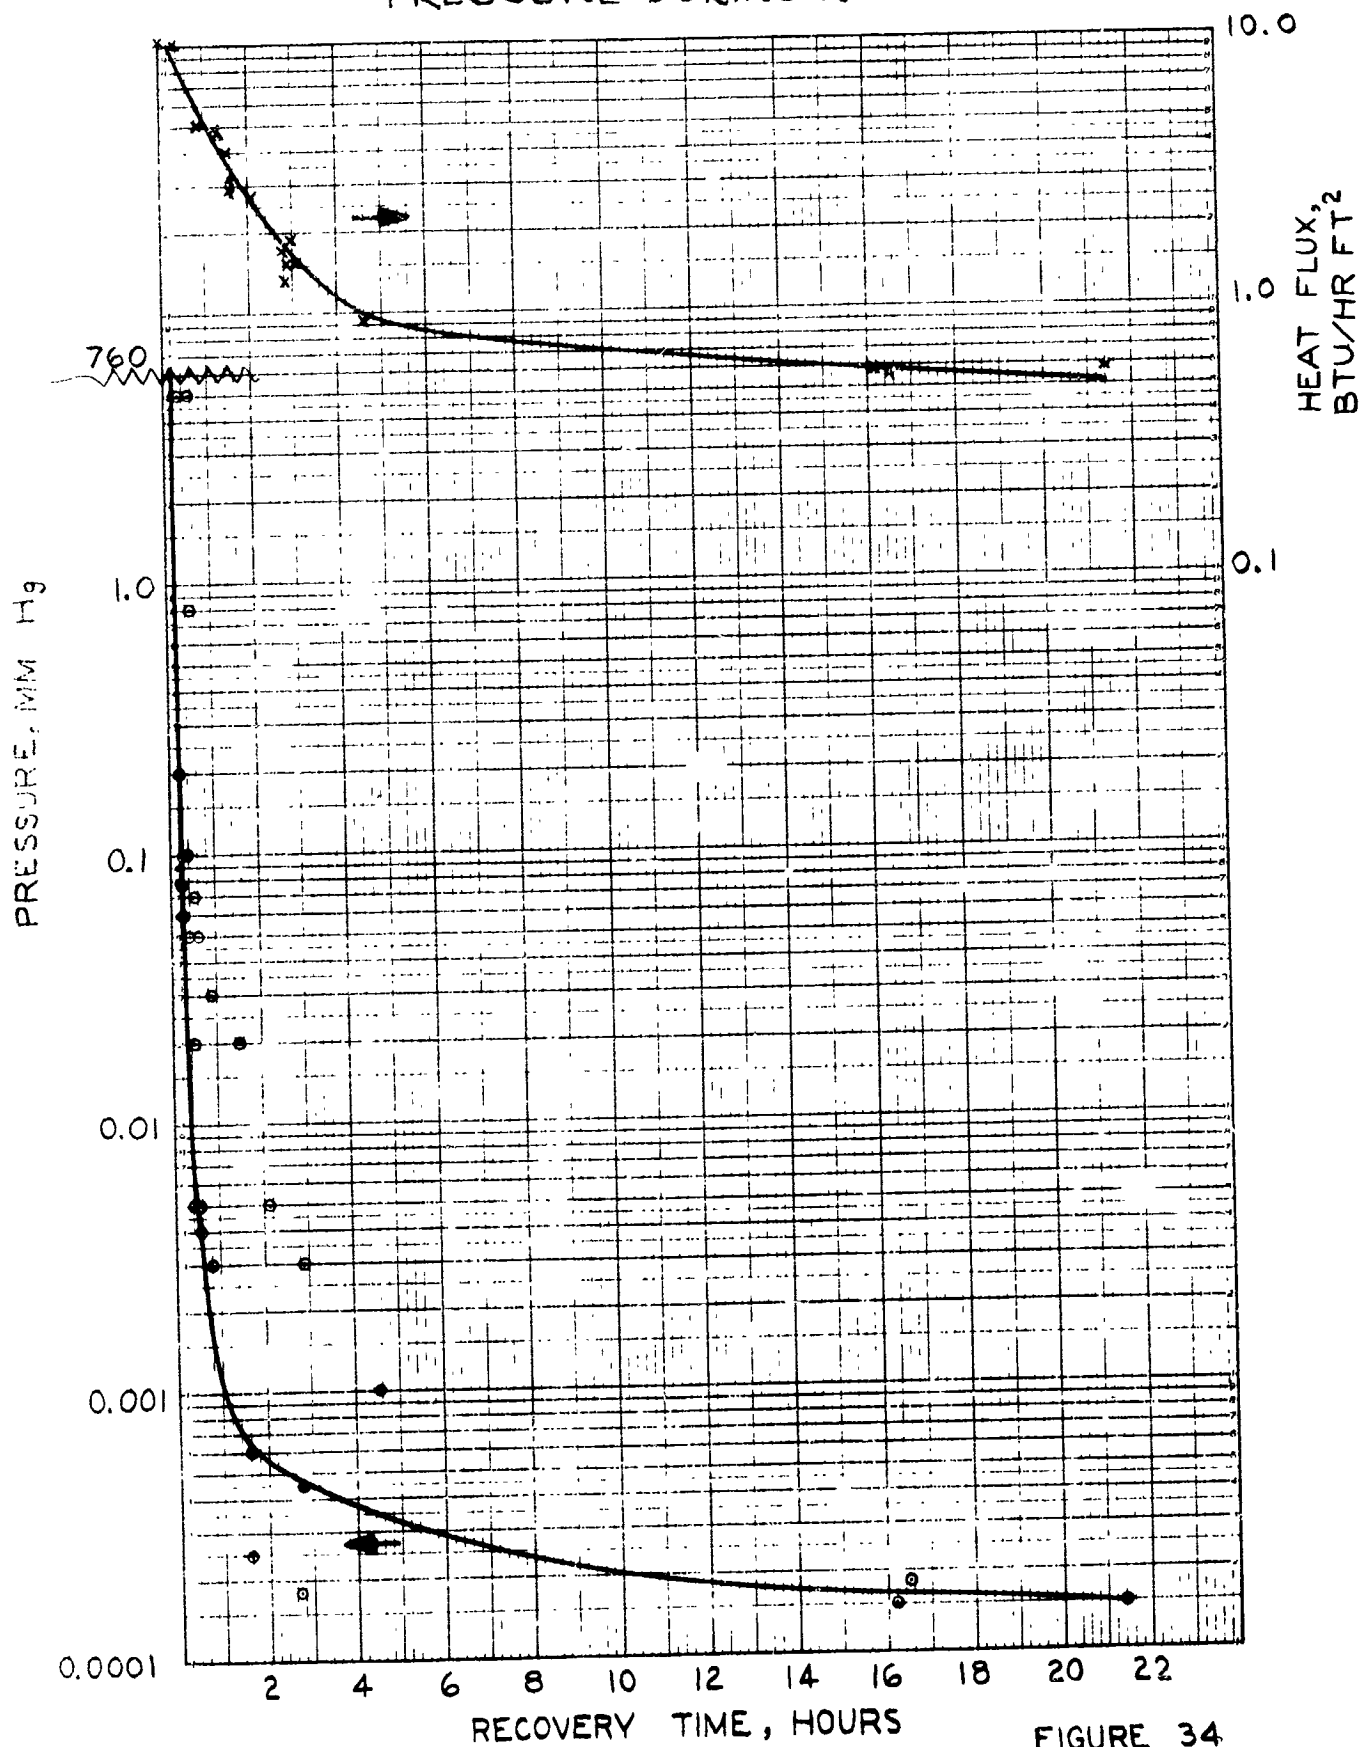
FIGURE 34

# INSULATION HEAT FLUX AND BELL JAR PRESSURE DURING RECOVERY

An NER test conducted on the recovered insulation, after the fifth cycle, for a 35 hour period, disclosed a heat leak of 7.8 Btu/hr.

Later tests showed that 1.2 Btu/hr. of this heat leak can be attributed to the necktube sleeve, making the heat leak chargeable to the insulation in this case 6.6 Btu/hr. NER tests conducted for approximately 15 hour periods at the conclusion of compression cycles seven and ten disclosed heat leaks of 7.3 and 7.1 Btu/hr. respectively. The heat leaks reached in these 15 hour periods do not represent thermal equilibrium because of the short time period, and since the heat leak after ten compressions was less than that after seven compressions, it is believed that overall insulation performance was not degraded from that of the fifth cycle.

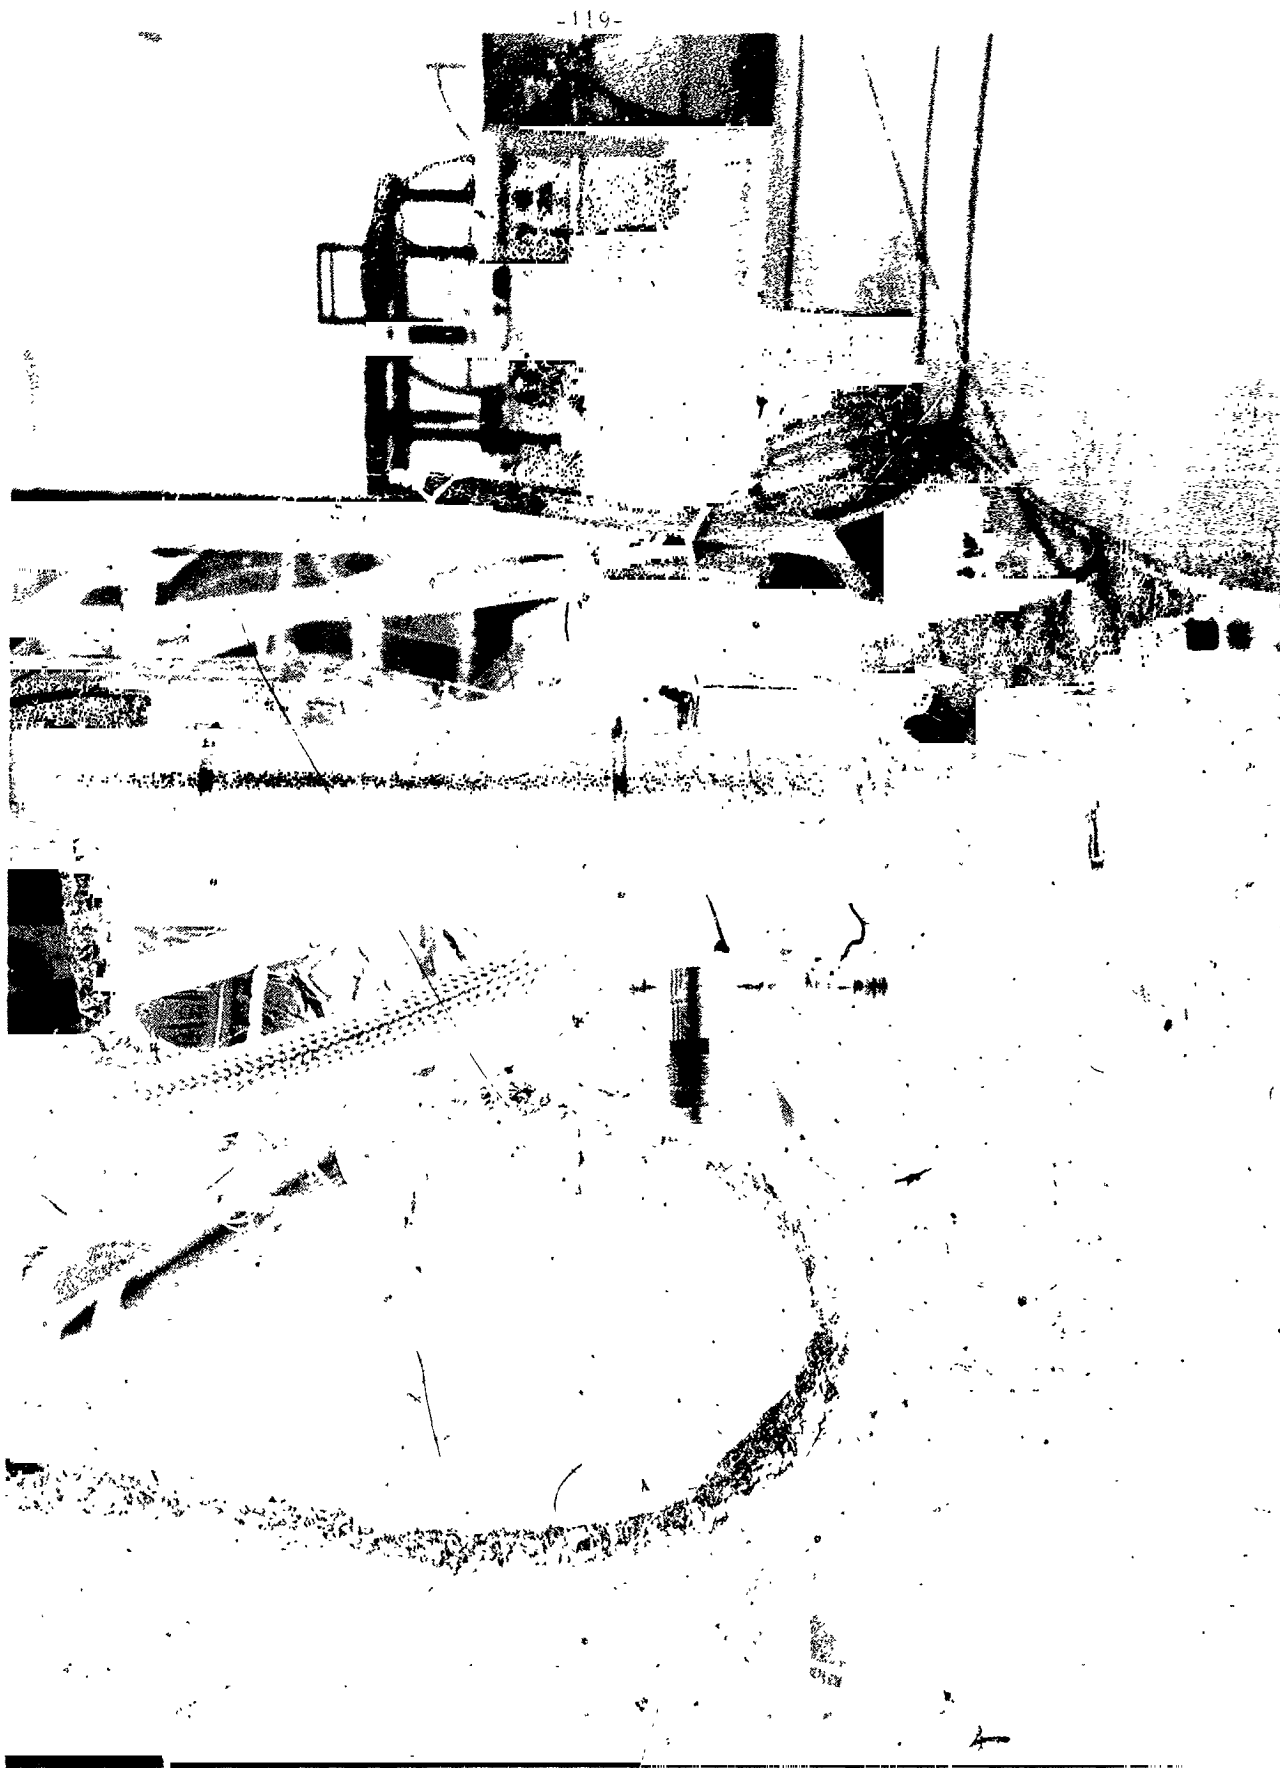
FIGURE 65 - Air Heater for Tank Purge

The evacuation process was probably further complicated by residual moisture in the molecular sieve trap although it is impossible to estimate the extent of this complication. An air heater, shown in Figure 65, was used to

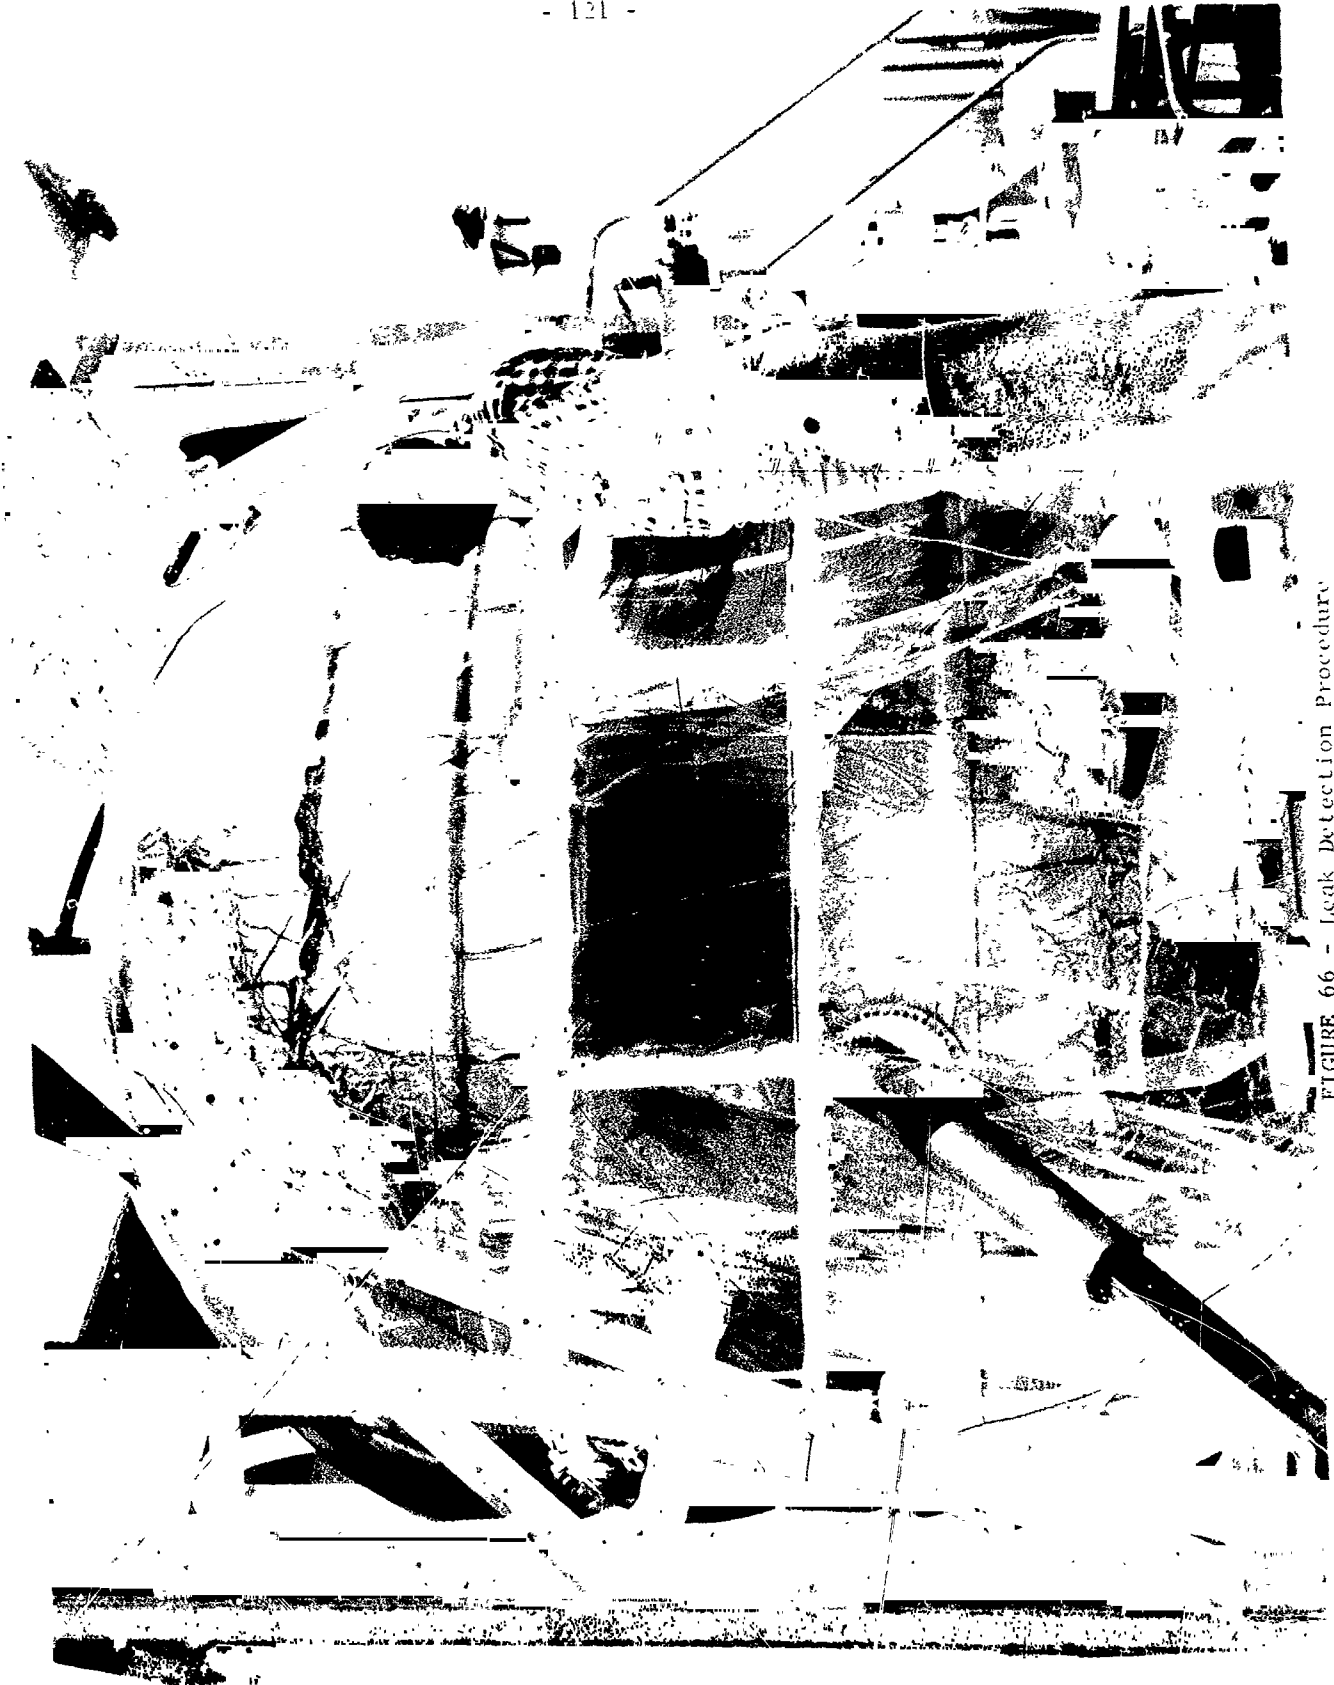
FIGURE 66 - Leak Detection Procedure

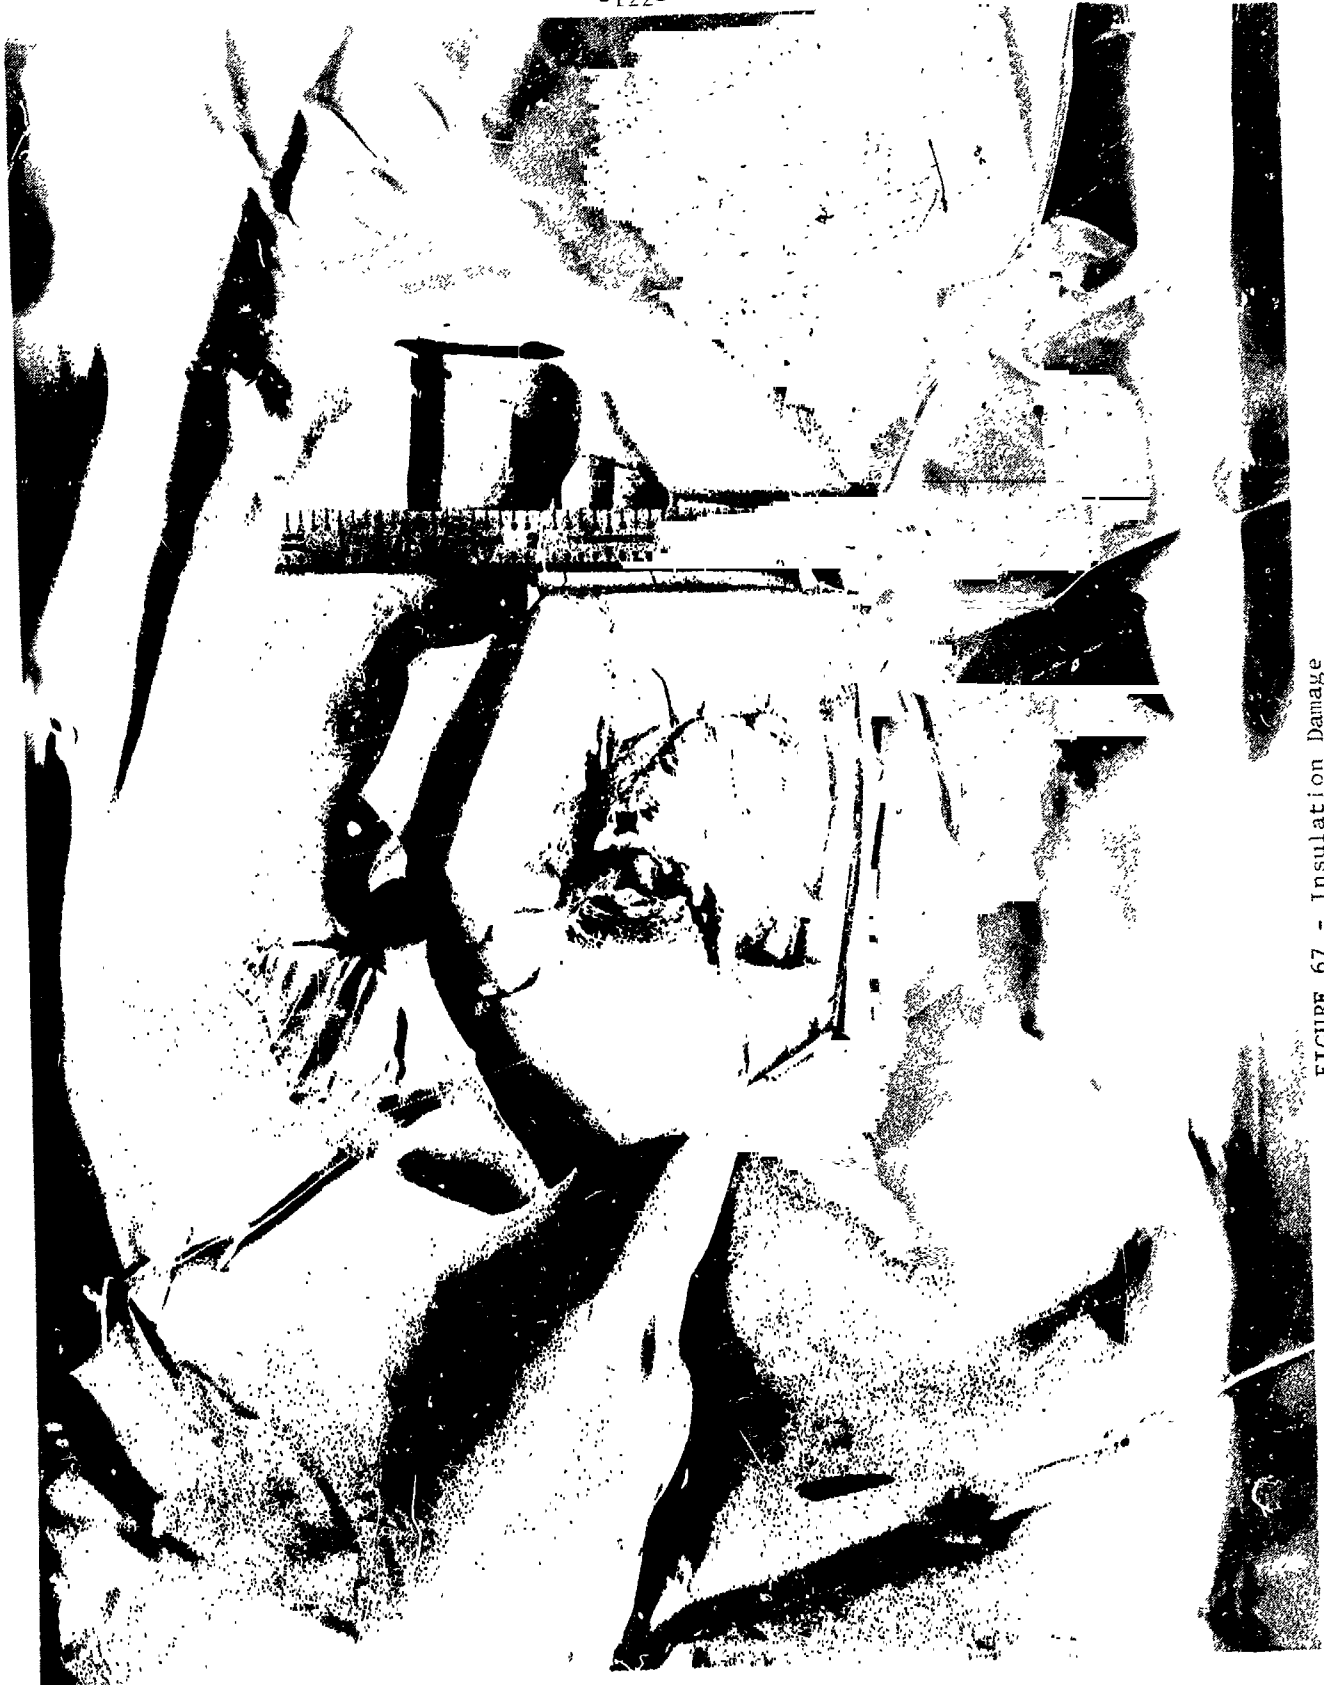
FIGURE 67 - Insulation Damage

Another serious mishap occurred during the first attempted altitude test. There was hydrogen gas leakage around the manhole cover seal at the top of the tank under the insulation. The resulting over-pressure under the manhole cover insulation tore the jacket apart and damaged a number of layers of insulation as can be seen in Figure 71. In order to make a more reliable system, a doubler was welded around the manhole cover to preclude leakage in that area. New insulation materials were interleaved over the top bulkhead replacing the original separate manhole cover panel. This new interleaving caused a buildup in thickness of the insulation in that area. As a result the

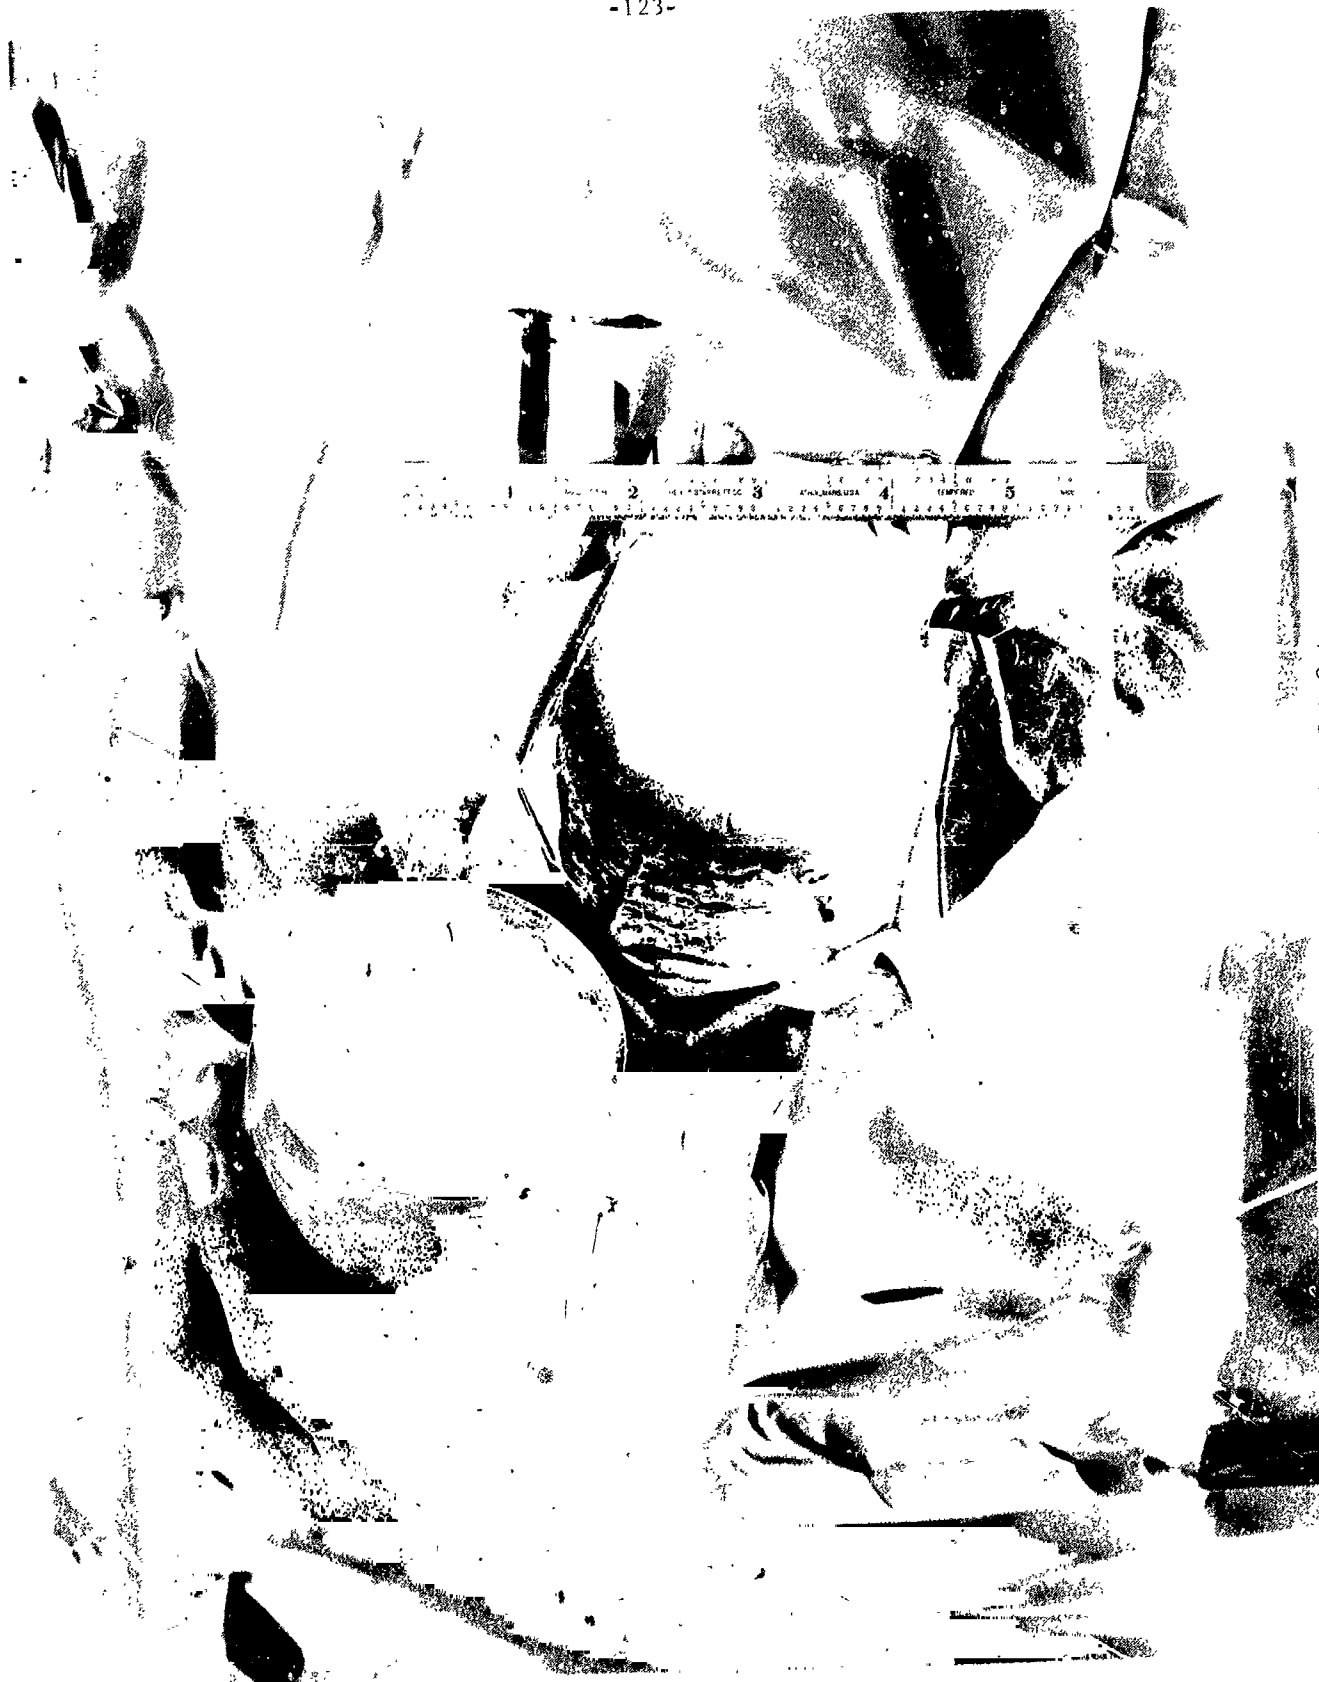
FIGURE 68 - Insulation Cut-Out

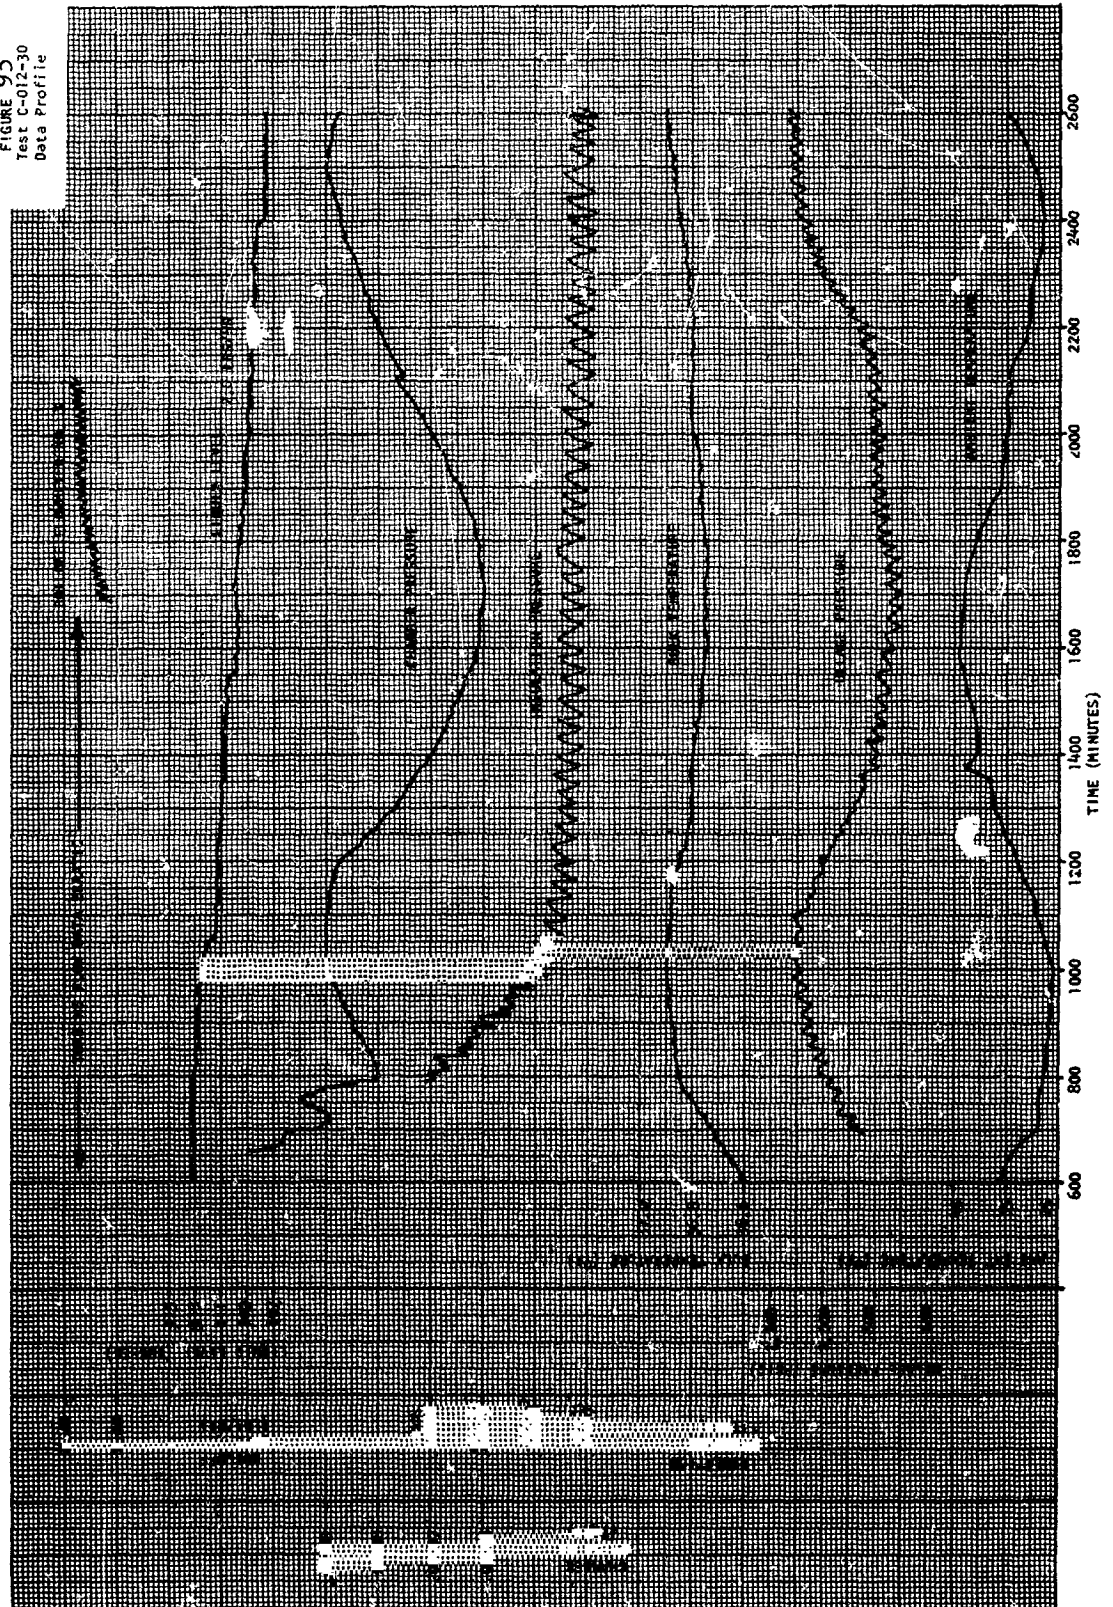
FIGURE 95  
Test C-012-30  
Data Profile

obtained. This is to be expected because the data were taken some 2,000 minutes into the test (as was true of the previous test also), well after the helium gas had been pumped out of the insulation space. Since the results are so similar, it can be concluded that little or no "fluffing" action resulted from the purge and a recovered insulation thickness and apparent thermal conductivity similar to that experienced previously resulted.
