SUPER INSULATION SYSTEMS FOR  
CRYOGENIC TEST TANK

FINAL REPORT

CONTRACT NAS 8-11740  
AND  
CONTRACT NAS 8-24567

C. R. Lindquist  
Linde Division  
Huntsville, Alabama - 35801

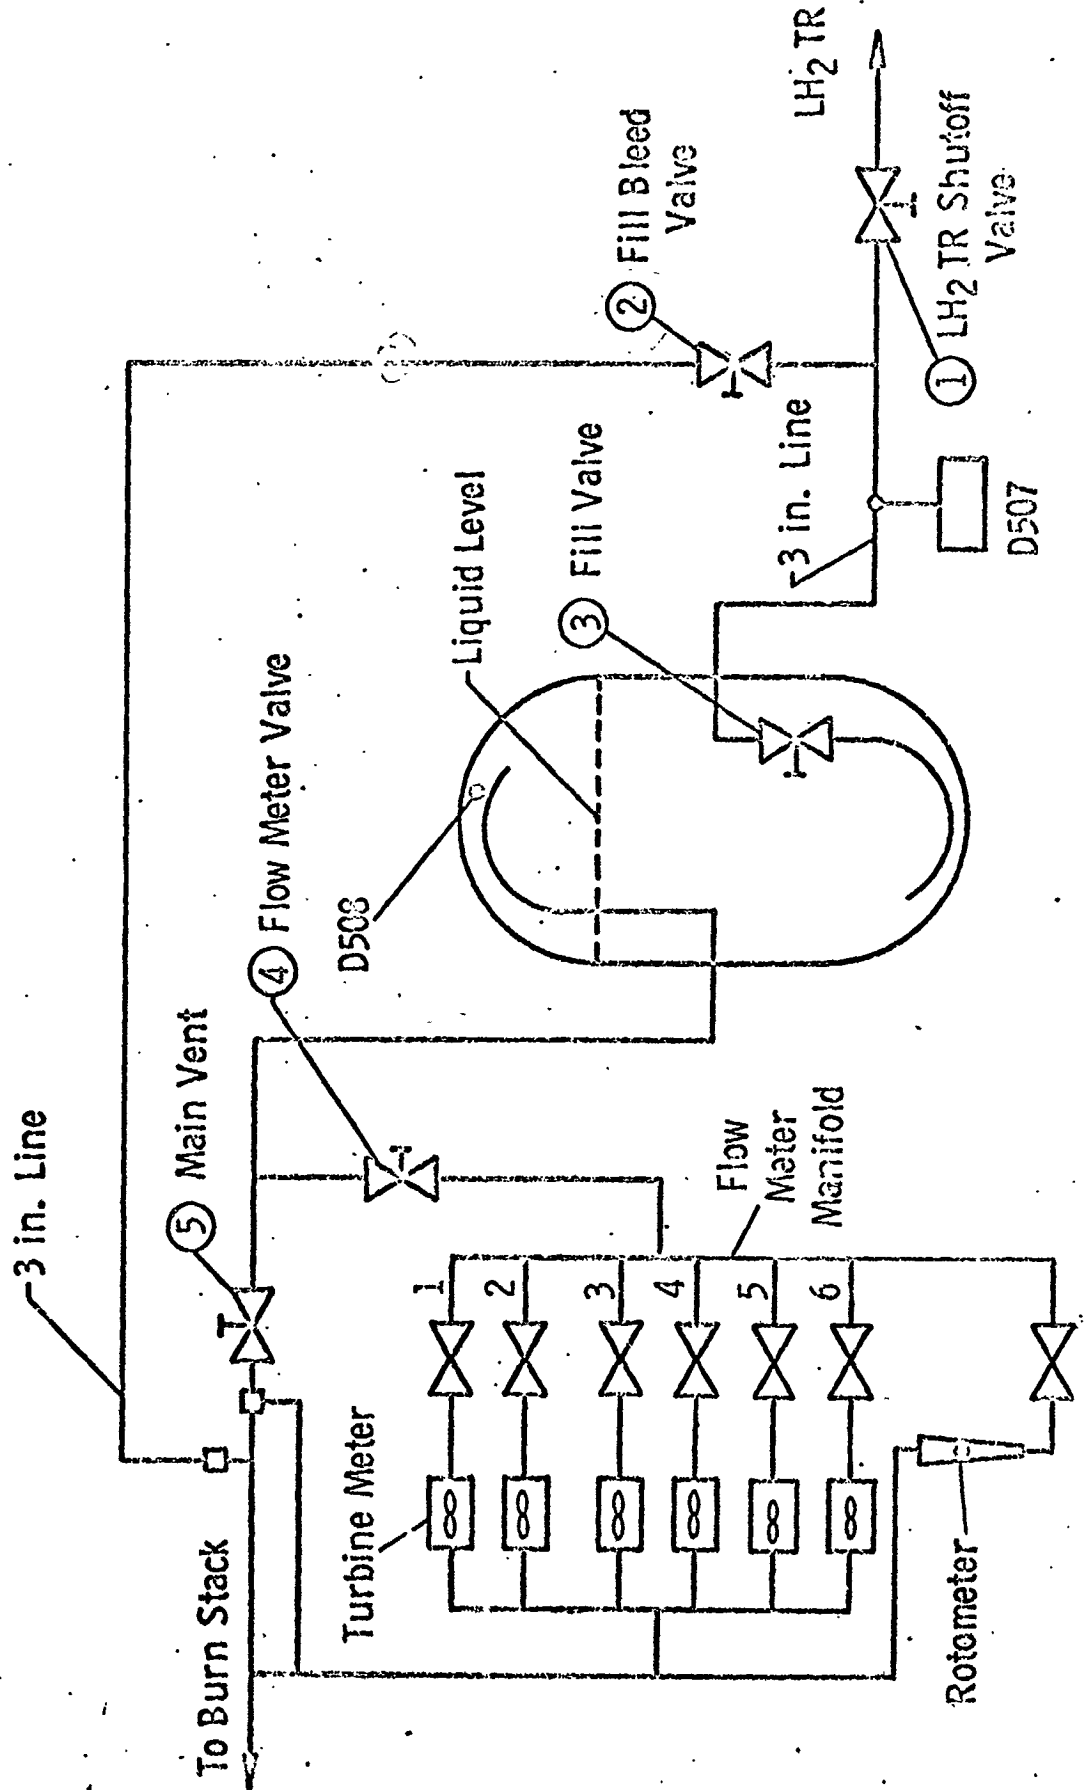
FIGURE 96  
SIMPLIFIED FLOW SCHEMATIC

Referring to the simplified test flow schematic shown in Figure 96 with the fill valve No. 3 leaking and the fill bleed valve No. 2 open, one would expect that the majority of the flow from the tank would be caused by gravity head to flow through the fill line, vaporize and bypass the metering system as was actually experienced. However, it was also noted that with the same condition except with the fill bleed valve closed, an increase in total boiloff resulted. This is probably due to a percolating effect within the fill line but there is no data to prove this point.

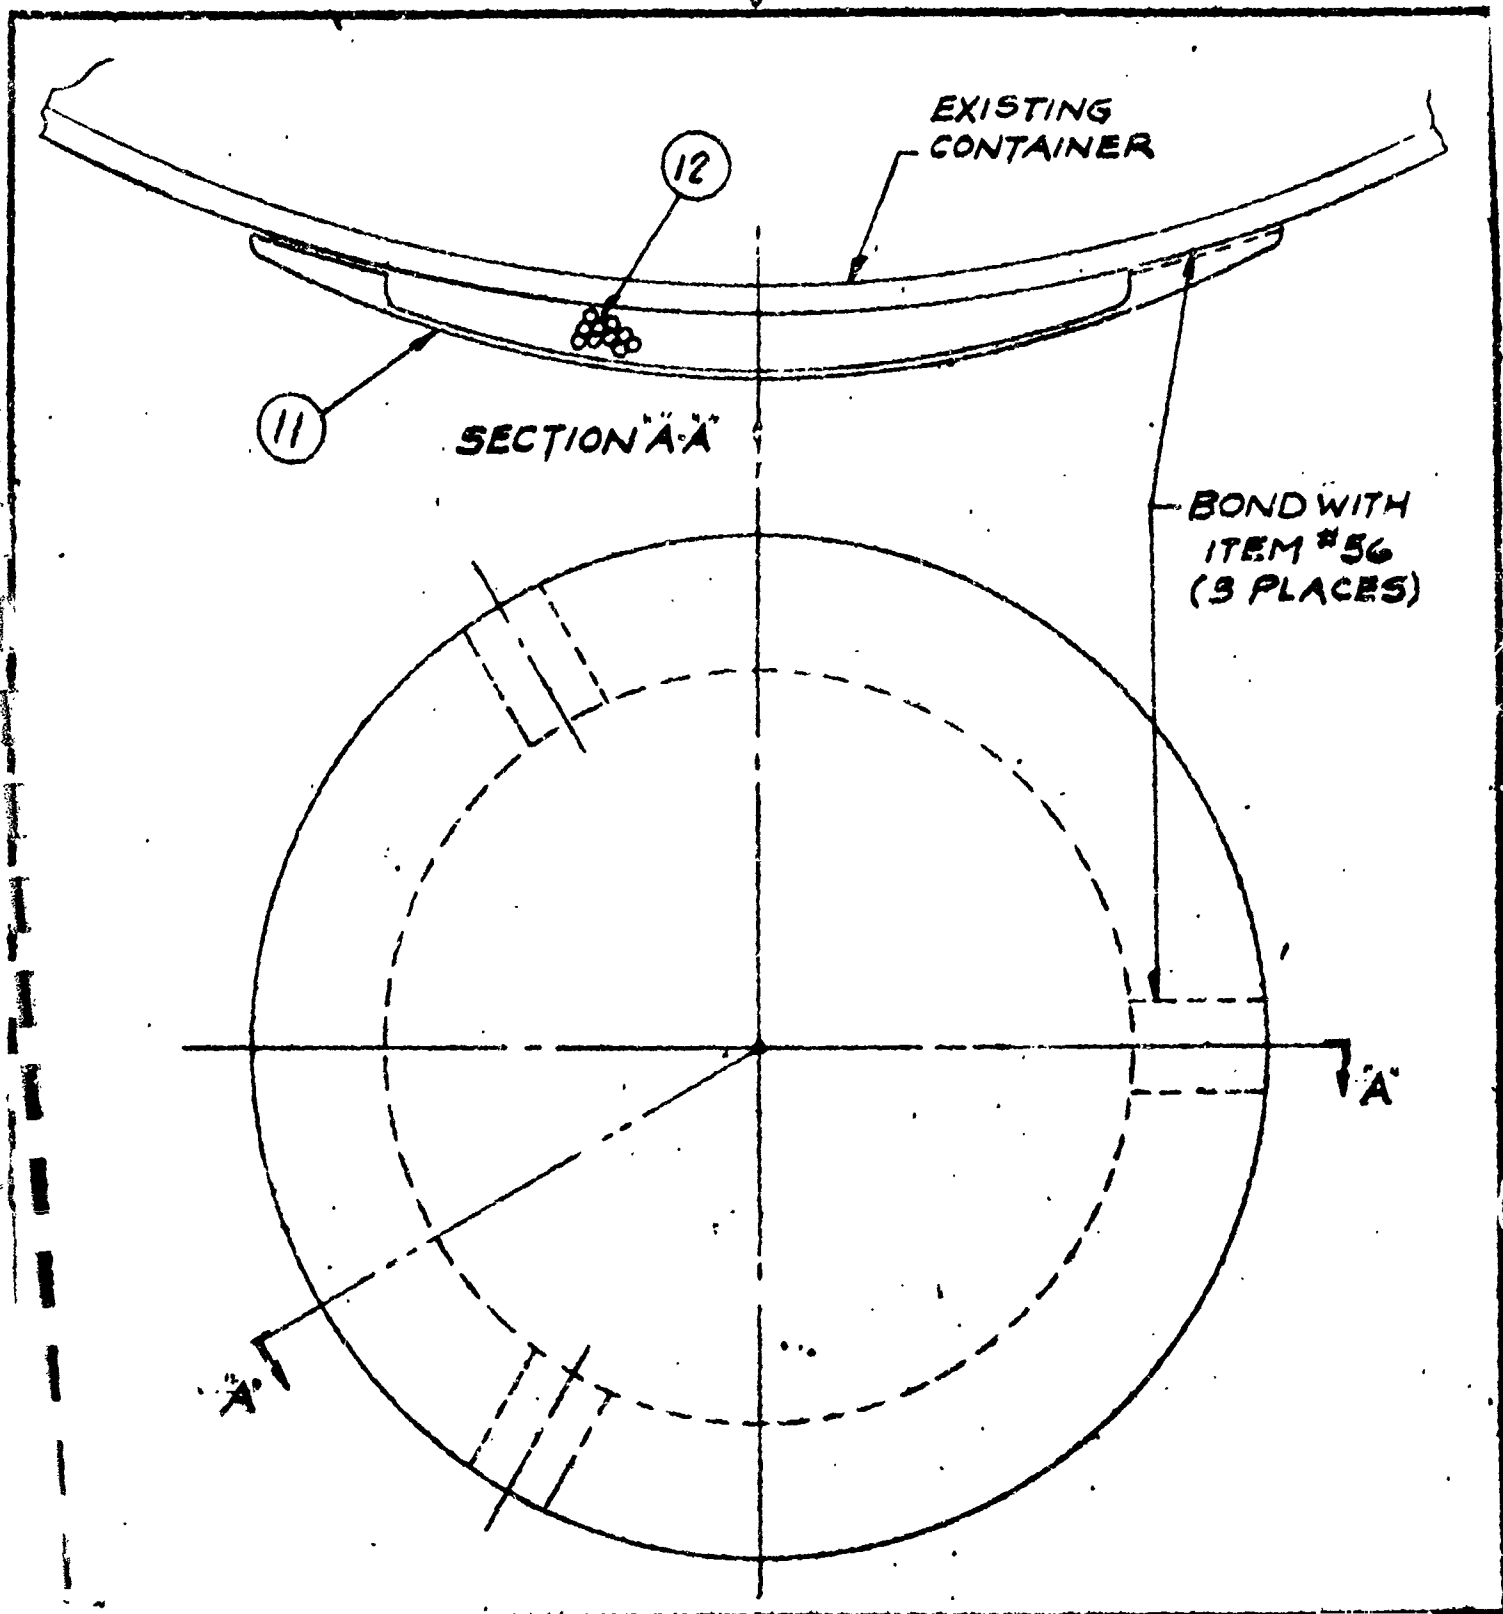
SD-7

MOLECULAR SIEVE  
INSTALLATION
