# NAVAL AIR PROPULSION TEST CENTER

NAPTC-AED-1901 May 1969

ROTOR BURST PROTECTION PROGRAM

PHASE V - FINAL REPORT  
PROBLEM ASSIGNMENT NASA DPR R-105

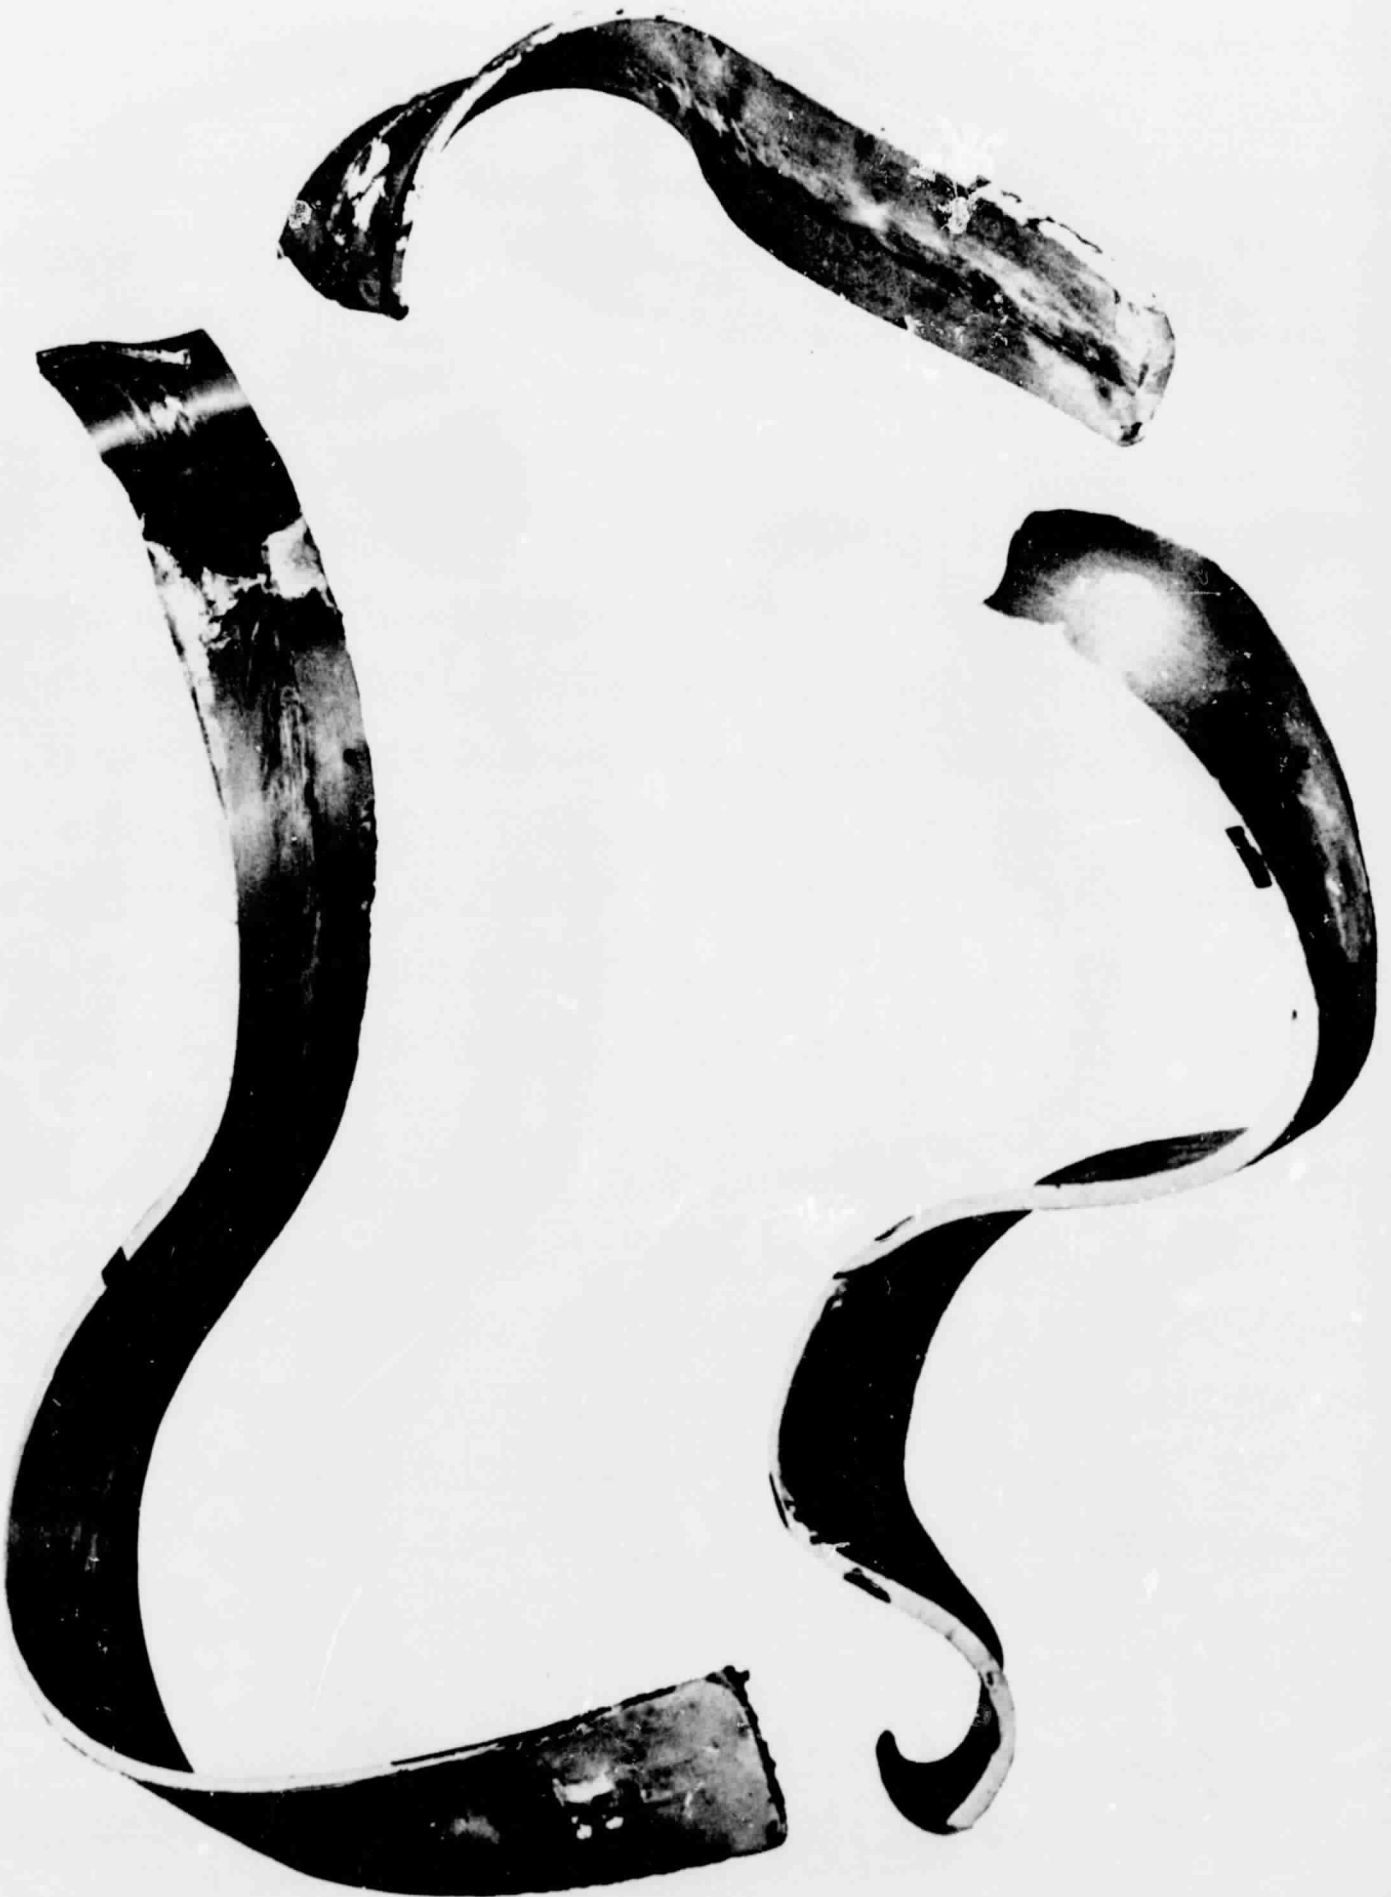
POST-TEST 22  
CONTAINMENT RING FRAGMENTS

Test 22 was an intentional tri-hub burst of a J65 engine second stage turbine rotor into a 4130 steel cylindrical control device. Unfortunately, no high-speed photographs were obtained of this test. The control device was severely deformed and, from the fracture surface appearance, had failed in tension at three locations (refer to Figure 33). The impact surface had experienced light to moderate gouging; no ballistic type penetration of this surface was noted.

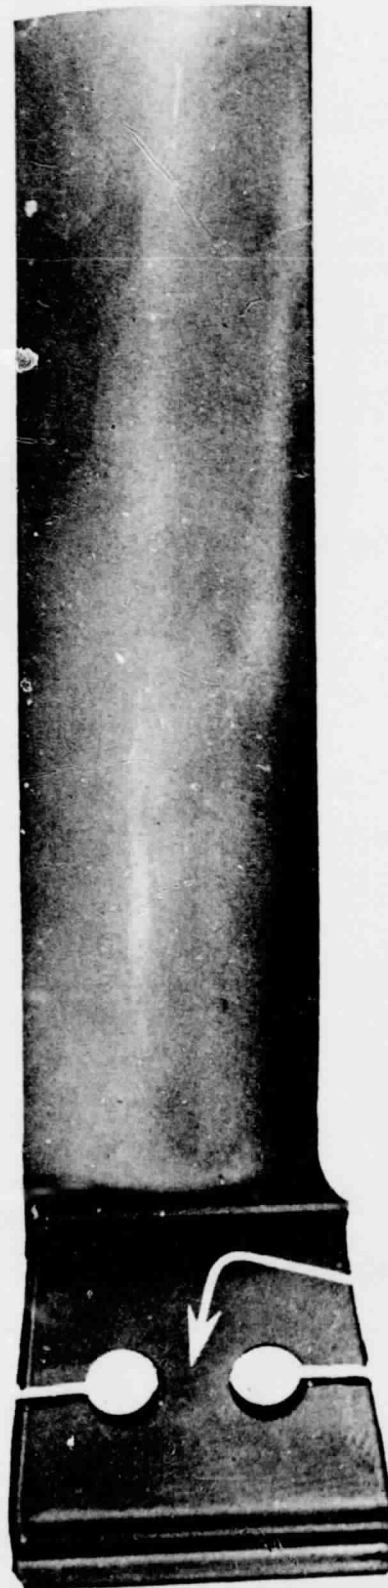
MODIFIED TURBINE BLADE

The fragments for all three tests were three blades from a T58 engine power turbine rotor. These blades were notched as shown in Figure 35 and placed in equally spaced locations on the rotor. Details concerning the fragment dimensions, weight, and material properties can be found in Table I.
