*Technical Memorandum 33-423*

*Mariner Venus 67 Power Subsystem Modification:  
Test and Flight Operation*

JET PROPULSION LABORATORY  
CALIFORNIA INSTITUTE OF TECHNOLOGY  
PASADENA, CALIFORNIA

June 30, 1969

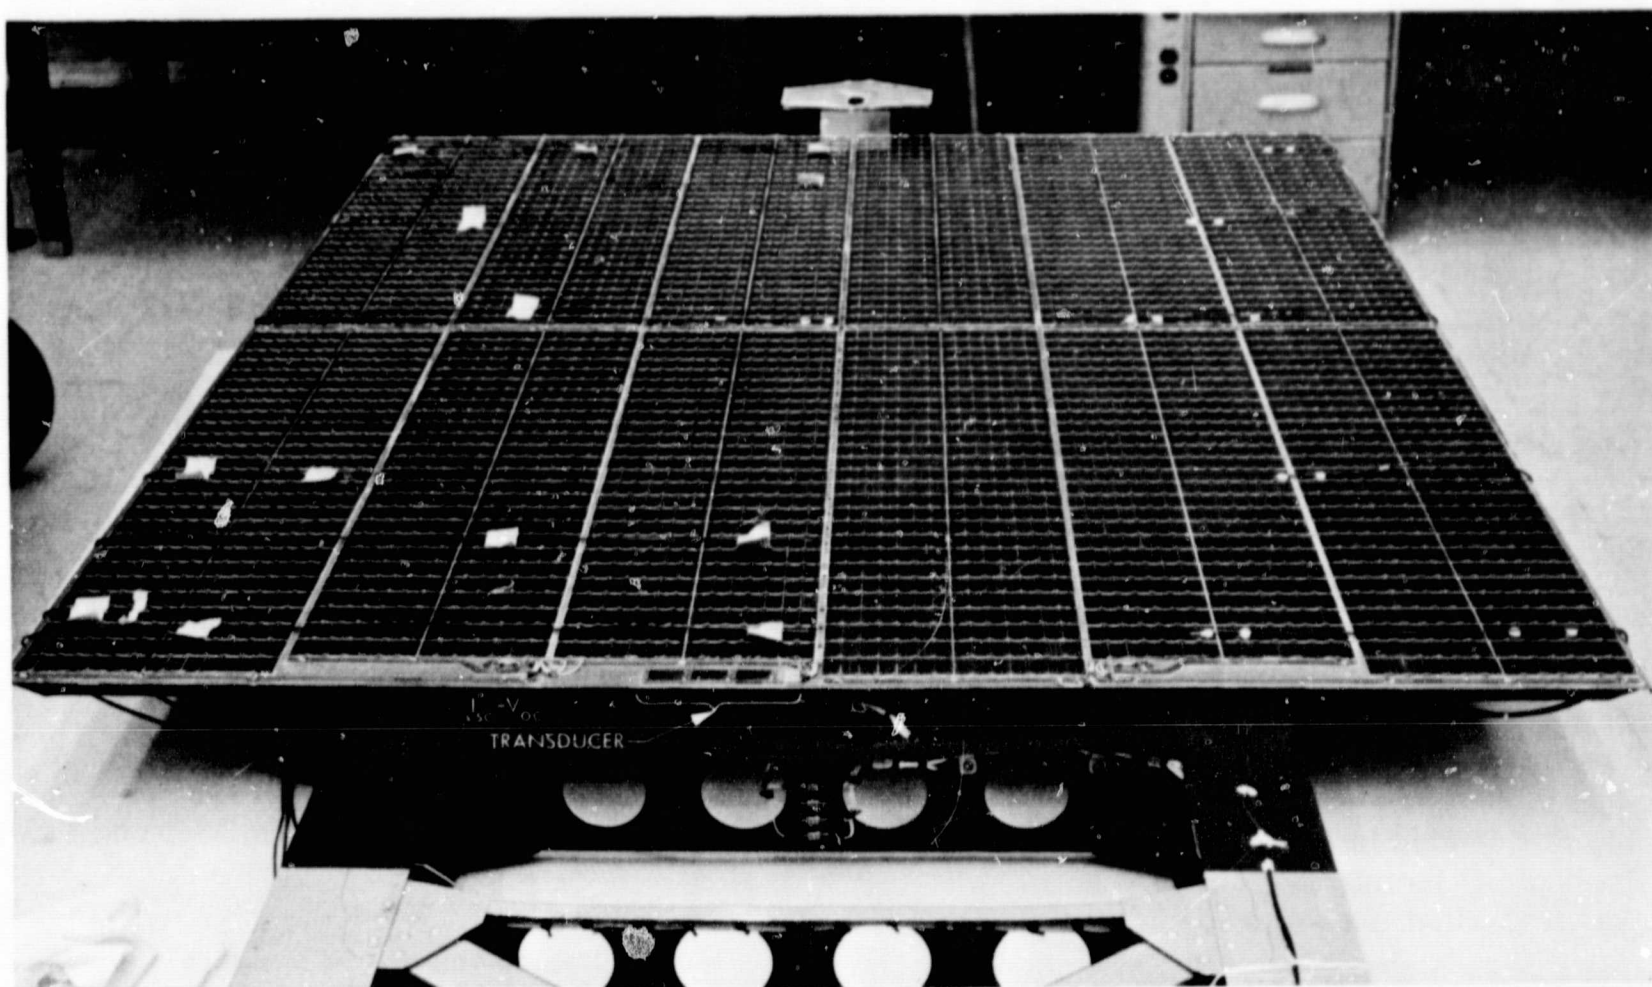
Fig. 4. Solar panel, front surface

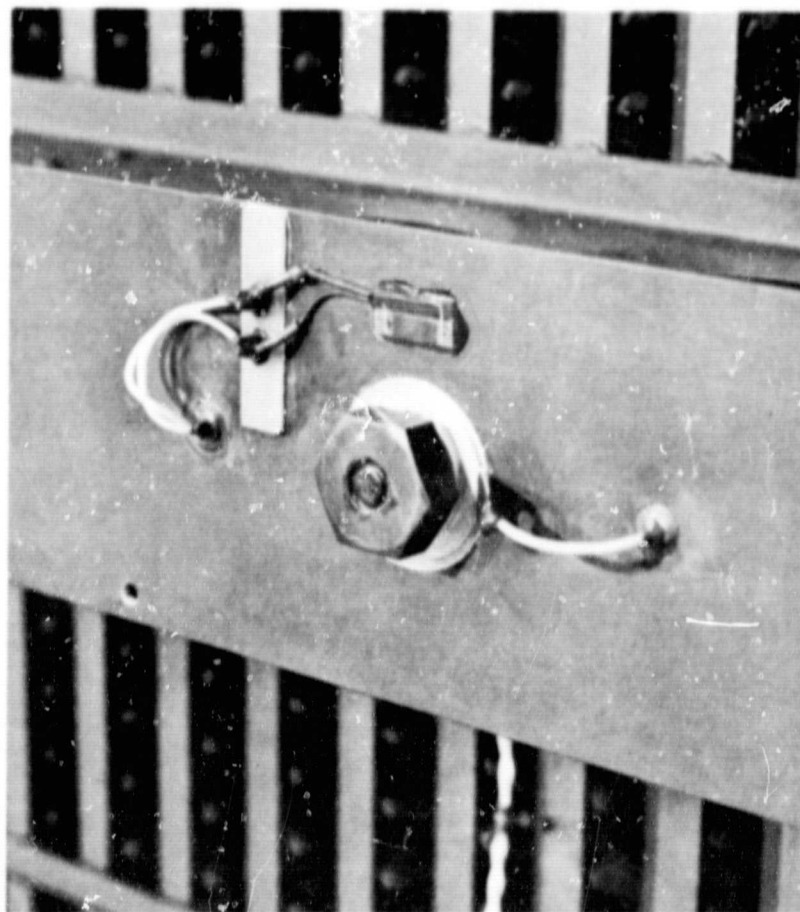
Fig. 6. Closeup of typical temperature transducer installation

Four temperature transducers are used to aid in the evaluation of the space performance of the *Mariner Venus 67* solar array. The temperature transducer selected for use on the *Mariner Venus 67* solar array was a small

resistive element encased in a thin electrically insulating mylar jacket  $\sim 2$ -mils thick. The transducer exhibits a relatively linear resistance vs temperature range from plus to minus  $300^{\circ}\text{F}$ .
