NASA PROGRAM APOLLO WORKING PAPER

LUNAR MODULE REACTION CONTROL SYSTEM
ENGINE EXHAUST-PLUME EVALUATION TEST IN THE
SPACE-ENVIRONMENT SIMULATION LABORATORY

September 15, 1969

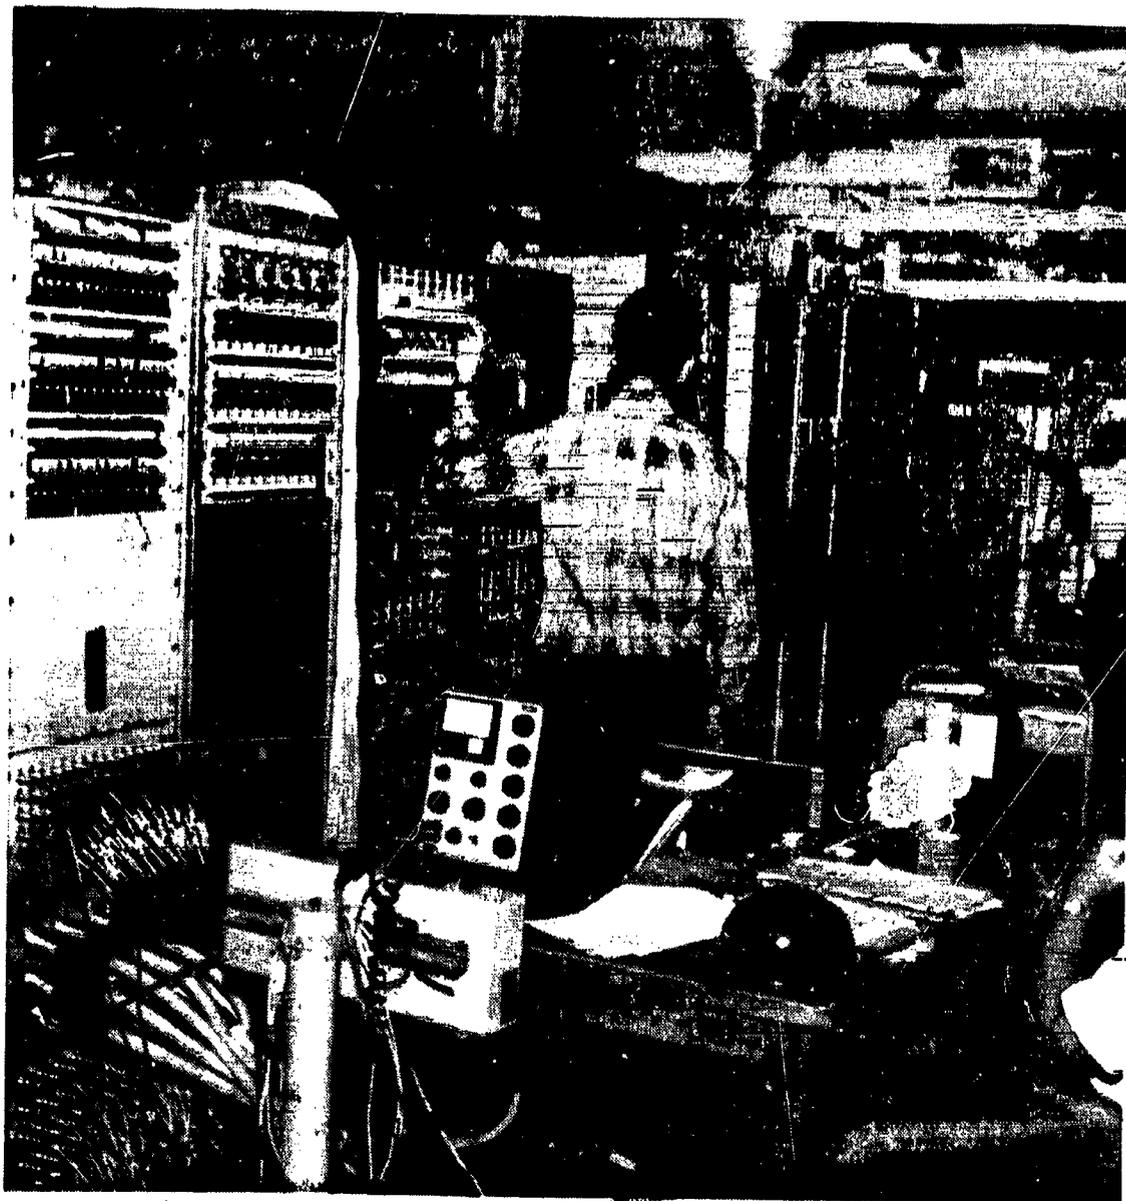
Figure 21.- Data acquisition system.

Frequency-modulated data acquisition system.- The elements of the FM data acquisition system (fig. 21) were provided by NASA. The system consisted of differential amplifiers, voltage-controlled oscillators, tape record/reproduce machines, and oscillographs. The data flow for the data acquisition system is shown in figure 22.

Frequency-modulated high-response data acquisition system. - Functionally, the FM data acquisition system performed well with few component failures during the test series.
