VACUUM IGNITION CHARACTERISTICS  
OF OXYGEN DIFLUORIDE/DIBORANE  
AND FLOX/DIBORANE

T. F. Seamans

Thiokol Chemical Corporation  
Reaction Motors Division

Final Report RMD 5536-F

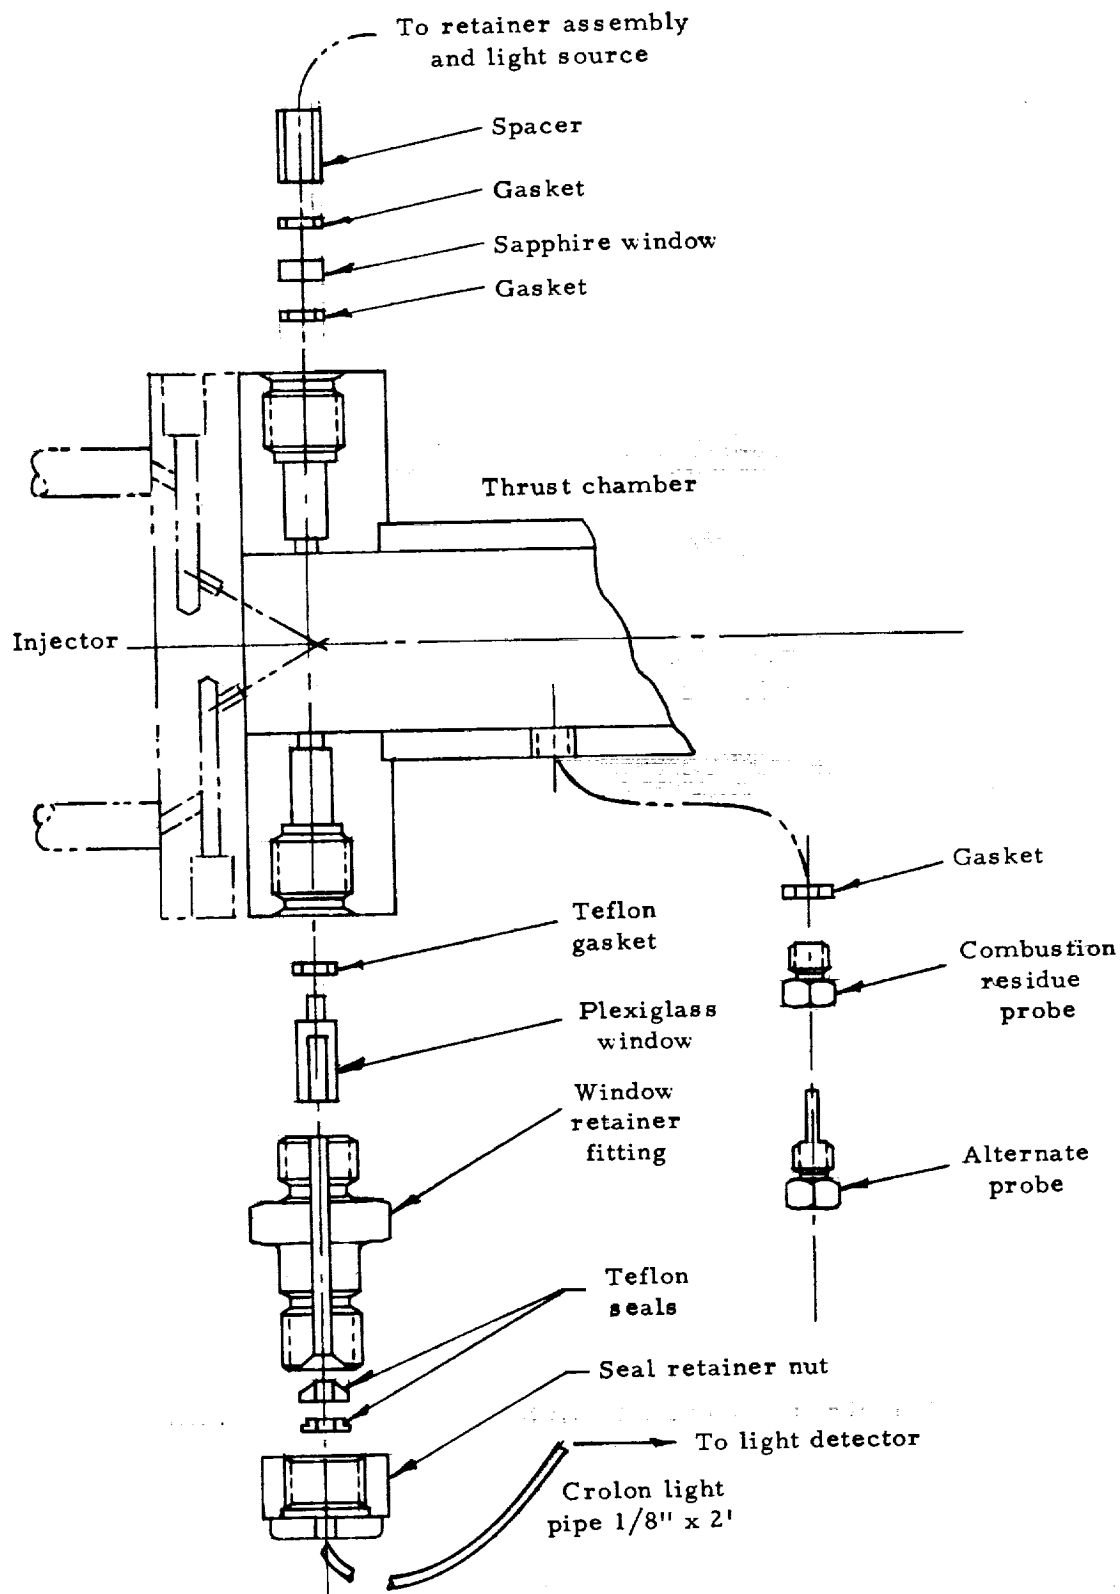
Figure 2. Sketch of Propellant Entry Detector Components and Residue Sampling Probes

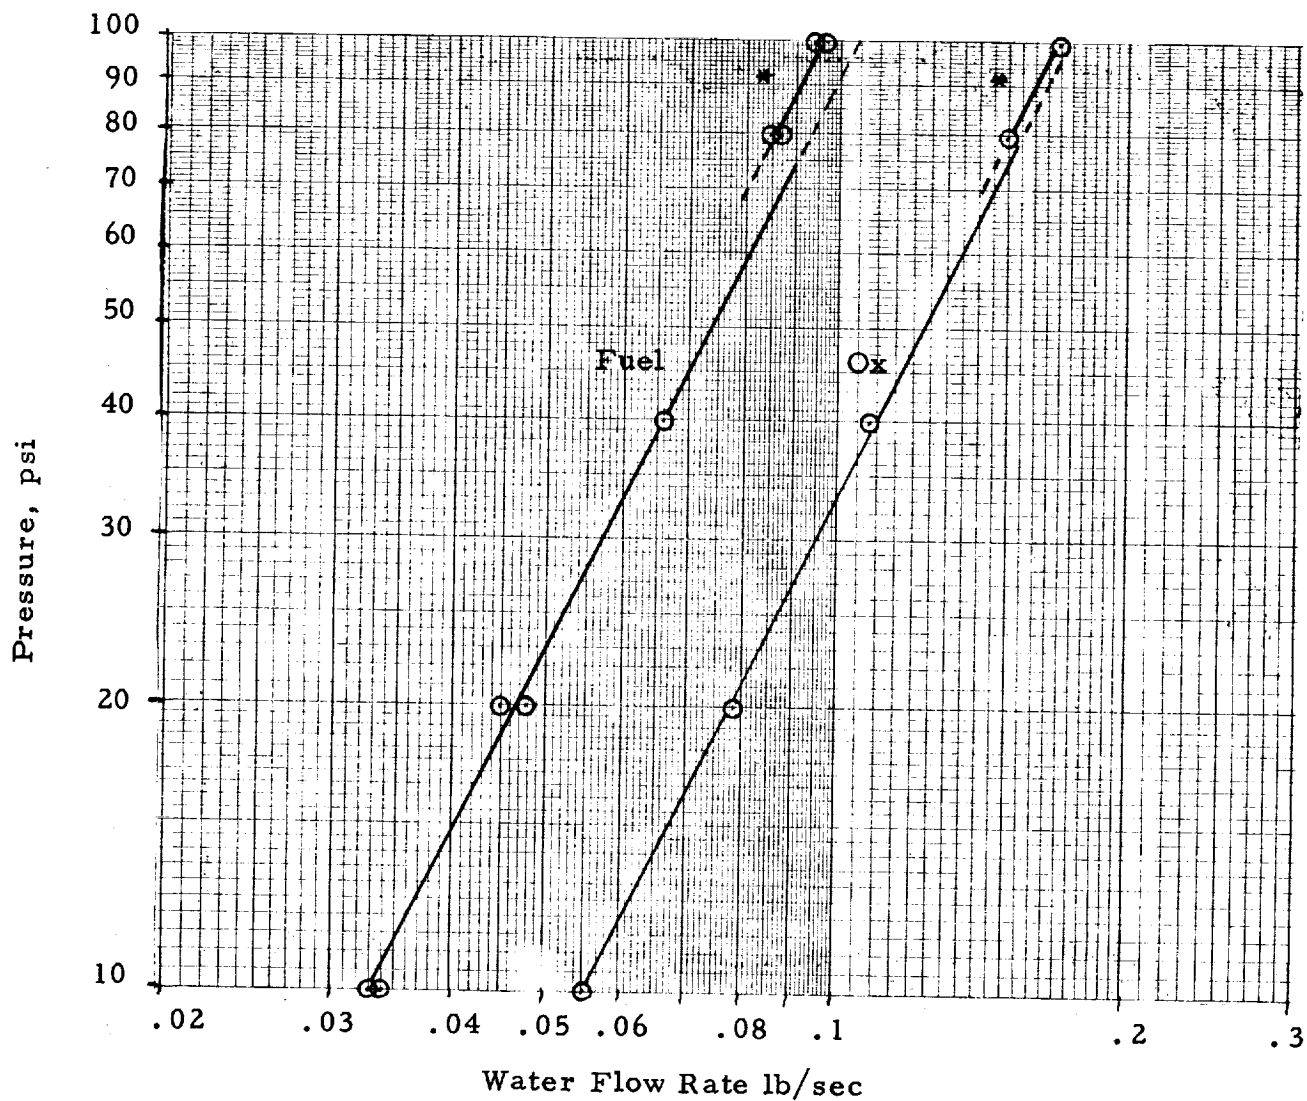
\*Hydraulic Flip

Figure 3. Water Flow Check - Valcor Valve and 9 Pair Doublet Injector (Drilled Inserts Installed)

The injectors were water flow checked to permit accurate calculations of tank pressure settings to produce design flows at steady state conditions. The water flow calibration curves are given in Figs. 3 and 4. Figures 5 and 6 show the injector assemblies.

The hydraulic "flip" labeled in Figs. 3 and 4 is a phenomenon often encountered during water flow calibration of rocket engine injector orifices (Refs. 3-5). It occurs with orifices which do not have perfectly rounded entrance ports and/or sufficiently long orifice length to diameter ratios and which are flowed without a sufficiently high gas back pressure (Ref. 6). The effect is not noted during normal steady state operation where high back pressures (i. e. chamber pressure) and relatively low injection velocities prevail.

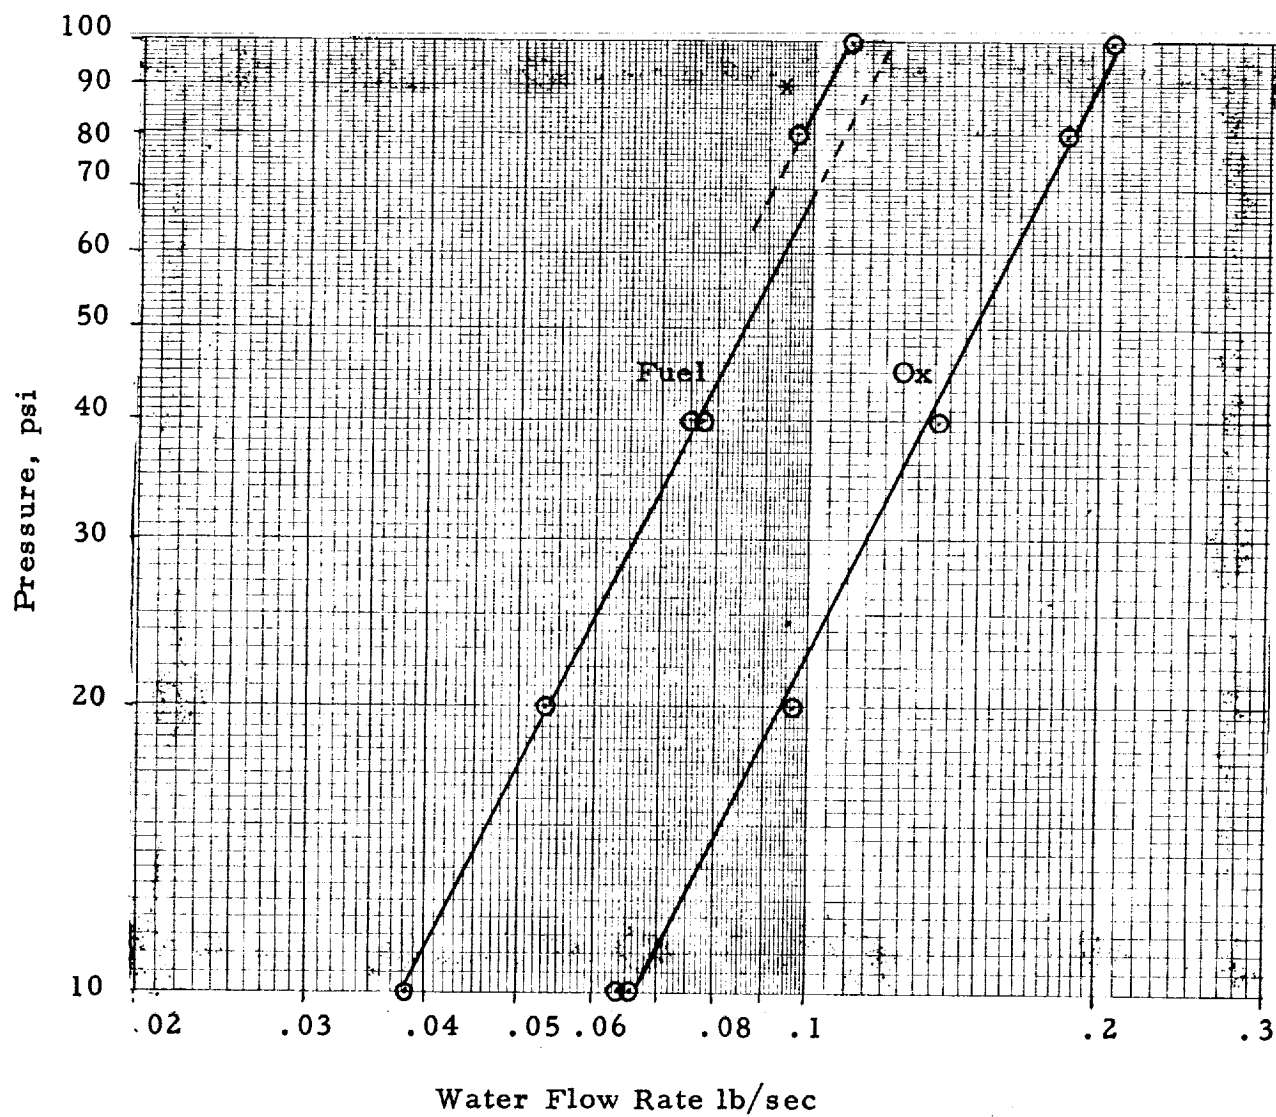
\*Hydraulic Flip

Figure 4. Water Flow Check - Valcor Valve and 1 Pair Doublet Injector (Drilled Inserts Installed)

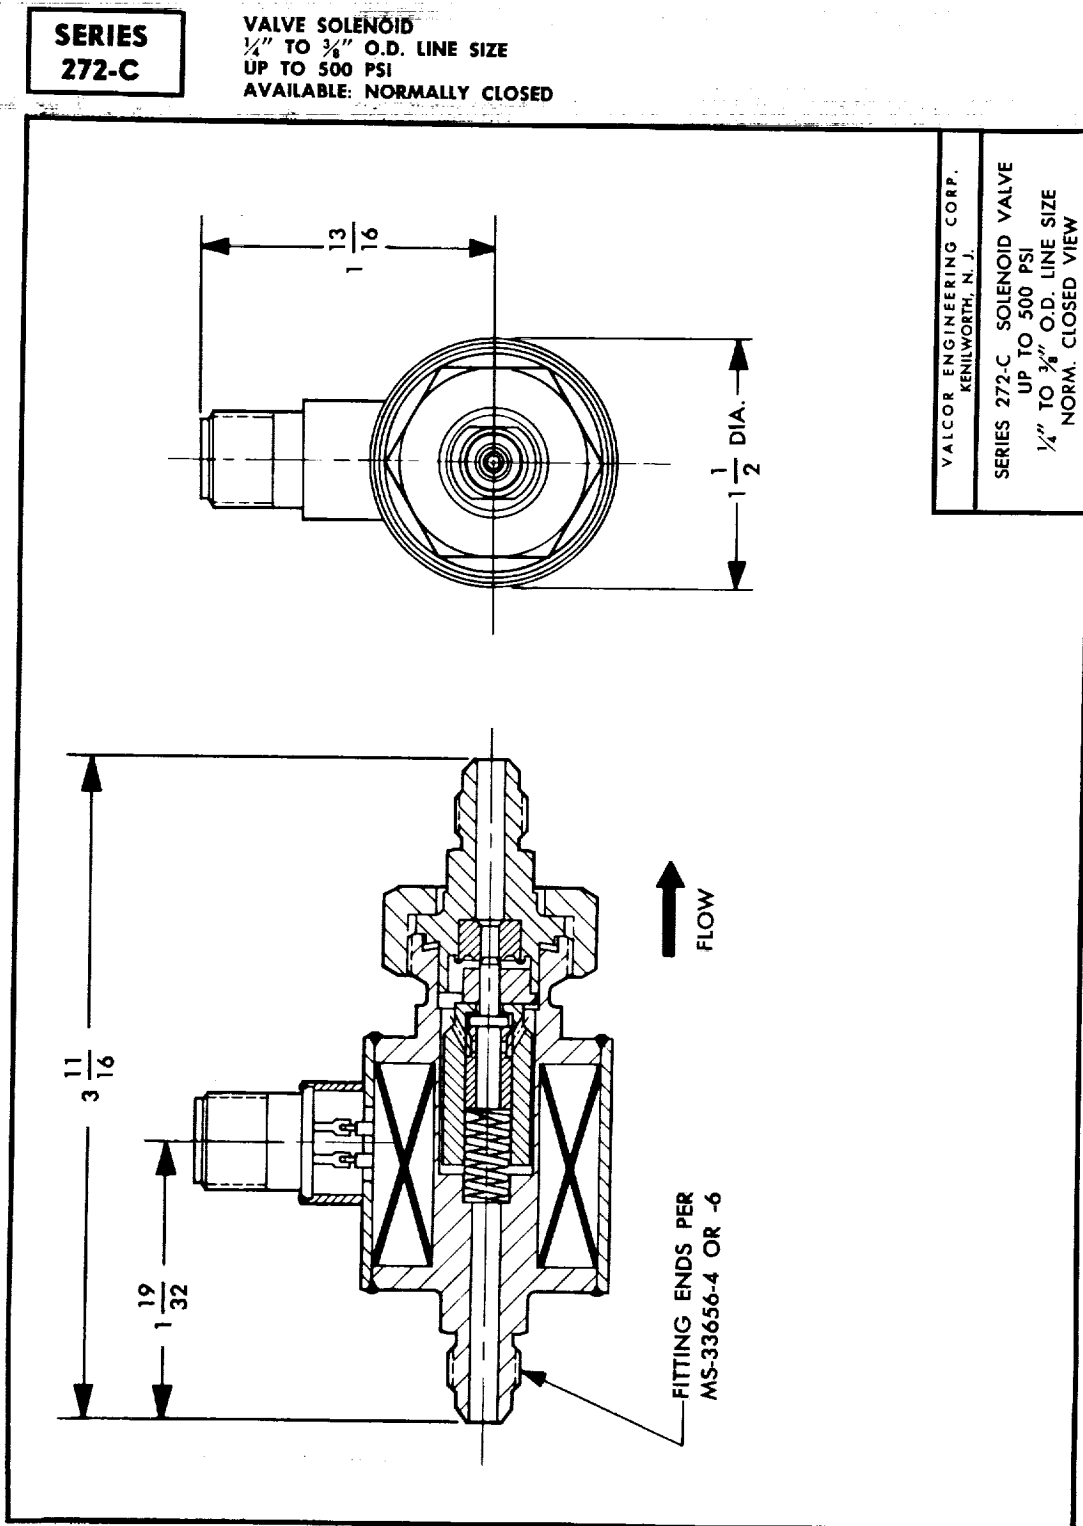
Figure 8. Drawing of Valcor Solenoid Valve Series 272-C

The great majority of tests performed under both phases of the program used two identical propellant valves manufactured by Valcor Engineering Corporation and designated P/N V27200-214. These light weight, compact, 1/4-inch valves are straight-through, solenoid operated, poppet type valves incorporating stellite seats and stainless steel seals. The valves have low pressure drops and are designed for very corrosive fluids and for immersion in liquid nitrogen. Figures 7 and 8 give, respectively, the manufacturer's technical data and a sectional drawing of a typical series 272 valve.

Ideally, with a new lightly coined metal-to-metal poppet and seat and proper axial alignment, the sealing line interface is circular. When the solenoid is energized the coil current starts to build up. At some point when the magnetic flux is still not great enough to overcome the unbalanced pressure and spring load forces, the poppet adjusts radially to the magnetic field causing the sealing surface to become elliptical. This provides two small leakage paths shortly before the flux buildup reaches the point where the poppet starts to transfer axially, lifting off the seat. In the present case, poppet cocking generally occurred 6-7 msec after voltage application. The occurrence of this cocking or radial motion of the poppet prior to valve opening can be determined from valve current traces such as Fig. 9 (Ref. 1) and Fig. 10 (Ref. 7). However, this phenomenon has been little recognized. The effect of the cocking with metal-to-metal poppets and seats is transient leakage, or a slight "pre-flow". The effect with metal-to-plastic or metal-to-elastomer seals may be absorbed by the elasticity of the materials with no resultant leakage.

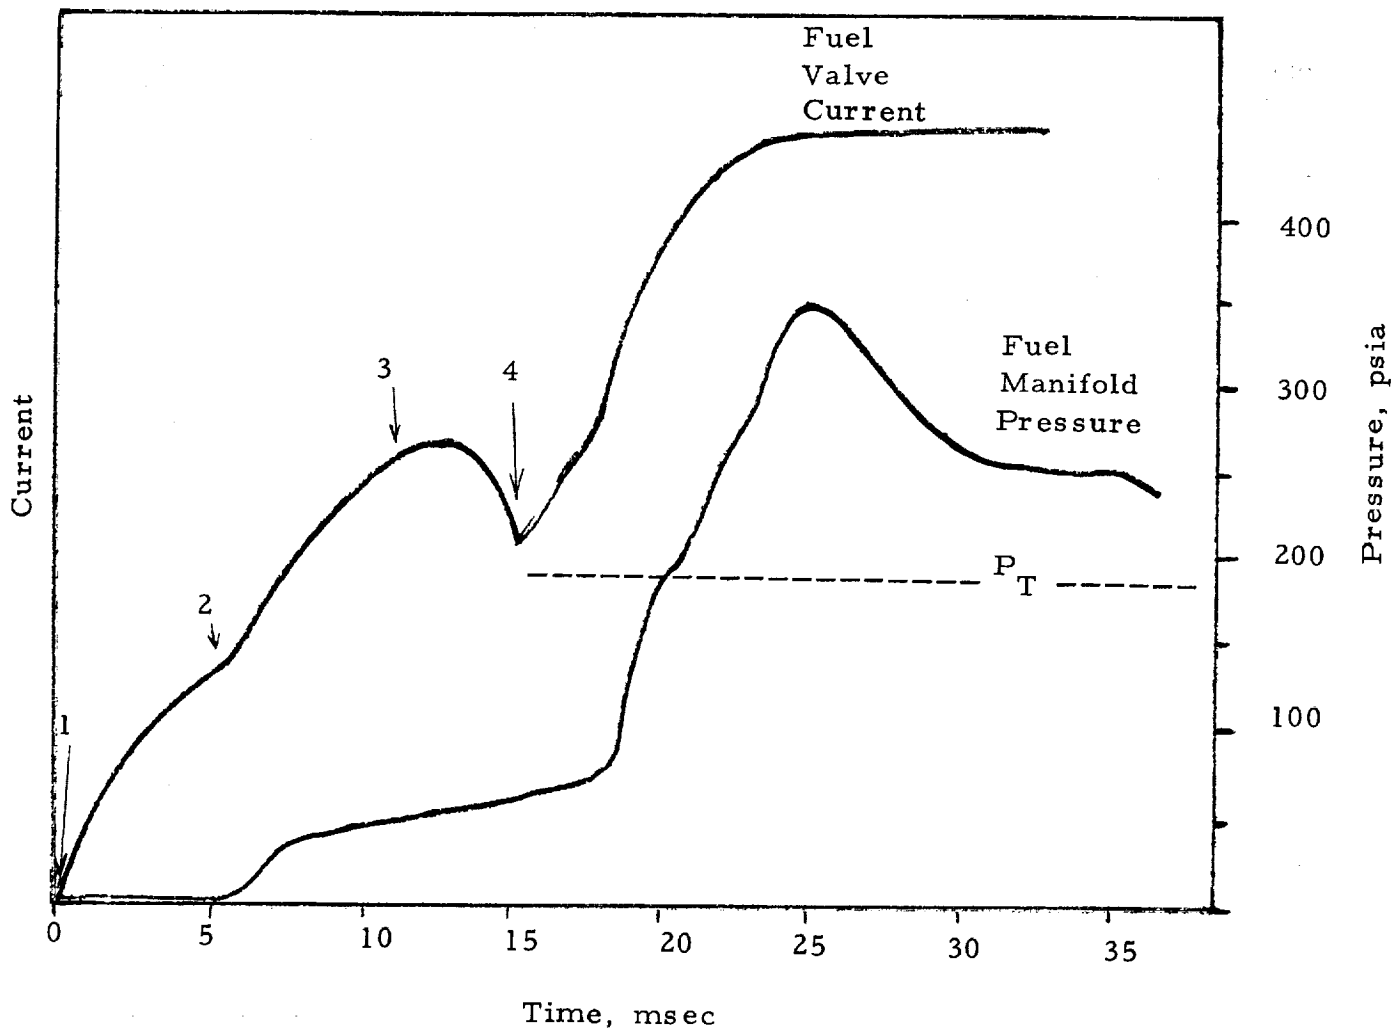
1. Voltage applied to valve
2. Poppet Unseats
3. Poppet starts to transfer
4. Valve full open

Figure 9. Valve Coil Current and Fuel Manifold Pressure vs Time (Ref. 1)

Typical valve opening times (poppet transfer times) experienced during the program are 2.5 to 4.5 msec with this period starting some 11-14 msec after application of 24 VDC. Generally, evidence of slight propellant flow was observed by the injector manifold piezoelectric transducers prior to the start of poppet transfer. This low flow resulted from cocking of the valve poppets.

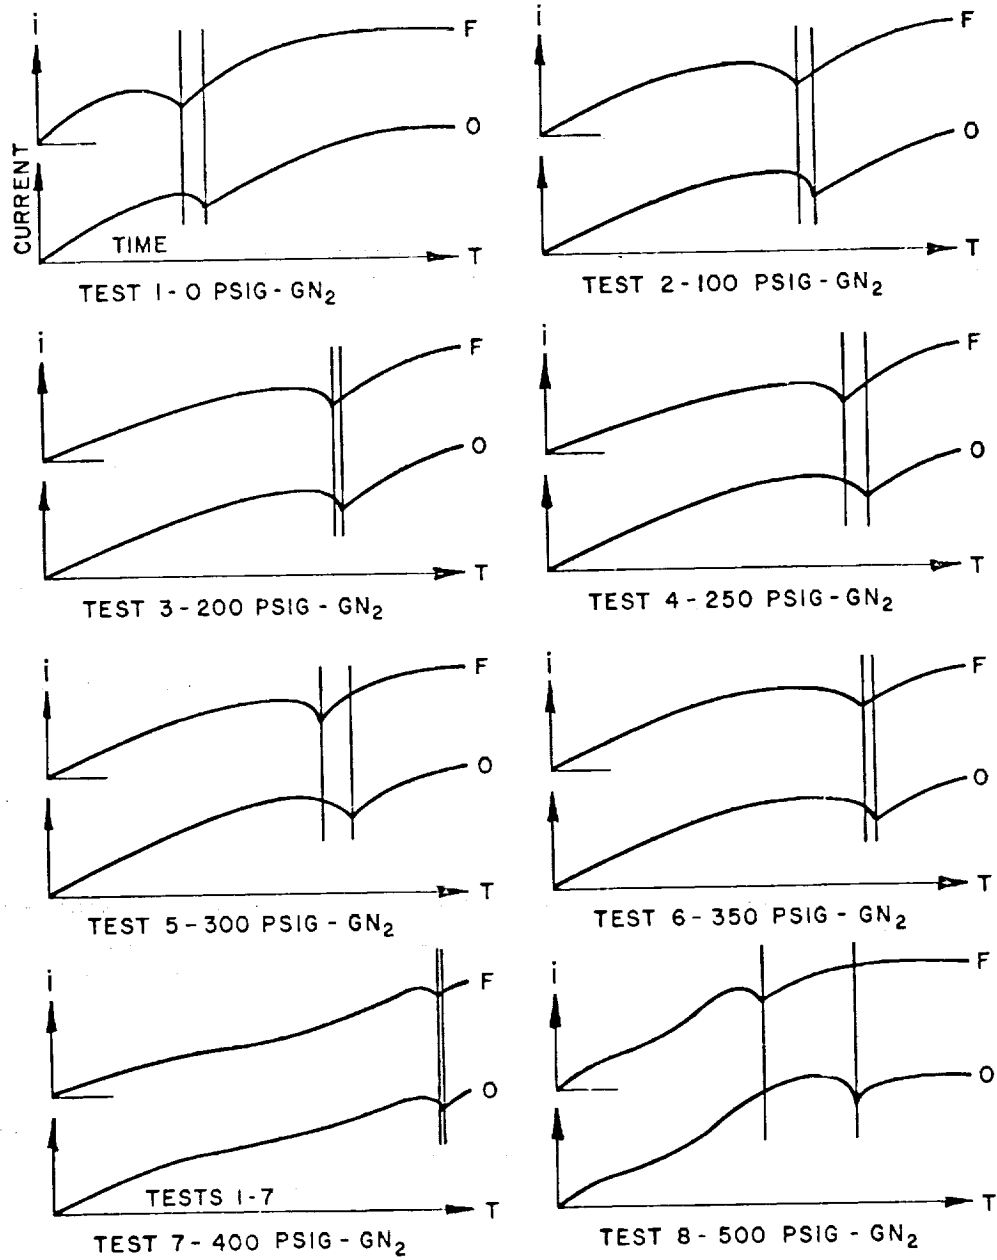
Figure 10. Typical Valve Current Traces (Fig. 19 of Ref. 7)

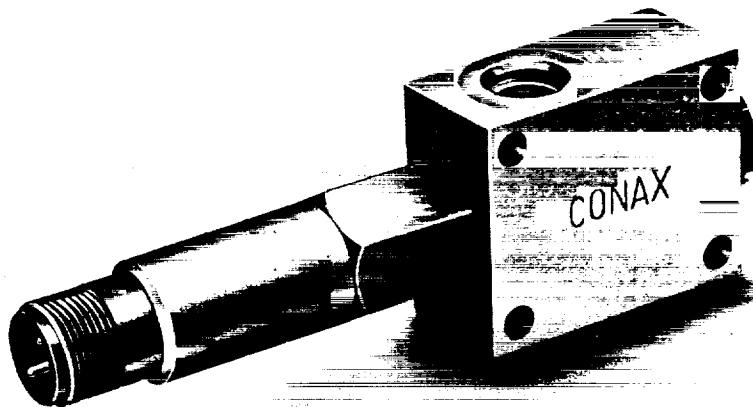
1. An electrical input causes ignition of detonator "A".
2. The high static friction at point "B" is broken as the ram starts its forward travel.
3. Ram head "D" cuts through diaphragm "E".
4. Diaphragm "E" is carried forward by the ram and pinned against plug "F" leaving a clear flow passage in the form of an annulus.

Figure 11 is a reproduction of page 6 of Conax Explosive Valves Bulletin Number 6200 which describes how standard normally closed and normally open valves operate. To circumvent the possible blow-by problem, a three-way valve was modified (by omitting the normally open port) in order to use not only the interference fit on the ram body to prevent blow-by, but also a tapered shoulder to form a second interference fit at end-of-stroke. In effect this made use of the sealing features of both normally closed and normally open valves. Figure 12 shows a drawing of the valves tested, Conax part number 1802-130.

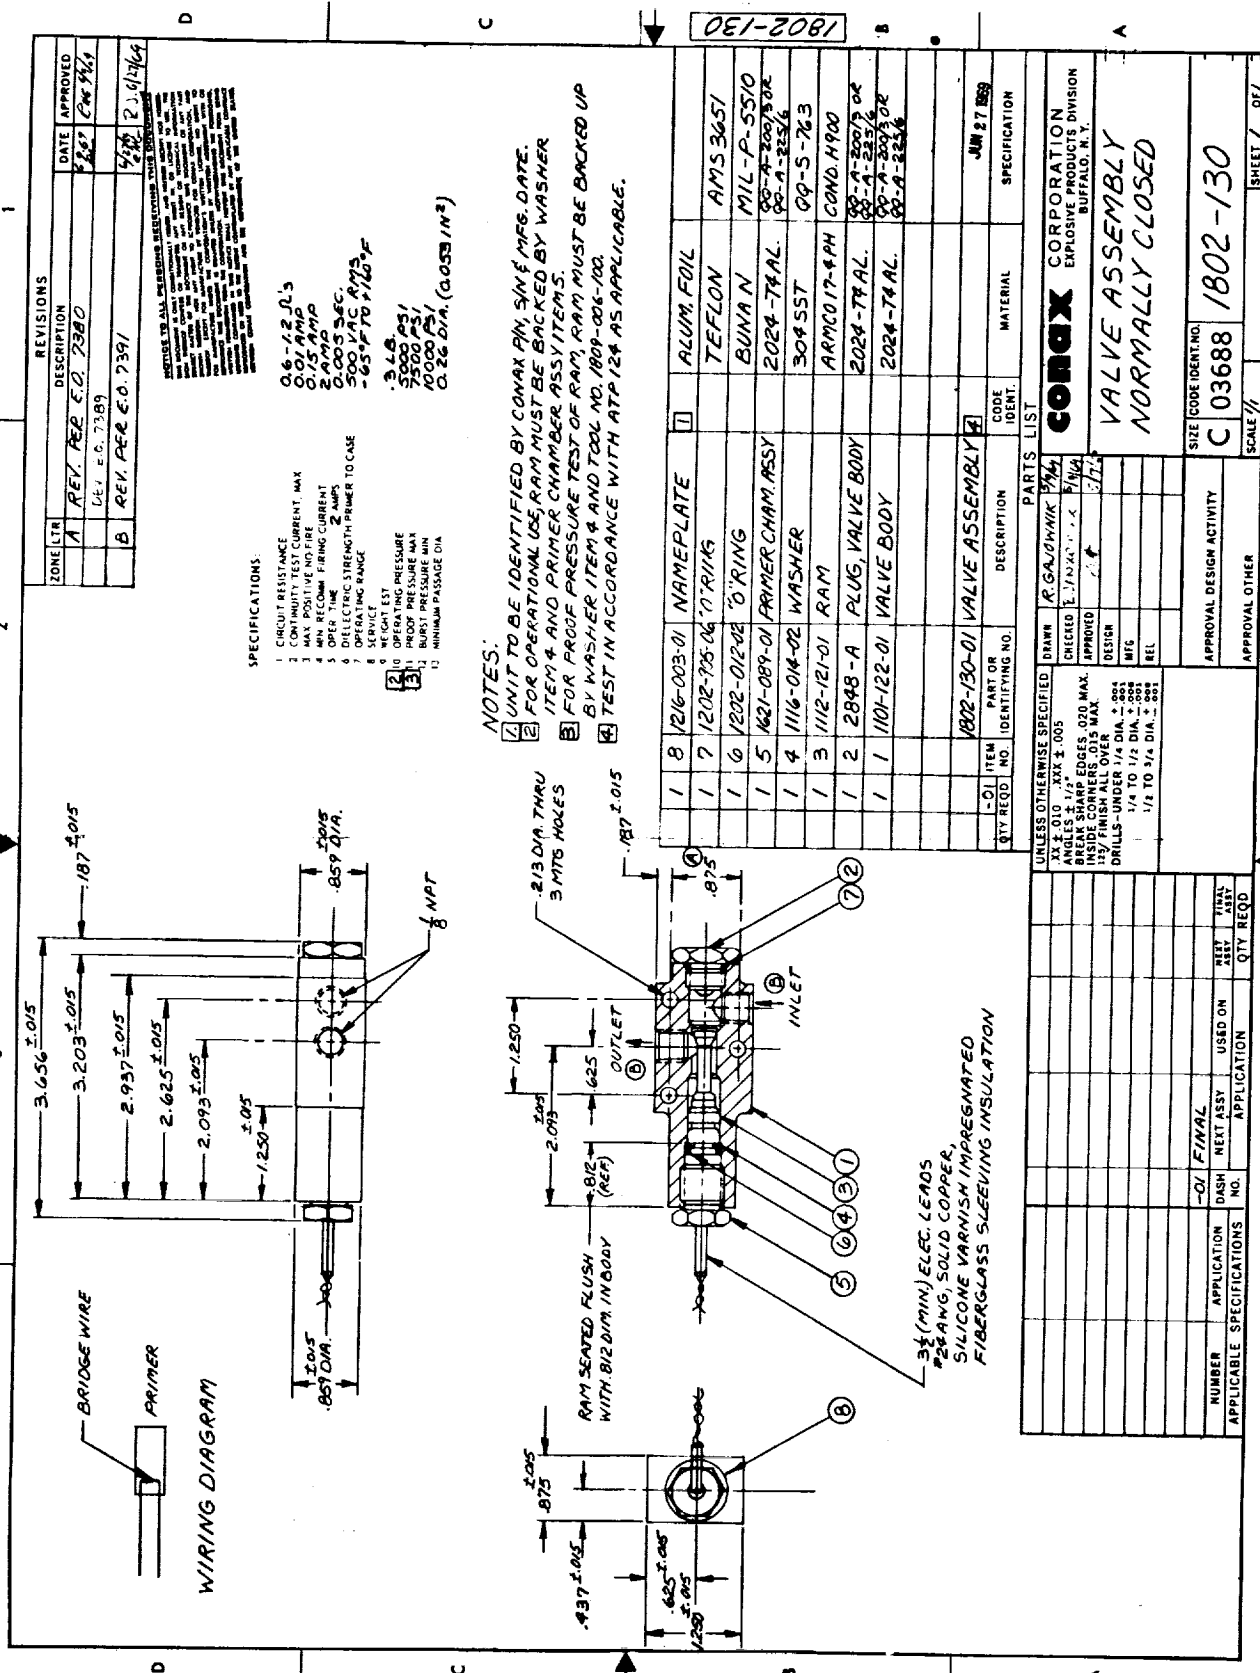
Figure 12. Conax Drawing of Explosive Valves P/N 1802-130.

Explosively actuated valves (Conax Corporation P/N 1802-130) were used in order to determine the effect of zero propellant leakage (positive sealing) on the starting transient, i. e. in the absence of any pre-flow arising from poppet cocking.

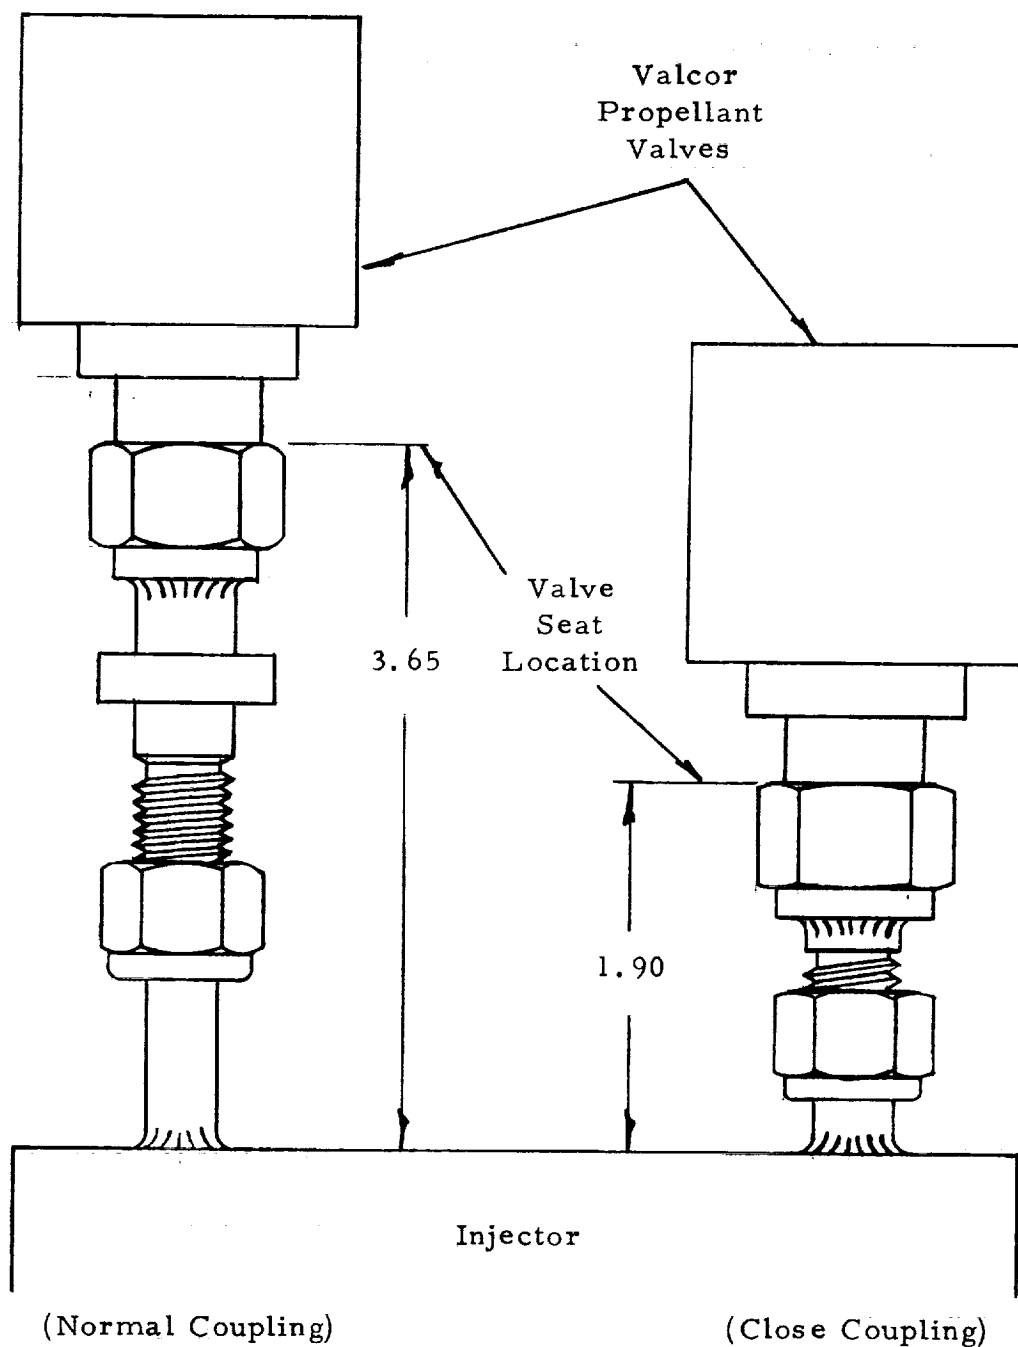
Figure 14. Sketches of Valve/Injector Coupling Configurations

To assure thermal conditioning of the initially entering propellant to the desired propellant temperature, it was necessary to condition the propellant valves together with the respective propellants. Therefore, short stand-off tubes with drilled inserts to minimize internal volumes were used between the propellant valves and the injectors. The inserts are visible in Fig. 6. Insert diameters are the same as the distribution manifolds in the nine-pair injector. Liquid propellant velocities in the inserts are 20 ft/sec at design flows. This arrangement wherein the propellant valves are conditioned with the propellants is the Normal Coupling configuration. (All tests discussed in Ref. 1 used this valve/injector coupling configuration.)

To examine this effect, the valve and injectors were reworked to minimize the line length, yet maintain the capability for interchanging the injectors and valves. The rework reduced the feed line length by about 49%. This configuration is the Close Coupling arrangement. An important consequence is that the valve is no longer conditioned with the propellant but rather with the injector/chamber.

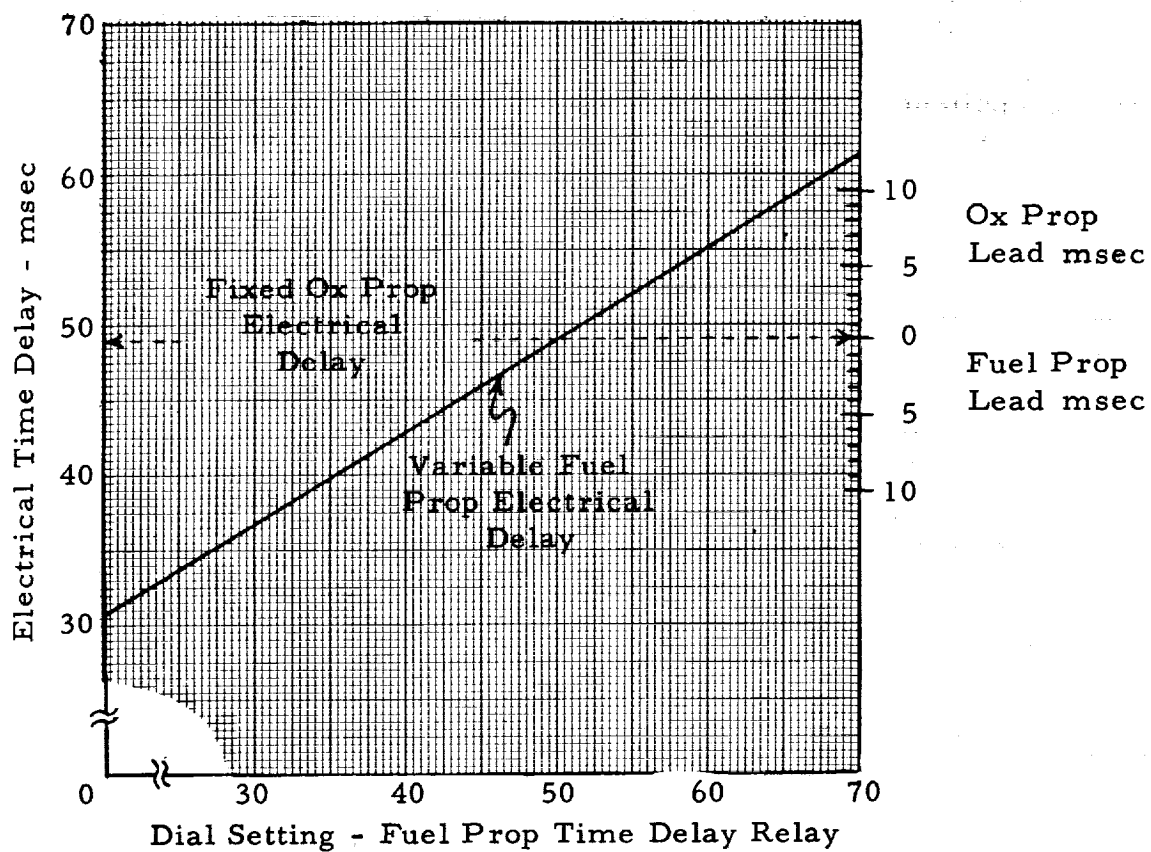
Figure 15. Electrical Lead/Lag Timing of Solenoid Propellant Valves  
(Run 67 onward)

In the Phase I program (Ref. 1) and in the initial runs of the present program, a fixed electrical lead was obtained with an additional time delay (nominally 11 msec) caused by a relay closure in series with the opposite propellant valve. This method had two shortcomings, however. First, propellant leads other than the nominal 11 msec could not be obtained at a given temperature and, second, a constant lead could not be obtained at various temperatures.

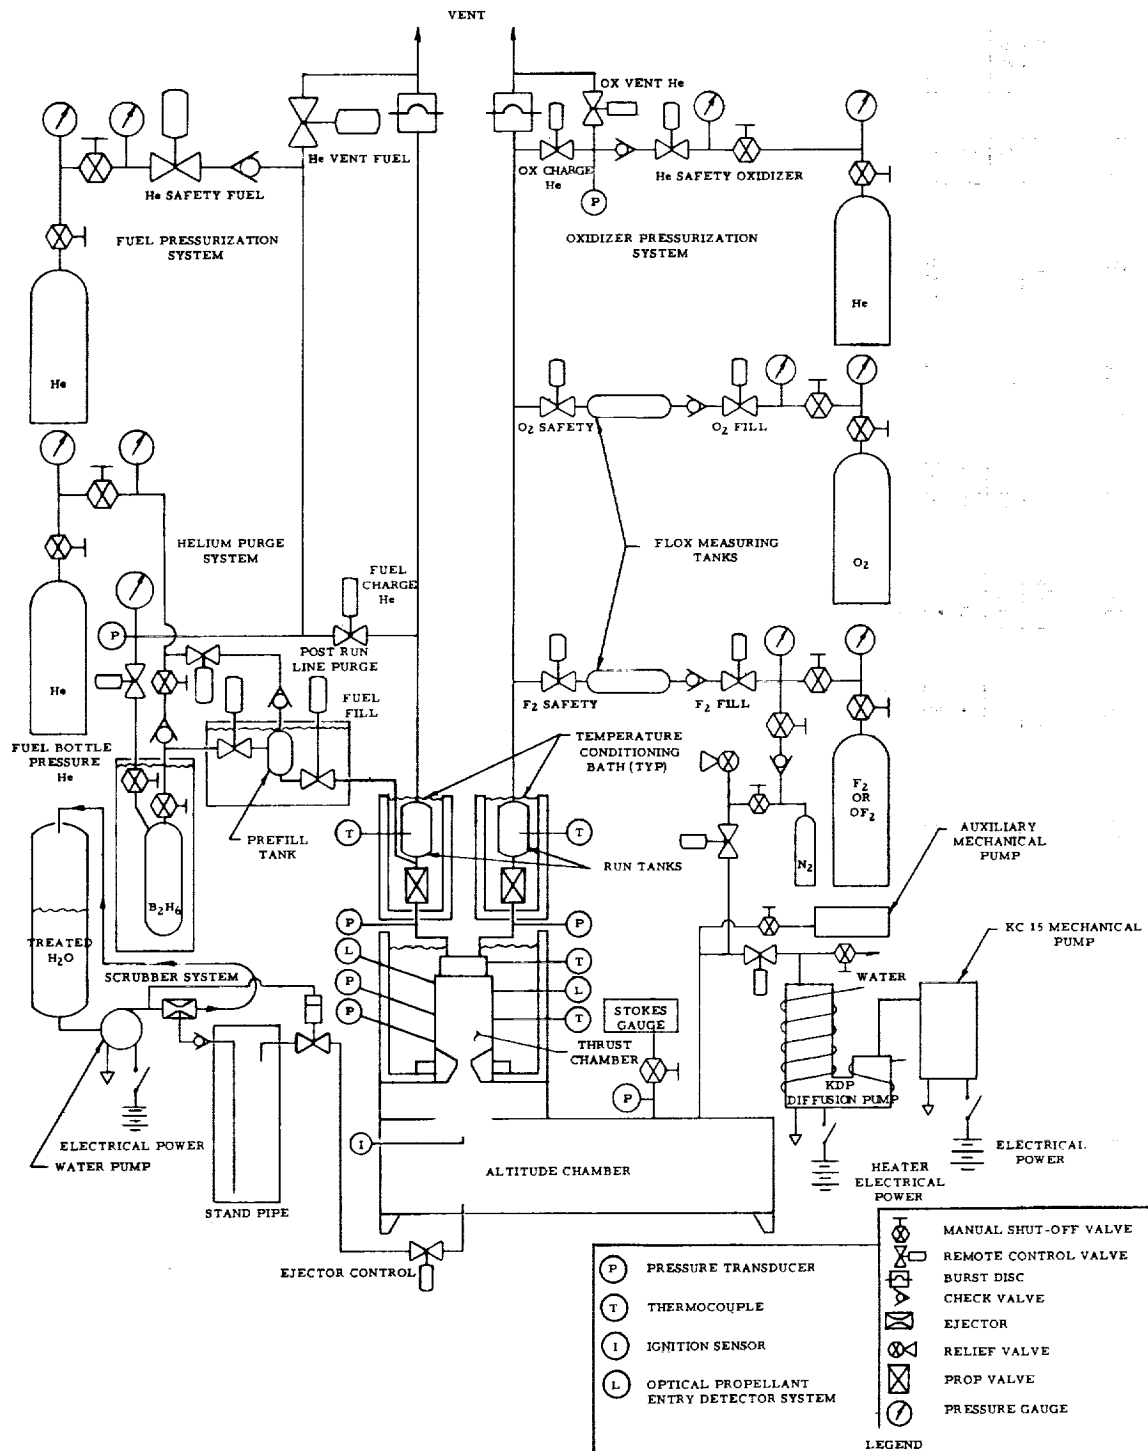
FIGURE 16. SCHEMATIC OF VACUUM IGNITION TEST SYSTEM FOR PHASE II PROGRAM

The schematic of the system used in the present program is given in Fig. 16. The system consists of several subsystems:  $B_2H_6$  system;  $O_2$ ,  $F_2$  and  $OF_2$  systems; helium pressurizing systems; temperature conditioning

Each of the three diborane subsystems is maintained at -100°F with crushed dry ice in separate conditioning baths (Fig. 16). Prior to loading propellant, the system is evacuated from the altitude chamber to the closed liquid transfer hand valve located on the diborane storage tank. The pre-fill tank is then loaded and subsequently transferred to the run tank. This technique provides vacuum fill of the diborane up to the propellant valve seat, thus eliminating trapped gases which could influence start transients. Following each run, the run tank, propellant valve and injector are purged with helium automatically. Subsequently, the fill lines, pre-fill tank and loading valves are also purged with helium.

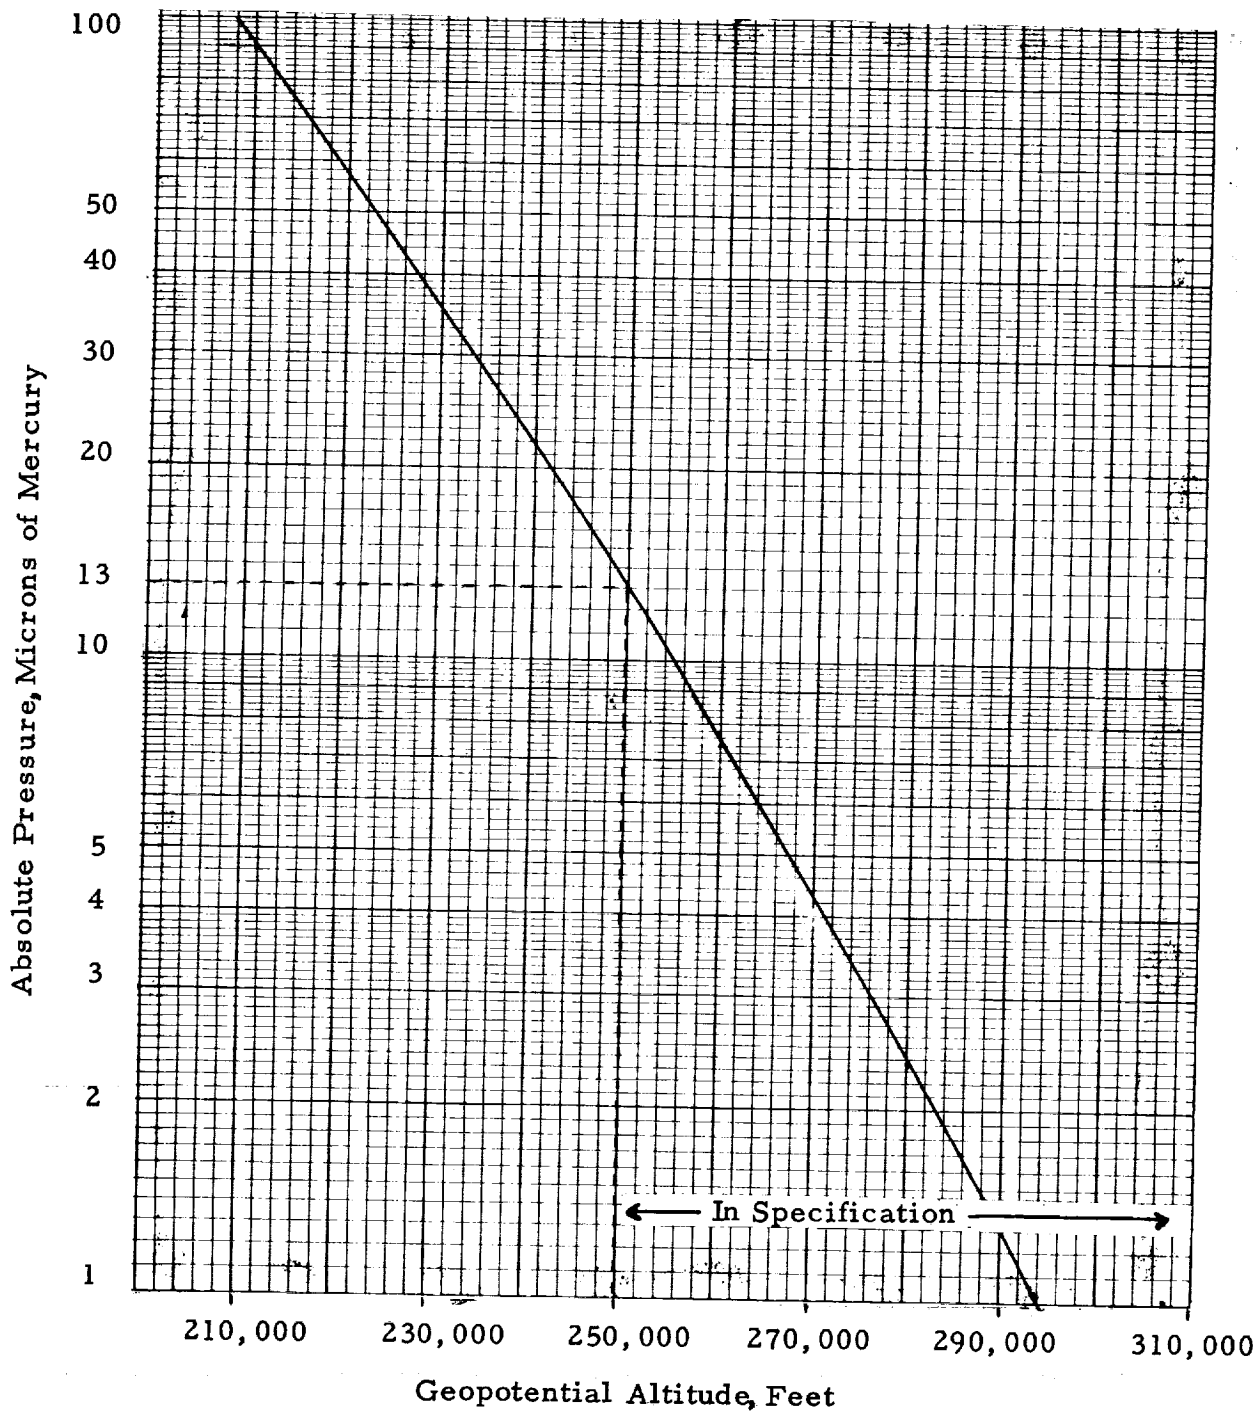
NOTE: Data converted from  
NASA U.S. Standard  
Atmosphere, 1962  
Table IV.

Figure 20. Pressure Vs Altitude

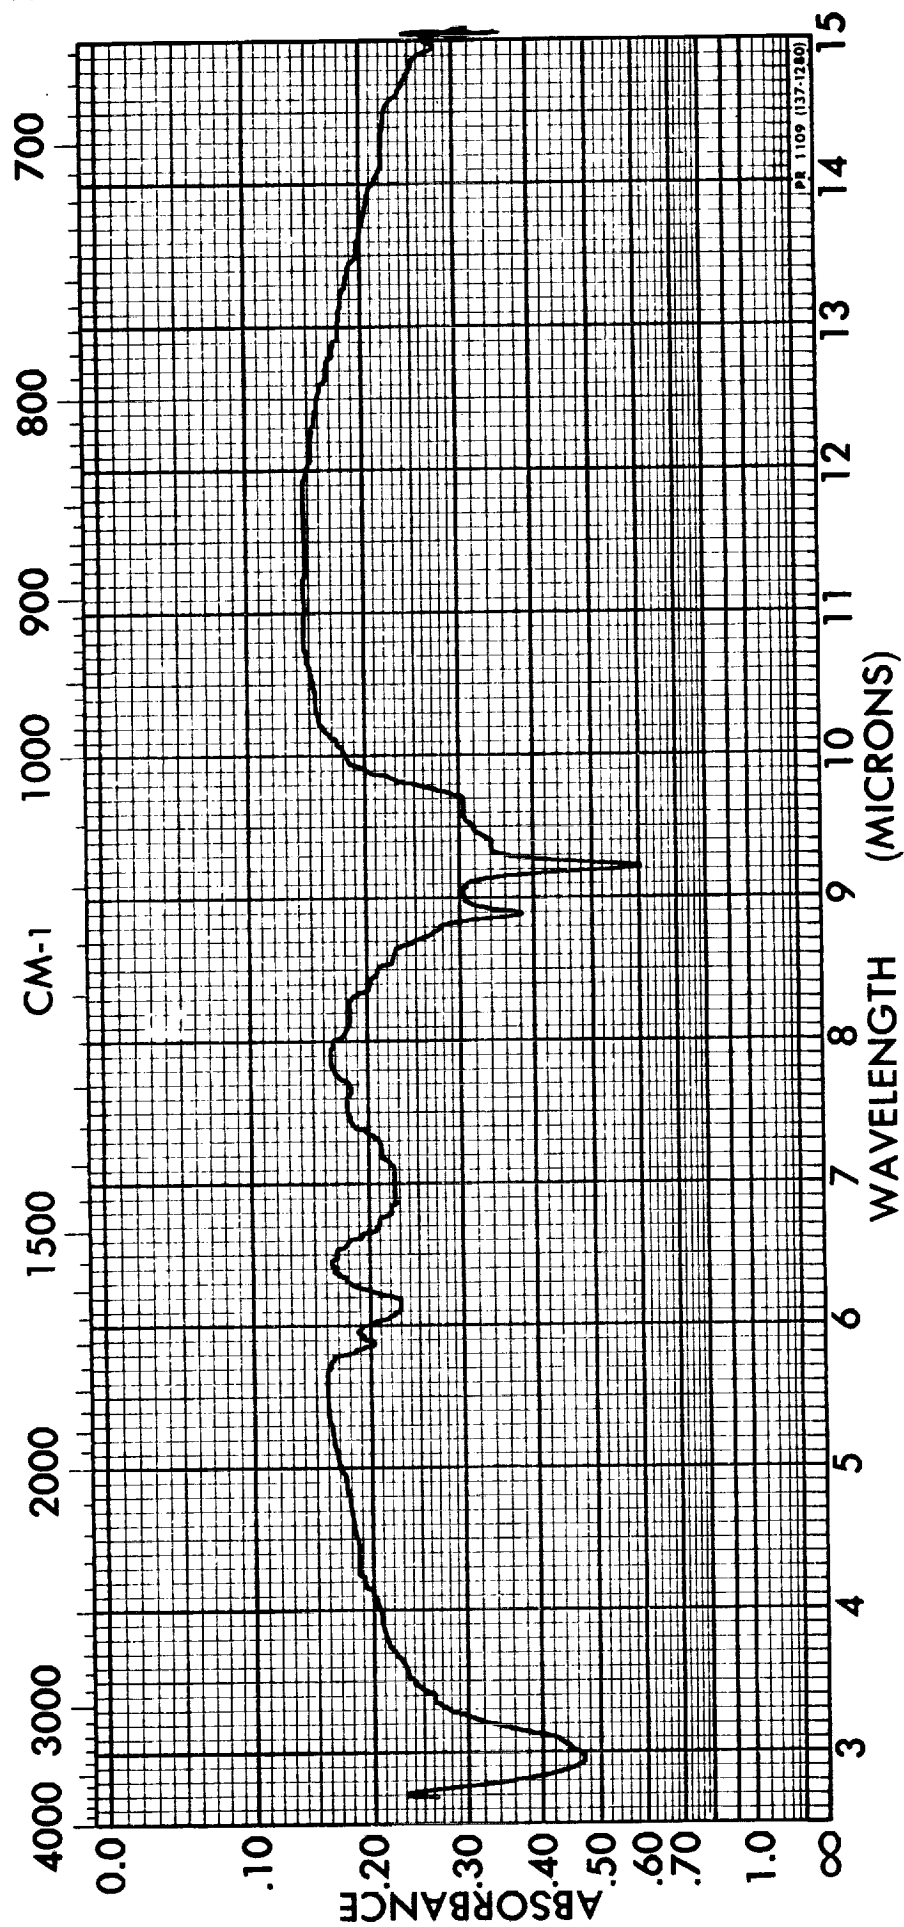
Figure 22. IR Spectrum of Black Powder Residue from  $\text{OF}_2/\text{B}_2\text{H}_6$  Run 108.  
(Low Concentration in KBr Pellet)

Upon removal of the sample plug from the engine following Run 108, the deposit on the plug was roughly 50% gray - 50% black. However, despite the nitrogen environment, the sample changed by the following morning to approximately 5% gray - 95% black. Figures 22 and 23 are IR spectra of the black material at two concentrations in the pellets. Figure 24 is a spectrum of the gray powder. It is seen that all three spectra have significant absorptions at 2.9, 6.2, 7.0, 8.9 and 9.2 microns. The spectra of the gray material differs from the black material in that the 7.0 micron peak is more pronounced relative to the other absorptions.
