VACUUM IGNITION CHARACTERISTICS  
OF OXYGEN DIFLUORIDE/DIBORANE  
AND FLOX/DIBORANE

T. F. Seamans

Thiokol Chemical Corporation  
Reaction Motors Division

Final Report RMD 5536-F

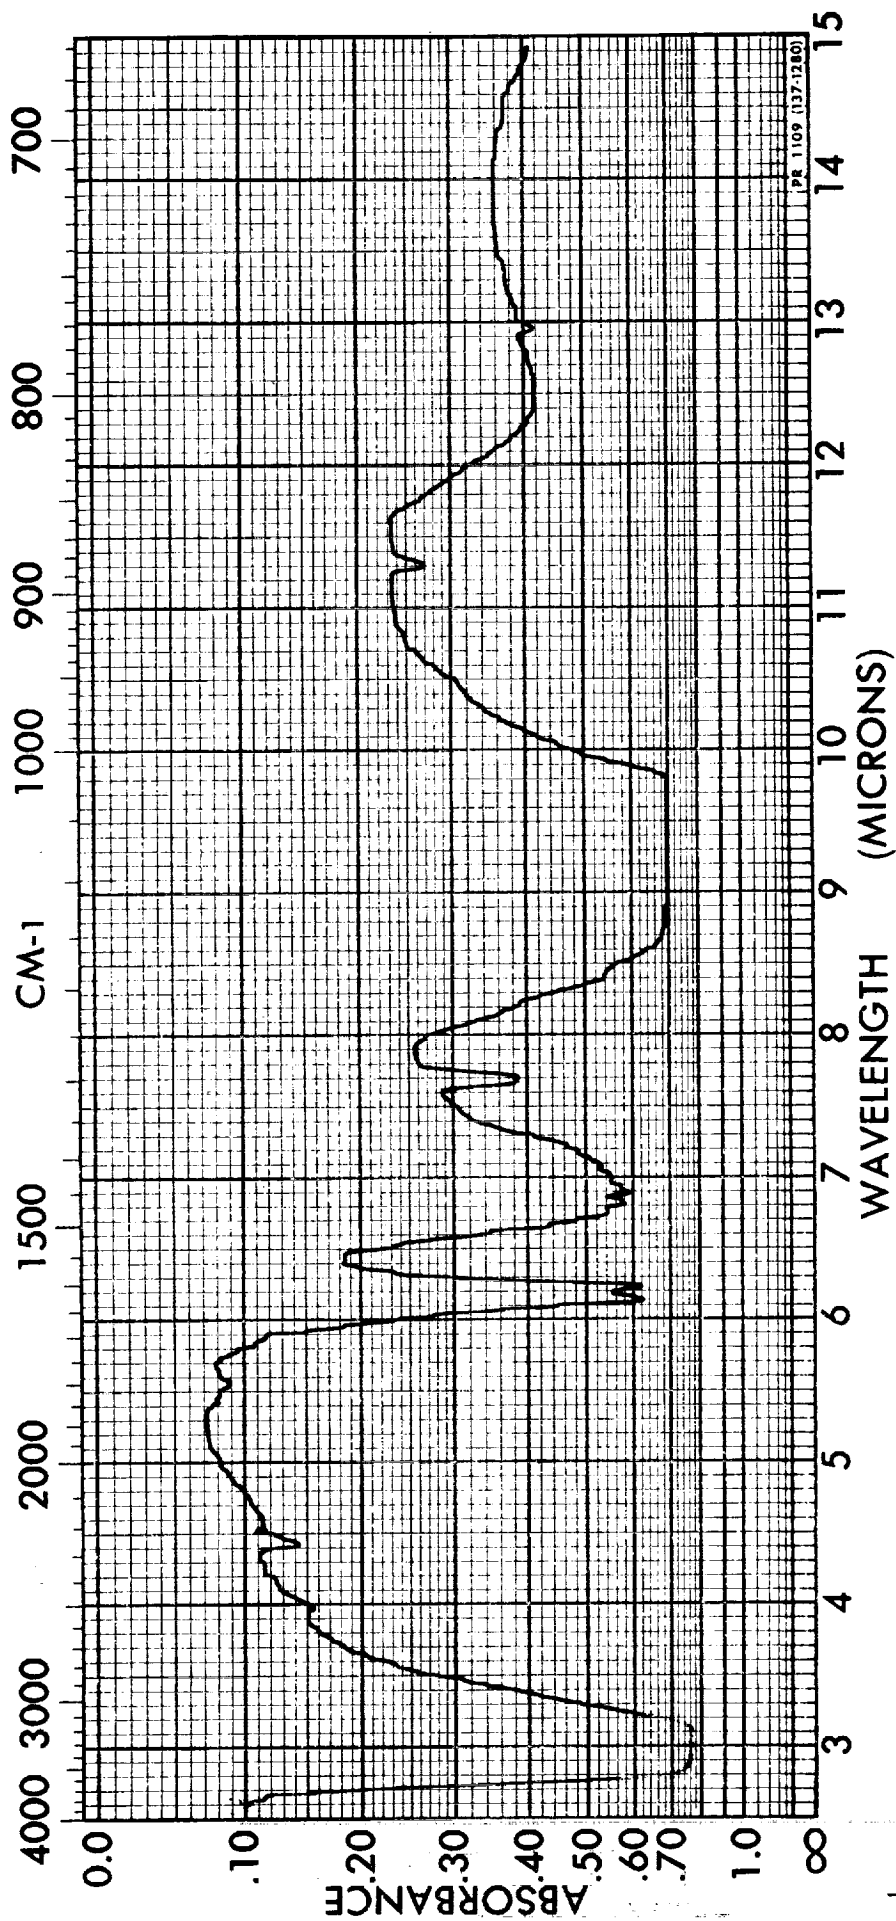
Figure 23. IR Spectrum of Black Powder Residue from OF<sub>2</sub>/B<sub>2</sub>H<sub>6</sub> Run 108.  
(High Concentration in KBr Pellet)

Upon removal of the sample plug from the engine following Run 108, the deposit on the plug was roughly 50% gray - 50% black. However, despite the nitrogen environment, the sample changed by the following morning to approximately 5% gray - 95% black. Figures 22 and 23 are IR spectra of the black material at two concentrations in the pellets. Figure 24 is a spectrum of the gray powder. It is seen that all three spectra have significant absorptions at 2.9, 6.2, 7.0, 8.9 and 9.2 microns. The spectra of the gray material differs from the black material in that the 7.0 micron peak is more pronounced relative to the other absorptions.

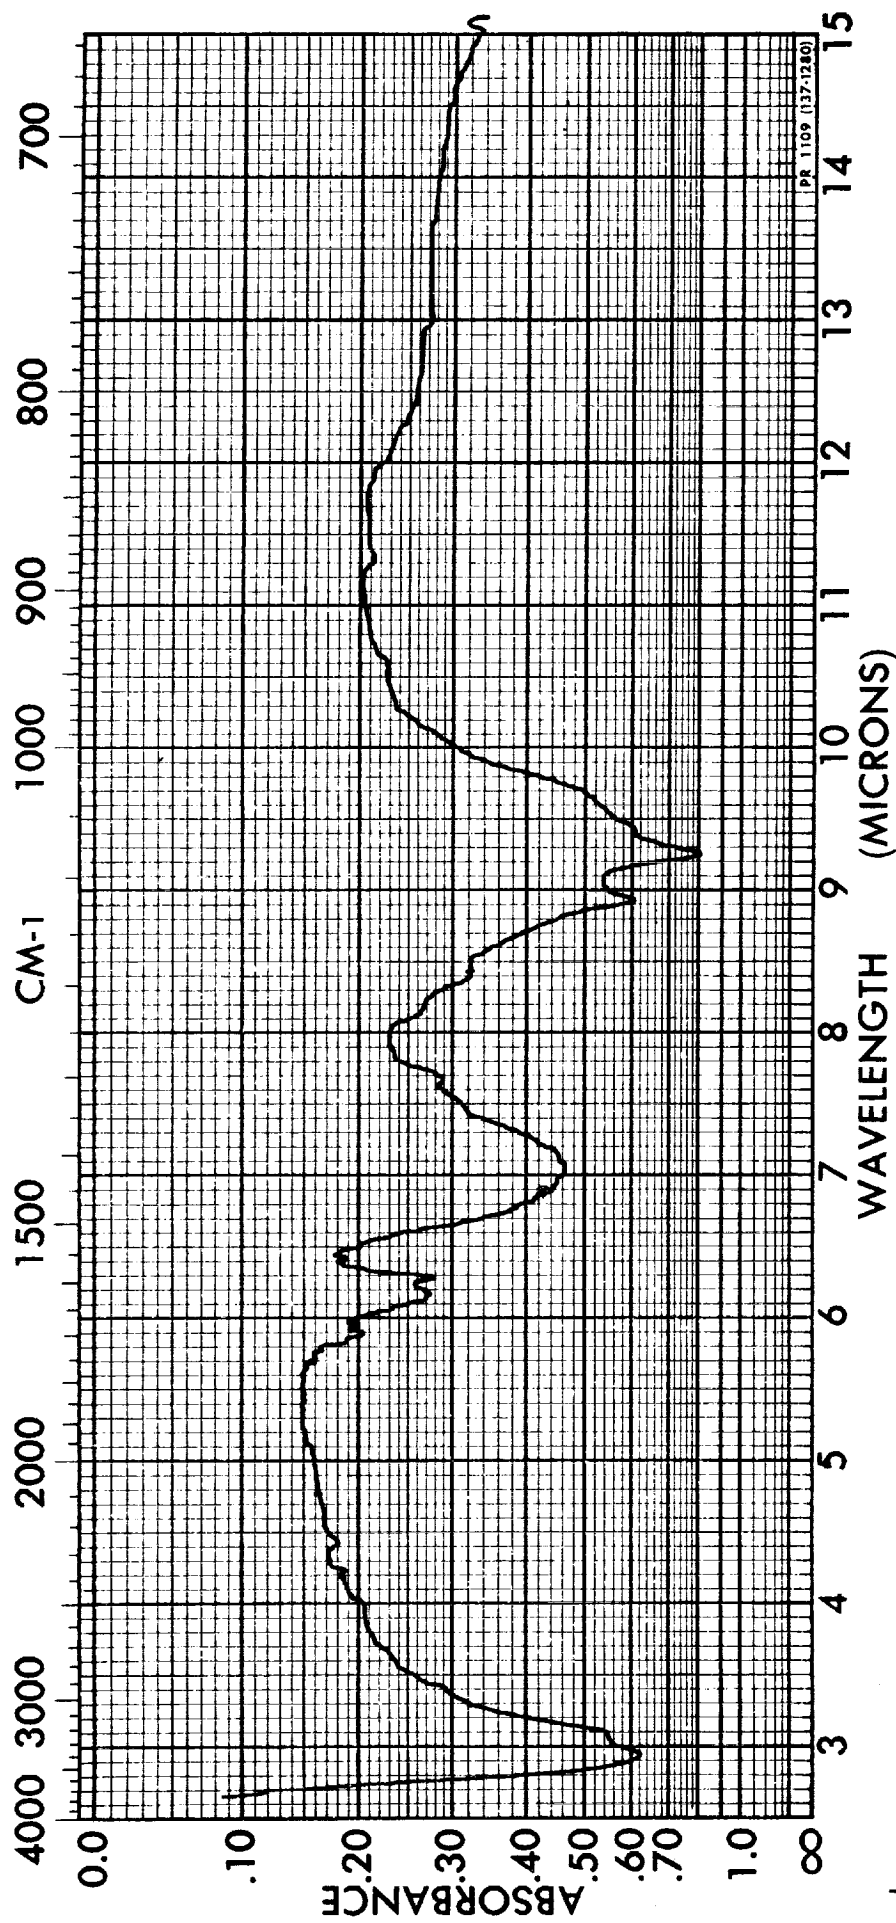
Figure 24. IR Spectrum of Light Gray Powder Residue from  $\text{OF}_2/\text{B}_2\text{H}_6$  Run 108.

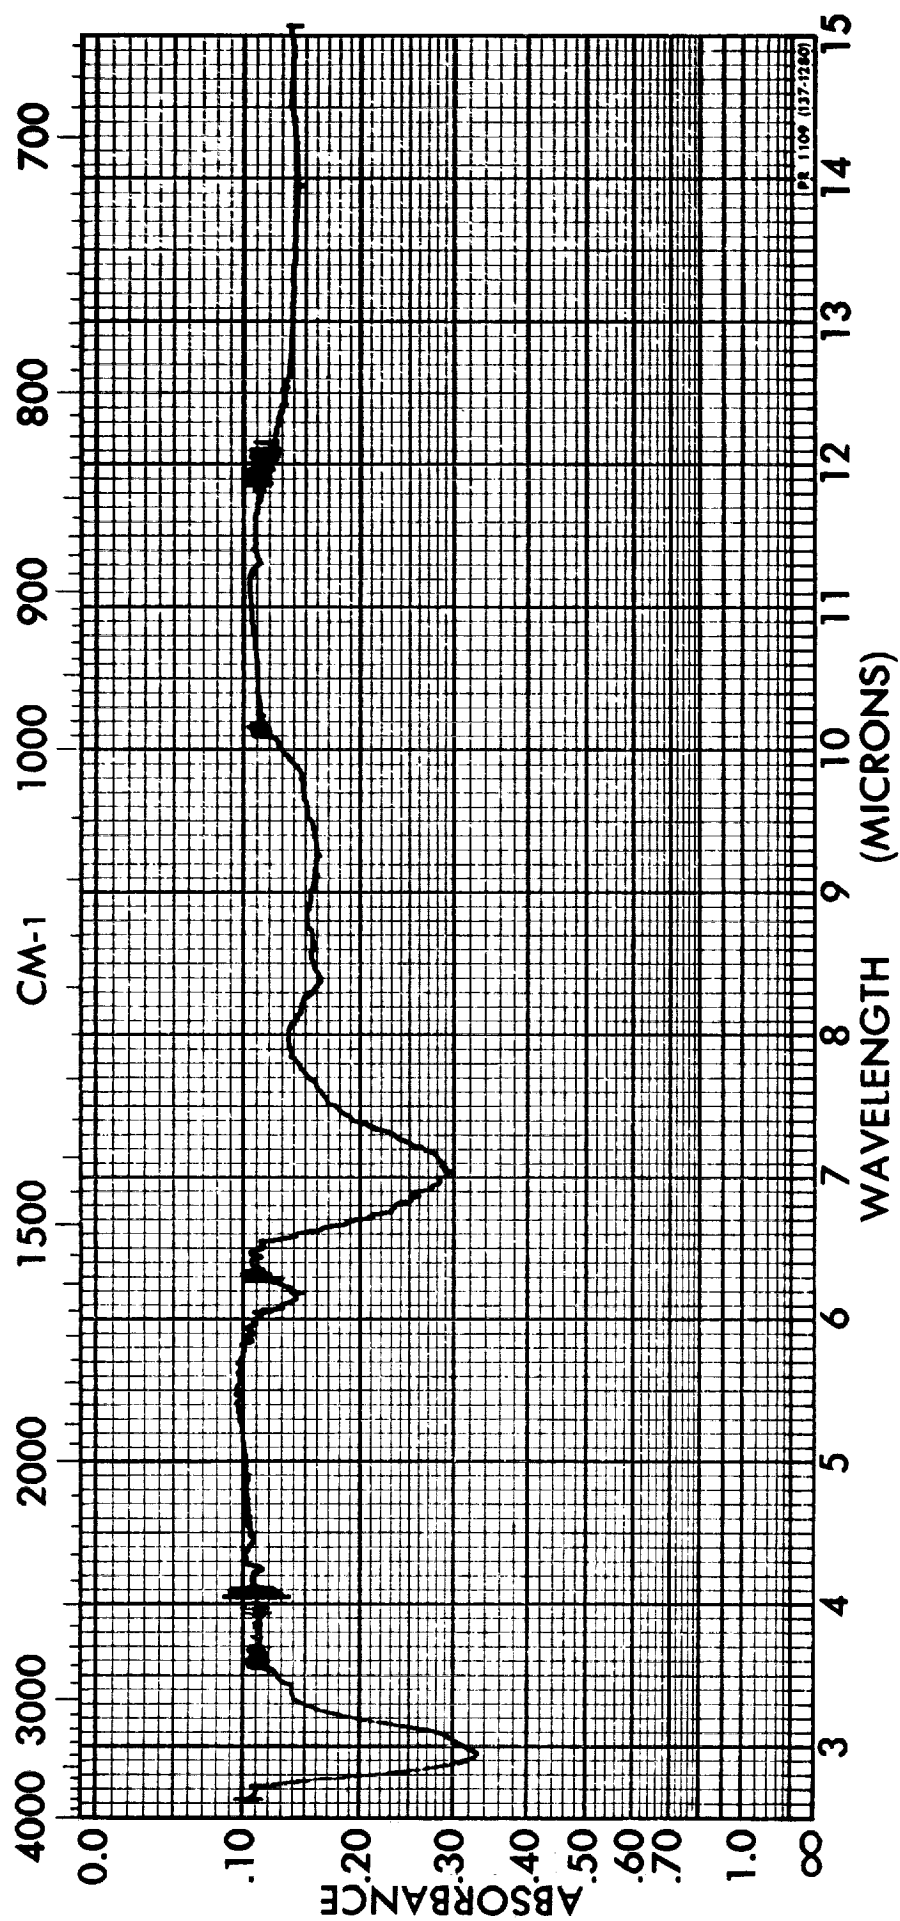
Figure 25. IR Spectrum of Powder Residue from OF<sub>2</sub>/B<sub>2</sub>H<sub>6</sub> Run 115.

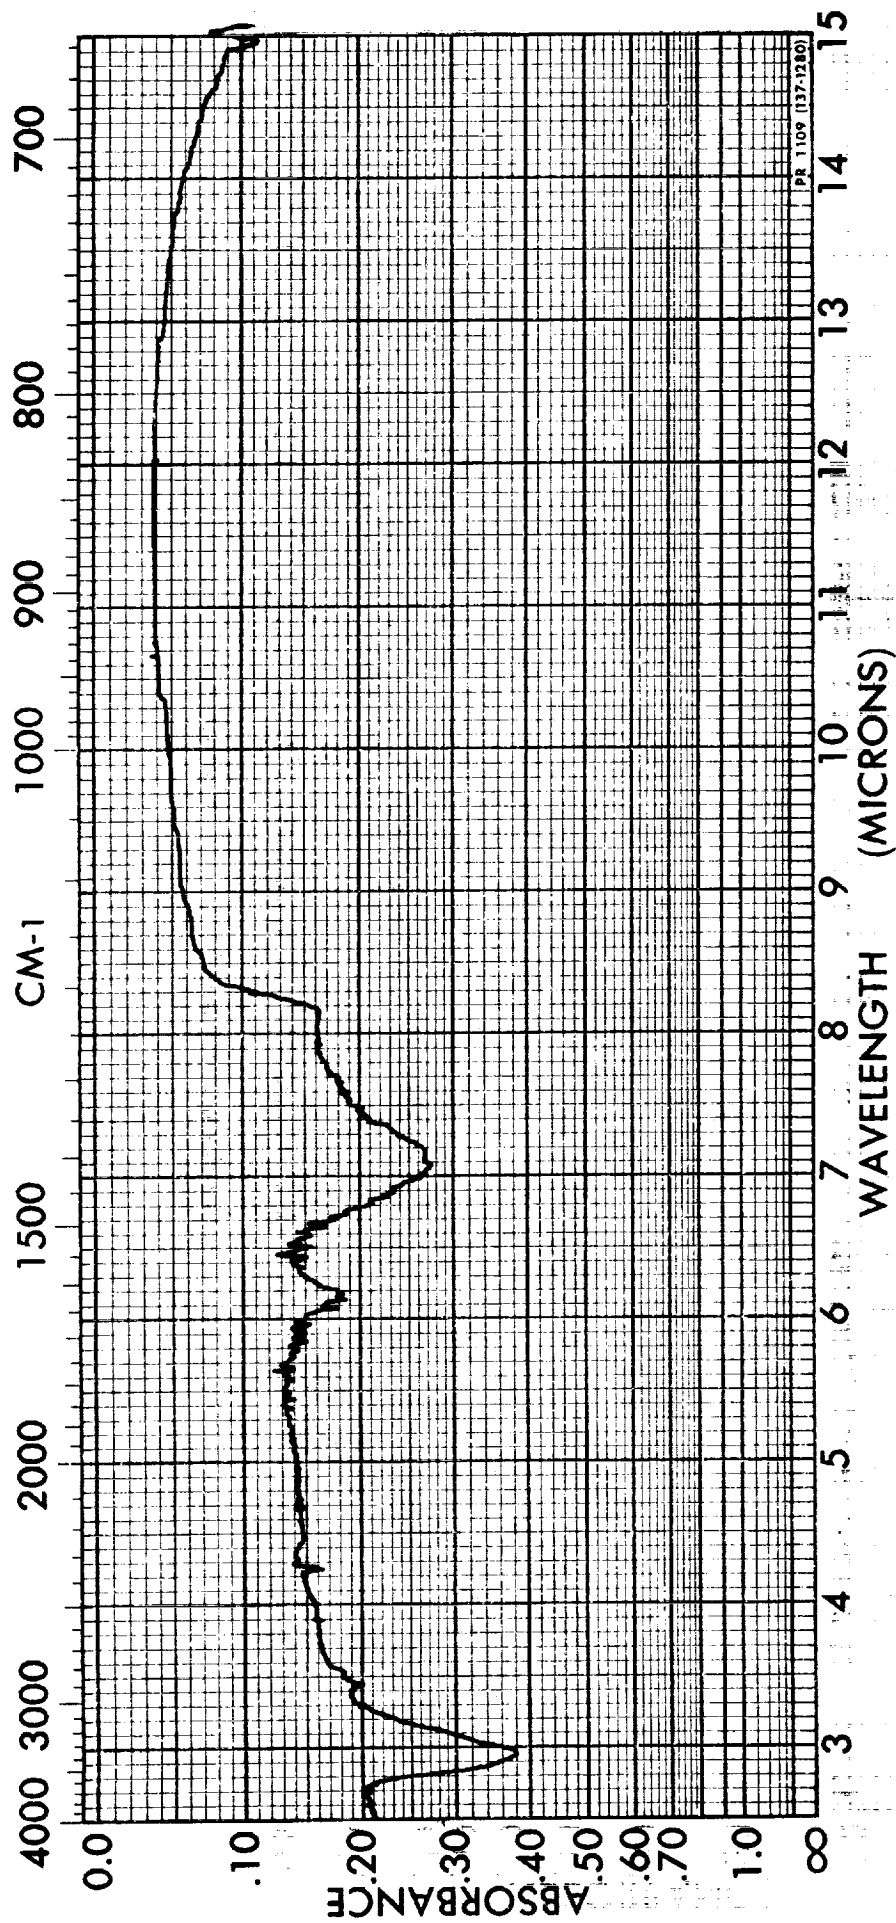
Figure 26. IR Spectrum of Powder Residue from OF<sub>2</sub>/B<sub>2</sub>H<sub>6</sub> Run 116.

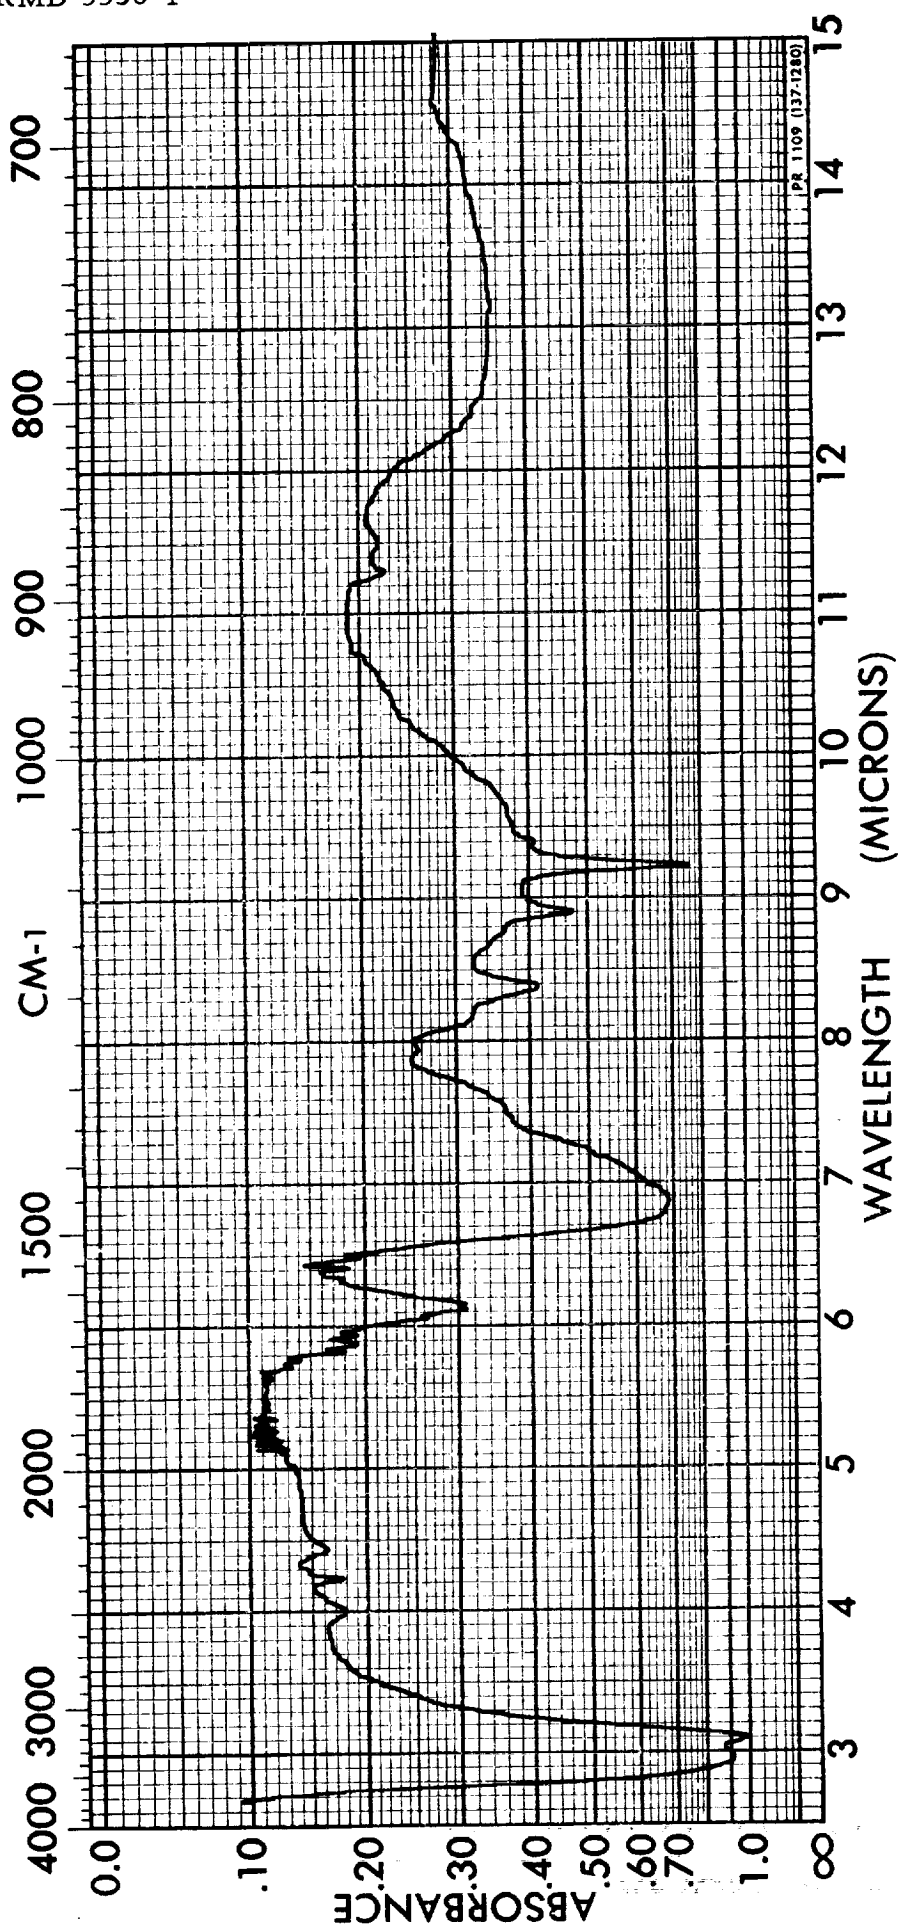
Figure 27. IR Spectrum of Air-Exposed, Gray Residue from OF<sub>2</sub>/B<sub>2</sub>H<sub>6</sub> Run 124.

The gray air-exposed residue of Run 124 was also examined on an X-ray diffractometer. Two strong, sharp peaks were obtained at 6.10 and 3.20 Å. In addition, weak, broad peaks were obtained at 5.47, 2.91 and

2.24 Å. The latter peaks are unidentified but the two strong ones are characteristic of  $B_2O_3$  and  $H_3BO_3$  although other lines from these crystals were not observed. It is possible that compounds involving B, O and F would have similar d-spacings as  $B_2O_3$  and  $H_3BO_3$  both of which have been ruled out by the IR results.

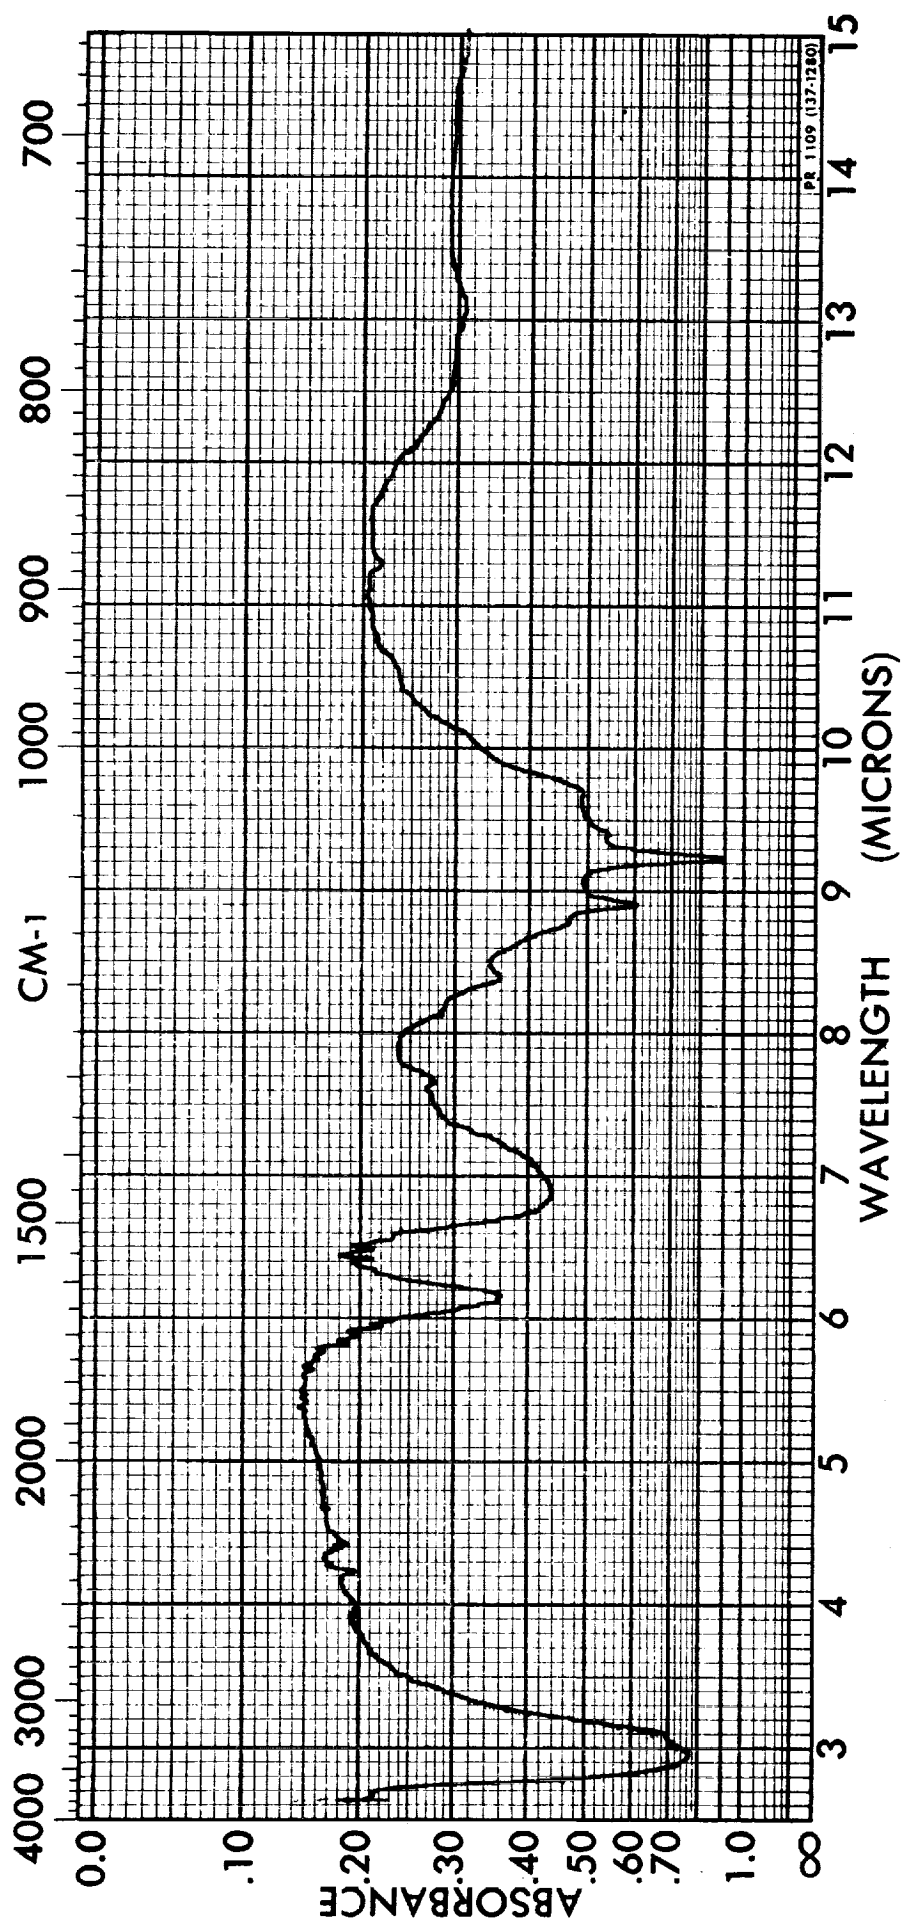
Figure 28. IR Spectrum of Powder Residue from Flox/B<sub>2</sub>H<sub>6</sub> Run 122.

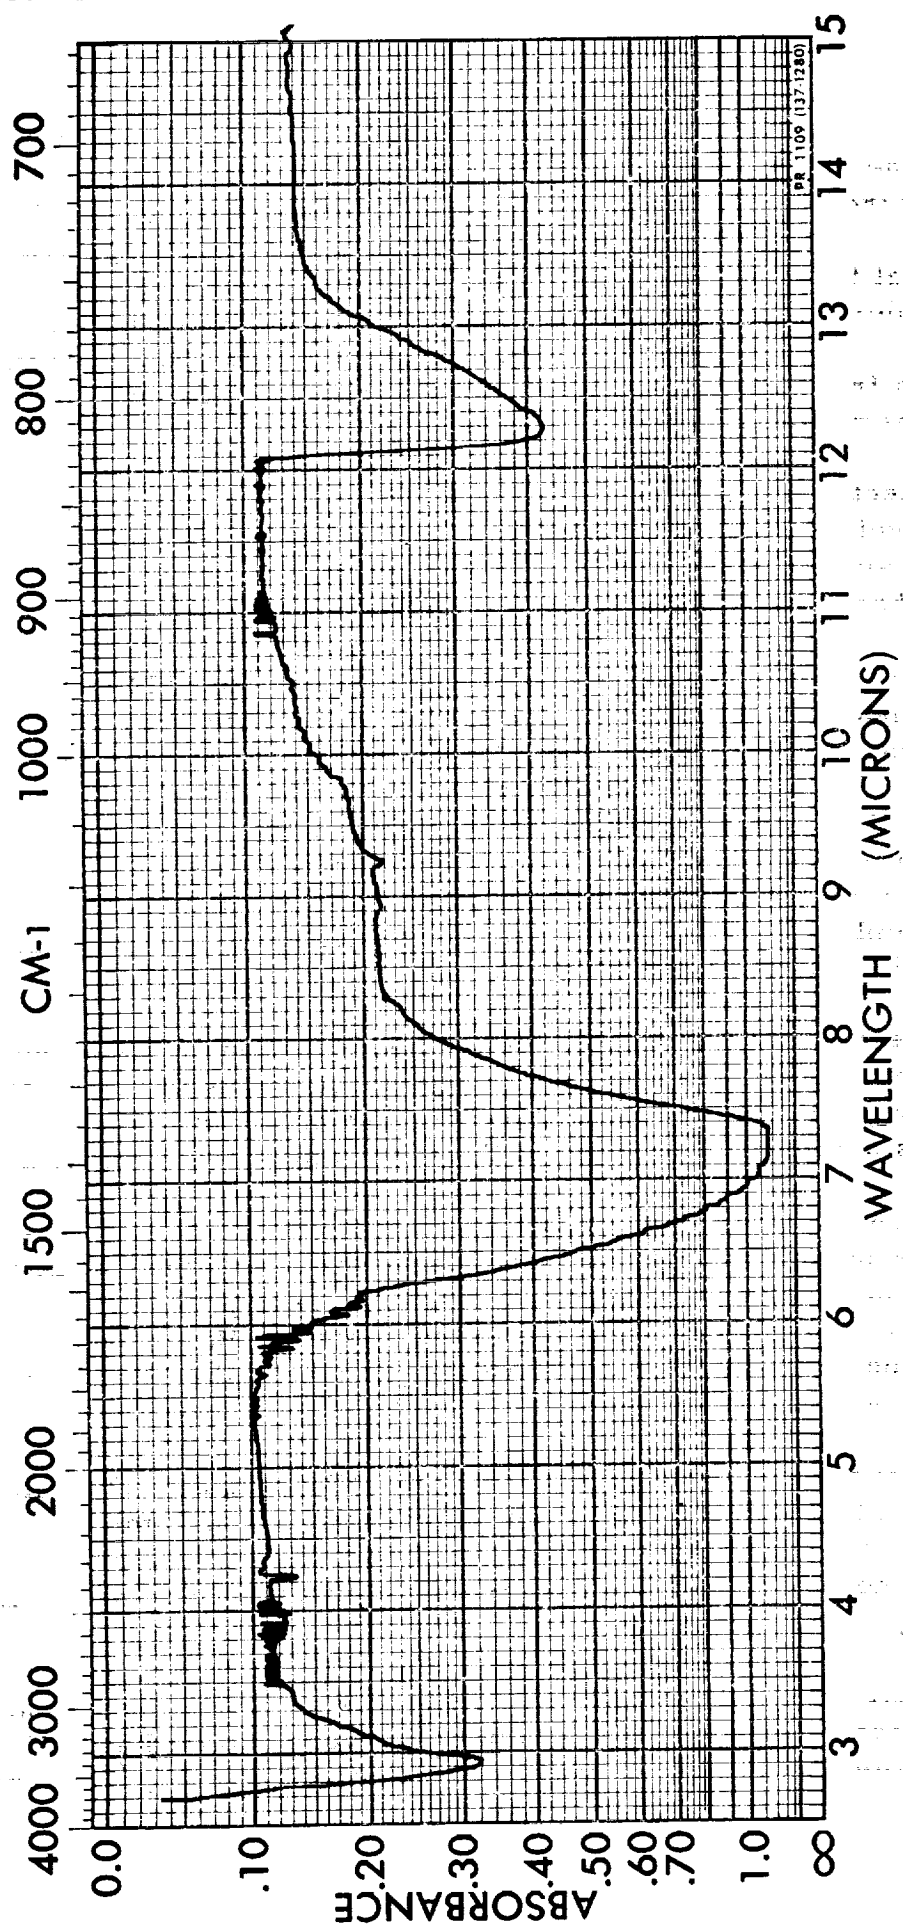
Figure 29. IR Spectrum of Boron Nitride.

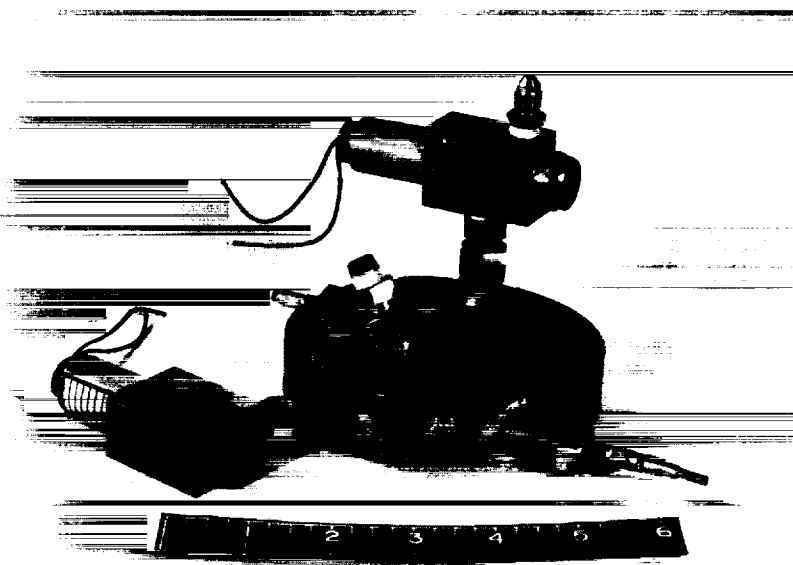
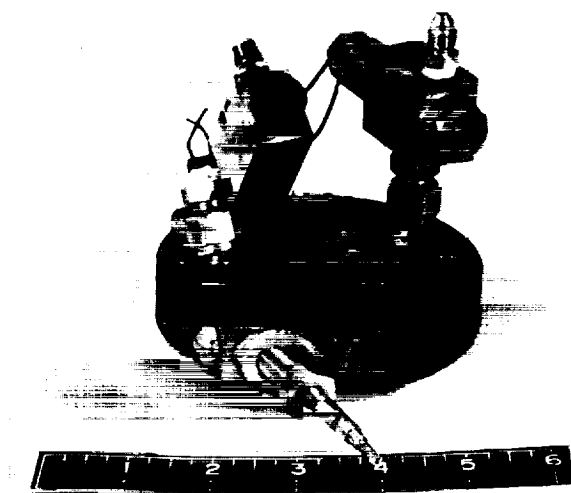
Figure 31. Injector and Explosive Valves after Run 78

A test with explosively actuated valves was made with the valves at below design-point temperatures. Although the fuel-side valve operated normally, the oxidizer-side valve failed due to reaction of the  $\text{OF}_2$  with the fuel-rich squib combustion products which blew-by the shear ram into the downstream cavity of the valve.

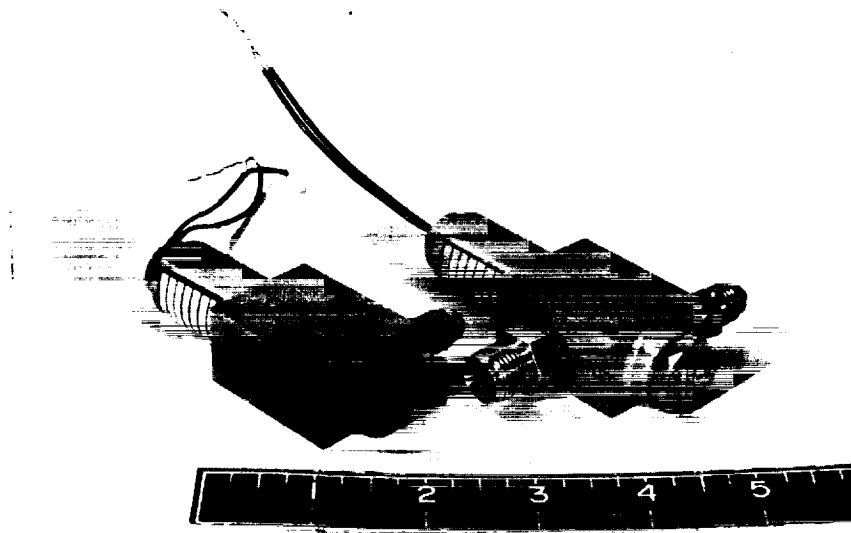
Figure 32. Explosive Valve Used in Run 78 and New Valve

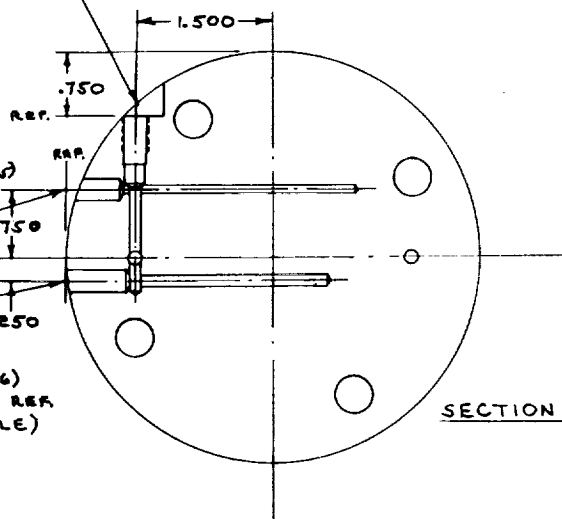
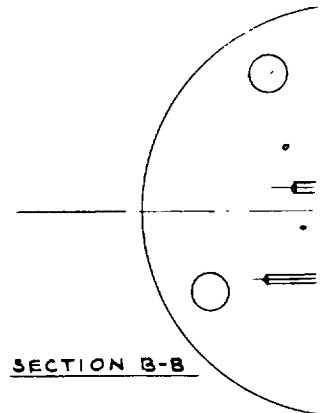
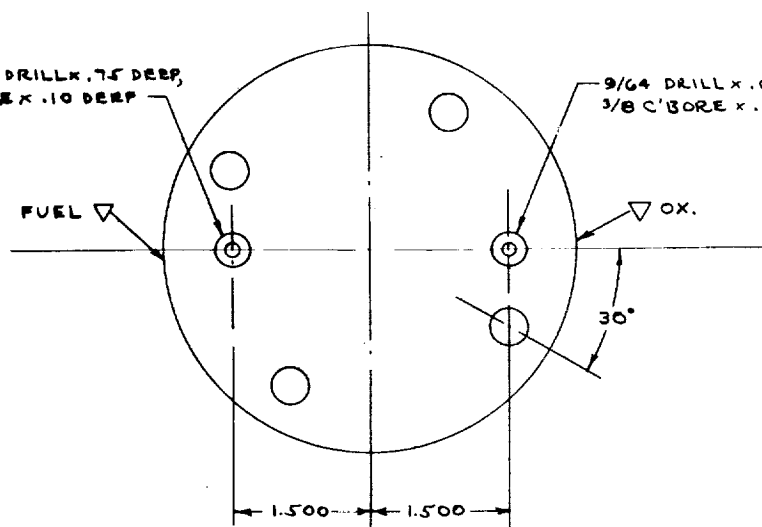
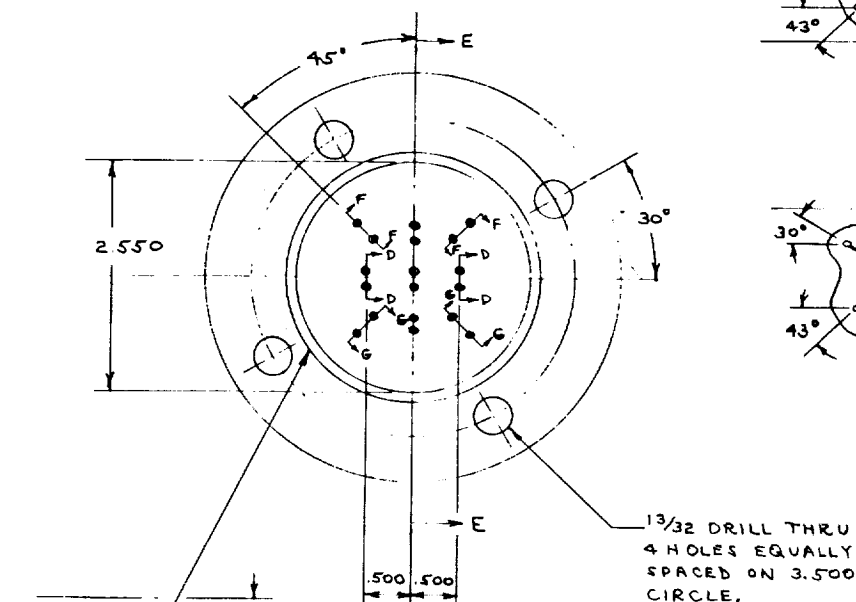
5/8 C'BORE TO .750 SHOWN TO FORM REF,  
 9/64 DRILL X 1.50 DEEP FROM REF,  
 7/32 DRILL X .700 DEEP FROM REF, 1/4 C'BORE  
 X .500 DEEP FROM REF, M7 X 0.75 TAP X .35 DEEP

1/4 DRILL X .60 DEEP  
 FROM REF, #39(.099)  
 DRILL X 3.15 FROM  
 REF.  
 (PLUG + WELD  
 1/4 HOLE)

1/4 DRILL X .65 DEEP  
 FROM REF, #32(.116)  
 DRILL X 2.00 FROM REF  
 (PLUG + WELD 1/4 HOLE)

SECTION CC

SECTION B-B

O-RING GROOVE  
DETAIL, 10X SIZE

To define potential problem areas relative to dribble volume and flow paths, two injectors were used. Both injectors are doublets and they are interchangeable with the two chambers. One injector is a single element doublet to reduce injector dribble volume to a minimum. The second injector is also a doublet but it contains nine pairs of orifices and a larger distribution manifold more representative of flight hardware. A comparison of the data from the two injectors at the same design flowrates and temperature conditions indicates the extent to which flashing of the propellants within the injector must be considered in designing flight hardware. Detail drawings of the two injectors are given in Appendix A.
