**TR-EE-70-43**

**FINAL REPORT ON GRAVITY  
SUBSTITUTE WORKBENCH  
(SKYLAB EXPERIMENT - M507)**

CONTRACT NAS8-21385

GEORGE C. MARSHALL SPACE FLIGHT CENTER

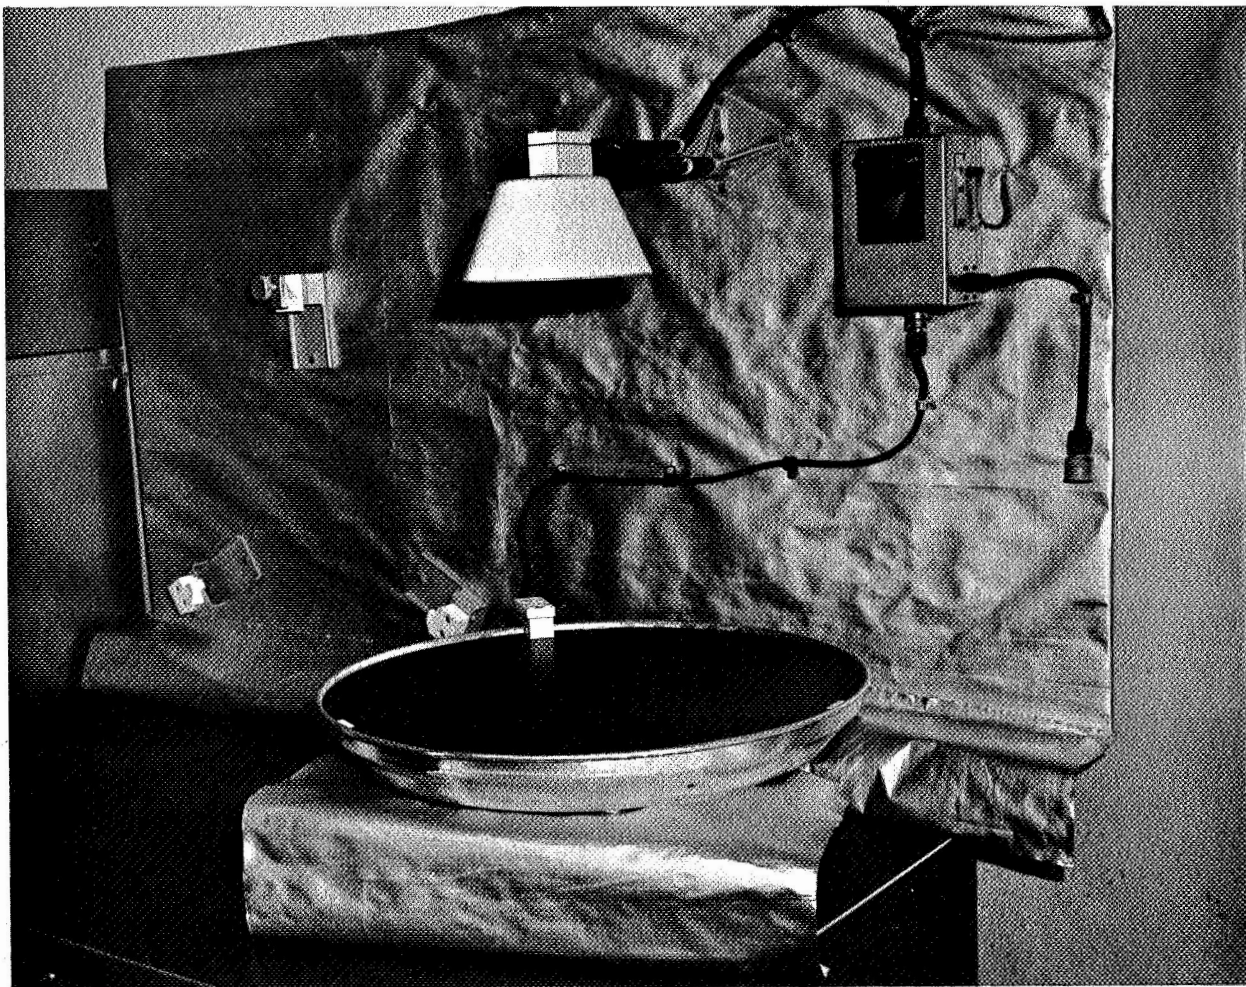
Figure 6. Electrostatic Workbench Operational Condition

2.2.3.2.1 General Configuration. The arrangement of the electrostatic workbench elements as shown in figure 6 was the result of human engineering considerations, Skylab interface requirements, and interaction with the aerodynamic workbench. The purpose of the M507 to serve as a work station established the location for the work surface and the use of one structure for both methods of gravity substitution was both logical and economical. The ion source and shield enclosure being 18 inches above the table allows ample working clearance and is situated like a light fixture over a normal 1g workbench. The power supply and its controls are located for convenient access and observation by the operator when he is standing in front of or to the right of the work surface. Location of the table top storage to the left was dictated by a reassignment of space in the Skylab. Elimination of connectors involving the operator not only reduces the things he has to do to activate and use the facility but adds to workbench reliability. This design is defined by MSFC drawing and Parts List No. 95M12015. Descriptions of the component parts are as follows:

- b) Work Surface. The work surface or table top is a 24-inch diameter aluminum alloy plate, 1/4-inch thick with the bottom side milled to leave a stiffening rib pattern and a minimum weight. The entire outside surface is given a hard coat anodize finish with the exception of a small electrical contact area which is treated with alodine. A single teflon insulated wire for the 300-vdc table bias is attached to the table with a terminal lug, forming a 3 1/2-foot pigtail which terminates in a 40M39569 connector plug. Core convolute tubing and end fittings protect the complete cable. The table top terminal is further protected by a teflon block and cap, designed as a convenient handle to move the table in and out of the operating position. Additional insulation protection and centering within the upper rim of the aerodynamic workbench is provided by three teflon spacers about the table's rim.
