ADVANCED TURBINE ENGINE MAINSHAFT LUBRICATION SYSTEM INVESTIGATION

Part 2 - Detailed Face Seals Performance, Mass Spectroscopic Study
of a Test Fluid, and Supplementary Test Data

RESEARCH LABORATORY
SKF INDUSTRIES, INC.
ENGINEERING AND RESEARCH CENTER
KING OF PRUSSIA, PA.

FINAL REPORT

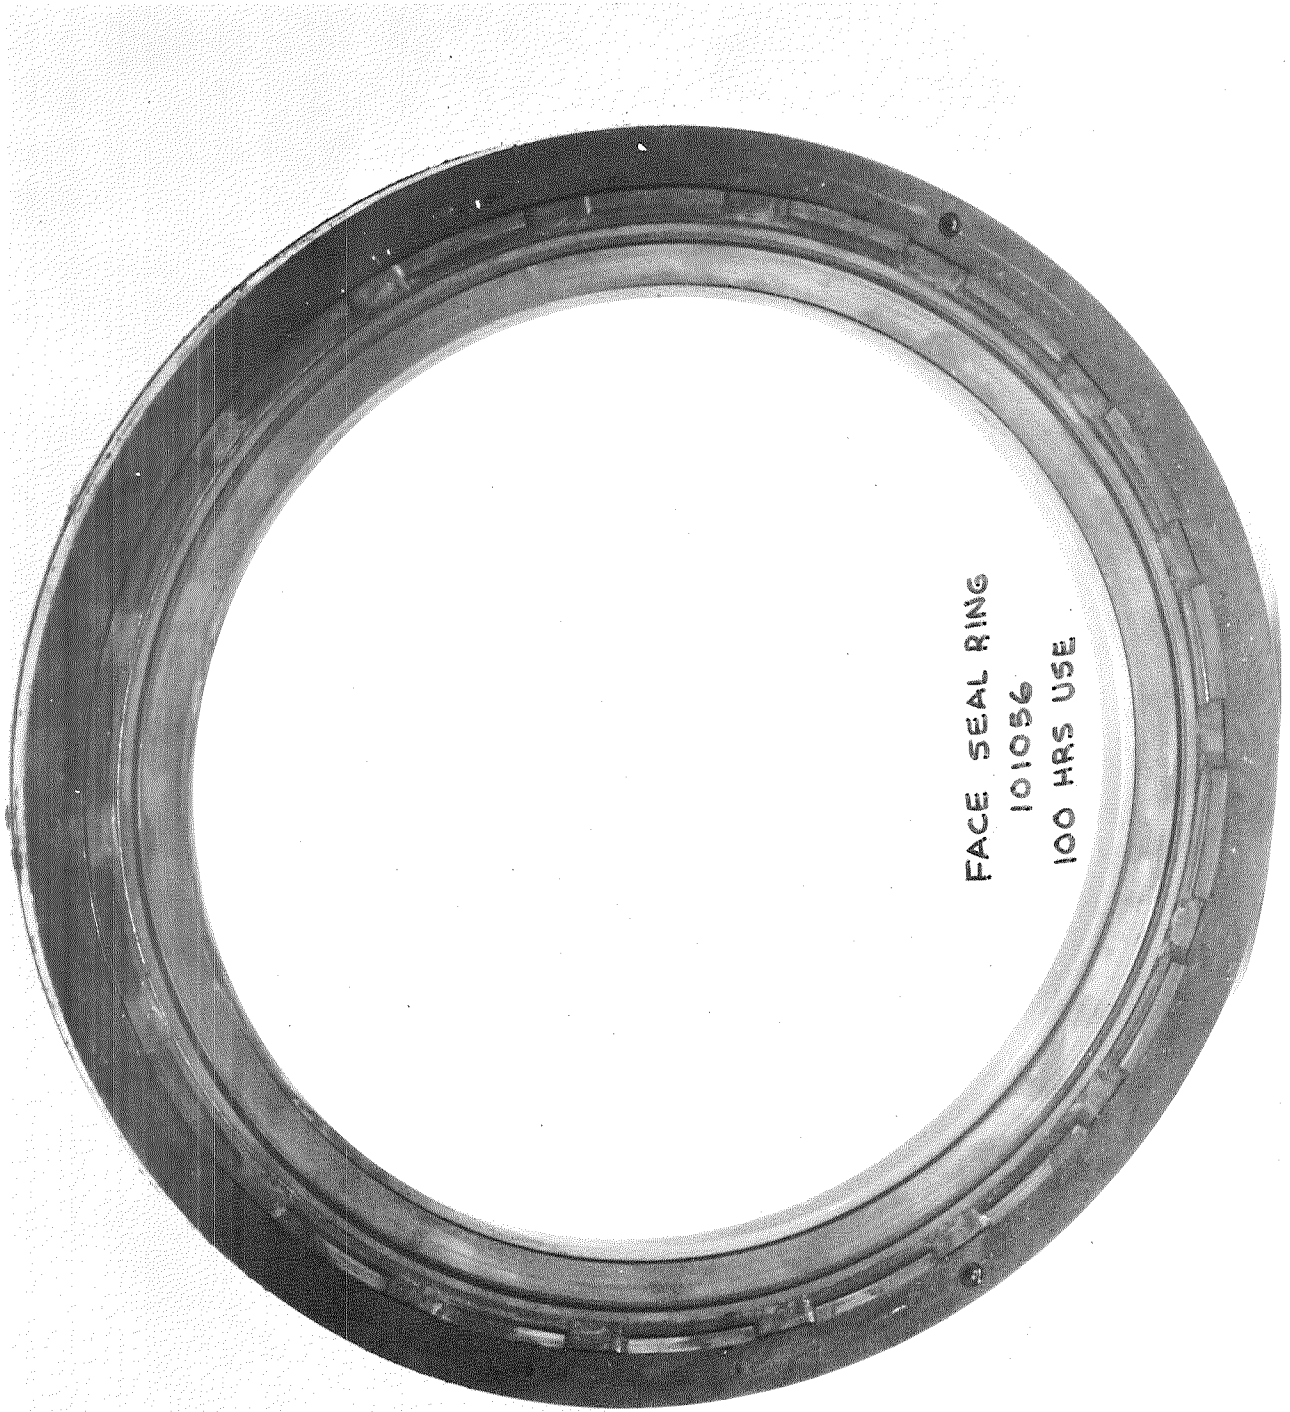
ENCLOSURE 4

CARBON FACE SEAL RING

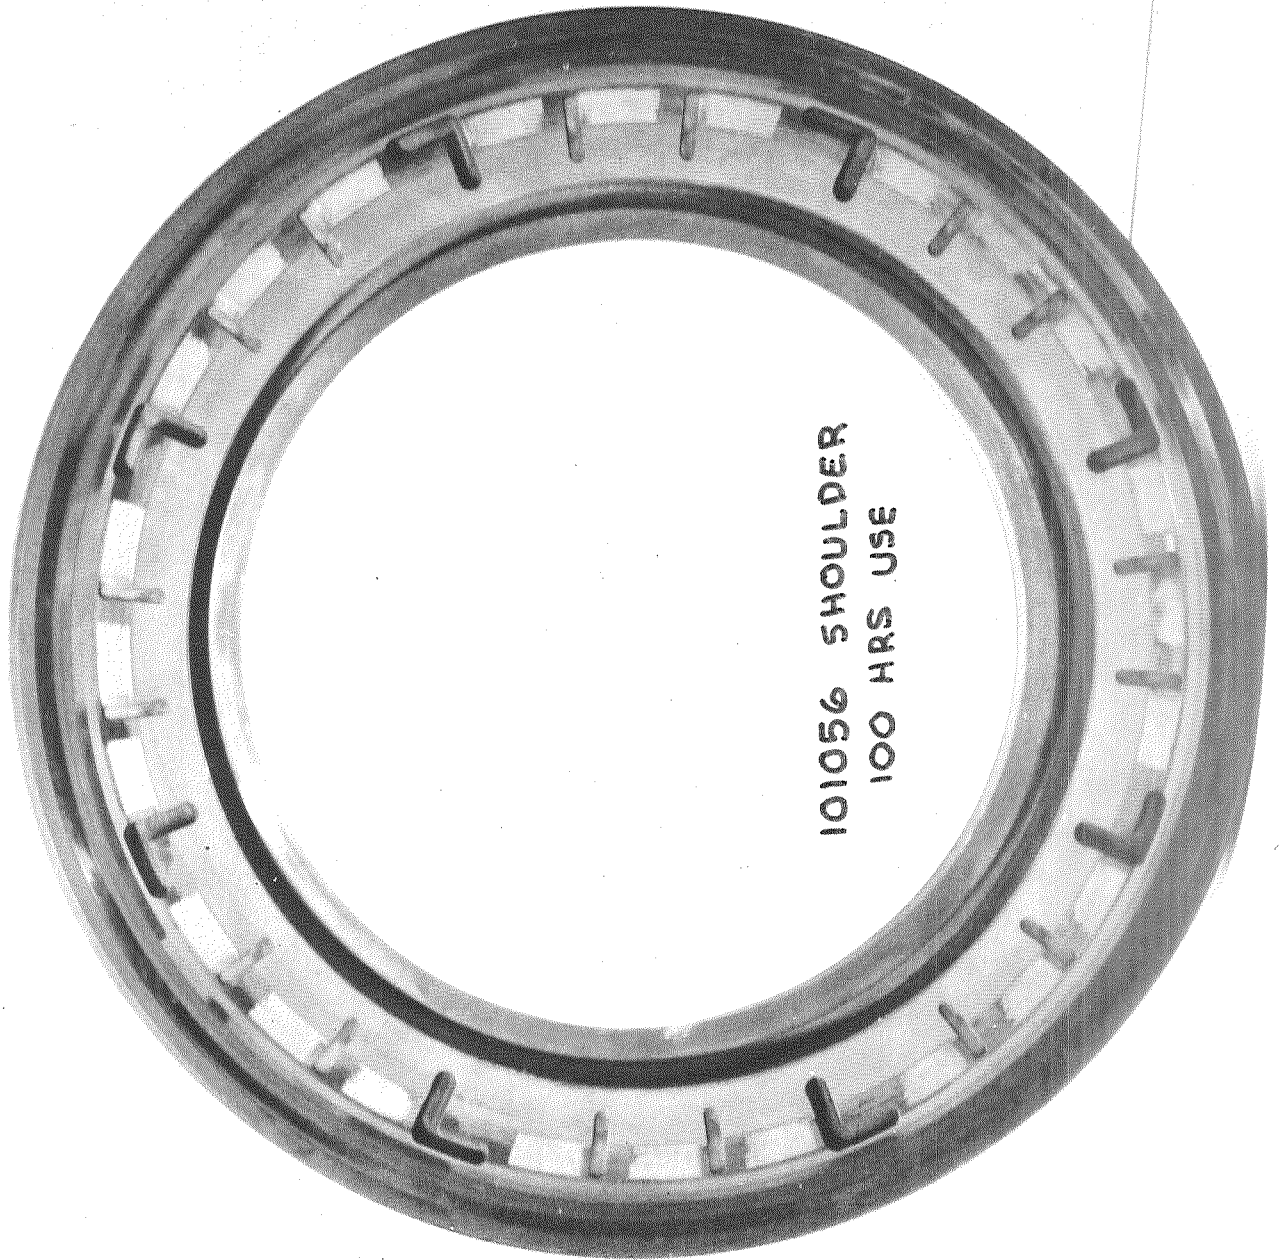
HYDRODYNAMIC LIFT DESIGN SHOULDER
