NASA TECHNICAL MEMORANDUM

NASA TM X-2459

EFFECT OF GROOVED CASING TREATMENT ON THE FLOW RANGE CAPABILITY OF A SINGLE-STAGE AXIAL-FLOW COMPRESSOR

by Everett E. Bailey Lewis Research Center Cleveland, Ohio 44135

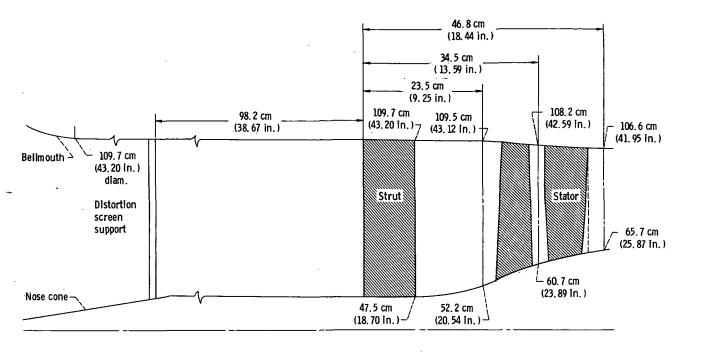
Figure 1. - Flowpath dimensions.

The outer and inner contour of the flow path in the vicinity of the stage are shown in figure 1. A description of the test facility and compressor rig is given in reference 2.

The steady-state data were digitized and recorded for computerized data reduction. Rotor inlet total pressure was obtained from the plenum and adjusted for the loss associated with a coarse support screen located between the plenum and the rotor inlet (see fig. 1) in anticipation of testing with inlet flow distortion. The inlet pressures were adjusted using a correlation of loss values as a function of weight flow obtained from previous testing of this same hardware. Rotor discharge total pressures and temperatures were obtained from a simple numerical average of the values obtained from the rakes described in the section INSTRUMENTATION.

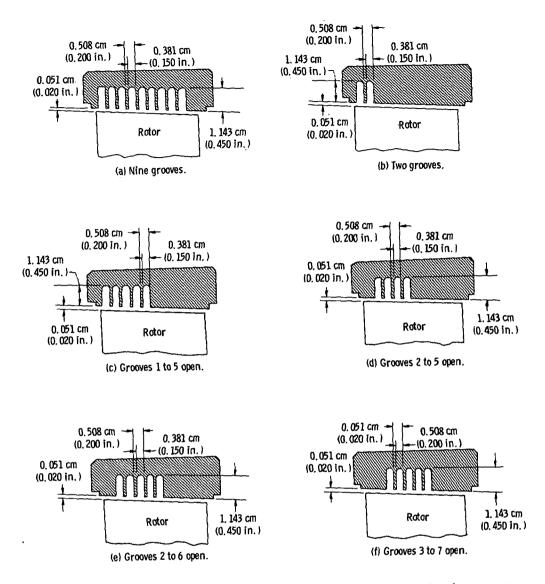
Figure 3. - Circumferential - grooved inserts showing variations in axial location and number of grooves open.

Grooves were 0.381 centimeter (0.150 in.) wide separated by a 0.127-centimeter (0.050 in.) land. Depths of 0.381, 1.143, and 2.896 centimeters (0.150, 0.450, and 1.140 in.) were evaluated. The number of grooves was varied up to a total of nine. The location of the grooved area with respect to the rotor tip was varied by selectively filling and opening certain of the nine grooves. Details of the geometry of the grooved inserts are shown in figures 2 to 4. A segment of the rotor blade tip is shown on each sketch to indicate the relation of the grooves to the blade chord.

Various combinations of number and location of grooves were investigated using a groove depth of 1.143 centimeters. These results are shown in figures 8(a) and (b).

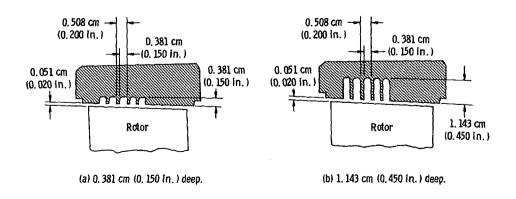
Figure 4. - Circumferential - grooved inserts showing variation in groove depth with grooves 2 to 6 open.

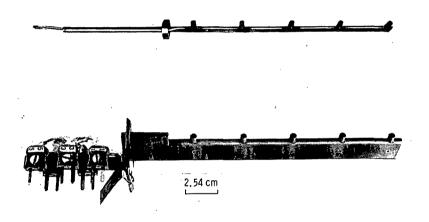
Figure 5. - Representative pressure and temperature rakes.

A relatively small amount of instrumentation was used for this screening program. Measurements of pressure and temperature were made in the large plenum upstream of the stage where the velocities were low. A single, five-element total-pressure rake was located between the rotor and stator. Sensing elements were positioned radially at 10, 30, 50, 70, and 90 percent of span. Four five-element temperature rakes were located downstream of the stator. The radial positions of the five sensing elements on each rake correspond to the same spanwise positions. Photographs of representative pressure and temperature rakes are shown in figure 5. A thin-plate orifice located in

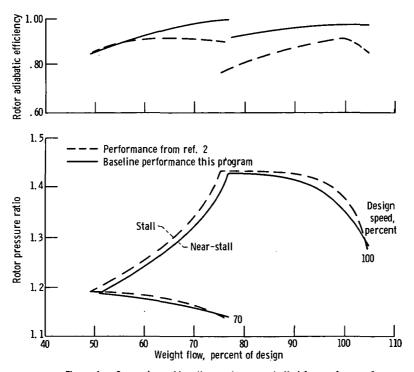
Figure 6. - Comparison of baseline performance to that from reference 2.

The overall rotor baseline performance with a solid wall casing is shown in figure 6. For comparison, the overall rotor performance from reference 2 is shown as dashed lines. The data from reference 2 were obtained with mass weighted computations of

values from more complete survey instrumentation. Thus it is considered more precise than that for the present screening program. The differences in pressure ratio and efficiency between the two builds are a consequence of the differences in instrumentation and data handling. The differences in the minimum weight flow at each speed are a result of test procedures, with the values from reference 2 being the weight flow at the point of the initiation of rotating stall and the values for this test, the weight flow for a steady-state data point near stall. The repeatability for the near-stall point was demonstrated to be 0.6 percent or less, whereas the estimated accuracy for flow measurement is 1 percent of design flow.

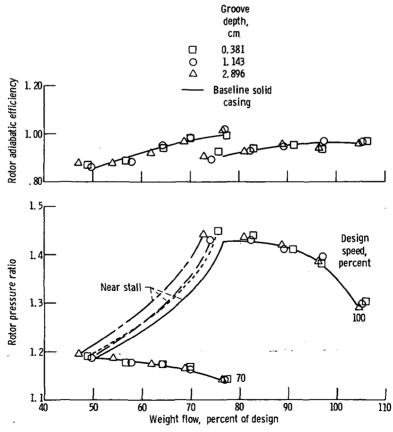
Figure 7. - Comparison of the effects of groove depth. Nine groves open.

With all nine grooves open, three values of groove depth were evaluated. These results are presented in figure 7. The 0.38-centimeter-deep grooves produced a new stall weight flow approximately 1.5 percent lower than the solid wall baseline configuration. The 1.143-centimeter-deep grooves resulted in a near-stall flow reduction of 3.6 percent at design speed; the 2.896-centimeter-deep grooves gave a 5.7-percent reduction. Within the anticipated data accuracy, the efficiencies are not significantly different from the baseline. Even though the deepest grooves indicates a marked improvement in stall margin, it is significant to note that, at disassembly, cracks in the 0.381-centimeter lands were observed. The cracks were not subjected to a thorough evaluation, but they appeared to be the results of vibratory stresses.

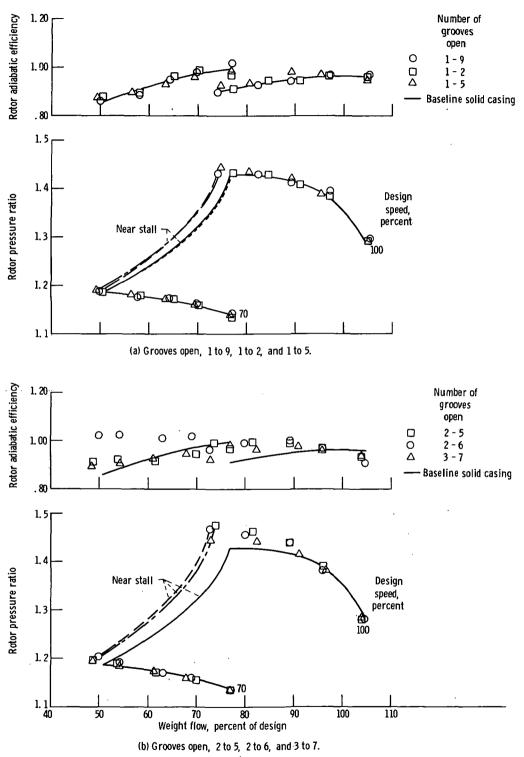
Figure 8. - Comparison of effects of location and number of grooves open. Groove depth, 1. 143 centimeters.

The configuration with grooves 2 to 6 open gave the maximum stall margin improvement. The reduction in near-stall flow amounted to 5.8 percent for design speed. As

indicated, the first, possibly the second, and the two rear grooves did not appear to be contributing to the observed improvement in stall margin. In fact, the indicated improvement in stall margin is greatest when the forward and rear grooves were not used. Compared with the baseline, there tends to be an indication of some increased pressure ratio and efficiency associated with the configurations where the grooves were over the midchord region. However, because of the minimum instrumentation and the method of data computation of these parameters, these increases are not considered to be significant. They are only considered substantiating evidence of no loss in performance associated with the presence of the circumferential grooves over the rotor tip.

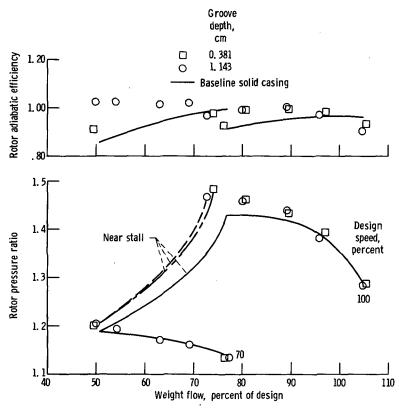
Figure 9. - Comparison of effects of groove depth. Grooves 2 to 6 open.

Considering these observations, the effect of groove depth was evaluated a second time with only grooves 2 to 6 open. The 0.381- and 1.143-centimeter depths were used. Results are shown in figure 9. As had been noted from figure 7, increased depth resulted in a greater reduction in near-stall weight flow. However, it is significant to note that the amount of the reduction in near-stall weight flow, compared with that for the solid wall casing, is greater for both groove depths with the grooves 2 to 6 open than that for comparable depths with all nine grooves open. The 0.381-centimeter-deep grooves showed a near-stall flow reduction of 3.9 percent, and the 1.143-centimeter-deep grooves 5.8 percent when compared with the solid case baseline configuration at design speed.
