NASA TN D-7082

APOLLO EXPERIENCE REPORT - ASCENT PROPULSION SYSTEM

by Clarence E. Humphries and Reuben E. Taylor

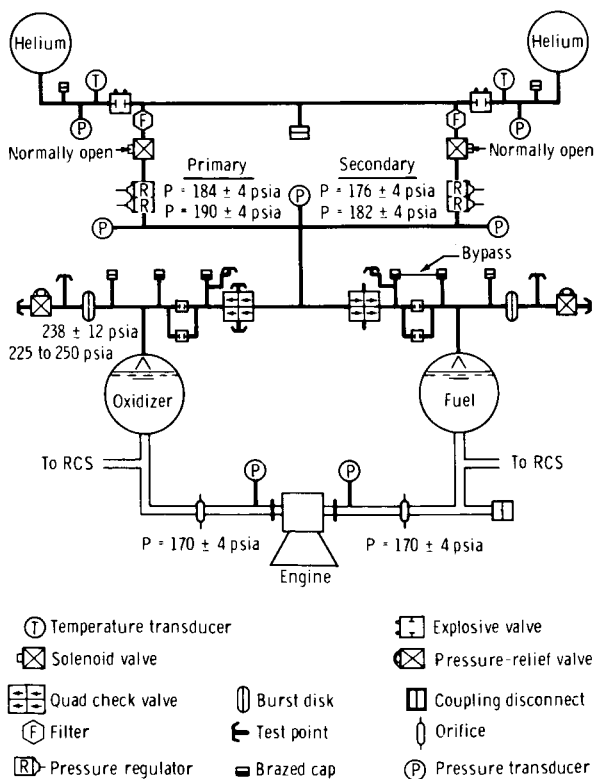
The primary and secondary helium-flow paths merge downstream from the regulators to form a common helium manifold. The manifold routes the helium into two flow paths: one path leads to the oxidizer tanks and the other path leads to the fuel tank. A quadruple check-valve assembly isolates the upstream components from the corrosive propellant vapors and prevents possible hypergolic action in the common manifold that may result from mixing of propellants or propellant vapors as a result of backflow from the propellant tanks.

Two parallel explosive valves, downstream from each quadruple check-valve assembly, provide a positive seal upstream from the propellant tanks to isolate the fuel and oxidizer (liquid and vapor) before the initial ascent-engine start. This configuration reduces compatibility problems involving helium components and prolongs the life of the pressurization-system components.

Immediately upstream from the fuel and oxidizer tanks, each helium-flow path contains a burst-disk relief-valve assembly. The relief valve on each helium-flow path can pass the entire helium flow from a failed-open pair of regulators without damaging the propellant tanks. A low-level sensor in each propellant tank causes a cabin caution light to turn on when the remaining propellant in either tank is limited to approximately 10 seconds of engine operation.

Each propellant flows through a trim orifice to the propellant filter in the engine assembly, then to the isolation and bipropellant valve assemblies (propellant-shutoff valves). The trim orifice provides an engine-interface pressure of 170 psia for proper propellant utilization by the engine. A secondary distribution line is interconnected to the reaction control system (RCS). A series-parallel arrangement of RCS/APS interconnect solenoid valves (part of the RCS) permits the RCS to burn APS propellants (providing the APS is pressurized and the propellant is settled during the time the interconnect valves are opened).

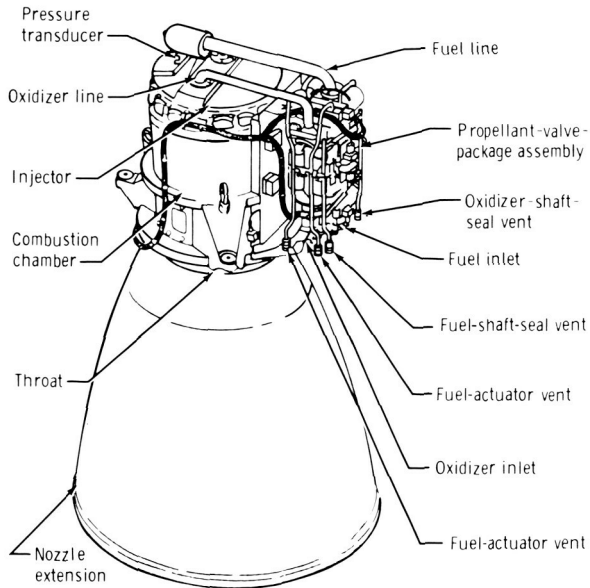
Figure 2. - Ascent-engine assembly.

The ascent engine, shown in figure 2, is a fixed-injector, restartable, bipropellant rocket engine that has an ablatively cooled combustion chamber, throat, and nozzle extension. Propellant flow to the ascent-engine combustion chamber is controlled by a valve-package assembly, trim orifices, and an injector assembly (fig. 3). The valve-package assembly is equipped with dual passages for both the fuel and the oxidizer and has two series-connected ball valves in each flow path.

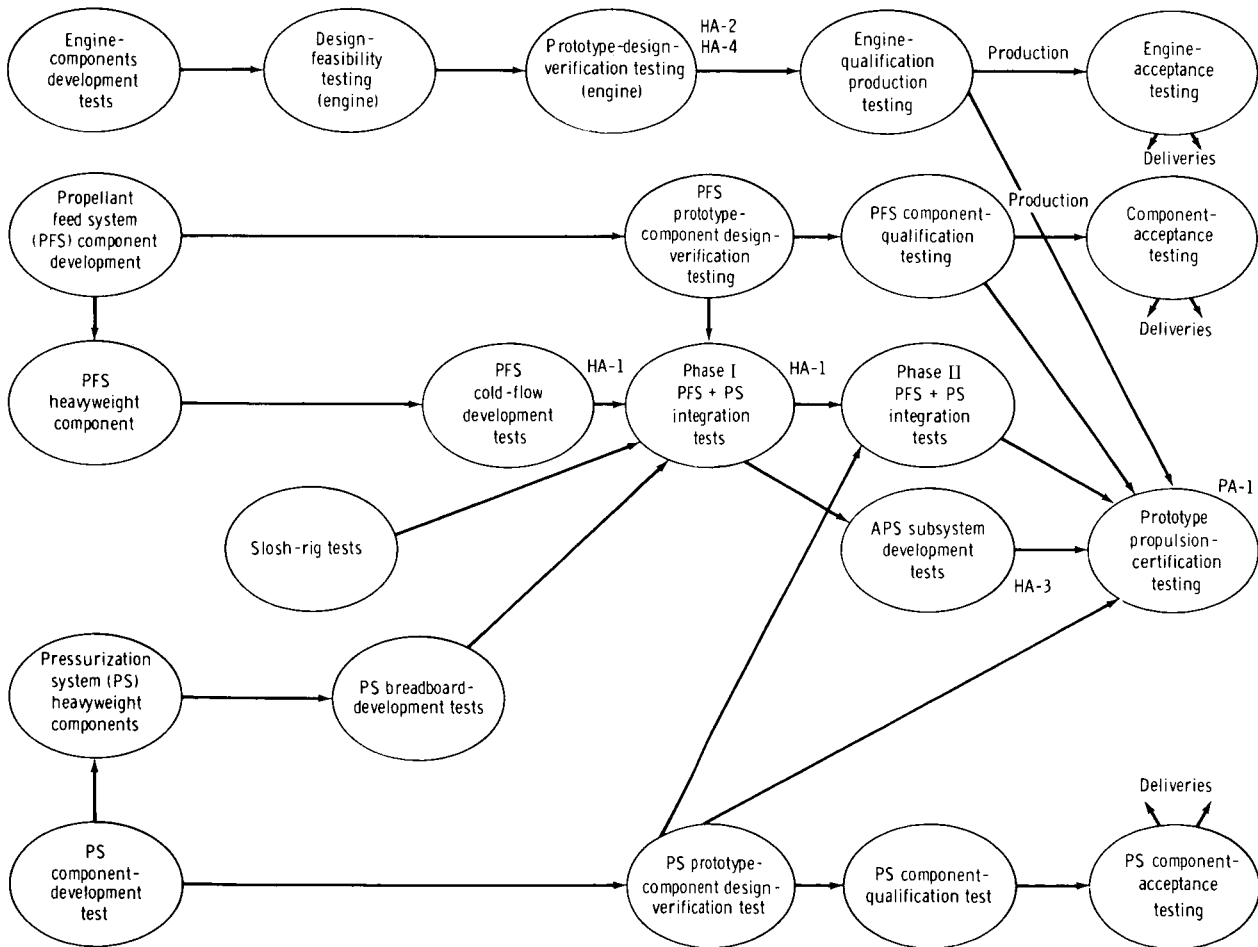
Figure 4. - Major phases of the APS development program.

Development of the APS through an extensive flight-test program was not feasible economically. Therefore, emphasis was placed on using proven manufacturing techniques, design integrity, and ground-based testing. The program was designed to achieve a fully qualified system in time to support the first manned lunar module (LM) flight. The plan was to test and evaluate materials, components, and assemblies in progressively integrated configurations, using various test rigs and prototype structural simulators. Major phases of the development program to accomplish this plan are shown in figure 4. The development and qualification of the APS started at the component level, progressed through the modular level, and, finally, moved into full-scale system tests.

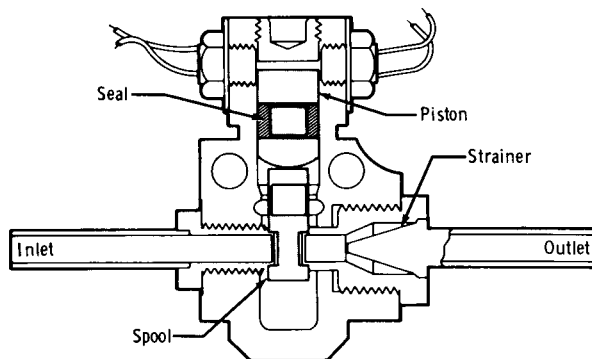
Figure 5. - Squib valve.

Squib valve. - During the DVT program for the squib valve, it was noted that the piston of the valve did not travel to the fully open position. The cause of the failure was determined to be a design deficiency in the piston seal (fig. 5). This design deficiency allowed pyrotechnic blowby. The valve was redesigned and, by means of subsequent testing, it was verified that the system was acceptable.

In late 1966, a squib valve that had previously met all acceptance-test leakage requirements was found to be leaking at a braze joint while it was installed on one of the WSTF test rigs (PA-1). An investigation of the failure revealed an inadequate braze joint between the inlet tube and the valve body. The faulty braze joint probably resulted from excessive porosity or poor brazing flow. The design of the braze joint did not lend the joint to adequate inspection procedures; therefore, the prime contractor initiated an inline braze change from an internal braze joint to an external braze joint that could be inspected. The modified design was not incorporated at this point in the program because the failure was believed to be an isolated case.

During the Apollo 9 (LM-3) mission in March 1969, the descent-engine pressurization system had a leak that was similar to that observed at the WSTF on test rig PA-1. Later, after the LM-2 drop test in May 1969, another squib valve was found to be leaking after operation. As a result of these additional failures, a decision was made to replace all valves of the early brazed configuration on the lunar modules.

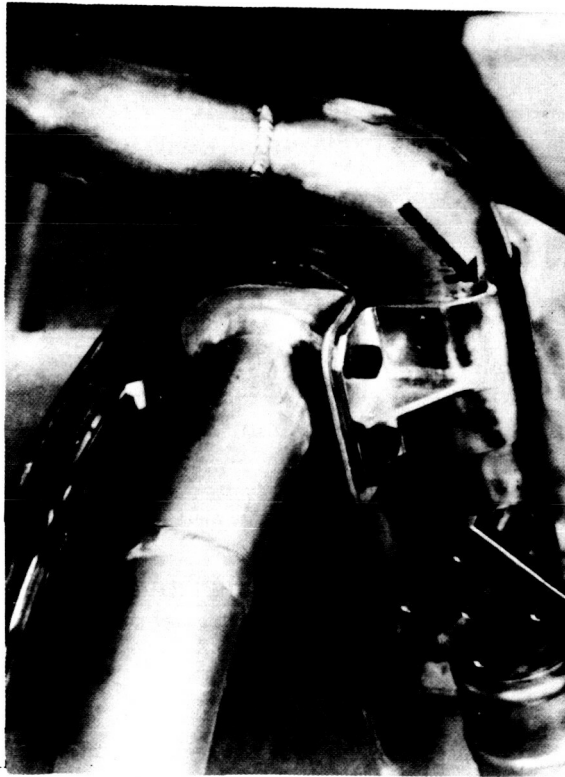
Figure 6. - Ascent propulsion system propellant-tank torus ring.

Because of the weight problem of the LM, a weight-saving program was initiated that resulted in reducing the propellant-feedline wall thickness. The new feedlines were installed on LM-6 and subsequent vehicles, and the subcontractor initiated a qualification program to verify the acceptability of the thin-wall line and ball-joint assembly. A leak was detected during vibration qualification testing on the lightweight lines. The leak was located at the bracket that holds the line to a torus ring at the bottom of the tank (fig. 6). The propellant-feedline design required welding of the bracket to the line; during subsequent vibration testing, cracks were noted in the welded area. Examination of the failure revealed that the problem resulted from a concentration of stresses in the welded area during vibration. The solution was to distribute the stresses by incorporating another supporting member in the design.

During the setup for the tank-qualification test, which incorporated the section of propellant line where the leak had been experienced, cracks were noted in the welded areas. A thorough investigation revealed that the cracks were induced during the welding of the bracket to the line. The following decisions were made as a result of the investigation.

2. The bracket for all lines less than the 0.049-inch wall thickness was to be ground off and, if there were no cracks, a clamshell bracket and saddle were to be installed with epoxy for structural support. This modification was made on the LM-6 oxidizer line and on both oxidizer and fuel lines for LM-7 to LM-9.

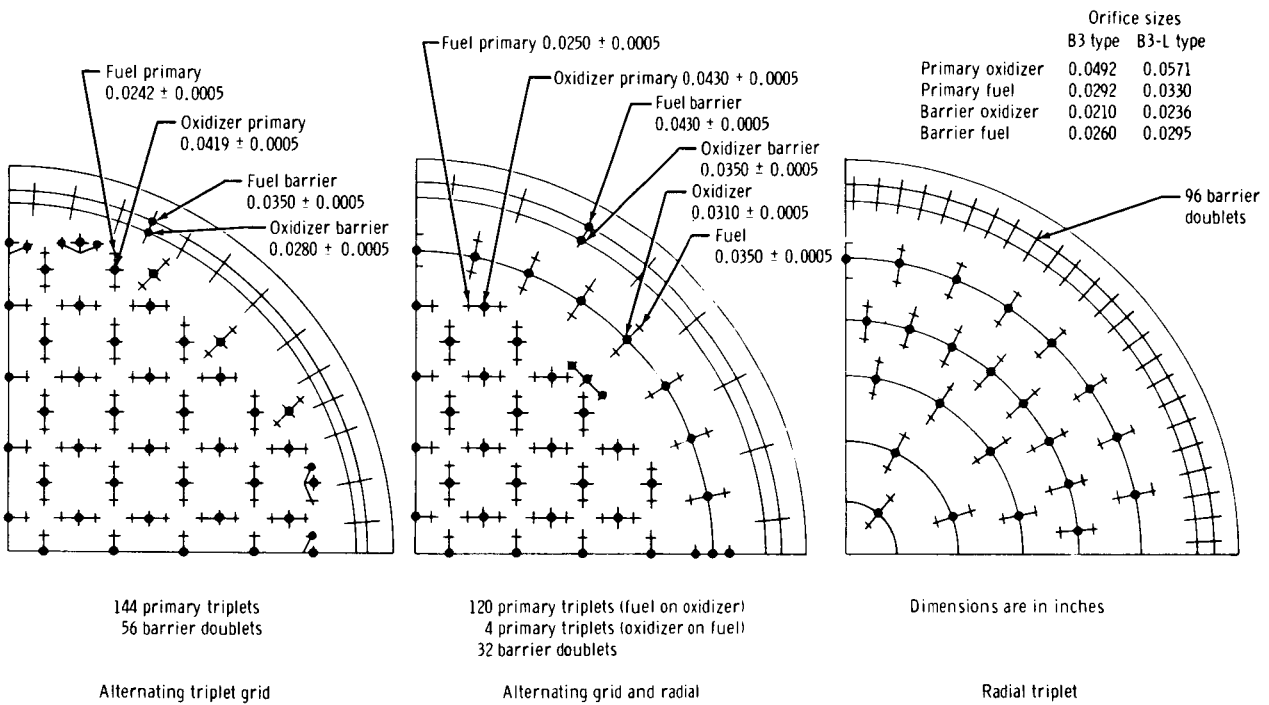
Figure 7. - Types of injector grid patterns.

In the summer of 1964, an injector that had a radial-triplet pattern was selected for the prototype because of its characteristic compatibility with the ablatively cooled thrust chamber. Performance was still a problem; therefore, modifications to the

injector pattern that increased the film-barrier propellant-mixture ratio to achieve higher performance and still maintain thrust-chamber compatibility were pursued.

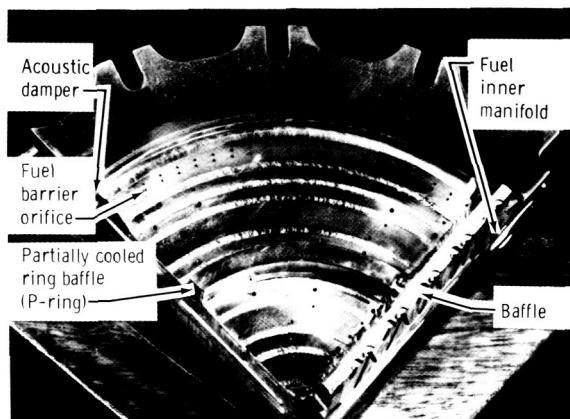
Figure 8. - Stability devices on the production injector.

Numerous modifications were made to the injector in an attempt to solve the stability problem. A photograph of the final configuration (fig. 8) shows the injector and the devices that were used in an attempt to ensure stable operation of the engines. The final configuration exceeded the performance requirement for the engine.

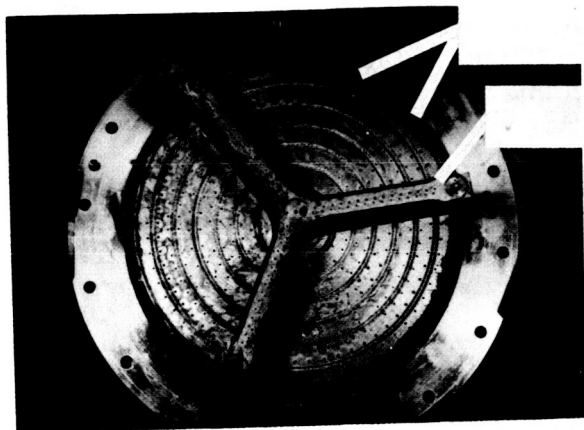
Figure 9. - Final-design injector.

A complete final-design injector is shown in figure 9, and a section through the propellant inlets is shown in figure 10 to illustrate the flow passages. An early injector inlet screen (filter) is shown in figure 11 installed in the typical manner. As can be seen in figure 11, the filter is a woven-wire-cloth truncated cone with pleats. The filter has a solid plug that effectively serves as a dynamic-head-suppression device, and the filter protects the injector orifices from contamination. The pleated filter, made of all-welded corrosion-resistant steel, with a 120-micron length along two major axes, was designed to stop all particles.

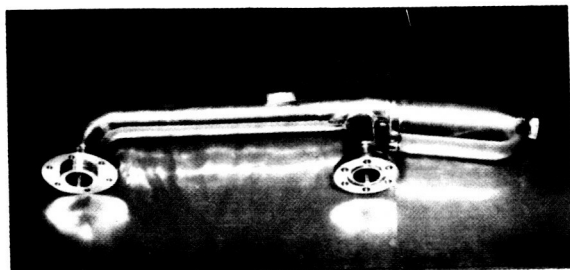
Figure 12. - Modified engine fuel duct.

The occurrence of preignition-pressure spikes during engine startup required a change in propellant ducting to ensure that the oxidizer would reach the combustion chamber before the fuel. The modified duct is shown in figure 12.

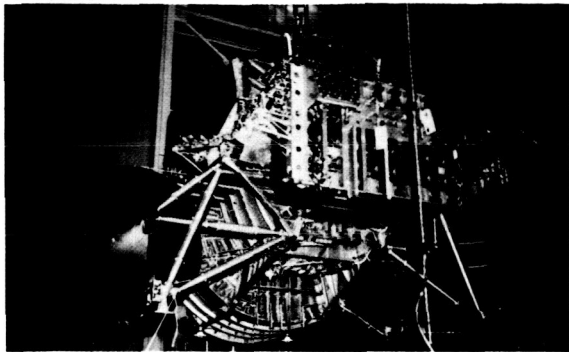
Figure 13. - Test rig PA-1.

Prototype testing. - Most of the prototype testing of the APS was conducted on the WSTF test rig PA-1. This test rig was an ascent-stage structure that incorporated the APS and RCS equipment in an approximate flight configuration (fig. 13). Simulation was used except where it would affect the APS performance. The test rig accommodated both the pressure-fed, 3500-pound-thrust ascent engine for firing in a downward position and the 16 RCS engines, using a separate propellant-supply system interconnected with the APS propellant tanks. The PA-1 ascent stage was constructed of aluminum alloy and consisted of three major sections: the forward cabin, the mid-section, and the aft equipment bay. The structure included provisions for installing

heat shields for the FITH testing. A summary of the tests conducted on test rig PA-1 is given in table II. These tests included all normal mission requirements and a number of off-limit tests of possible problem areas such as FITH tests, pressure overshoots, and component-abort tests. Although all of these hot-firing tests were not conducted with a qualified engine injector, the tests proved successfully the integrity of the propellant and pressurization sections.
