Technical Memorandum 33-616

*The Mariner 9 Power Subsystem Design
and Flight Performance*

Robert H. Josephs

May 15, 1973

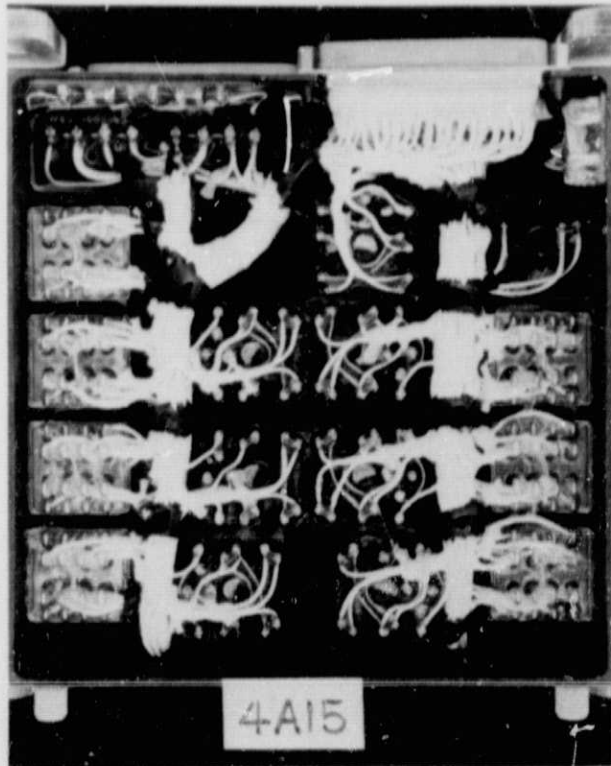
Figure 1-8. MM'71 Welded Module Packaging in Power Distribution A Subassembly

The modified PS&L in MM'71 was able to accommodate the additional circuitry because of circuitry volume reduction with welded modules that was used by a Mariner power subsystem for the first time. These modules packaged circuits that were repetitively used in the power subsystem, such as circuits for telemetry and command, and also some of the regulated supplies used for command functions. The larger unit in Figure 1-7 is a welded module that houses a relay driver used in Mariner '71 PCE. The smaller unit in Figure 1-7 is a thick film version of the same relay driver that is presently undergoing tests as a candidate for a new generation of PCE modules of greater circuitry density. Figure 1-8 shows the density of the welded module packaging in the MM'71 power distribution A subassembly.
