NASA TECHNICAL
MEMORANDUM

NASA TM X-64812

MSFC SKYLAB MULTIPLE DOCKING ADAPTER
Vol. II

Skylab Program Office

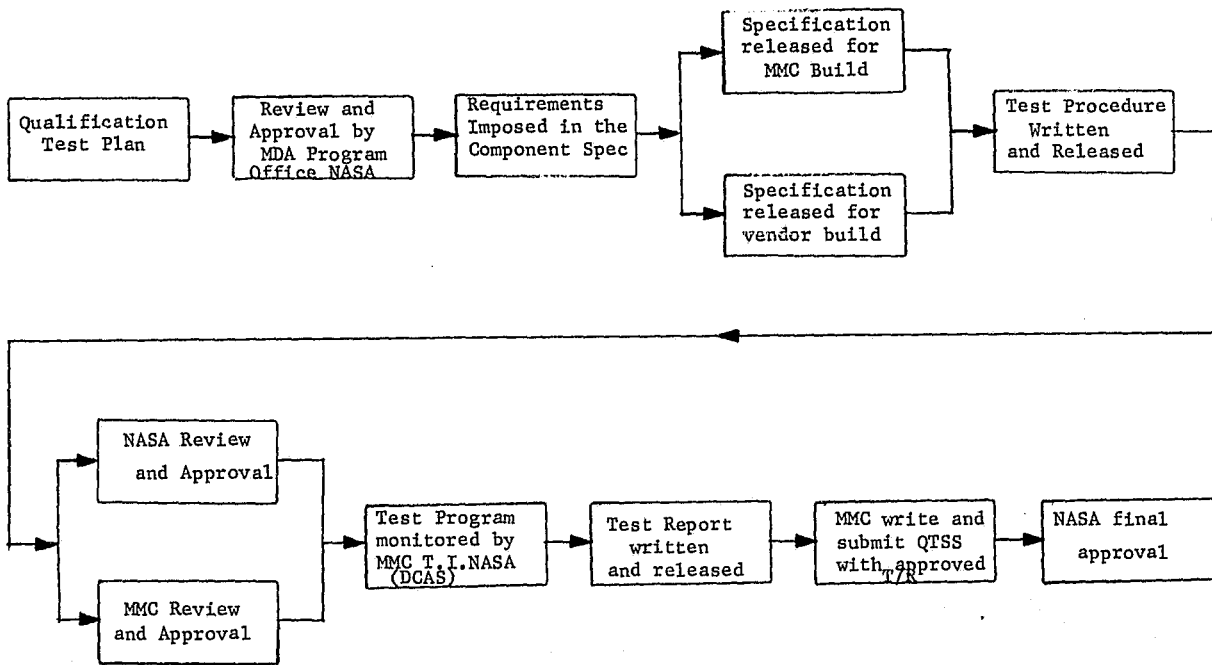
Figure 7.2-2 Qualification Test Program Sequence

A minimum of two test units were subjected to the complete qualification program (all performance and environmental tests) with

COMPONENTS QUALIFIED BY SIMILIARITY OR TEST							
SYSTEM	QUALIFIED BY SIMILIARITY	DELTA QUALIFICATION	COMPLETE QUALIFICATION	TEST PHASING			
				1970	1971	1972	1973
Environmental Control Subsystem			9		████████████████████		
Electrical Subsystem	2	6	7		████████████████████		
Instrumentation Subsystem		2	2		████████		
Structural Subsystem		1	6				████
