## 4. THE EFFECTS OF LIGHTNING ON DIGITAL FLIGHT CONTROL SYSTEMS

J. Anderson Plumer  
General Electric Co.  
Corporate Research and Development

The NASA Flight Research Center has developed and is presently demonstrating a digital fly-by-wire (DFBW) flight control system in an F8 aircraft. Recognizing the possibility of this hazard, a program was implemented with General Electric to evaluate the possible electromagnetic effects of lightning on this flight control system and obtain data for use in minimizing these effects in future generations of fly-by-wire aircraft. The F8 DFBW system was not designed to withstand lightning strike effects. Therefore, the opportunity existed to experimentally determine the severity of effects in this unprotected system, thus providing test data upon which to base design guidelines for protection of future systems.

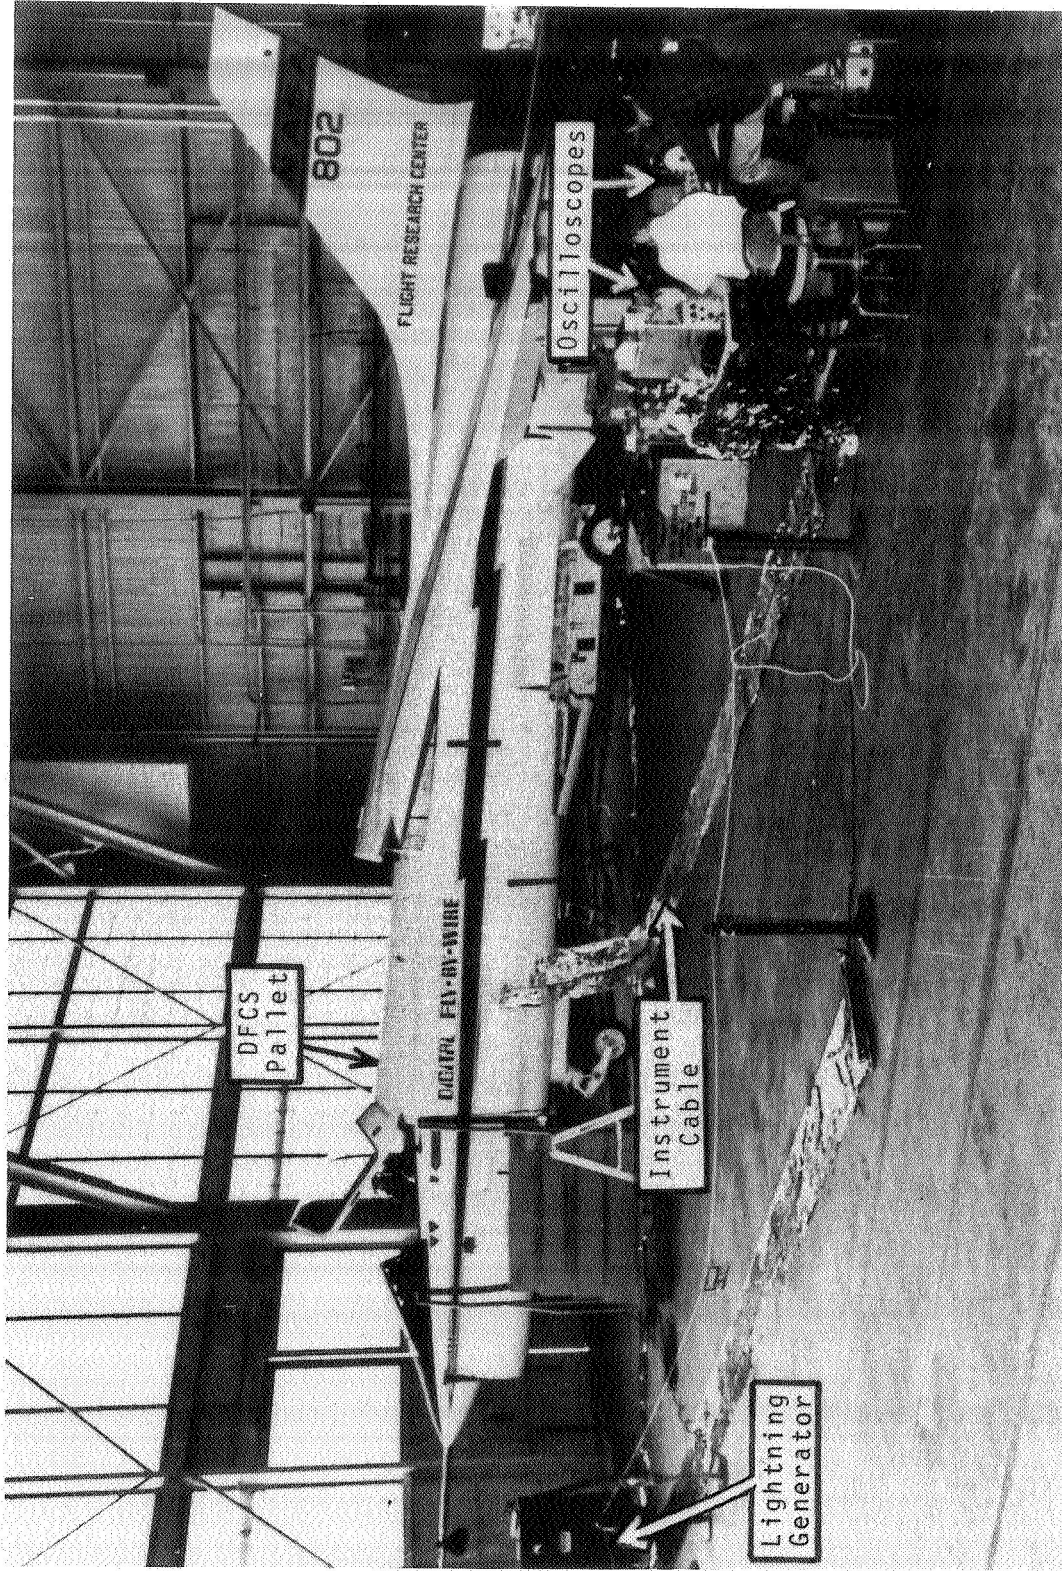
FIGURE 1 - TEST SETUP FOR MEASUREMENT OF LIGHTNING-INDUCED VOLTAGES IN NASA F8 DFBW AIRPLANE.

A recently developed simulated lightning test and measurement system known as the TRANSIENT ANALYSIS technique offers a means of investigating the electromagnetic effects of lightning without hazard to the aircraft being tested. This technique, the development of which was sponsored by the Aerospace Safety Research and Data Institute of NASA-Lewis Research Center (Ref. 1), consists of injecting current surges into an aircraft, of the same waveshape as those produced by lightning but of greatly reduced amplitude. The responses of the aircraft's electrical circuits to these current surges can be measured and then extrapolated to correspond with full lightning stroke amplitudes to determine if they present a hazard to the equipment under test. During the development of this technique, tests were made to show that the response of an aircraft electrical system was linear with lightning current amplitude and that this extrapolation was valid. The transient analysis technique was utilized in the study of the NASA F8 DFBW aircraft in this program. A photograph of the aircraft and test setup is shown in Figure 1.

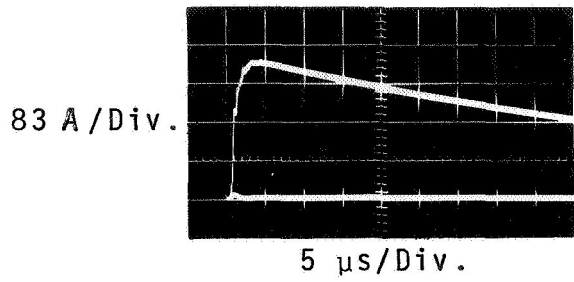
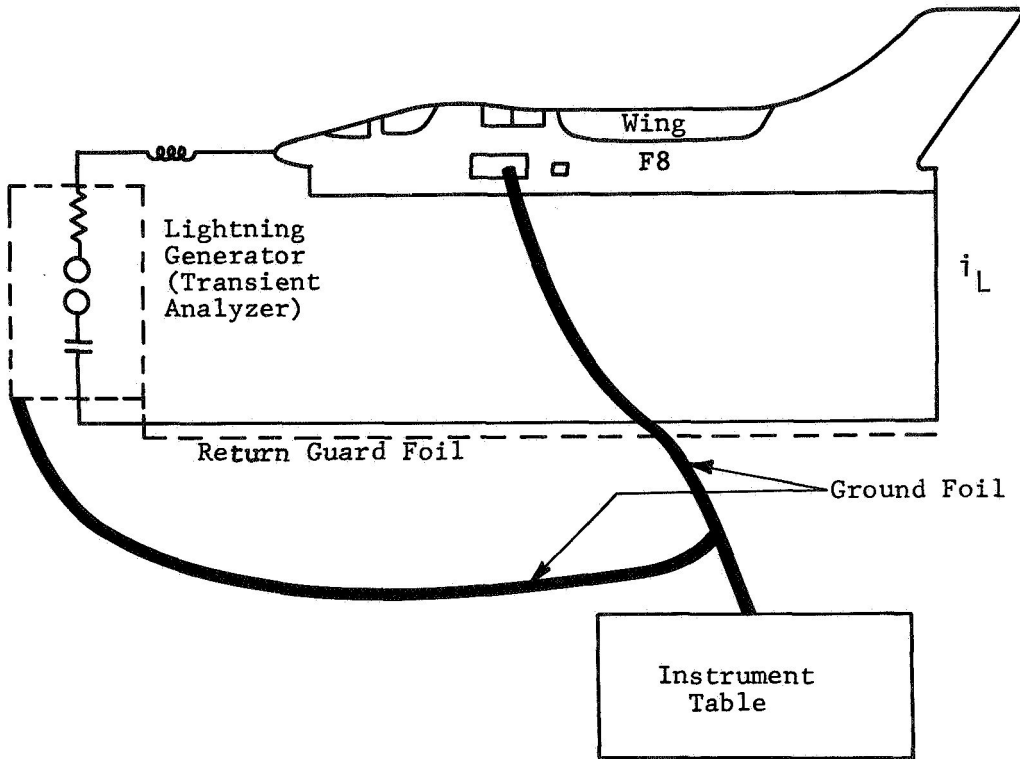
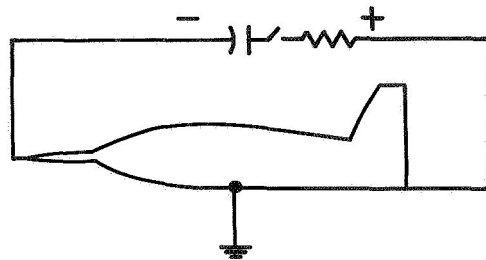
Simulated Lightning Current  
300 Amperes Peak

a) Actual Test Circuit

b) Equivalent Test Circuit

FIGURE 2 - SIMULATED LIGHTNING WAVEFORM AND TEST CIRCUIT

The test circuit is shown on Figure 2(a). The airframe is connected to ground at the point nearest the terminals of the circuit being measured via a 36 inch wide, 3 mil aluminum foil. This was attached to the instrument table and the hangar ground about 20 feet away. Use of the aluminum foil provides a very low impedance between the airframe and instrument table. The instrument cable was placed along this foil so that no air gap existed between it and the foil. As shown on Figure 2(b), the lightning current circuit is grounded once and only via this airframe ground foil. Consequently, no simulated lightning

Most of the tests were made with a unidirectional simulated lightning stroke current rising to its crest in 2.75 microseconds and decaying to half value after 60 microseconds. This waveform is representative of natural lightning stroke waveforms and is similar to the waveform specified for indirect effects testing of the Space Shuttle. Its crest amplitude was set at 300 amperes to minimize the possibility of interference or damage to any of the electronic systems or components aboard the aircraft. Natural lightning strokes exceed 200,000 amperes about 1% of the time and average about 30,000 amperes in amplitude. Therefore, voltages induced by this waveform must be extrapolated upward by a factor of 100 to correspond with an average lightning stroke or 670 to correspond with a severe 200 kA stroke. The test current waveform is shown on Figure 2a.

It will be noted that damped oscillations appear on the test current wavefront. These are believed to be the result of traveling wave reflections in the transmission line formed by the aircraft and return conductor beneath it. Measurements were made of the current entering as well as leaving the aircraft, verifying that the superimposed oscillations flowed through the aircraft along with the fundamental current waveform. The extent to which oscillations or "jagged edges" occur in natural lightning current wavefronts is not well known, although available oscillographic data (Ref. 2) does show evidence of such occurrences in some strokes.

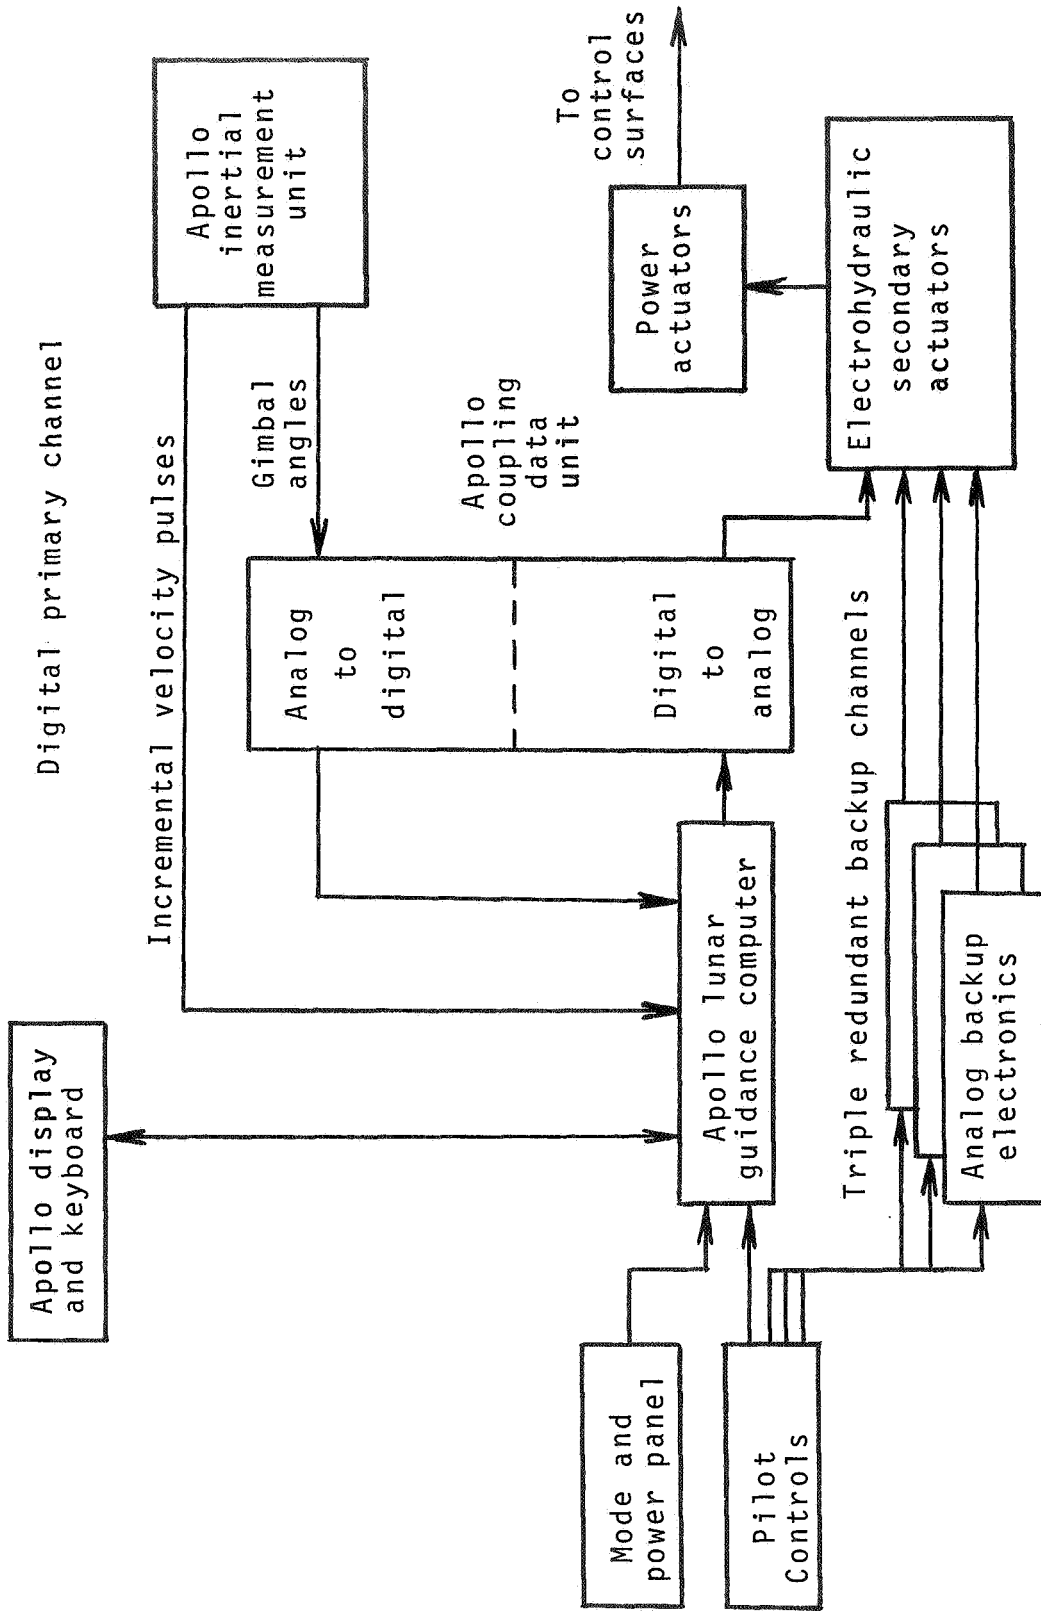
FIGURE 3 - F-8 DIGITAL FLY-BY-WIRE CONTROL SYSTEM HARDWARE ELEMENTS.

The F8 digital fly-by-wire flight control system components are shown in Figure 3. A single digital primary channel and triple redundant electrical analog backup channels replaced the F8 mechanical control system. The primary and backup channels all provide three-axis control of the airplane. The digital channel consists of a lunar guidance computer, inertial measurement unit, coupling data unit, and astronaut display and keyboard, all taken from the Apollo guidance and navigation system. A mode and power panel permits the pilot to request the lunar guidance computer to make mode and gain changes. The three-channel backup control system consists only of surface position command electronics. Specially designed electro-hydraulic secondary actuators interface the primary and backup electronic commands with the conventional F8 control surface power actuators.

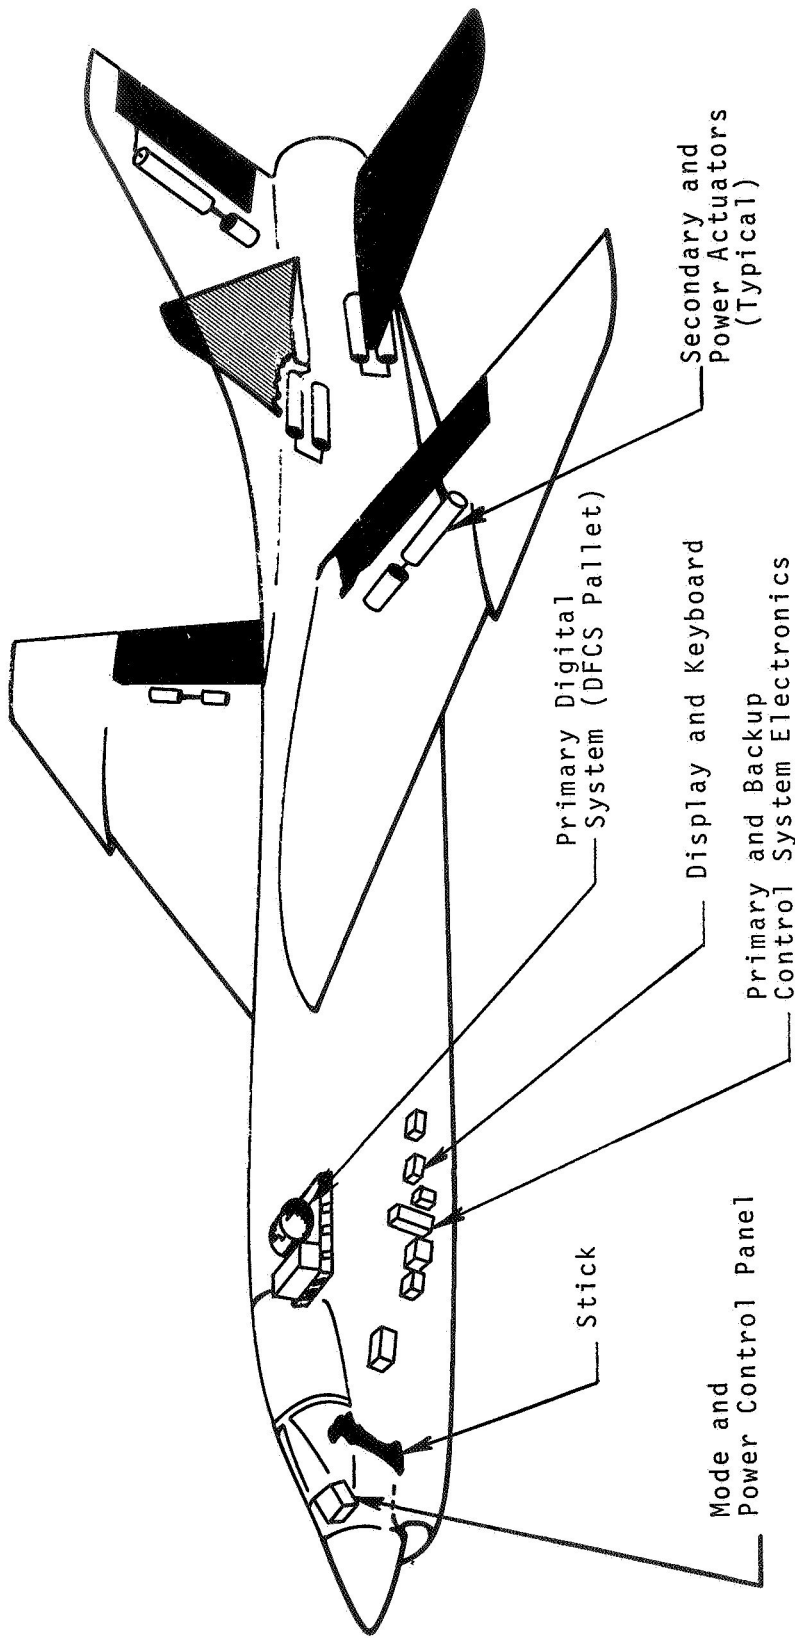
FIGURE 4 - LOCATION OF FLY-BY-WIRE CONTROL SYSTEM HARDWARE IN F8 AIRPLANE .

Figure 4 shows the general arrangement of the flight control system hardware in the F8 airplane. Five secondary actuators were required, one for the rudder and one each for the two horizontal stabilizers and the two ailerons. The Apollo lunar guidance computer is the heart of the primary control system and performs all flight control computations.

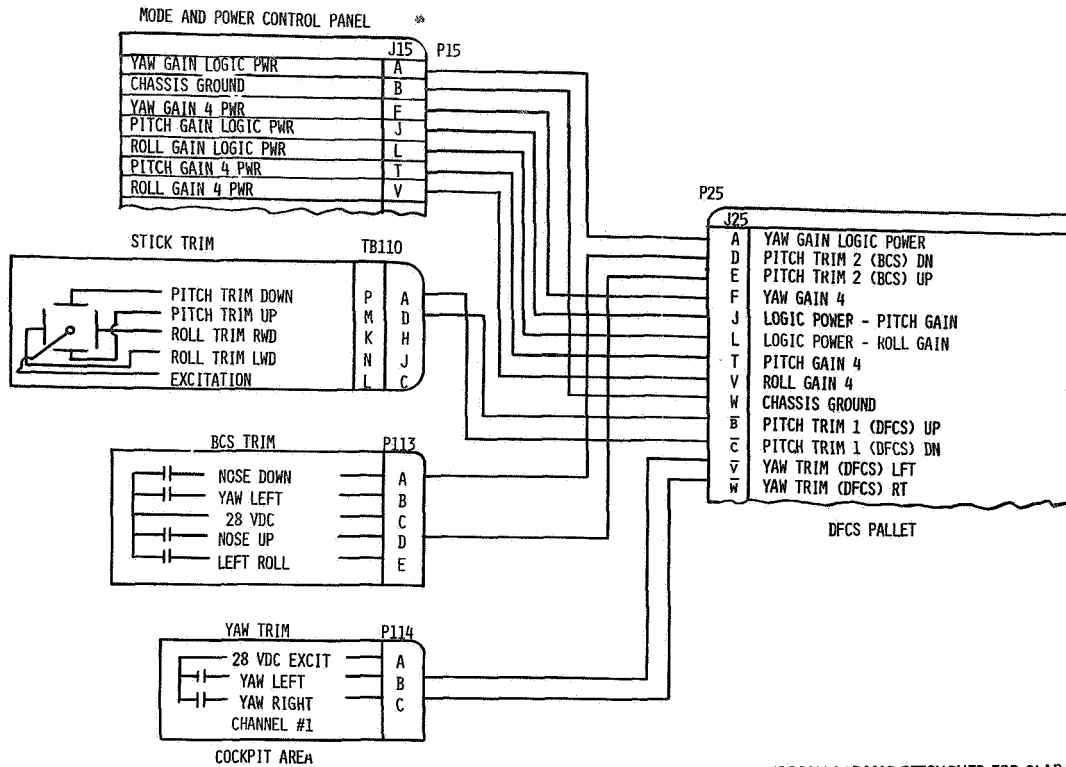
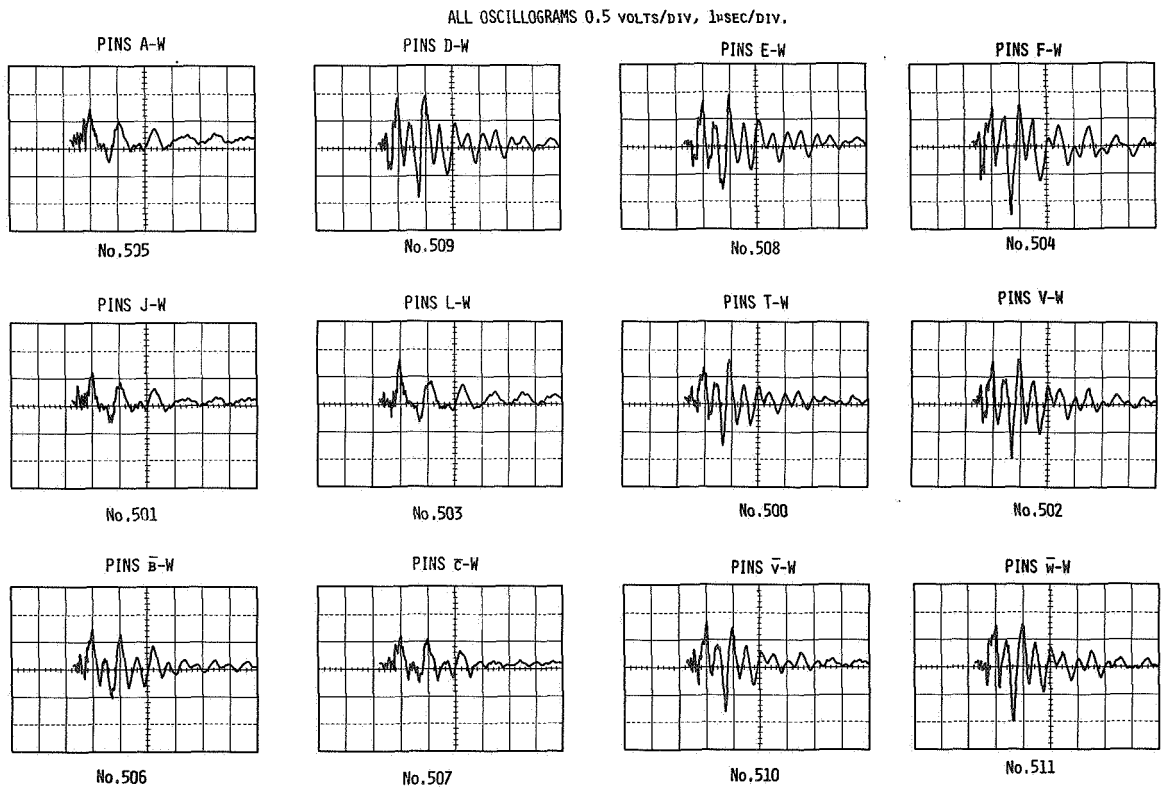
(OSCILLOGRAMS RETOUCED FOR CLARITY.)

FIGURE 5 - INDUCED VOLTAGES ON MPC AND STICK TRIM INPUTS TO DFCS AT J25 INTERFACE.

Measurements were made at a variety of primary and backup system interfaces. Of greatest interest were the induced voltages appearing at the wiring interfaces with the primary DFCS system, which includes the Apollo lunar guidance computer (AGC). Figures 5, 6 and 7 show some of the measurements. For all of these measurements the simulated lightning current entered the nose and exited from the tail of the aircraft. Figure 5 shows measurements made at the J25 interface on circuits coming from the mode and power control panel and stick, BCS and yaw trim transducers in the cockpit area. These appear as damped oscillations at a fundamental frequency of about 1 megahertz. Most of the voltage has subsided after about 6 microseconds has elapsed. Each voltage shown on Figure 5 is a damped oscillation at a fundamental frequency of about 1 megahertz since all conductors follow the same bundle to the cockpit. The waveforms have slight variations which are probably due to differences in load impedances at each end.

The closed circuit J2 interface measurements shown on Figure 7 are of the same 1 megahertz fundamental as those measured at the J25 interface of Figure 5, except that the polarity is reversed.

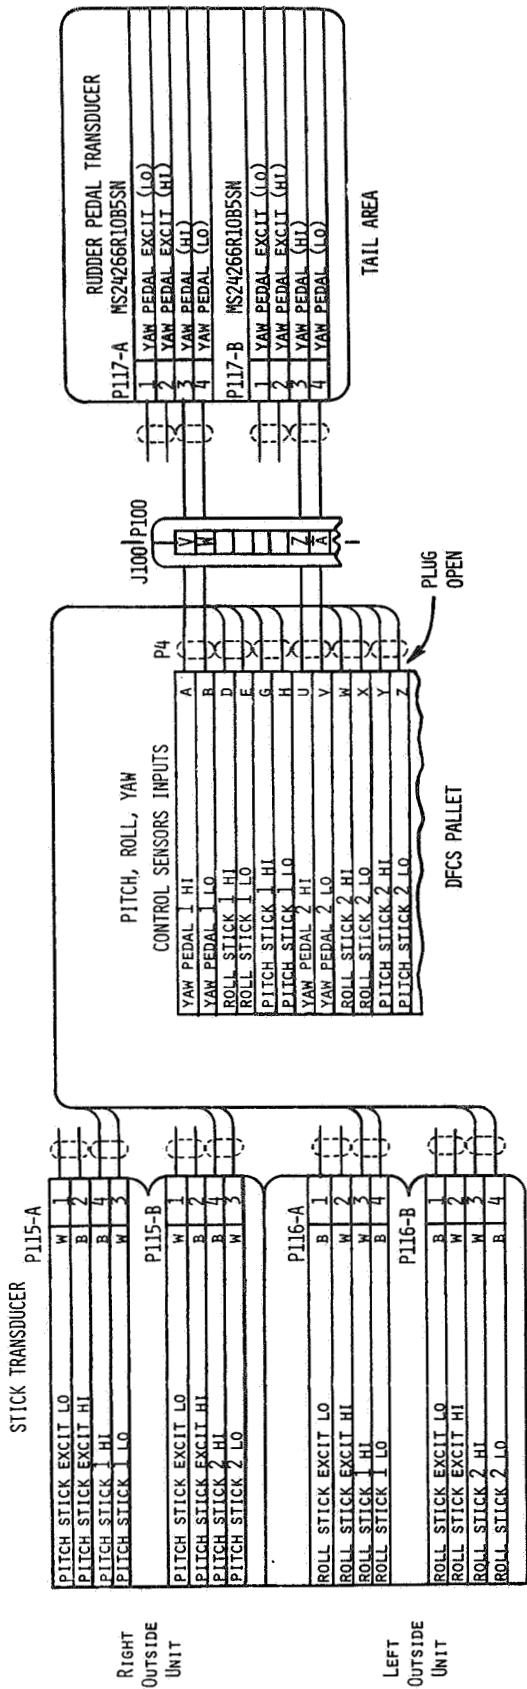
ALL MEASUREMENTS ON CONNECTOR P4  
ALL OSCILLOGRAMS 0.1 VOLTS/DIV, 1μSEC/DIV.

FIGURE 6 - INDUCED VOLTAGES ON CONTROL SENSOR INPUTS TO DFCS AT P4 (OPEN).

Figure 6 shows voltages induced in the pitch, roll and yaw control sensor circuits coming to the DFCS computer, but the measurements were made at plug P4 with this plug disconnected from the DFCS system. These, therefore, are open circuit voltages and are not necessarily the same as the voltages which might appear at the closed interface, since DFCS input impedances would affect the voltages impressed across them. The characteristic frequencies of the open-circuit voltages measured at pins D-E (osc. 528), G-H (osc. 525), W-X (osc. 523) and Y-Z (osc. 526) have a fundamental frequency of about 1.7 megahertz with lower amplitude oscillations of several higher frequencies superimposed. These are induced in circuits coming from the DFCS stick transducer in the cockpit. The fundamental frequency of voltages measured at pins A-B (osc. 524) and U-V (osc. 527) in circuits coming from the rudder pedal transducer in the tail area is also 1.7 megahertz but without as much of the superimposed higher frequency component. Neither fundamental frequency is the same as that measured at the closed J25 interface in circuits also coming from the cockpit area.

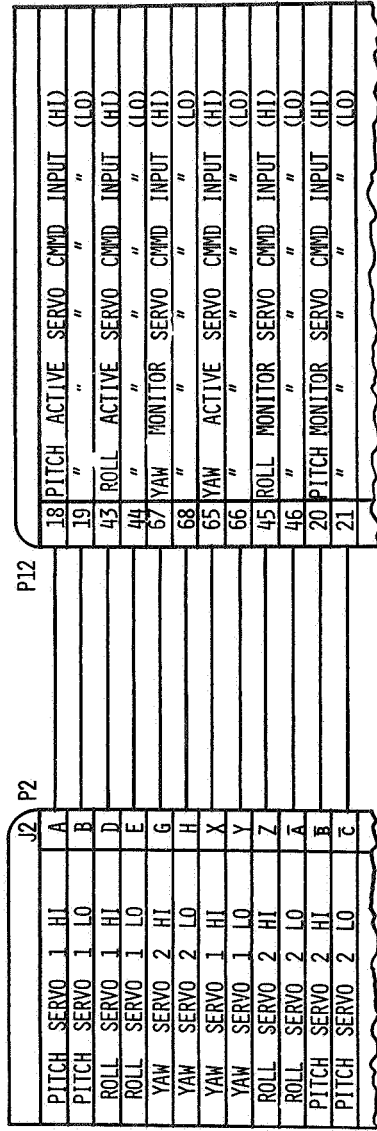
ALL MEASUREMENTS: 0.5 VOLTS/DIV, 1 μSEC/DIV.

FIGURE 7 - INDUCED VOLTAGES ON DFCS DIGITAL CONTROL CIRCUITS AT J2 INTERFACE.

As another example, the DFCS digital control output circuits are considered. The schematic diagram of these circuits is shown on Figure 9. Induced voltages measured at the J2 interface are shown on Figure 7 and range from 233 to 400 volts. Those measured at the P12 end ranged between 222 and 422 volts. At the DFCS, capacitor C2 has a 15V rating. Therefore it would

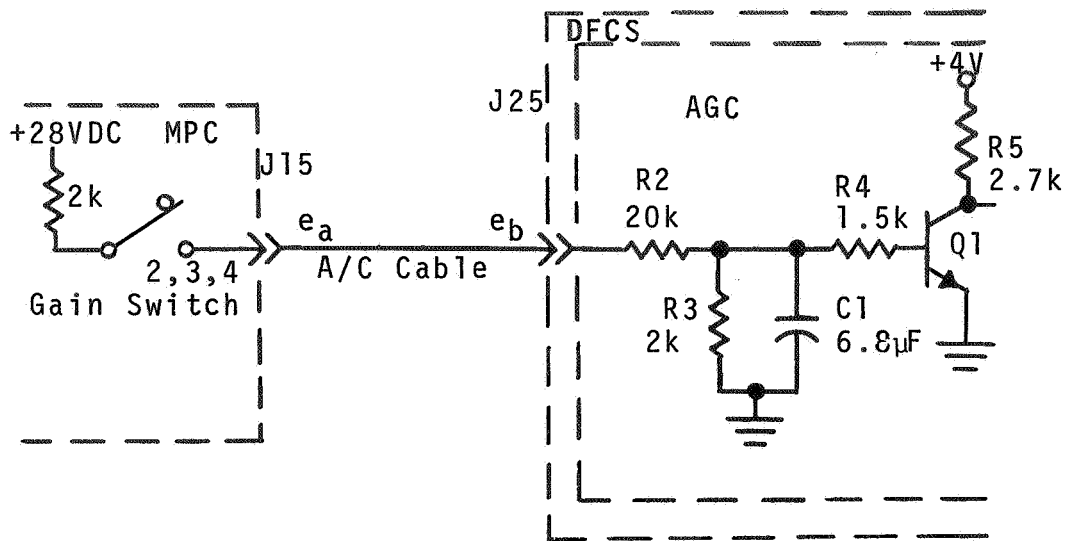
J15 Interface

$e_a$  average = 1119 V<sub>(o-p)</sub>

$e_a$  range = 1065 to 1132 V

f = 1.0 MHz

J25 Interface

$e_b$  average = 677 V<sub>(o-p)</sub>

$e_b$  range = 566 to 865 V

FIGURE 8 - ATTITUDE GAIN SWITCH POSITION 2, 3, and 4  
 SIGNAL CIRCUIT FOR DFCS AND MPC INTERFACE.

The expected impact of the induced voltages measured in the DFCS system on system operation was analyzed by DELCO Electronics, manufacturer of the DFCS. Comparison of individual component vulnerability data, when available, with induced voltage levels at single circuit interfaces was utilized to determine vulnerability of system components and effect on circuit operation. In other cases, best engineering judgment was used. An example of such an assessment is the attitude (yaw, pitch or roll) gain logic power circuits (pins A-W) from the MPC panel to the DFCS pallet. The schematic diagram of one of these circuits is shown on Figure 8. Induced voltages at the J25 interface are shown on Figure 5 (i.e. osc. 505). The voltages at the J25 interface (DFCS) ranged from 566 to 865 volts, and at the J15 interface (MPC), 1065 to 1132 volts. At the MPC, the induced voltage exceeds the 1000 volt (at sea level) dielectric breakdown rating of the switch. Arc-over may therefore occur either to case and mounting or between contacts, with a possibility of switch failure.

This circuit (+28 VDC) provides a request to the computer to change attitude control loop gain. If the wiper arm of the switch burns open, the computer will notice no gain requests and under this condition is programmed to assume attitude gain position 1. The DFCS control will survive at this gain position. If the switch would short such that two gain-position requests exist, the computer is programmed to assume the lower gain of the two requests. The DFCS control will survive.

At the AGC, the induced voltage exceeds the 500 volt dielectric breakdown rating of the 20K resistor, R2. Arc-over of R2 may then expose capacitor C1 to damaging overvoltage, causing it to short circuit. If it remains shorted during the entire lightning flash, no further damage should occur. If C1 opens between successive strokes of a multiple stroke flash, arc-over(s) of the 1.5K resistor R4 on successive strokes may permanently destroy transistor Q1. If C1 is short circuited, the AGC gain change circuit will be inhibited. Selection of this gain position after the lightning flash will cause the computer to select attitude gain position 1. The DFCS control will survive at that gain position. The same applies if transistor Q1 fails.

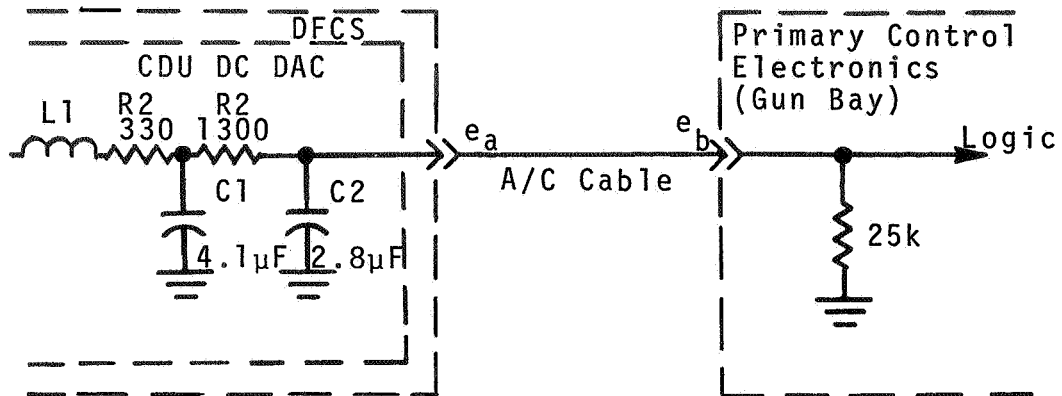
$e_a$  average = 316 V<sub>(o-p)</sub>

$e_b$  average = 355 V<sub>(o-p)</sub>

$e_a$  range = 233 to 400 V<sub>(o-p)</sub>     $e_b$  range = 222 to 422V<sub>(o-p)</sub>

$f = 1.0$  MHz

No. of measurements = 6  
(J2: Yaw, Pitch and Roll  
DACs' 1 and 2, Figure 7)

FIGURE 9 - DFCS DIGITAL CONTROL DIGITAL-TO ANALOG  
CONVERTER OUTPUT SIGNAL CIRCUIT TO  
PRIMARY CONTROL ELECTRONICS.

break down as a short circuit. The capacitor could then fail as an open circuit. In either case the remaining circuit components would probably survive the lightning stroke. These are dual circuits which provide attitude commands which are utilized as control surface inputs. The dual outputs are compared to each other for failure detection purposes. Since capacitor C2 can be failed as an open or short circuit, several combinations were considered. If C2 is shorted as a dual output, no failure detection would occur. The pilot would discover that a problem existed only by noting the lack of aircraft response to control stick position. If one of the dual command outputs contained C2 open circuited and the other short circuited, any off-neutral control stick position would trigger the failure detection circuit which would remove that attitude axis control from DFCS to the BCS. In the case of C2 open-circuited as a dual output, DFCS aircraft attitude control could be maintained.
