NASA TN D-8006

FRICITION AND WEAR OF
CARBON-GRAPHITE MATERIALS
FOR HIGH-ENERGY BRAKES

Robert C. Bill

Lewis Research Center

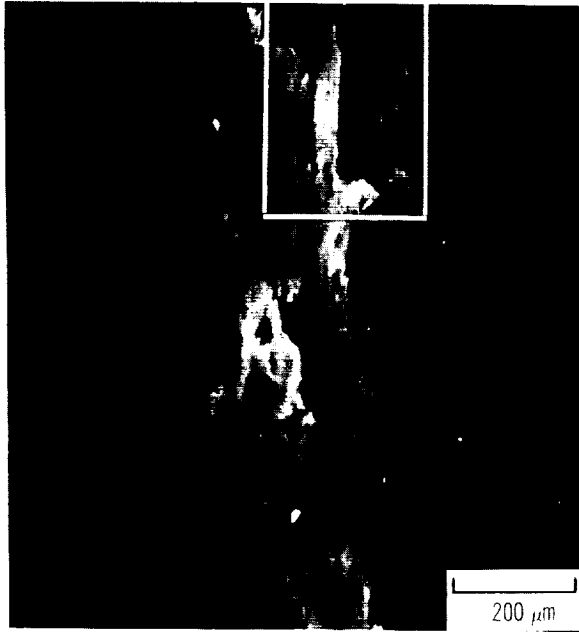
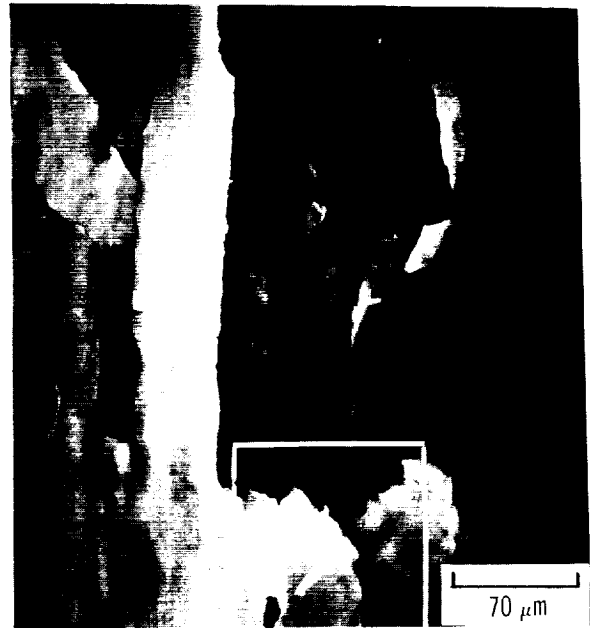
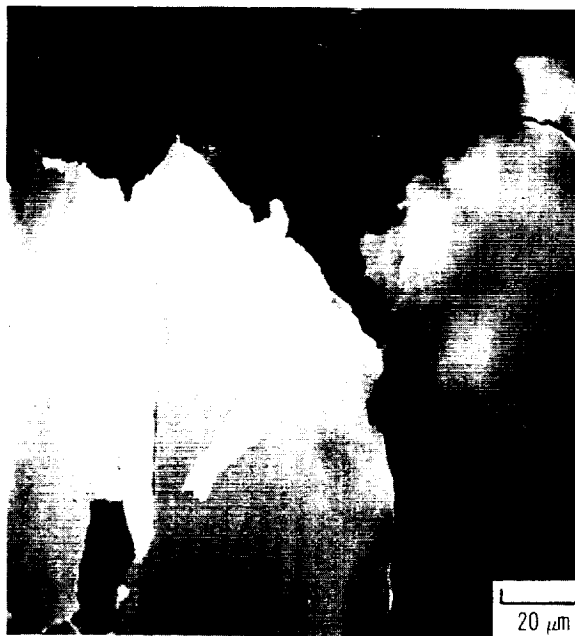
(a) Overview of blistered area.

(b) Enclosed region in (a).

(c) Enclosed region in (b).

Figure 5. - Surface of carbon graphite – low binder (CG-LB) after 1 minute of sliding against a 17-22 AS steel disk at 26 m/sec (83 ft/sec) under a normal load of 422 N (95 lbf).

After exposure to conditions that produced the type of transition described in figure 3, the sliding surface of the carbon-graphite pads showed a distinctly different appearance. On a microscopic scale the sliding surface of the pads showed elongated "blisterlike" features that had a metallic appearance in room light. These features covered about 10 to 20 percent of the surface, the remainder having an appearance like that in figure 4. Examples of these "blistered" areas are shown in figure 5. Here the "blistered" areas are seen to be regions where the shear layer is disrupted; some structural detail is revealed by the way in which the layer breaks up. The shear layer is seen to consist of distinct sheets, probably composed of preferentially oriented graphite. Regions of graphite sheet that have buckled and fractured, with resulting separation from the substrate, are revealed by the "glowing" white areas. The transition to higher friction may then be related to the disruption of a dense, continuous surface shear layer composed of oriented sheets of graphite. According to the literature, disruption can be induced (1) by the desorption of water and other vapors from the shear layer (refs. 6 and 10) and/or (2) by the disruption of the surface oxide present on the metal disk (ref. 9). Once the shear layer is broken up, the pad sliding surface is composed of randomly oriented carbon and graphite particles. Unless the shear layer is restored, sliding will continue to be in a high friction and wear mode.

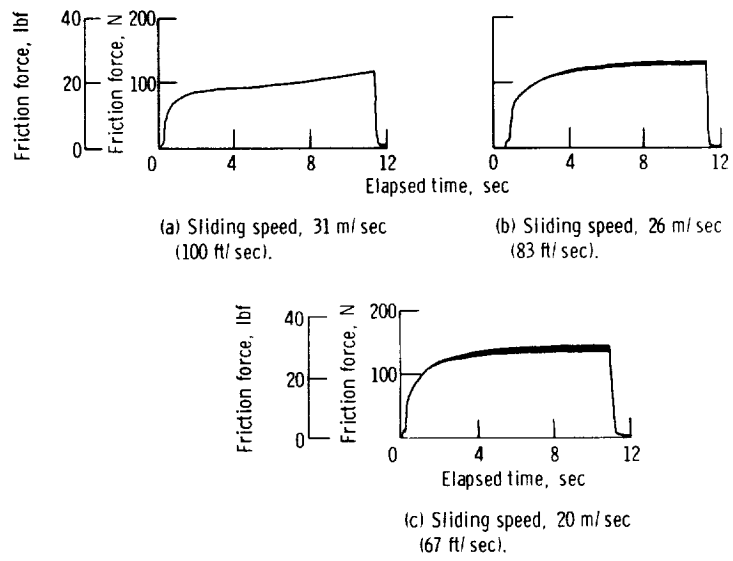
Figure 7. - Friction data obtained from carbon graphite - fine fibers (CG-FF) sliding against a 17-22 AS steel disk under a normal load of 382 N (86 lbf).

A pattern of increasing friction with time of application was observed when CG-FF was subjected to sliding against 17-22 AS steel. A typical case is shown in figure 7. None of the other carbon graphites exhibited this phenomenon. Also, as shown in table II, the highest friction against the graphite-cloth-reinforced composite disk was observed in the case of CG-FF.

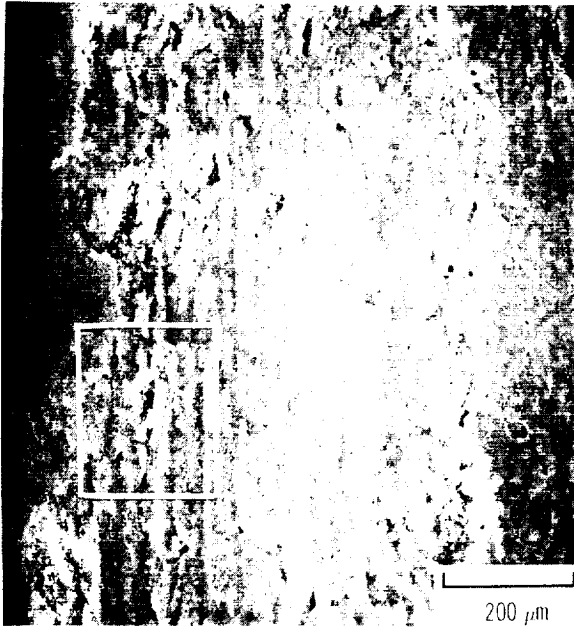
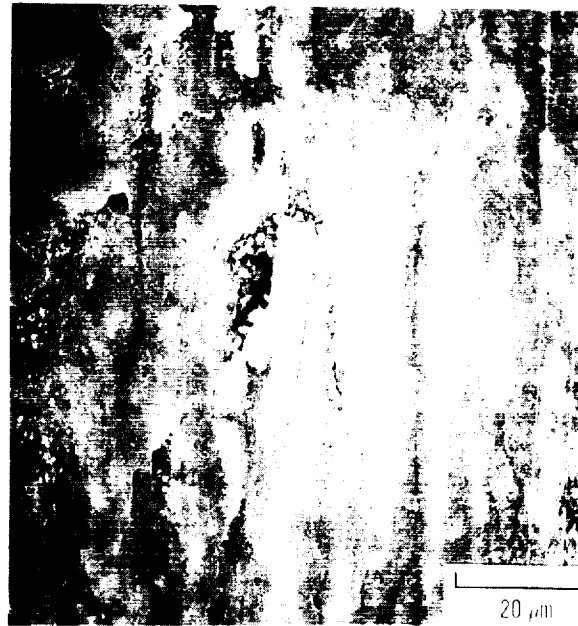
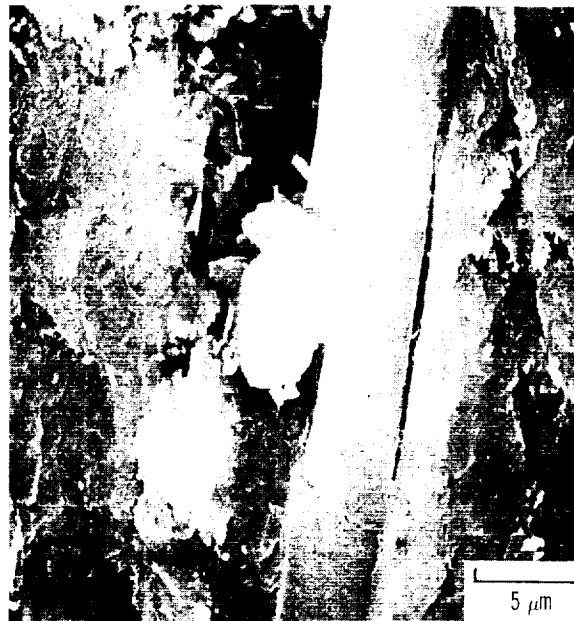
(a) Appearance of general surface.

(b) Enclosed region in (a) showing fiber segment.

(c) Expanded view of fiber shown in (b).

Figure 8. - Surface of carbon graphite – fine fibers (CG-FF) after two 30-second sliding exposures against a 17-22 AS steel disk at 26 m/sec (83 ft/sec) under a normal load of 422 N (95 lbf).

An SEM study was made of the features present on the surface of a CG-FF pad which had been subjected to sliding against a 17-22 AS steel disk. Fiber segments were visible on the wear surface shown in figure 8, and there were signs of interaction of the fibers with the film formed on the pad surface. In particular, surface striations can be seen in figures 8(a) and (b), which suggests an abrasive interaction between the fiber segments and the sliding surfaces. The interaction would have to be caused by loose, broken pieces of fibers as they moved out of the contact area. The fibers constitute comparatively hard, discrete bodies on the sliding surface and have sharp corners and edges generated by fracture. Loose, broken fiber segments certainly have the potential to mechanically disrupt the softer low-shear-strength film - much as an abrasive would. It is a question of fiber concentration as to whether this effect will result in a higher macroscopic wear rate.

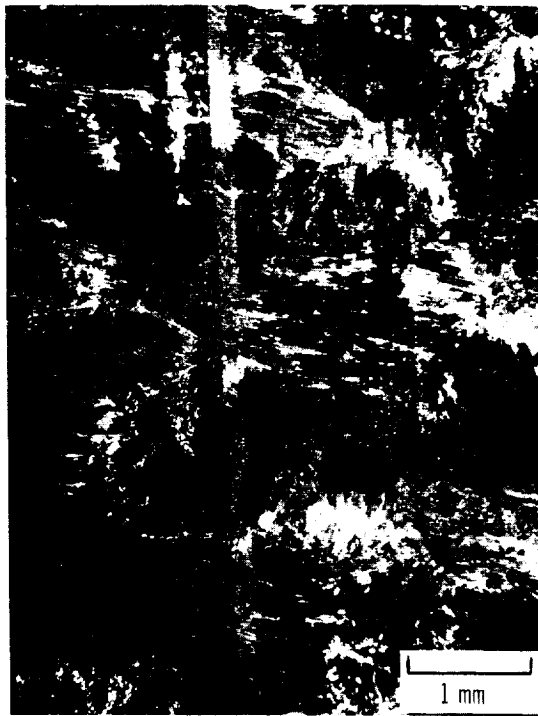
(a) Optical photograph.

(b) Scanning electron micrograph.

Figure 9. - Surface of graphite-cloth-reinforced composite (GCRC) after sliding against a 17-22 AS steel disk in a simulated-stop – speed-variation test.

Friction and wear of graphite-cloth-reinforced composite. - The graphite-cloth-reinforced composite (GCRC) pads were the most wear resistant of the experimental carbon materials when sliding against the 17-22 AS steel disk material. After a sliding exposure, the pad sliding surfaces had a polished appearance with the structure of the graphite cloth apparent, as shown in figure 9. The continuous fiber structure of the composite had remained essentially intact with a continuous film smeared over the sliding surface. Figure 9(b), an SEM photograph, shows the fiber structure barely visible through the surface film.

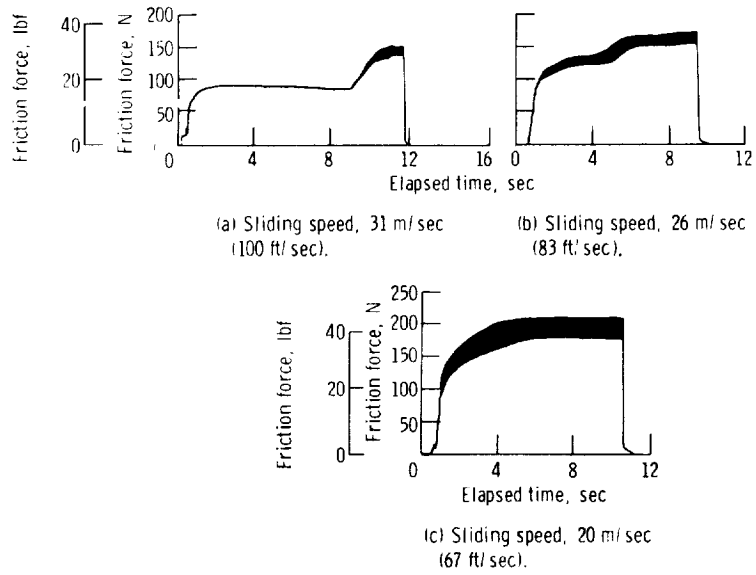
Figure 10. - Friction data obtained from graphite-cloth-reinforced composite (GCRC) sliding against a graphite-cloth-reinforced-composite disk under a normal load of 382 N (86 lbf).

The friction and wear of GCRC pads in sliding contact with the graphite-cloth-reinforced disk were markedly different from the preceding results. Even though wear rates to the pads (table III(b)) were not significantly higher, instances of unstable transitions to severe wear and high, irregular friction (not reflected in the values shown in table II) were observed. Furthermore, these transitions seemed to be irreversible. That is, once they occurred, severe wear and high friction were observed on subsequent sliding exposures, even after sufficient time intervals to allow for specimen cooling, as

shown in figure 10. The severe wear was accompanied by the generation of clouds of loose carbon debris being spewed from the contact area. The condition of the GCRC pad surface after such a sliding exposure was significantly different from that shown in figure 9. Exposed fibers are obvious in the SEM photographs of figure 11. A remarkable feature of the GCRC material shown in these photographs is the very irregular, sharp-edged fiber cross section. The lack of any coherent shear layer on the pad sliding surface is good evidence that fiber exposure ultimately leads to the disruption of this layer. The shape of the fibers and the high mechanical strength associated with them would enable them to act as potentially abrasive constituents on the pad surface.

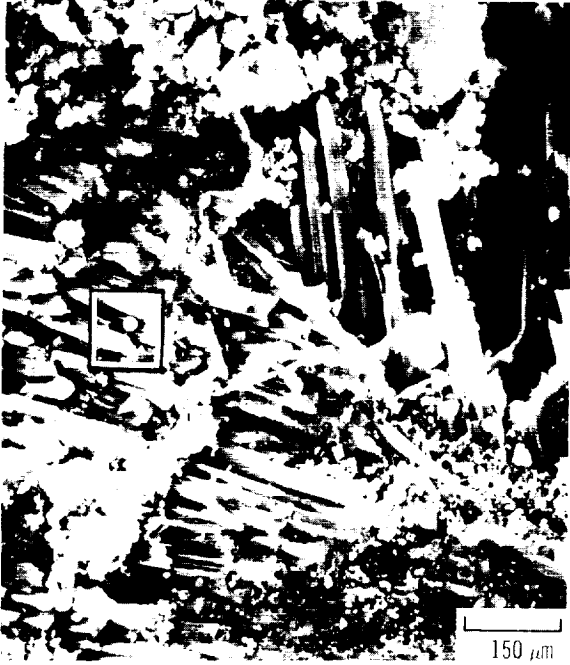
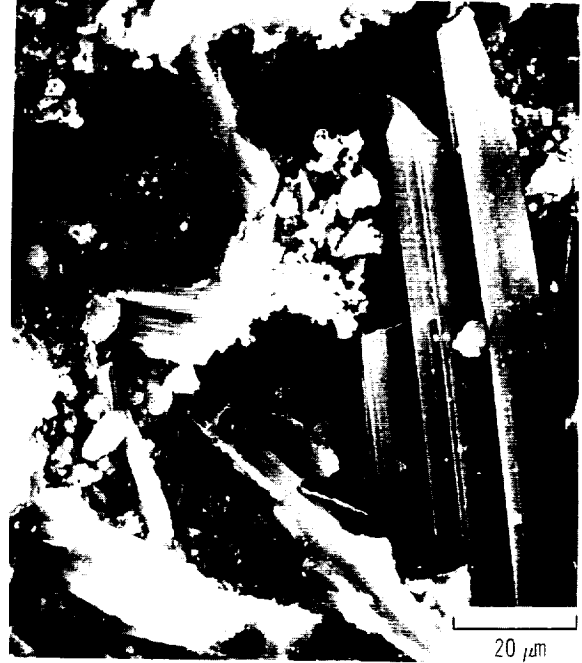
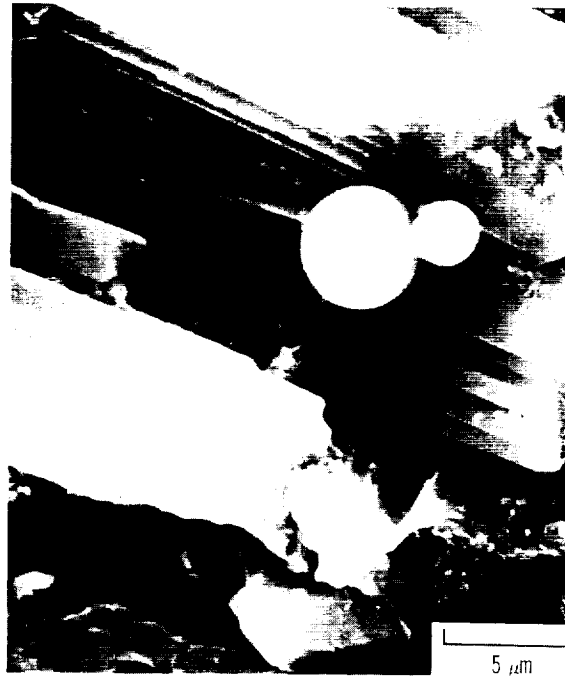
(a) Area of exposed fiber structure.

(b) Region in (a) showing fiber structure of reinforcing cloth.

(c) Enclosed region in (a).

Figure 11. - Surface of graphite-cloth-reinforced composite (GCRC) after sliding against a graphite-cloth-reinforced disk in simulated-stop – speed-variation test shown in figure 10.

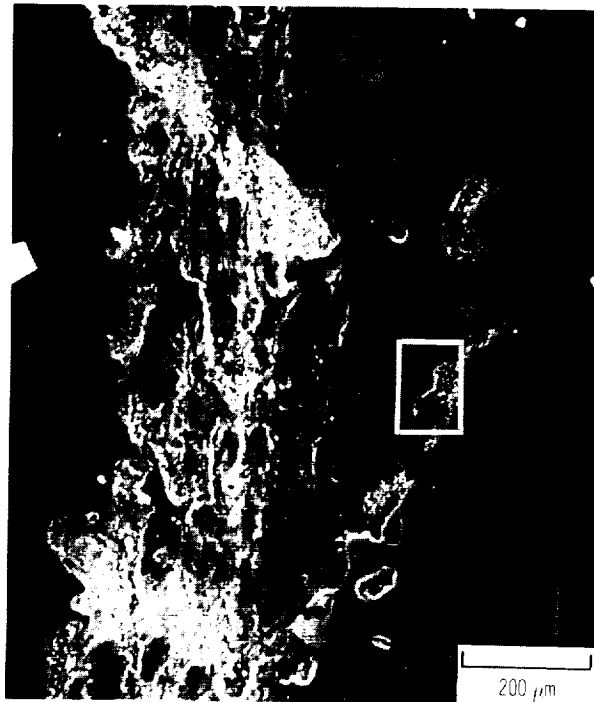
(a) General surface condition.

(b) Enclosed region in (a).

Figure 12. - Surface of boronated graphite (BG) after sliding against a graphite-cloth-reinforced composite disk in a simulated-stop – speed-variation test.

The wear of the boronated graphite material, against both the 17-22 AS steel and graphite-cloth-reinforced disk materials, was comparable to that of the CG-HB baseline material. This is somewhat unexpected in view of the low mechanical strength of the boronated graphite and the relatively high wear shown by the standard carbon graphite with B_4C additions (CG-BC). The extremely soft graphite must have effectively lubricated the sliding interface. There was no indication of abrasive disruption of the surface. The only surface features that can be related to wear are the presence of surface pits, as shown in figure 12.
