EFFECTS OF IONIZING RADIATION ON CHARGE-COUPLED IMAGERS

J. M. Killiany, W. D. Baker, N. S. Saks, and D. F. Barbe
Naval Research Laboratory
Washington, D.C.

The effects of ionizing radiation on three different charge-coupled imagers have been investigated. Device performance was evaluated as a function of total gamma ray dose. The principal failure mechanisms have been identified for each particular device structure. The clock and bias voltages required for high total dose operation of the devices are presented.

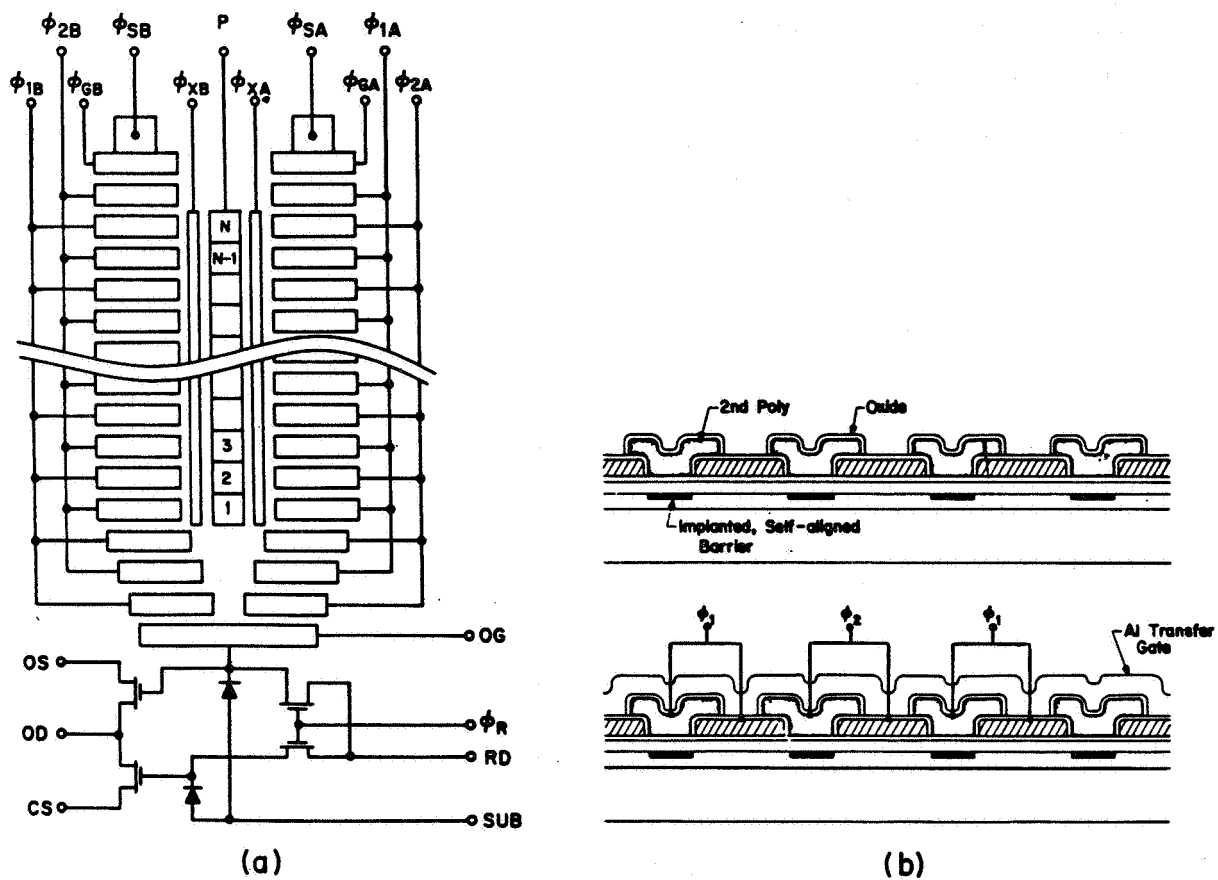
Figure 1. 256 X 1 CCD structure: (a) top view of the device; (b) cross-sectional view along the shift register

The test device is a 256-bit linear imager employing the double-register parallel transfer readout organization shown in Figure 1a (Ref. 6). The 256 photosites are separated by diffused channel stops and covered by a polysilicon photogate 23 μm wide. The center-to-center spacing of the photosites is 13 μm . The two-phase parallel shift registers have overlapping polysilicon gates and self-aligned ion implanted barriers. The right-left register outputs are interlaced at the output gate and fed into the gated charge integrator. The shift registers are designed to operate at 5 MHz with a resulting 10 MHz output data rate. The on-chip compensation amplifier can be used to suppress the reset clock noise by use of a differential amplifier in the external video circuitry.

A cross-section of the shift register is shown in Figure 1b. The gate insulator is a combination of an oxide and a nitride (Si_3N_4) layer. The self-aligned barrier is formed by means of a boron implant. The shift registers are covered with aluminum to prevent the incident light from going through the polysilicon gates and smearing the image.

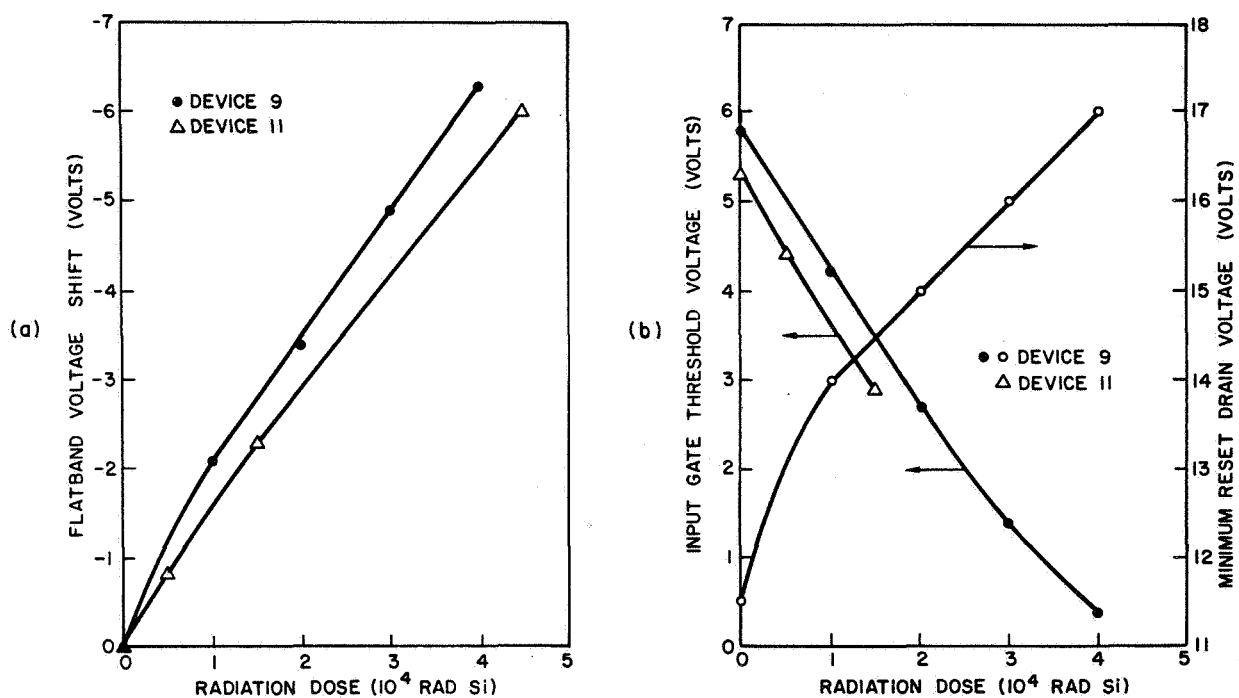
Figure 2. (a) Flat-band voltage shift vs. total dose for 256 X 1; (b) input gate threshold voltage and minimum reset drain voltage vs. total dose for 256 X 1

The radiation-induced flat-band voltage shift (ΔV_{FB}), shown in Figure 2a, limited device operation with the pre-irradiation clocks and bias to 4.5×10^4 rads (Si). The failure mechanisms resulting from ΔV_{FB} were: (1) buried channel driven out of depletion, (2) reset transistor biased in the conducting state for the entire clock period, and (3) input gate turned on. These three effects will be discussed separately in the following paragraphs.

The input gate threshold voltage as a function of dose is shown in Figure 2b. For a pre-irradiation input gate voltage of 0 V, the input would be turned on at 4.5×10^4 rads, filling the shift register wells. Saturation of the imager shift register can be avoided by simply increasing the reverse bias on the input diode while biasing the input gate to a negative voltage. In order to apply an analog signal to the shift register, a more sophisticated input scheme which minimizes the effect of the flat-band voltage shift must be employed since the input gate voltage swing between threshold and full-well is only about 0.5 V (Ref. 7).

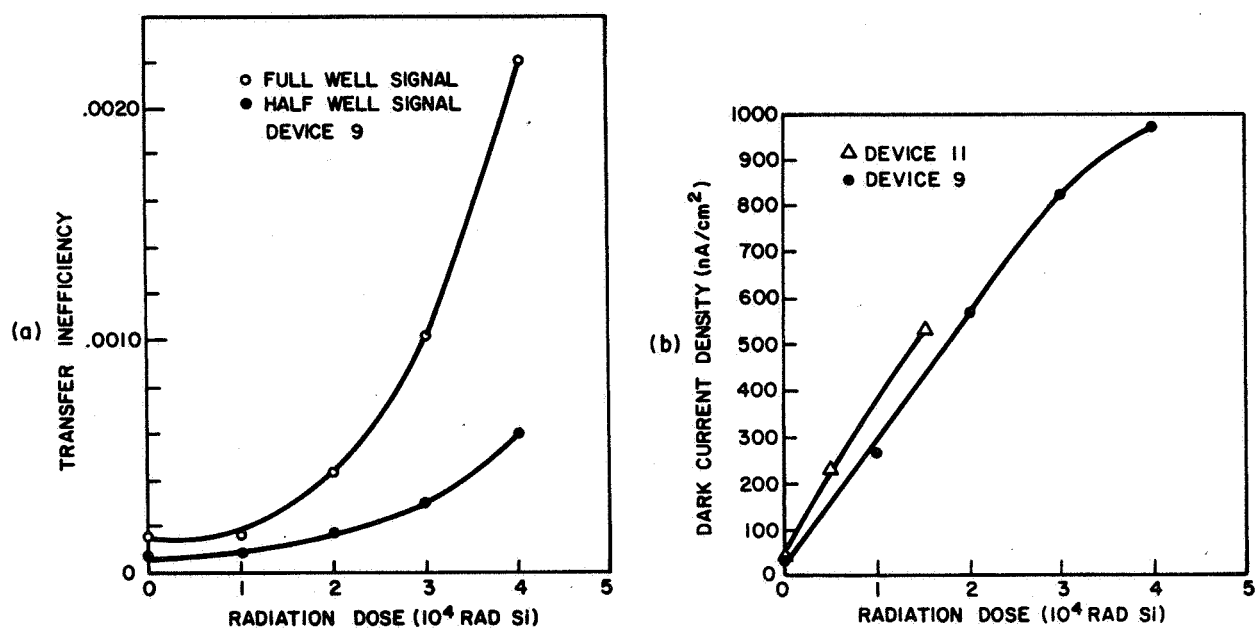
Figure 3. (a) Transfer inefficiency vs. total dose for 256 X 1; (b) dark current density vs. total dose for 256 X 1

The transfer inefficiency as a function of dose for electrically introduced full-well and half-well signals is shown in Figure 3a. The larger increase in the inefficiency for the full-well signal can probably be attributed to increased interface trapping. The interface state density as measured by a G-V technique was $1.3 \times 10^{10}/(\text{cm}^2 \text{eV})$ at 0 rads and increased to a value of $6 \times 10^{10}/(\text{cm}^2 \text{eV})$ at 4.5×10^4 rads. At 4×10^4 rads, a measurement of inefficiency vs. signal amplitude showed a sharp increase in loss for signals greater than 50% full-well. The inefficiency for 25% full-well was approximately the same as the 50% full-well value. A larger inefficiency for signals greater than 50% full-well is expected since the buried-channel device is operating in the surface-channel mode with increased interface state trapping (Ref. 8).

The increase in the thermally generated charge (dark current) density as a function of dose is shown for both devices in Figure 3b. The 27-fold increase at 4×10^4 rads would restrict operation to short integration times (i. e., the wells are filled with the dark charge in approximately 17 ms) or require cooled operation.

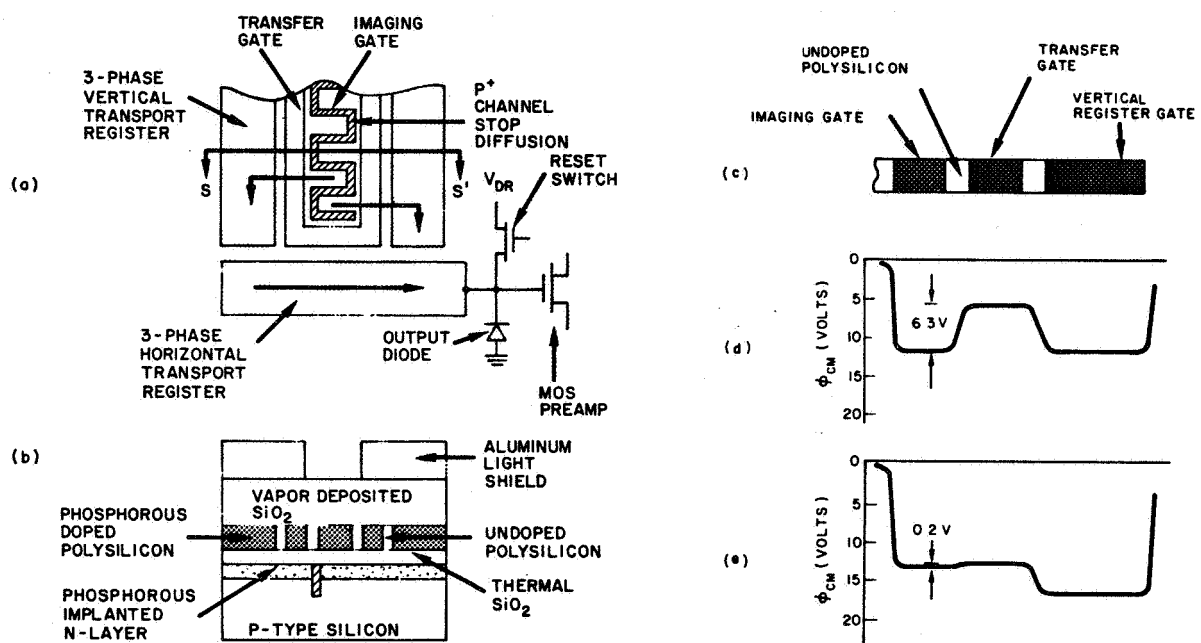
Figure 4. 60 x 1 CCD structure and potential profiles: (a) top view; (b) cross-sectional view; (c) cross-section of the gate structure; (d) pre-irradiation profile of the maximum channel potential; (e) profile of the maximum channel potential after 3×10^4 rads

This device, with a structure as illustrated in Figure 4, is a three-phase buried-channel CCD with planar, doped polysilicon electrodes and high-resistivity polysilicon interelectrode isolation. The substrate is 60-95 ohm-cm p-type silicon with $\langle 100 \rangle$ orientation. The channel oxide is thermally grown by a dry oxide technique and is 1800 \AA thick. Ion implantation of phosphorus through the oxide is used to form a buried-channel 3000 \AA thick with an average doping of $3 \times 10^{16} \text{ cm}^{-3}$. A layer of high-resistivity polysilicon about 5000 \AA thick is deposited over the channel oxide. The electrode pattern is formed by selective phosphorus diffusion into the polysilicon sheet. A vapor-deposited oxide is used to protect the device from damage.

The resistivity of the undoped polysilicon isolation between the gate electrodes was reduced by a factor of approximately 20 after a total dose of 3×10^4 rads. This drop in the resistance was due to field-induced channeling in the undoped polysilicon as a result of trapped positive charge in the oxide. The lower isolation resistance allowed the various clock and bias voltages to mix together. The principal result of the mixing was that the transfer and imaging gate waveforms were altered such that almost no barrier existed between the photosensitive elements and the vertical transport registers. A cross-section of the device with calculated pre- and post-irradiation potential profiles is shown in Figures 4c through 4e. The barrier reduction allowed almost all of the photo-generated charge under the imaging gate to continuously spill into the vertical registers instead of being collected for an integration time prior to being transferred. As a result, the effective output signal was reduced to approximately 3% of the pre-irradiation full-well capacity. This observed reduction agrees well with that expected from the profile of Figure 4e. Consequently, these devices became inoperative at a total dose of 3×10^4 rads, and operation could not be recovered by adjusting the bias and clock voltages.

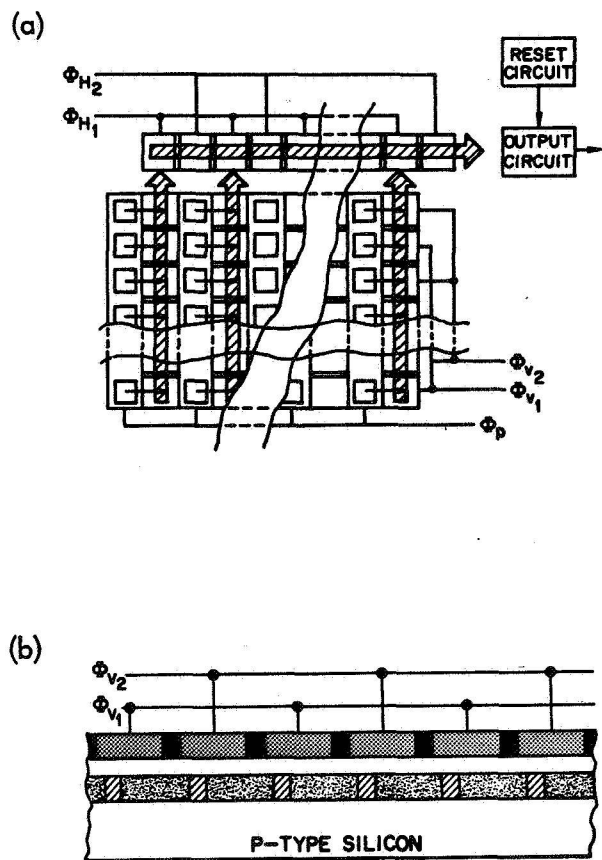
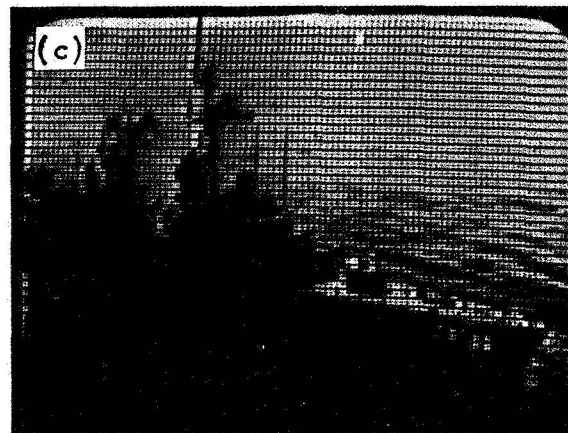
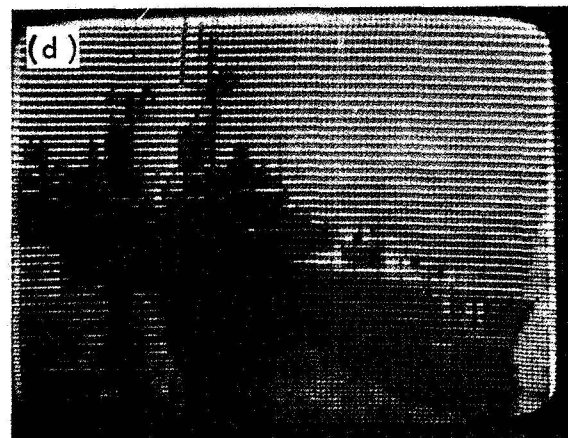
Figure 5. 100 x 100 CCD structure and image quality: (a) top view of the device; (b) cross-sectional view along a vertical transfer register; (c) pre-irradiation image; (d) image after 3×10^4 rads

The device consists of 10^4 photosensitive sites arranged in 100 columns, each containing 100 sites (see Figure 5a). Adjacent to each column of photosensitive sites is a vertical transfer register. The horizontal shift register is employed to multiplex the signals from the vertical registers. A differential FET amplifier on the chip provides the video output.

The device has the structure shown in Figure 5b. It is a two-phase, buried-channel CCD with ion-implanted barriers. The electrodes are doped polysilicon and the interelectrode isolation is high-resistivity polysilicon. The CCD substrate is 60-90 ohm-cm p-type silicon with <100> orientation. The channel oxide is 1200 Å thick and is grown by a dry oxide technique. Ion implantation of arsenic through the oxide is used to form an n-type buried channel with a thickness of about 3000 Å and an average doping of $1 \times 10^{16} \text{ cm}^{-3}$. The barriers necessary for two-phase operation are formed by implanting boron into the channel. A layer of high-resistivity polysilicon is deposited over the channel oxide. The electrode pattern is formed by selective diffusion into the undoped polysilicon sheet. A thick vapor-deposited oxide covers the device. Aluminum light shields are used to cover all of the active region except for the photosensitive areas.

resolution target range from 14 to 16 lp/mm vertically and from 11 to 12 lp/mm horizontally. A typical pre-irradiation image is shown in Figure 5c.

For a total dose of 1×10^4 rads, no change in the imaging quality of the devices was observable. At 3×10^4 rads, the image did deteriorate significantly. A qualitative demonstration of this is shown in Figure 5d. The limiting resolution at this total dose decreased to between 6 and 10 lp/mm vertically and between 5 and 6 lp/mm horizontally. At a total dose of 1×10^5 rads, no image at all was obtained with the original clock and bias voltages. After substantial adjustments of the operating conditions, a rather poor image could be recovered.
