NASA TN D-8313 *e.l*

# FLEXURAL FATIGUE OF HOLLOW ROLLING ELEMENTS

*Lewis Research Center  
Cleveland, Ohio 44135*

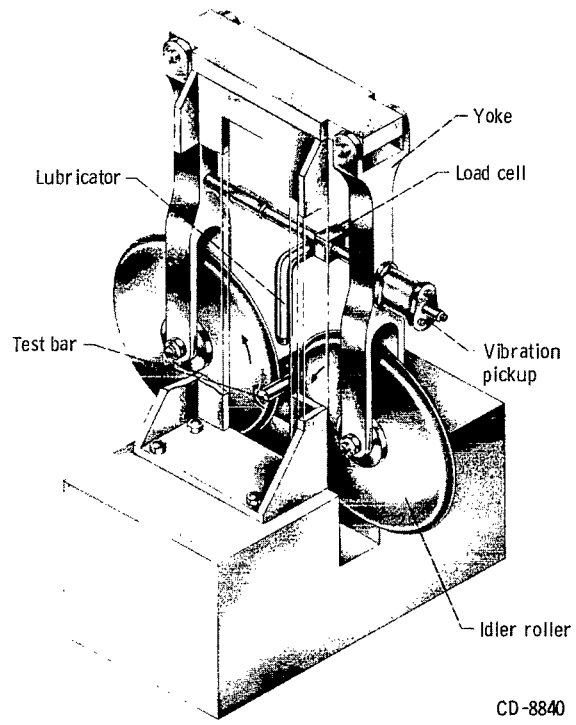
Figure 1. - Rolling-contact fatigue tester.

The test apparatus used in this investigation was the rolling-contact fatigue tester shown in figure 1. This apparatus is ideally suited for the type of flexural fatigue testing desired with hollow test specimens. The hollow, cylindrical test bar is mounted in a precision chuck. A drive motor is attached to the chuck. It drives the bar, which in turn drives two large idler rollers. The rollers are 19.1 centimeters (7.50 in.) in diameter and have a crown radius of 0.64 centimeter (0.25 in.). The rollers are mounted on double-row ball bearings and are supported by massive pendulum yokes. Load is applied by closing the rollers against the test bar with a micrometer-threaded turnbuckle and a calibrated load cell. The concentrated Hertzian contact between the rollers and the test bar is lubricated by drip feeding with a needle valve to control the flow rate. The test bar is rotated at 12 500 rpm, thus receiving 25 000 stress cycles per minute from the pair of rollers. A velocity type of vibration pickup is mounted on one of the support yokes. This pickup acts as a failure sensor and terminates the test upon occurrence of a failure. The lubricant used in these tests was a superrefined naphthenic

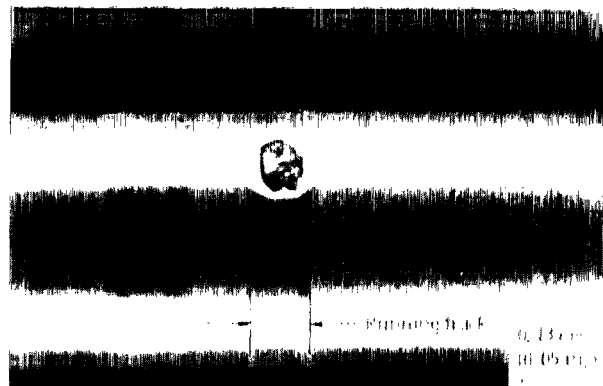
(b) Section through spall in (a).

Figure 6. - Typical rolling-element fatigue spall on hollow test bar surface.  
Material, AISI M-50; OD/ID ratio, 2.0.

At OD/ID ratios of 2.0 and 1.6, neither the 52100 nor the M-50 test bars failed by flexural fatigue within 1 million stress cycles up to the maximum contact load of 3820 newtons (860 lbf). This load was not exceeded because of the magnitude of the maximum Hertz stress (5520 MPa (800 000 psi) in the concentrated contact of the rollers and the test bar. At a contact stress greater than this level, it was expected that rolling-element fatigue spalling of the test-bar outer surface would be the predominant mode of failure and that the fatigue life would be less than the desired 1 million stress cycles. An example of a spalling type of fatigue failure is shown in figure 6(a); it markedly differs in appearance from the flexural fatigue failure. A section through this fatigue spall (fig. 6(b)) shows that cracking did not originate at the bore.

Life tests were run on test bars of each material for each OD/ID ratio at loads below that where flexural failure had occurred within 1 million cycles in the exploratory tests. At least 10 test bars were run at each of seven combinations of load and OD/ID ratio with the AISI 52100 bars and at each of five combinations with the AISI M-50 bars. The maximum tensile tangential stress at the bore of the bars ranged from 200 to 490 megapascals (29 000 to 71 000 psi). The results of the life tests are shown on Weibull coordinates in figures 7 and 8 and are summarized in table III. With the AISI 52100 hollow test bars, no flexural failures occurred when the bore stress was 379 megapascals (55 000 psi) or less. In the tests where the bore stress was 490 megapascals (71 000 psi), 10 of the 14 test bars failed by flexural fatigue, with a life distribution from 0.7 to 40.1 million cycles. Tests on the other four bars were suspended without failure at approximately 40 million cycles. The appearances of the flexural failures, regardless of life, were similar to those shown in figure 5. In the tests where no flexural failures occurred, rolling-element fatigue spalling of the bar outside surface (fig. 6) was the mode of failure.

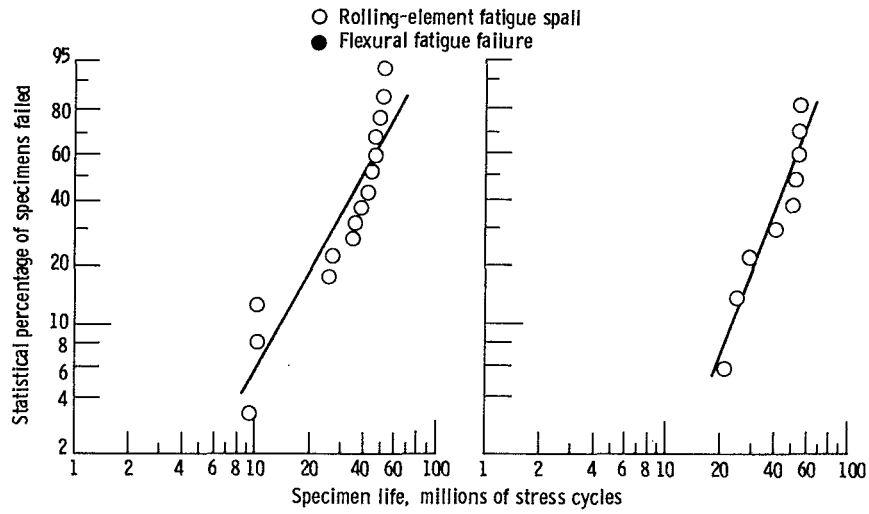
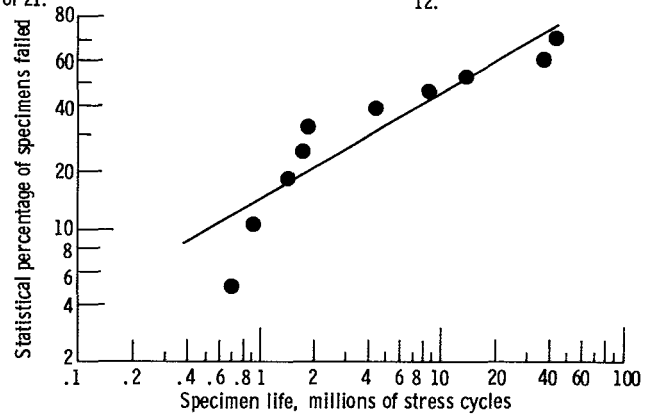
Figure 7. - Fatigue life of AISI 52100 hollow test bars in rolling-contact fatigue tester.

(e) OD/ID ratio, 1.4; contact load, P, 2050 N (461 lbf); failure index, 15 out of 21.

(f) OD/ID ratio, 1.2; contact load, P, 680 N (153 lbf); failure index, 9 out of 12.

(g) OD/ID ratio, 1.2; contact load, P, 934 N (210 lbf); failure index, 10 out of 14.

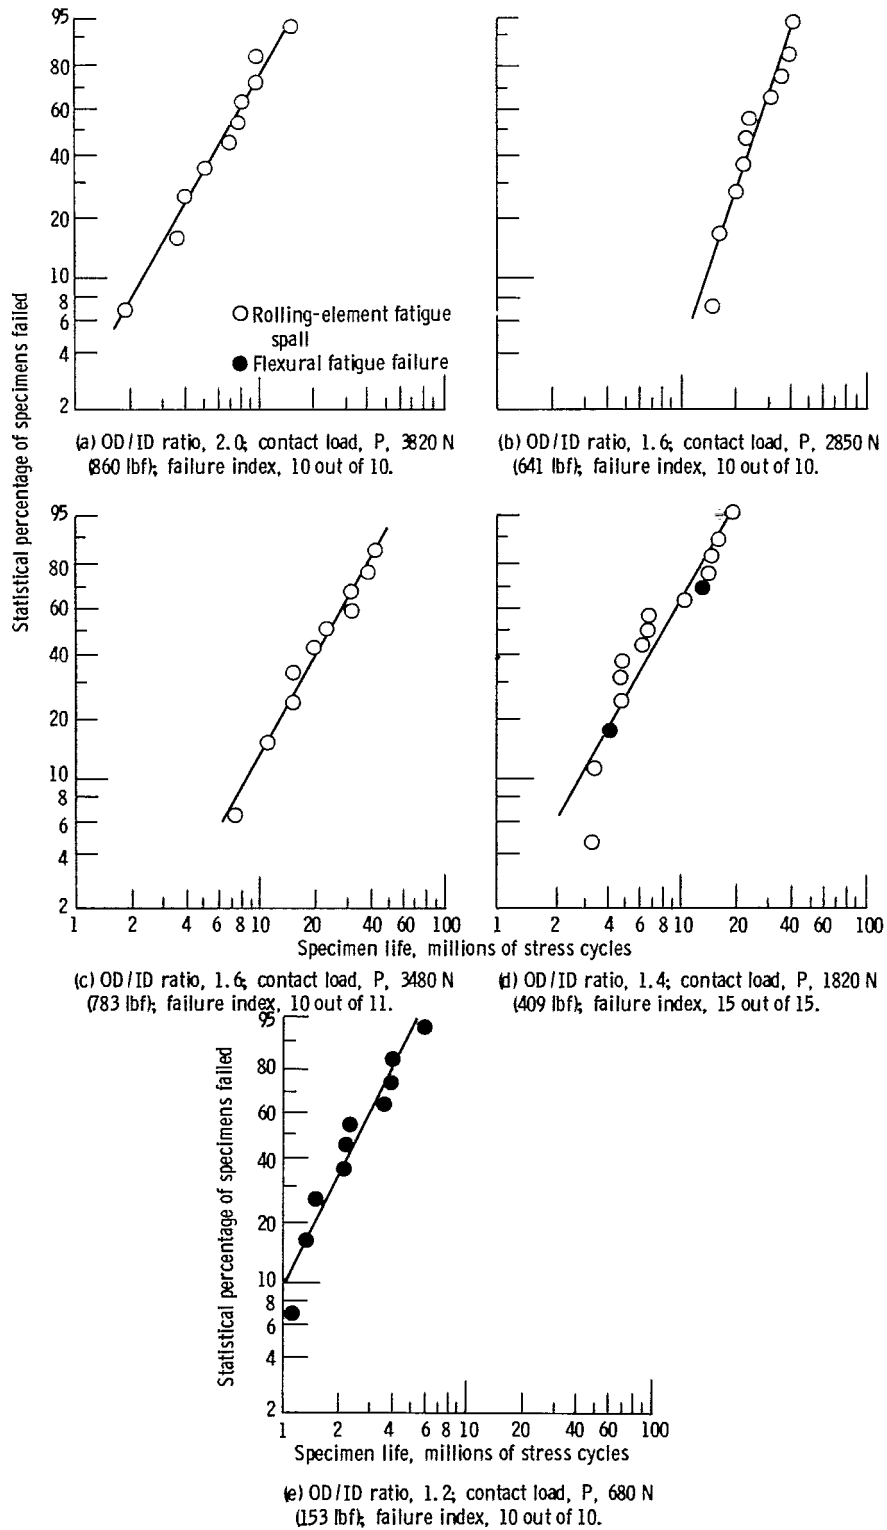
Figure 8. - Fatigue life of AISI M-50 hollow test bars in rolling-contact fatigue tester.

For the AISI M-50 hollow test bars, flexural failures occurred at tensile tangential bore stresses as low as 338 megapascals (49 000 psi), but only two flexural failures occurred out of 26 tests at this bore stress. Rolling-element fatigue spalling was predominant at this stress and less. At 359 megapascals (52 000 psi) all 10 AISI M-50 hollow test bars failed by flexural fatigue in less than 6 million cycles.
