**MICROSTRUCTURAL AND WEAR PROPERTIES OF
SPUTTERED CARBIDES AND SILICIDES**

by T. Spalvins
Lewis Research Center
Cleveland, Ohio 44135

TECHNICAL PAPER to be presented at the
International Conference on Wear of Materials
St. Louis, Missouri, April 25-27, 1977

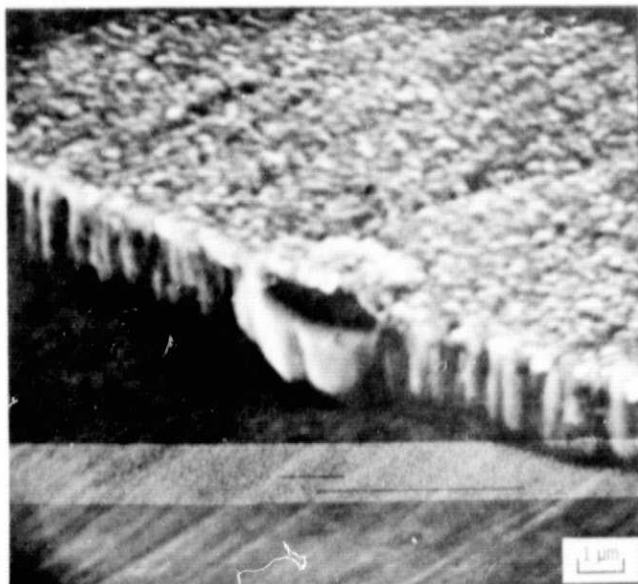
(a) Overlapping nodule.

(b) Isolated and fused nodules.

(c) Extreme localized outgrowth.

Figure 5. - Fracture cross section and surface view of sputtered MoSi_2 and Cr_3C_2 film.

Typical SEM micrographs in Fig. 5 show the surface views and a fracture cross section of the coating. The exact configuration and dimensions of the nodules, whether they are individual, fused, overlapping, or extreme localized growth features forming unusual complicated configurations are shown in Fig. 5. The surface morphological composition as revealed by the higher SEM magnification is composed of individual crystallites as shown in Fig. 6. These crystallites have a spherical shape and are about 0.6 μm in diameter.
