NASA TM-78876

THE ROLE OF THERMAL SHOCK IN CYCLIC OXIDATION

by Carl E. Lowell and Daniel L. Deadmore
Lewis Research Center
Cleveland, Ohio 44135

TECHNICAL PAPER to be presented at the
One hundred fifty-third Meeting of the Electrochemical Society
Seattle, Washington, May 21-26, 1978

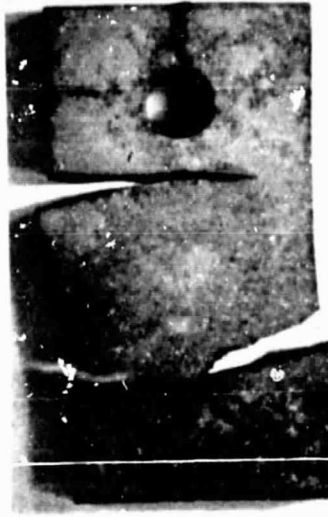
(a) BRITTLE ALLOY TD NiCrAl.

(b) DUCTILE ALLOY HOSKINS 875.

Figure 4. - Deformation modes of thermal shock after 80 one hour cycles.

One thing that was apparent in the fast cooling tests was that the alloy coupons became more and more distorted as the tests progressed. Examples of such distortion are shown in figure 4. The wrought alloys HOS-875, TD-Ni, IN-702, and IN-601, all plastically deformed extensively, while cast B-1900+Hf had considerably less, but measurable plastic deformation. These alloys all tended to elongate and assume a dogbone shape, although the HOS-875, the weakest alloy, also curled (fig. 4(b)). In contrast, the alloy with very limited ductility (TD-NiCrAl) had little plastic deformation, and cracked extensively (fig. 4(a)).

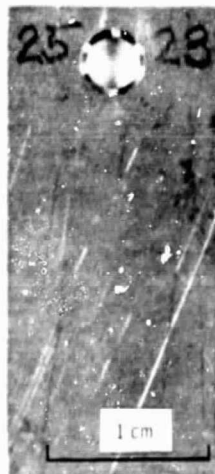
(a) AS MACHINED.

(b) 40 ONE MINUTE CYCLES
WATER QUENCHED.

Figure 5. - Metal flow from thermal shock IN-601.

It was assumed that the cause of the deformation was the rapid cooling and not oxidation. To test this assumption, a coupon of IN-601 was put into a 1100° C furnace just long enough to reach temperature (~1 minute), removed, and plunged into water. After a few such thermal cycles, thermal growth was noted. By the end of 40 cycles, the change was quite obvious as can be seen in figure 5.

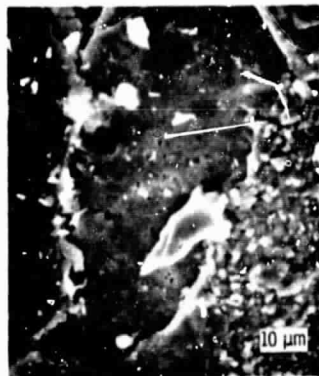
(a) IN-702 AIR COOLED.

(b) IN-702 WATER QUENCHED.

Figure 6. - Effect of cooling rate on oxide surface structure of a ductile alloy.

A comparison of the slow cooled oxide surface morphologies with those of rapidly cooled oxides was made using scanning electron microscopy. Of particular interest were the surfaces on IN-702, IN-601, and B-1900+Hf. Figure 6 shows the comparison for IN-702. The oxide morphology of the air cooled sample is typical of the type of spalling which normally occurs on cooling. It results from CTE mismatch induced compressive stresses in the oxide exceeding the strength of the oxide. When this happens, large flakes of oxide part from the scale, often explosively. In the case of the rapidly cooled sample, the oxide appears to have failed by cracking, but there is no evidence of the loss of large oxide flakes of oxides. Furthermore, the crack pattern is nearly a regular array much as one might expect from a biaxial tensile failure.
