NASA
Technical Memorandum 79003

AVRADCOM
Technical Report 78-47

WEAR OF SEAL MATERIALS USED IN AIRCRAFT PROPULSION SYSTEMS

Robert C. Bill
Propulsion Laboratory
AVRADCOM Research and Technology Laboratories
and
Lawrence P. Ludwig
Lewis Research Center
Cleveland, Ohio

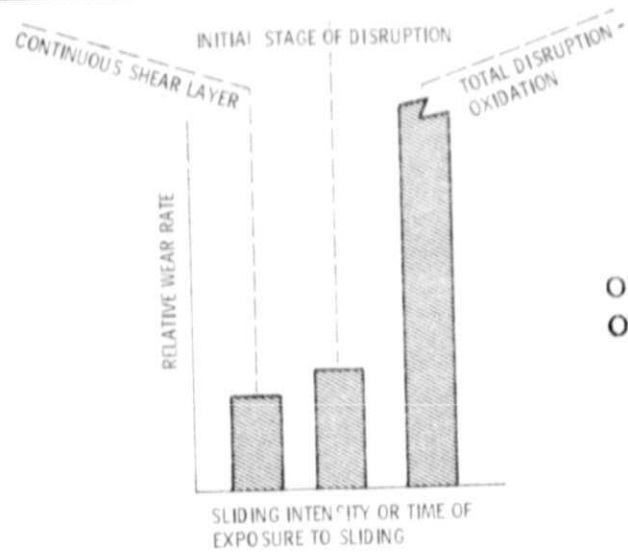
Fig. 8. - Three stages of shear layer transitions observed in sliding wear of carbon graphite.

Besides wear rates and friction measurements, screening tests provide some clues concerning the friction and wear mechanisms operating at seal material interfaces. The ability of carbon graphite to be self-lubricating in the event of dry contact depends on the formation of a thin, oriented, easily shearable layer of graphite on the sliding surface (11). So long as this layer is maintained wear will be low. Certain conditions lead to the disruption of the easily shearable graphite layer. Among them are the thermally induced desorption of adsorbed gases (O_2 , H_2O) on the surfaces and edges of crystallites comprising the shear layer (11), and disruption of the surface oxide present on the metal counterface (12). Disruption of the oriented graphitic film exposes the underlying randomly oriented carbon graphite material to sliding contact. The sequence of SEM photographs shown in Fig. 8 illustrates the condition of the carbon graphite sliding surface with the oriented film

intact, and various stages of film disruption. It is unclear as to what conditions lead to restoration of the oriented graphite film, possibly from graphitic debris particles (13), and what conditions promote ever more severe sliding wear and higher friction.

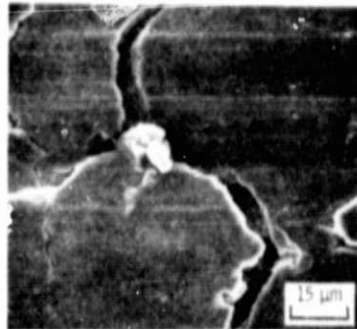
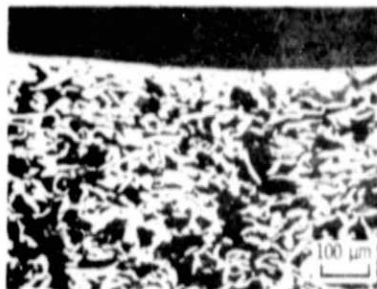
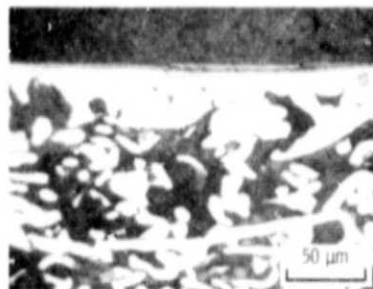
(a) OVERVIEW OF SMEARED RUB SURFACE.

(b) CENTRAL REGION OF (a) SHOWING CRACK AND LAMINAR MORPHOLOGY DETAIL.

(c) SECTION PARALLEL TO SLIDING DIRECTION, THROUGH SMEARED RUB SURFACE.

(d) DETAIL OF (c) SHOWING INCIDENCE OF LAMINAR CRACKS.

Fig. 15. - SEM overview and metallographic section of rub surface on sintered Hastelloy-X fiber-metal seal material after rub interaction with Ti-6Al-4V simulated blade tips.

Low density materials. - For low density gas path seal materials, the intent is that rub interaction be accommodated by removal of discrete particles, thereby minimizing frictional heating effects and wear to the rotating component. Under some rub conditions however, it is observed that the surface of the low density seal material becomes smeared, and in effect the rotating component is in contact with fully dense seal material. Such a smeared rub surface is depicted in Fig. 15. As indicated in Fig. 16, the rate of frictional heat generation at the rub interface increases by two orders of magnitude when smearing occurs (19). Microsections of a Ti-6Al-4V rotating component after such a high energy rub (Fig. 17) show evidence of very rapid oxidation in some cases as indicated by quasi-spherical cavities in the rub surface and intense white sparking during the rub. Also, in other studies it was observed that high energy rubs promoted fine martensitic platelet formation near the rub surface (20).

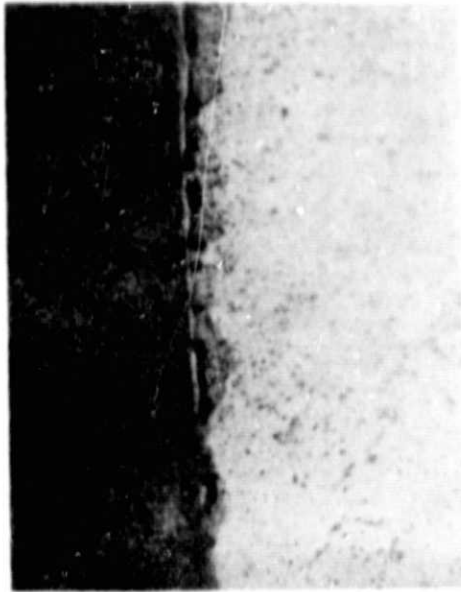
(a) NEAR BLADE-TIP LEADING EDGE.

(b) ABOUT HALFWAY ACROSS BLADE TIP.

Fig. 17. - Section view of Ti-6Al-4V simulated blade tip rub surface.

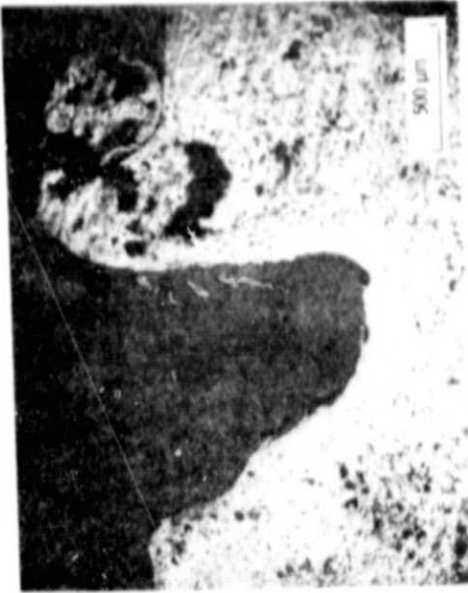
(a) OVERVIEW SHOWING DISPLACED MATERIAL.

(b) DETAIL, BOTTOM OF RUB GROOVE.

Fig. 19. - Microsection of rub groove on plasma-sprayed aluminum gas path seal material after interaction with 17 - 4 PH labyrinth seal knife-edge.

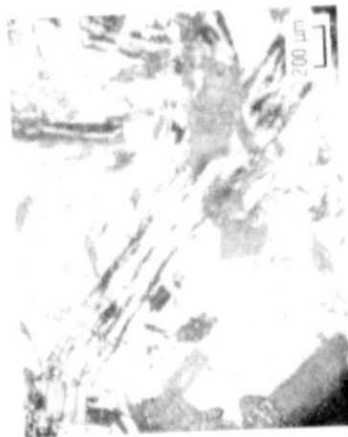
(a) RUB SURFACE ON PLASMA SPRAYED ALUMINUM.

(b) Ti-6Al-4V BLADE-TIP LEADING EDGE SHOWING 20 MICROMETER A MINIMUM TRANSFER.

(c) WEAR DEBRIS IN FORM OF THIN TRANSLUCENT RIBBONS.

Fig. 20. - Plasma-sprayed aluminum rub surface. Ti-6Al-4V blade tip, and wear debris.

In studying the rub mechanisms associated with fully dense materials (19), it was proposed that the radial or normal load was controlled by plastic indentation considerations. The frictional energy resulting from the rub was then simply the product of this normal load, the coefficient of friction, and the rub velocity. Order of magnitude agreement with knife edge rub data was obtained with this very simple model, and microsections of rub grooves (Fig. 19) are consistent with the plastic indentation model for normal load. Under blade tip rub conditions however, in contrast to knife-edge conditions, the indentation (rub groove) is at least ten times as wide as it is deep, and the rub cannot be entirely accommodated by plastic displacement of material. Some mechanism of micromachining chip or wear particle formation is required. Examples of such particles are to be seen in the rub debris shown in Fig. 20.
