T700 Power Turbine Rotor Multiplane/ Multispeed Balancing Demonstration

prepared by
G. Burgess and R. Rio

Mechanical Technology Incorporated

NASA Lewis Research Center
Contract NAS 3-18520

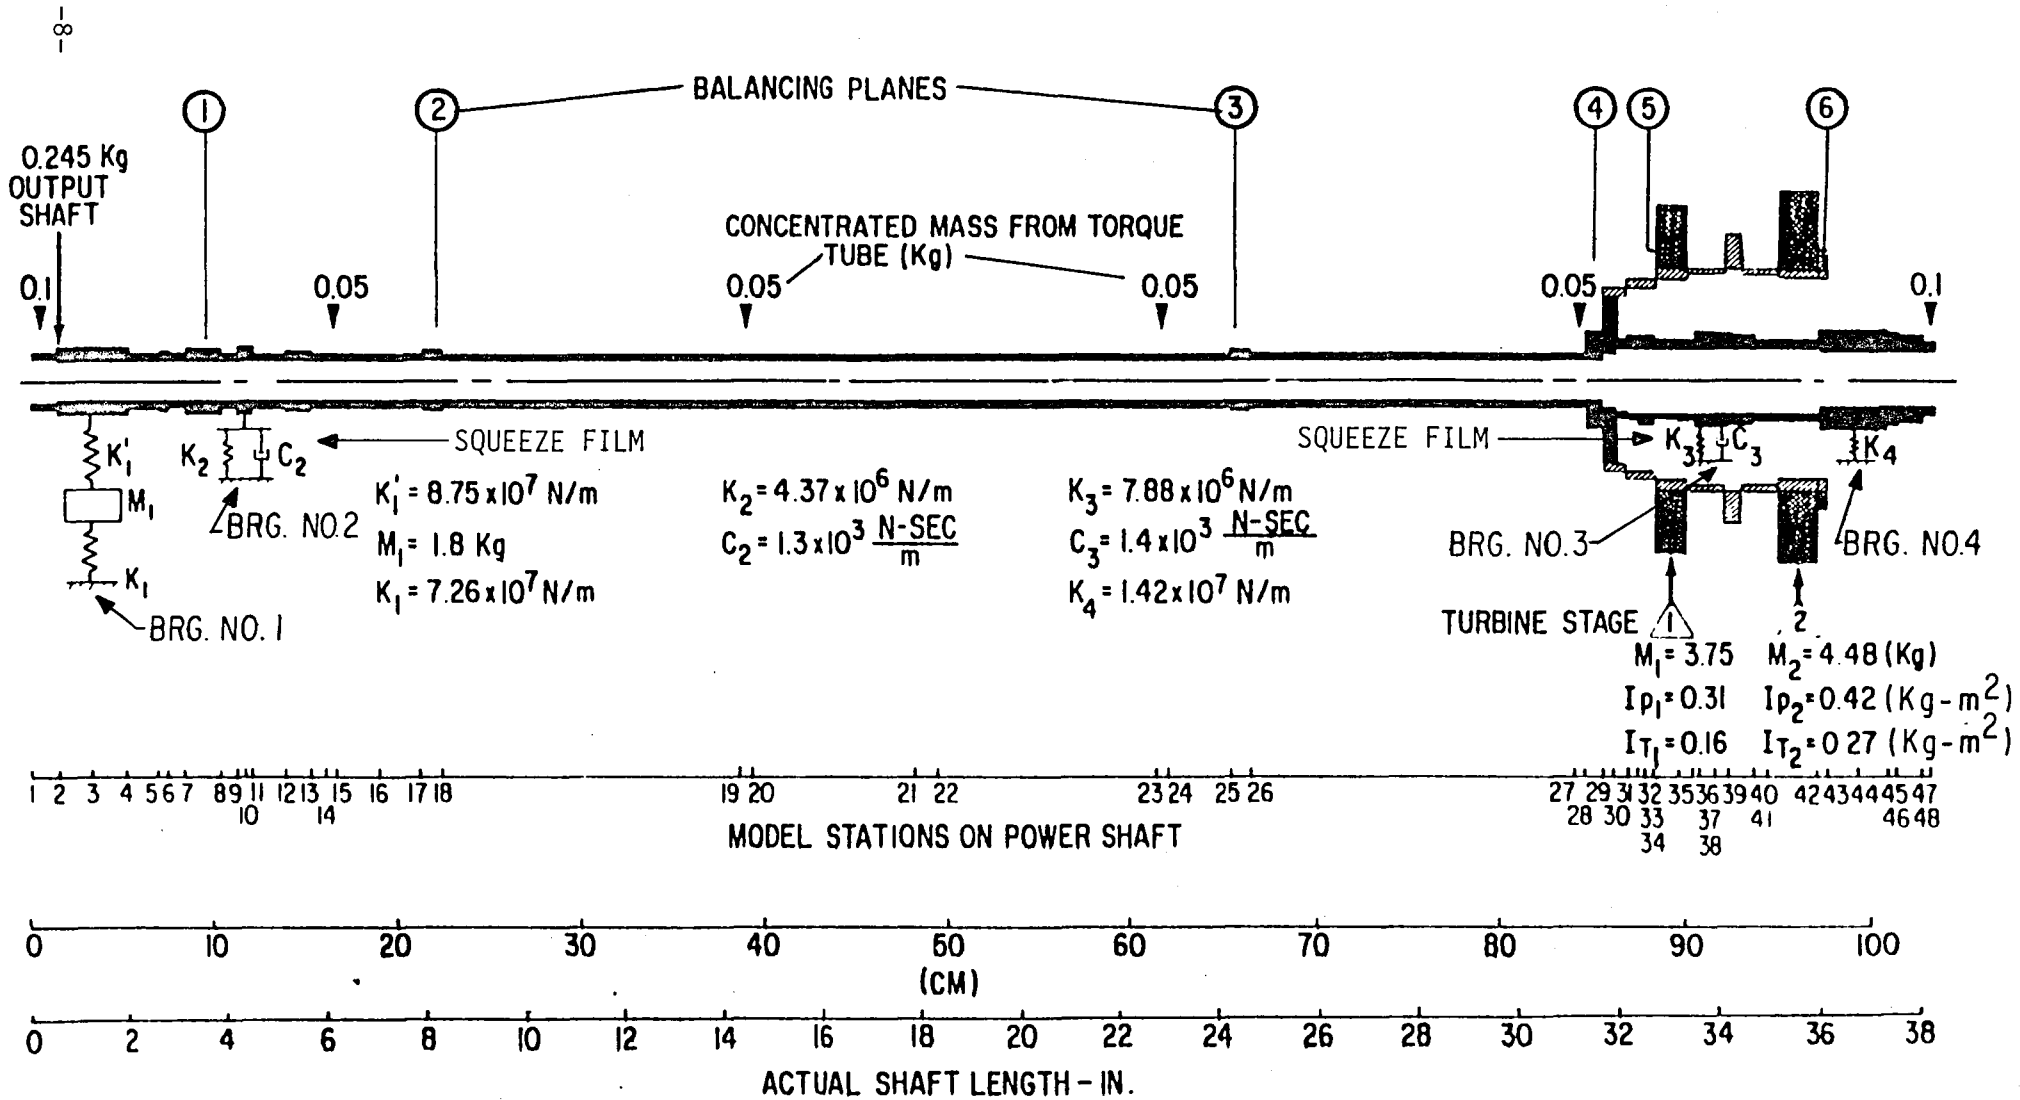
Figure 2 Analytical Model of the T700 Power Turbine Shaft for Critical Speed and Amplitude Response Calculations

The power turbine rotor was manufactured with six balance correction planes - four on the shaft and two on the turbine assembly (see Figure 2). An early prototype included an additional balance land at shaft midspan. Since the rotor mode shape indicates a large balance sensitivity at midspan, the existing balance planes 2, 4, and 6 are adequate for high-speed balance. Adding a midspan plane might lower possible vibration levels or serve as a replacement for planes 2 and 3.

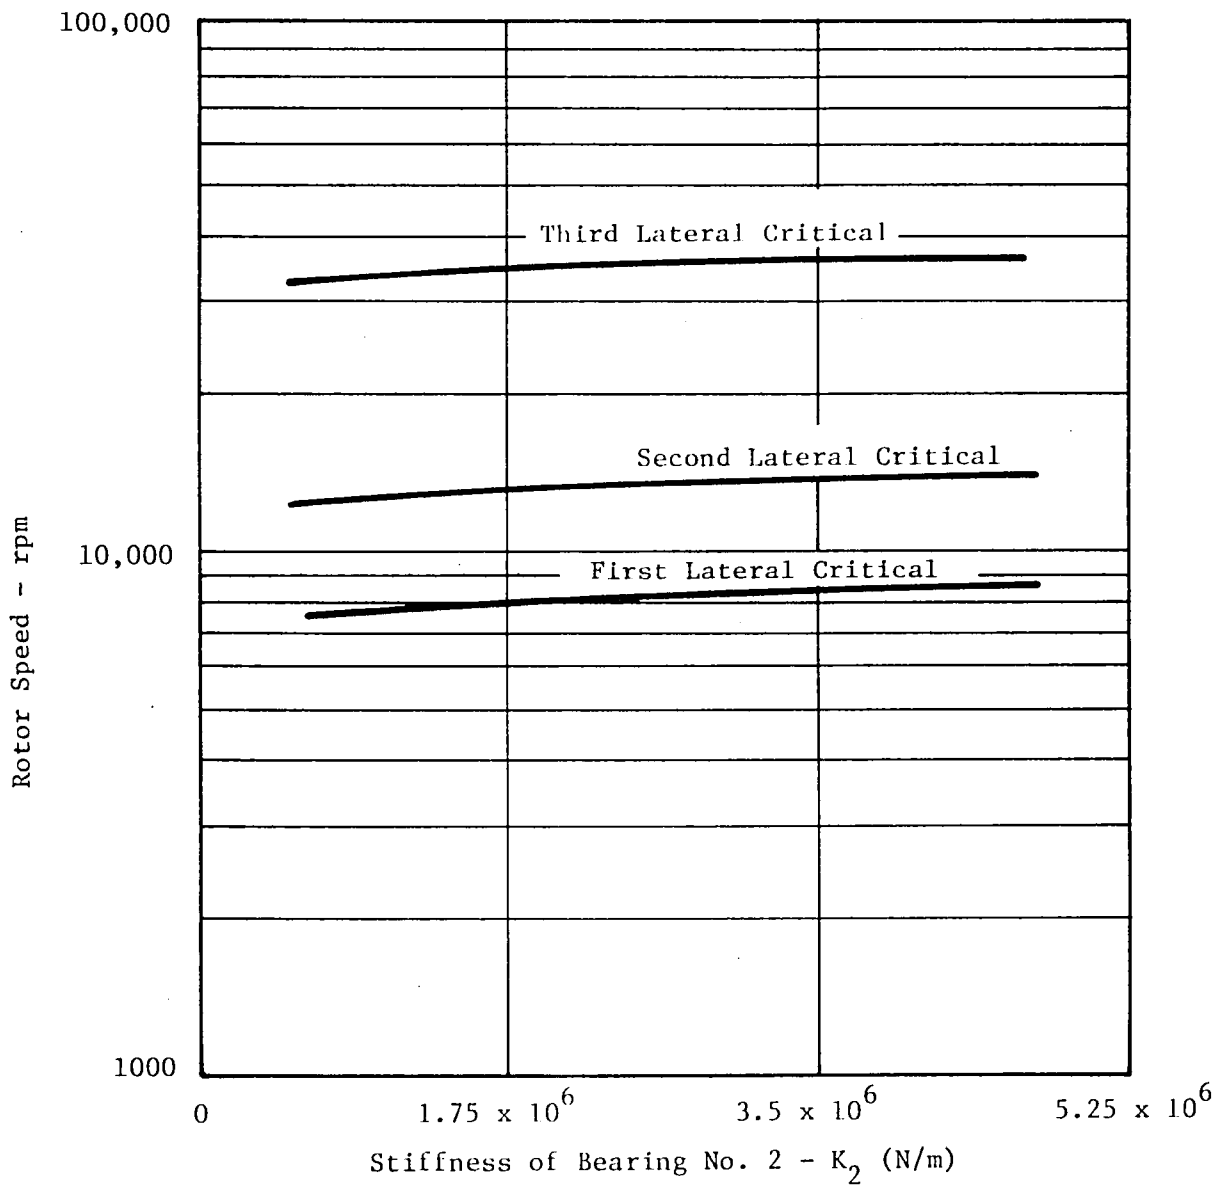
Figure 4 Undamped Critical Speeds of T700 Power Turbine Rotor as a Function of No. 2 Bearing Stiffness

The same features do have a definite effect upon the speed at which the mode occurs. The improved final model with number-two bearing stiffness of 4.4×10^6 N/m (Figure 4) resulted in critical speeds of 8,500, 13,740, and 35,700 rpm for the first three critical speeds. One early model's first three critical speeds were at 6,538, 15,377 and 35,371 rpm. Therefore, it is possible to provide for practical rotor balancing even though the balance rig stiffness is not an exact duplicate of the engine.
