Influence of Quality Control Variables on Failure of Graphite/Epoxy Under Extreme Moisture Conditions

Linda L. Clements and Pauline R. Lee

October 1980

ABSTRACT: Tension tests on $(0^\circ)_8$ T300/5208 graphite/epoxy composites were performed to determine the influence of various quality control variables on failure strength as a function of moisture and moderate temperatures. The extremely high- and low-moisture contents investigated were found to have less effect upon properties than did temperature or the quality control variables of specimen flaws and prepreg batch-to-batch variations. In particular, specimen flaws were found to drastically reduce the predicted strength of the composite, whereas specimens from different batches of prepreg displayed differences in strength as a function of temperature and extreme moisture exposure. The findings illustrate the need for careful specimen preparation, studies of flaw sensitivity, and careful quality control in any study of composite materials.

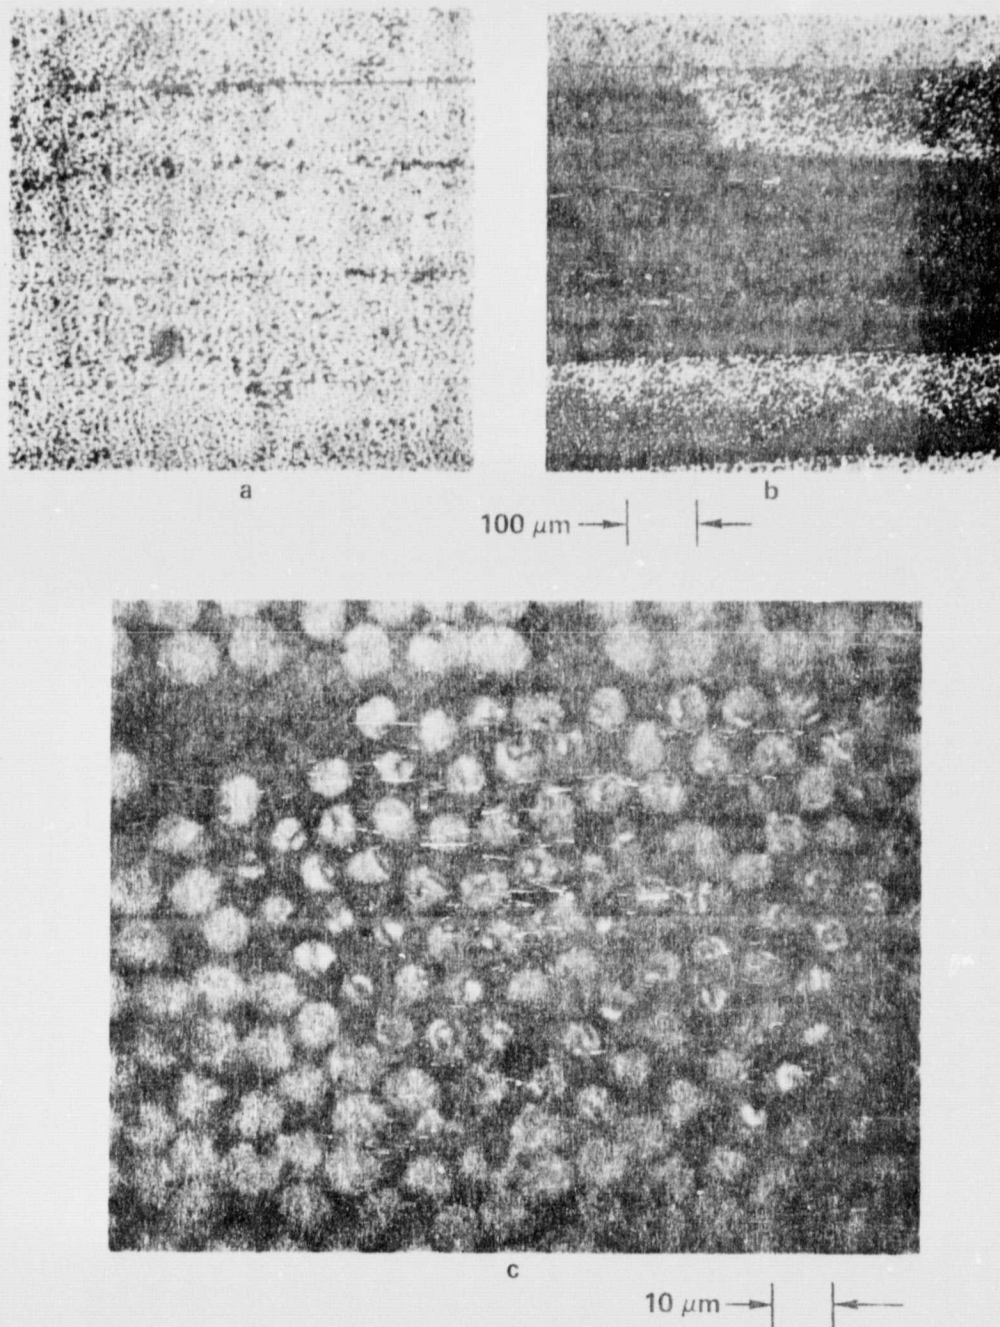
Fig. 1

FIG. 1 — Photomicrographs of T300/5308 laminates from "normal" (batch A) and "anomalous" (batch B) prepreg. (a) batch A, (b) batch B, and (c) batch B: anomalous fiber bundle among normal bundles.

Our concern with the effect of prepreg batch upon properties resulted from some early findings in this study. Anomalous results from some early tests were traced to specimens prepared from prepreg batch B. A microscopic investigation of tested and untested batch B specimens and of the prepreg itself was performed. From optical microscopy, scanning electron microscopy (SEM), and consultation with NARMCO and Union Carbide, we concluded that there were indeed some differences between batch B and other prepreg such as batch A. Some of these differences are illustrated in Fig. 1. A photomicrograph of a laminate made from "normal" prepreg (such as batch A) is shown in Fig. 1a. The cut and polished filament ends reflect light very effectively and thus appear light-colored. A photomicrograph of a laminate made from prepreg batch B is shown in Fig. 1b. In this laminate, there are light and dark areas, with the transition between such areas occurring both between layers and within a single layer. In the dark areas, as can be seen from the magnified view of Fig. 1c, the individual filaments have been damaged. Figure 1c also illustrates that the dark areas are frequently connected with

individual fiber bundles (3000 filaments to a bundle). The obvious conclusion that the filaments are somehow degraded in these areas was refuted by careful polishing and SEM work, which showed that the epoxy matrix in these areas is somehow altered and weakened. Unless extreme care is exercised the apparent filament degradation actually occurs during metallographic preparation. The altered epoxy matrix allows the filaments to move around and thus be damaged during polishing. Since the altered epoxy occurs within and around individual fiber bundles, the epoxy probably has reacted to some surface effect or contaminant on *some* of the fibers used to make up the prepreg. We suspect that this effect is related to another problem encountered on a few occasions by other T300/5208 users and labeled "zebra tow" by them.⁴ In this case, some of the surface tows (fiber bundles) of the composite panels tended to pull loose from the panel when the peel ply was removed. We have noted some such surface features on specimens made from our batch B prepreg.

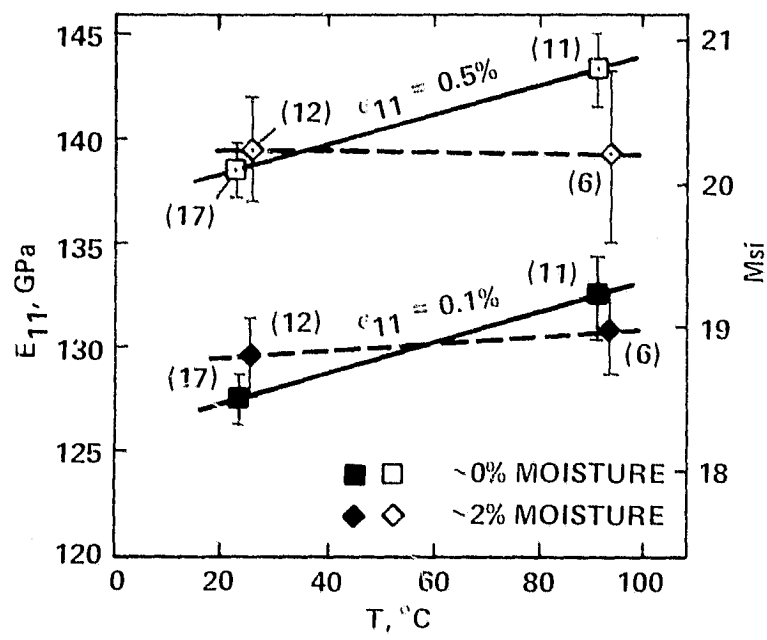
Fig. 2

FIG. 2 — Axial elastic modulus, E_{11} as a function of temperature at two different axial strains, ϵ_{11} , levels and moisture contents for batch A specimens. (Error bar shows 95% confidence limits. Numbers in parentheses are numbers of specimens.)

Figure 2 is a plot of axial elastic modulus, E_{11} , as a function of temperature and moisture content at two strain levels. As can be seen from this figure, E_{11} (as determined from the slope of the stress-strain curve) is statistically significantly higher at an axial strain, ϵ_{11} , of 0.5% than at $\epsilon_{11} = 0.1\%$. Other researchers have also observed this increase in modulus with strain [2,4]. Figure 2 also illustrates that the increase holds true for all combinations of moisture and temperature. One possible explanation for the phenomenon is that curved filaments in the composite straighten with increased strain so that more filaments carry the applied load [2]. Another possible explanation is that there may be a strain-induced improvement in orientation of the covalently bonded carbon platelets within the individual filaments.⁵

- There is a statistically significant temperature-induced increase in E_{11} for dry specimens only. (See Fig. 2.) Since the axial thermal-expansion coefficient of the fiber is negative, that is, the fiber *contracts* axially with increased temperature, the increase in E_{11} is not surprising. However, it is not clear why no such effect is seen for wet specimens.

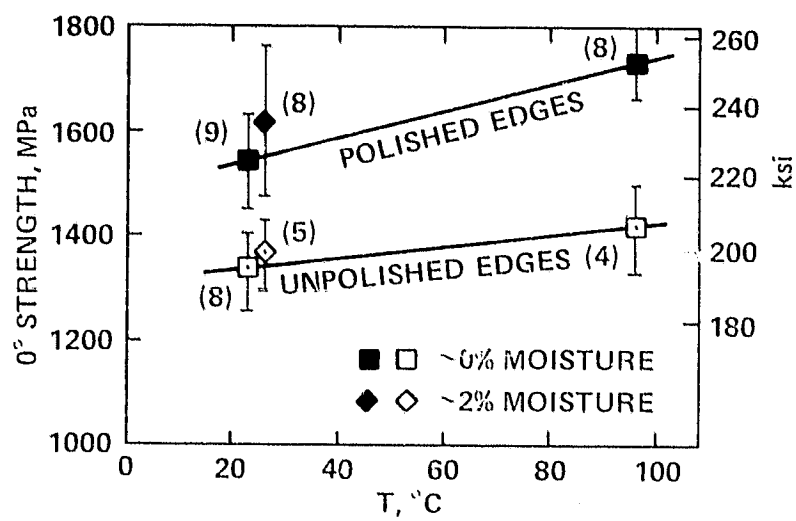
Fig. 3

FIG. 3 — 0° tensile strength as a function of temperature for polished-edge and unpolished-edge batch A specimens at two moisture contents.

A very important finding of this study was the magnitude of the influence of specimen quality upon 0° strength. Figure 3 compares 0° strength as a function of temperature for polished-edge and unpolished-edge batch A specimens. As can be seen, the strength is significantly increased by the improved specimen quality resulting from polished edges. It is also interesting to compare these results with strengths of specimens previously rejected as having irreparable defects:

From Fig. 3, it is also seen that edge polishing produced a change in strength behavior as a function of temperature. The 0° tensile strength of dry polished-edge specimens increased significantly with an increase in temperature, whereas the small increase in mean strength for dry unpolished-edge specimens is not statistically significant. Moisture content, on the other hand, had no statistically significant effect upon strength for batch A specimens whether they were edge polished or not. Unfortunately, we were unable to get reliable strength data at 96°C wet because of end-tab failures. This was because the additional moisture content we produced using the "reverse thermal effect," when combined with elevated temperature, caused tab failure to occur before composite failure. (For batch A specimens, the tabs themselves failed prior to composite failure, but for batch B specimens,

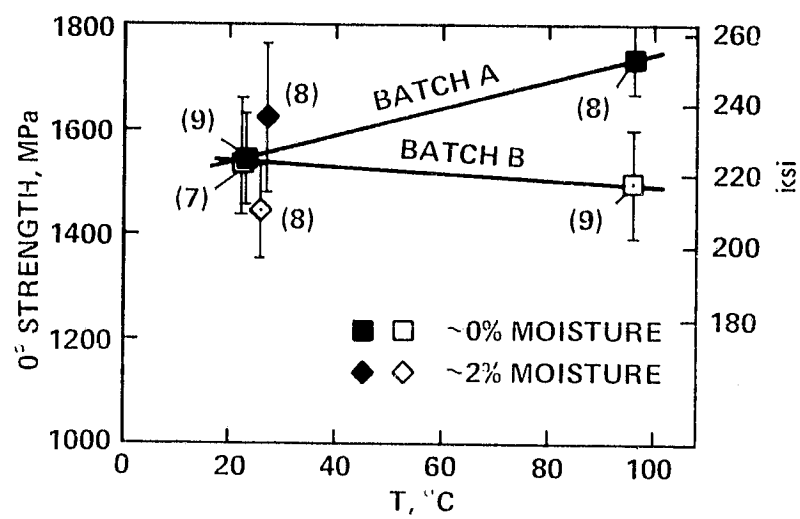
Fig. 4

FIG. 4 — 0° tensile strength as a function of temperature for polished-edge batch A and batch B specimens at two moisture contents.

Figure 4 illustrates the effect of prepreg batch upon 0° strength. The mean strength at 25°C for wet batch B specimens is less than that for dry batch B specimens at the 90% confidence level (but not at the 95% confidence level). Far more clearly significant is the difference in strength between batch A and batch B specimens at 96°C. As can be seen from Fig. 4, the batch B specimens are much weaker at this temperature. As we have explained, we were unfortunately unable to fail the composite itself at 96°C wet. Nevertheless, we suspect that the combination of temperature and moisture — each of which seems to affect the batch B specimens adversely — may have produced significant degradation in the strength of batch B specimens.

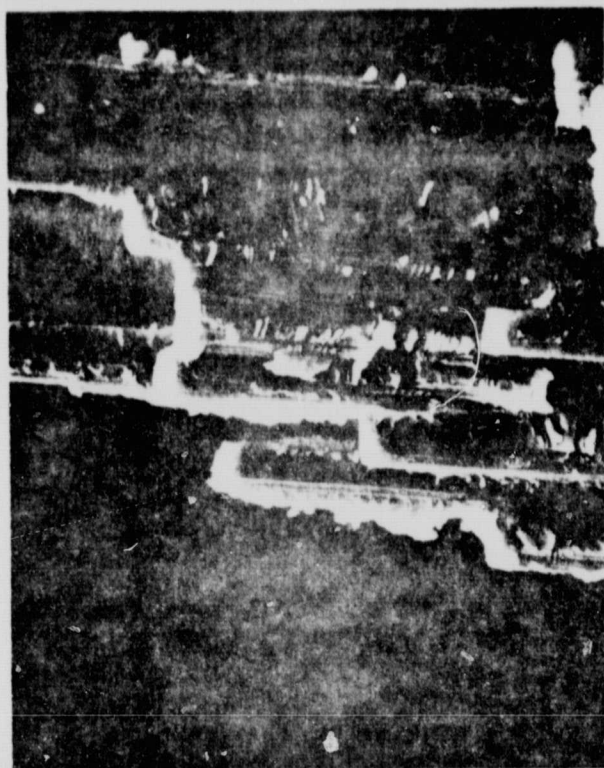
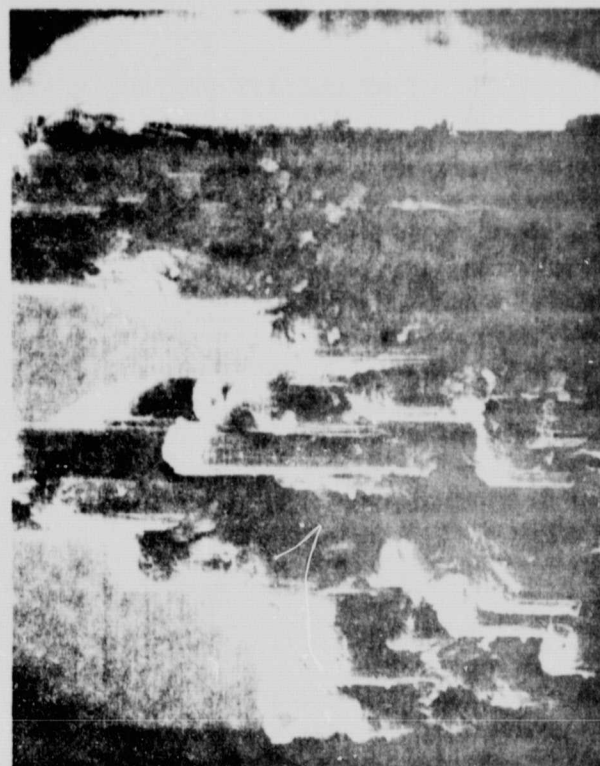
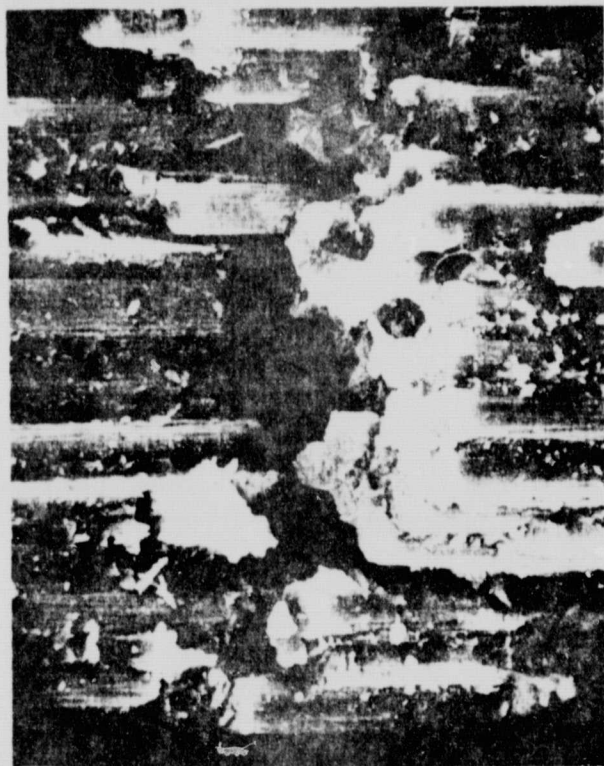
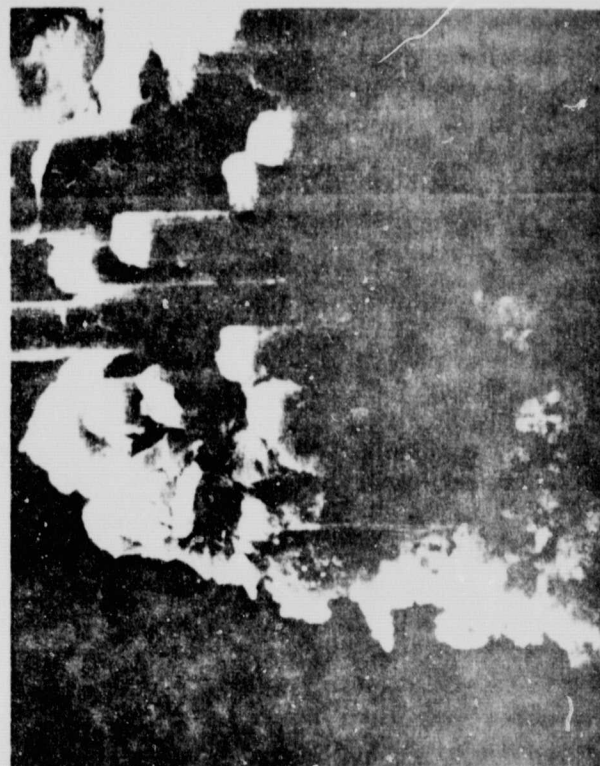
FIG. 5 — Scanning electron micrographs of failure surfaces of dry, not-postcured, polished-edge specimens. (a) batch A, tested at 250°C , (b) batch B, tested at 25°C , (c) batch A, tested at 96°C , and (d) batch B, tested at 96°C .

In an attempt to understand the mechanisms that have produced the property changes described above, we have initiated scanning electron microscopy studies on the failure surfaces of the composite specimens. Figure 5 shows typical failure surfaces for dry, polished-edge, not-postcured specimens.

One specimen from each batch A and batch B was tested at 25° and 96°C. As can be seen from this figure, the appearance of the individual broken filament is the same regardless of the temperature or batch. In fact, this holds true for typical failures at all conditions. Furthermore, there are few single filaments "pulled out" of any of the failure surfaces, and the amount of epoxy remaining on the surface of the filaments indicates that the interfacial bond in all cases is reasonably strong.

It is difficult, however, to pick out differences in the specimens which might explain the observed differences in properties. Obtaining such an explanation from the failure surfaces is complicated by a number of factors. First, the elastic recoil at failure induces significant secondary damage, which complicates failure-surface analysis. Second, there is a great deal of specimen-to-specimen variability at any one condition. Third, even for a given specimen, the differences in appearance between different areas are great. Thus, no single set of micrographs such as is shown in Fig. 5 can represent the specimens.

One difference, however, appears again and again regardless of area or specimen. The matrix in the specimens tested at 96°C shows less of the smooth, cupped, and glass-like signs of conchoidal failure than does the matrix of specimens tested at 25°C. Unfortunately, this is equally true for batches A and B specimens, so it does not explain the observed strength differences between specimens of the two batches. We hope that further microscopy will clarify these observations.
