# NASA Technical Memorandum 81907

## PRELIMINARY ARC-JET TESTS OF ABLATOR/RSI JOINTS IN SIMULATED SPACE SHUTTLE ASCENT AND ENTRY HEATING

W. D. BREWER, C. M. PITTMAN, AND  
S. S. TOMPKINS

OCTOBER 1980

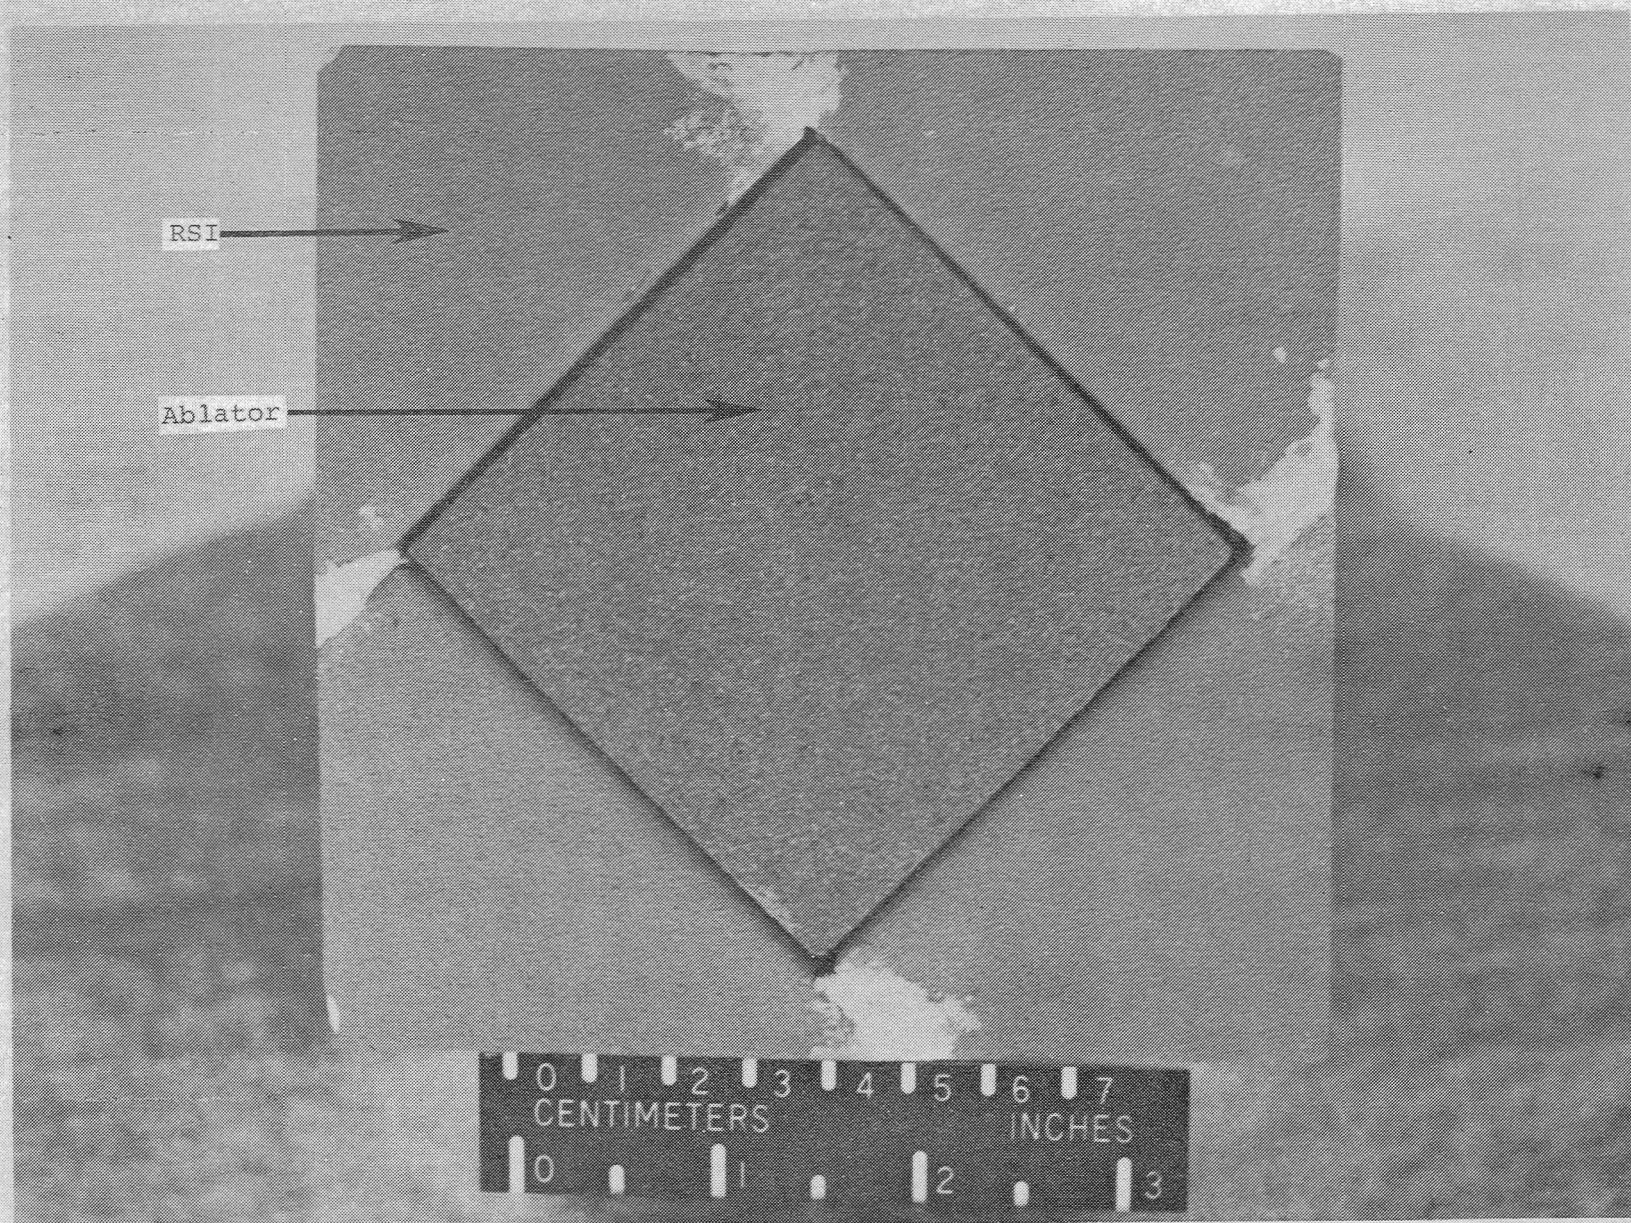
Figure 1.- Test panel before testing.

The test specimens consisted of a 3-inch square, 1-3/8-inch thick piece of ablative material surrounded by RSI, making a complete test panel 5 inches square with all heated surfaces as flush as possible (fig. 1). The ablator and the RSI were bonded directly to a 1/8 inch thick Bakelite backing sheet and were oriented so that the arc-jet gas flow was at a 45-degree angle to the ablator/RSI gaps. The gaps were unfilled and ranged in width from 0.003 inch to 0.034 inch before testing. The joints between the RSI pieces were sealed with ceramic adhesive to prevent gas flow out the sides of the test panels. However, after most of the tests, the adhesive had cracked and some flow out the joint probably occurred.

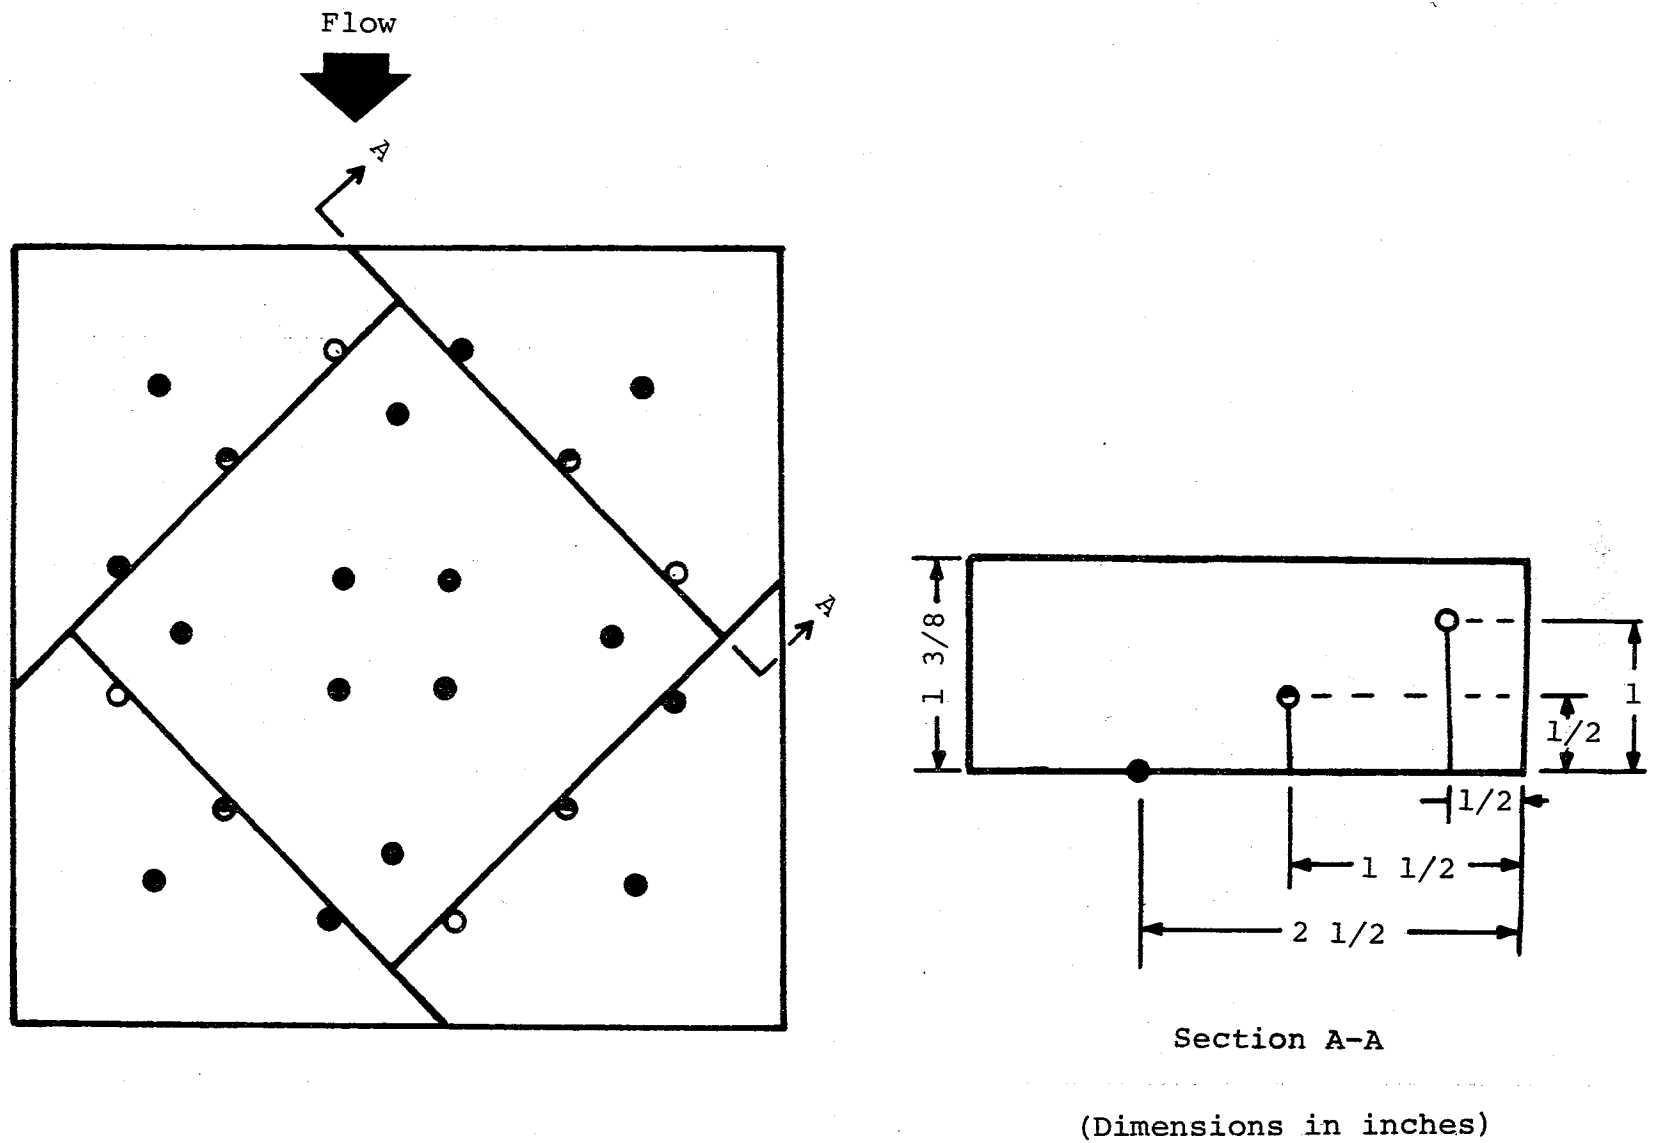
Figure 2.- Thermocouple locations for all test panels.

Each test panel was instrumented with 24 thermocouples, the locations of which are shown in figure 2. The thermocouples shown next to the ablator/RSI gaps were potted in grooves along the surface of the RSI facing the ablator. The other thermocouples were located at the back surface of the ablator and the RSI. All thermocouples were monitored continuously during the tests. The test panels were mounted on a wedge-shaped water-cooled test fixture as shown in figure 3. The test fixture was oriented in the arc-jet so that the surface of the test panel was at a 32-degree angle-of-attack with respect to the gas flow.

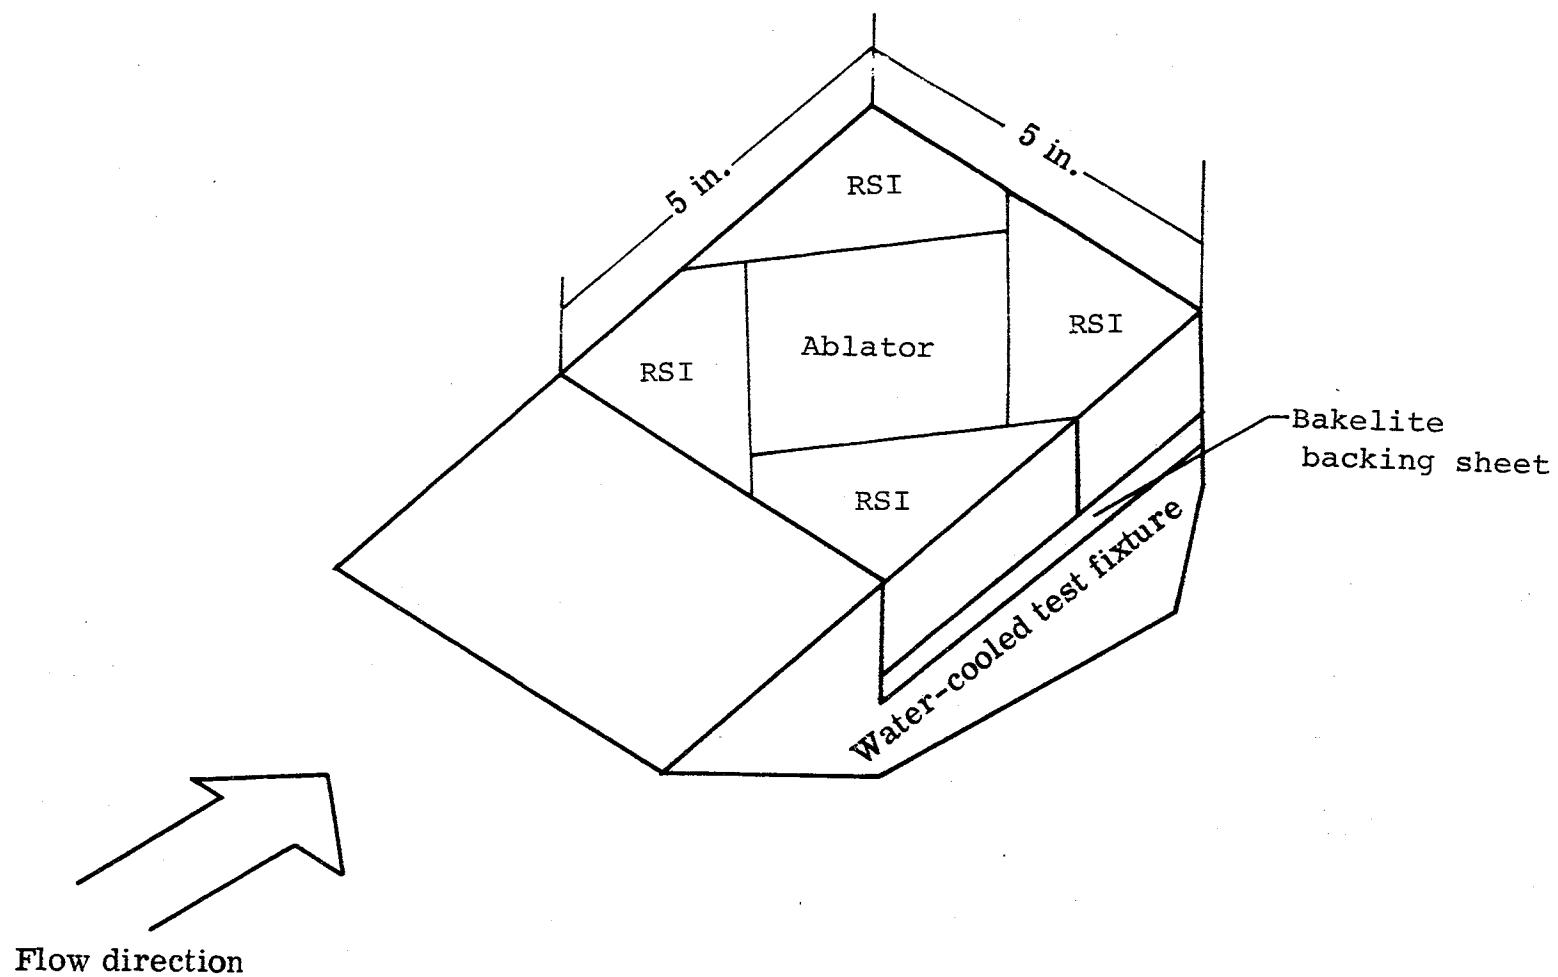
Figure 3.- Test panel and test fixture configuration.

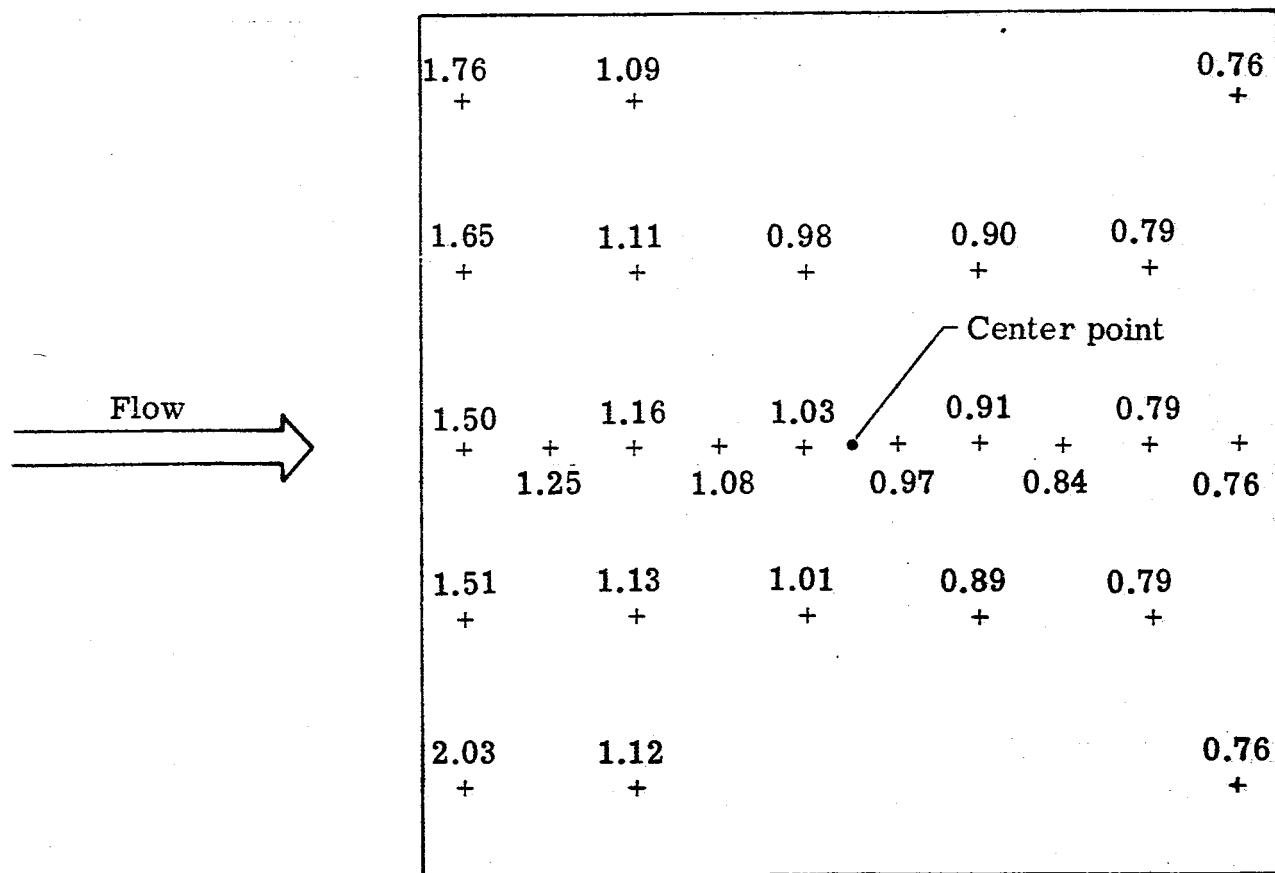
Figure 4.- Typical heating rate distribution normalized to center point.

All tests were conducted in the supersonic arc-powered tunnel, designated Apparatus B of the Langley Entry Structures Facility. Details of the arc-jet facility are given in reference 2. Heating rates to the panels were determined with a 5-inch square, thin-skin calorimeter and pressures were measured with pressure transducers attached to small orifices in a 5-inch square copper plate. Heating rate and pressure distributions over the test panels are shown in figures 4 and 5, respectively. All tests were in air.

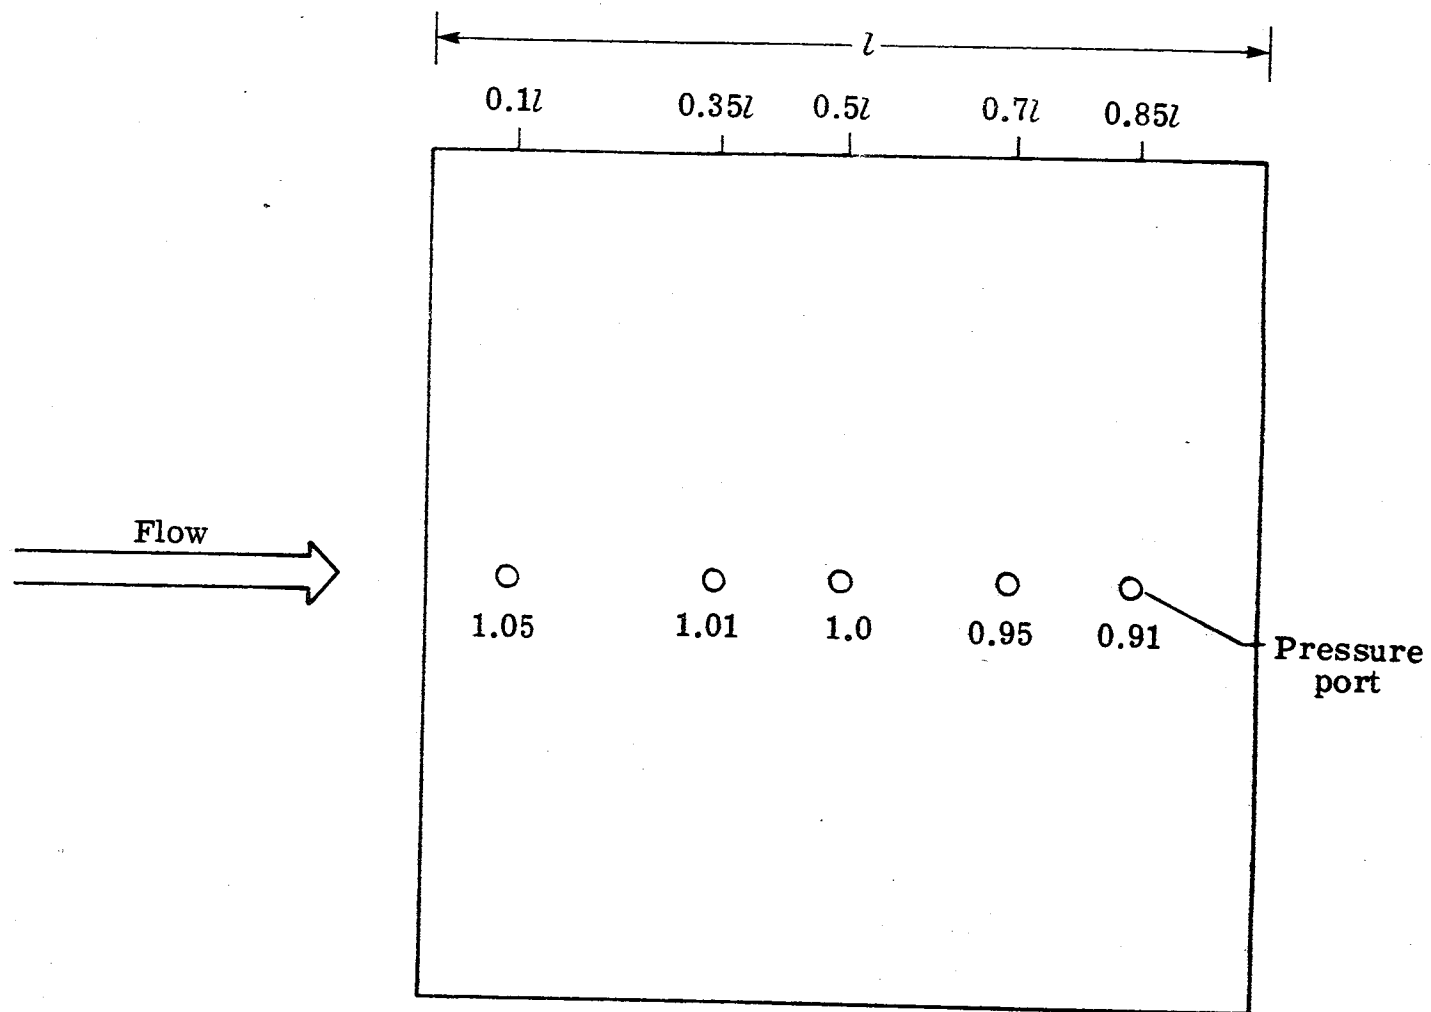
Figure 5.- Typical pressure distribution normalized to center point.

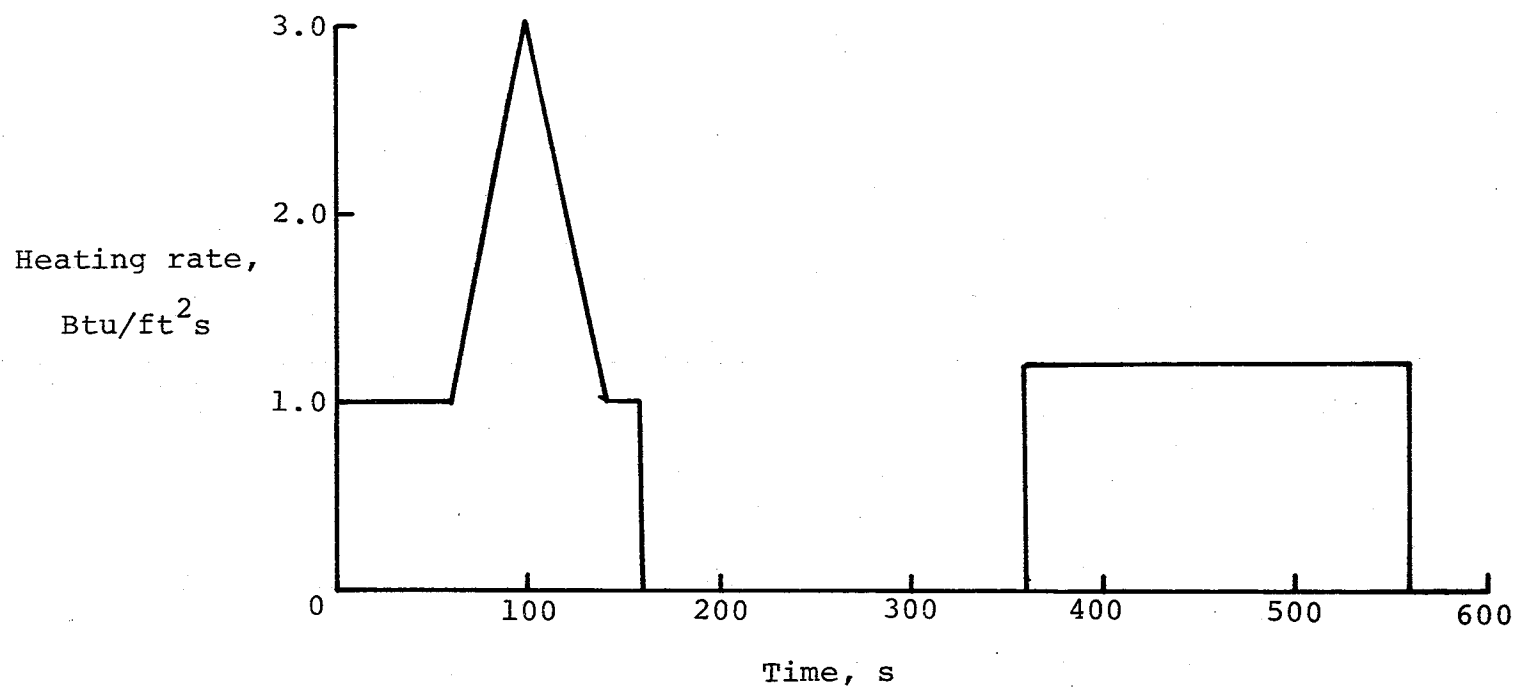
Figure 6.- Arc-jet simulation of Orbiter ascent heating-body point 1030.

Five panels were tested, two of which were subjected to ascent heating as well as entry heating and three of which were subjected to entry heating only. The ascent heating pulse used is shown in figure 6. This pulse corresponds to the heating environment at orbiter body point 1030. Entry heating was simulated by a constant heating rate of either 17 or 20 Btu/ft<sup>2</sup>-s. The test conditions are summarized in Table 1. The test section pressure was only about 0.0026 atm. Therefore, from the corners of the ablator through the RSI/RSI joint a pressure gradient of about 1.0 psi/inch existed. This pressure gradient is extremely severe compared to pressure gradients on the shuttle heat shield.

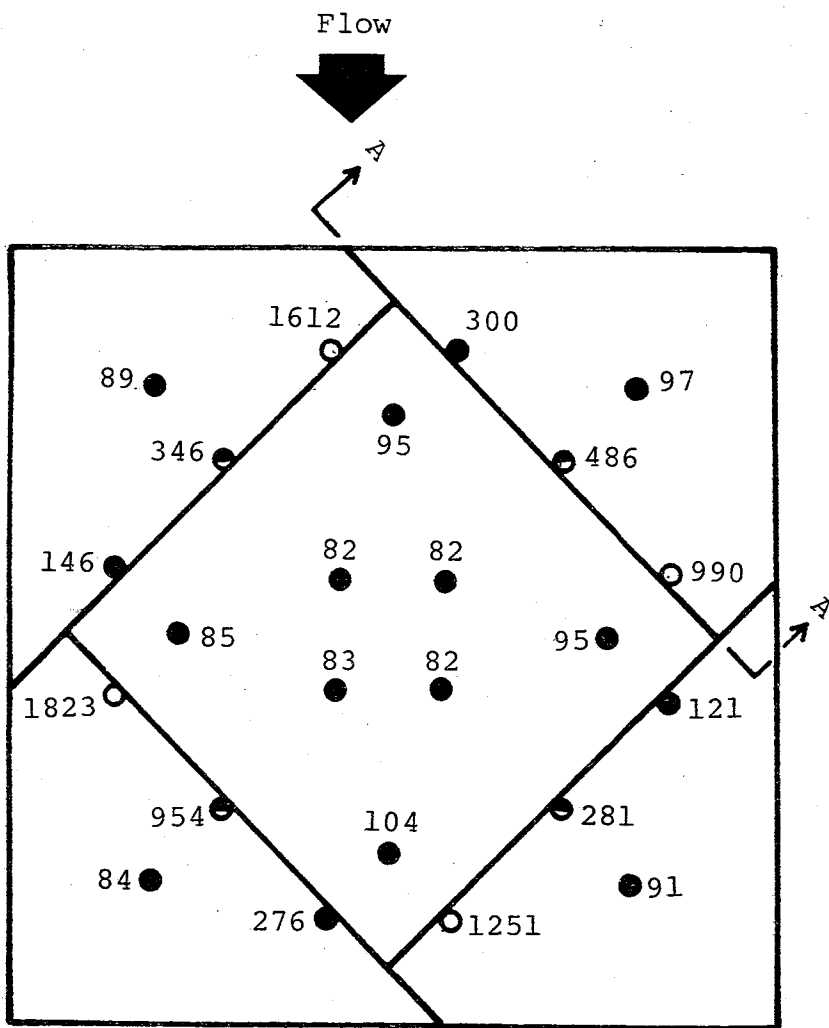
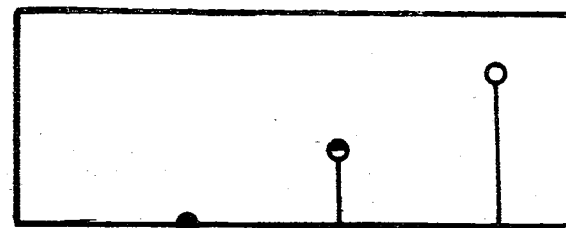
(a) Panel no. 1, SLA-561  
Ascent plus 236s entry at 17 Btu/ft<sup>2</sup>s

Figure 7.- Measured temperatures at end of entry heating test, F.

Figure 7(a) shows the temperatures in panel 1 (SLA-561). The test of this panel was terminated prematurely at 236 s because of a facility malfunction. In general, the temperatures beneath the ablator were lower than those beneath the RSI, indicating that the thermal performance of the ablator is satisfactory (at least as good as that of the RSI) for the application of interest. The highest temperature at the base of a gap was 300°F (nearest the panel leading edge) which was about 205°F higher than the back surface temperatures at nearby locations. The differences between gap temperatures and temperatures beneath the ablator and RSI ranged to a low of 26°F. In this test, the ablator/RSI gaps did not appear to present any particular problem.

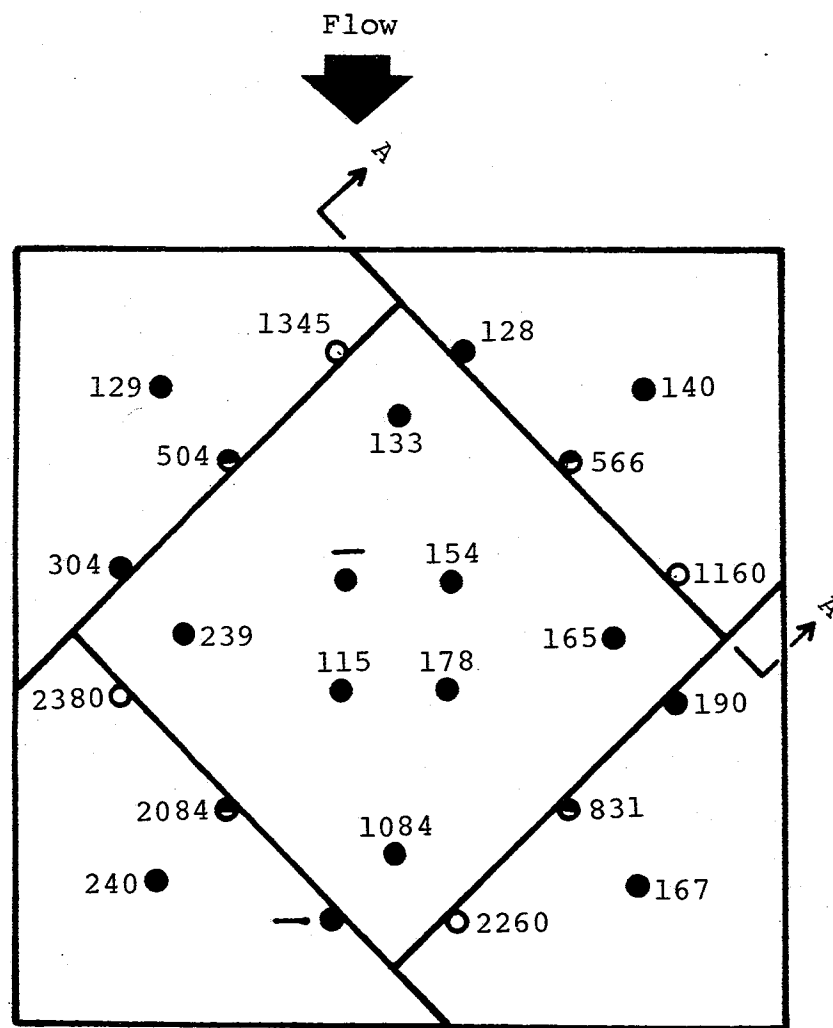
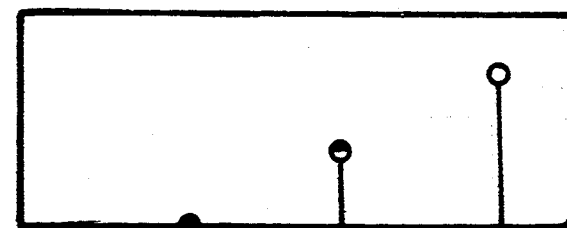
(b) Panel no. 2, SLA-561.  
Ascent plus 550s entry at  $17 \text{ Btu/ft}^2\text{s}$

During entry testing, panel 2 (figure 7(b)) developed a gas leak where the thermocouple wire went through the Bakelite near the trailing corner of the ablator and allowed gas flow down into the model holder in that area. The increased heating caused the high temperatures shown in the figure and, in fact, burned through the Bakelite located at the base of the gap. The temperatures away from the burn-through area, however, were not excessive and in those areas the test panel again performed reasonably well. Given the severe pressure gradients that developed when the leak occurred, a porous type gap filler would probably not have completely prevented the gas flow into the gaps and the subsequent high temperatures.

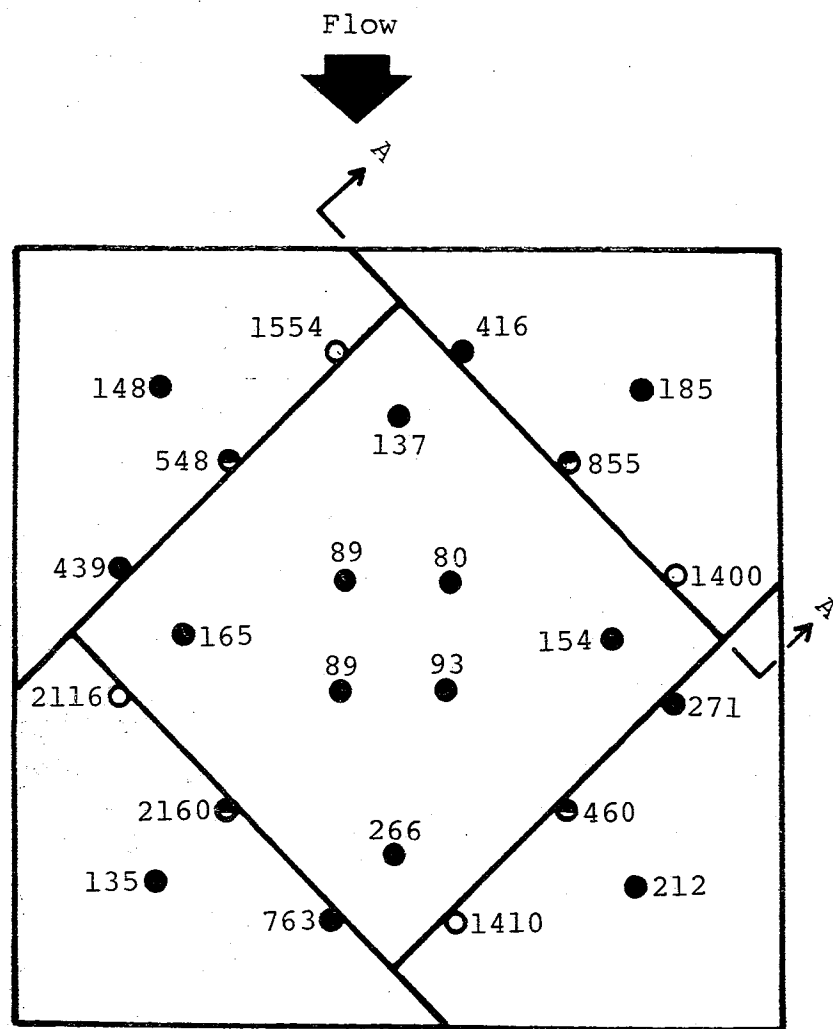
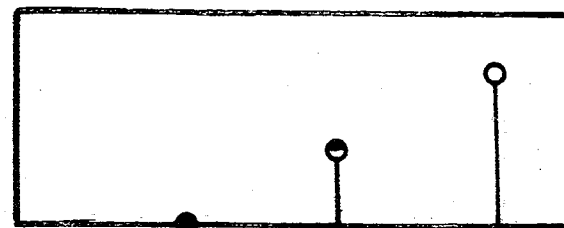
(c) Panel no. 3, SLA-561  
500s entry at  $17 \text{ Btu/ft}^2\text{s}$

The temperatures along gap 4 of panel 3 (see fig. 7(c) and Table 2) were somewhat higher than the corresponding temperatures

in other panels because the ablator was apparently recessed slightly with respect to the RSI initially, creating a small forward facing step at the ablator/RSI gap near the panel trailing edge. The temperature at the base of the gap in this area was about 500°F greater than nearby ablator back surface temperatures, whereas temperatures within the other gaps were less than 300°F greater than surrounding back surface temperatures. The higher temperatures in panel 3 did not produce any noticeable gap perturbations.

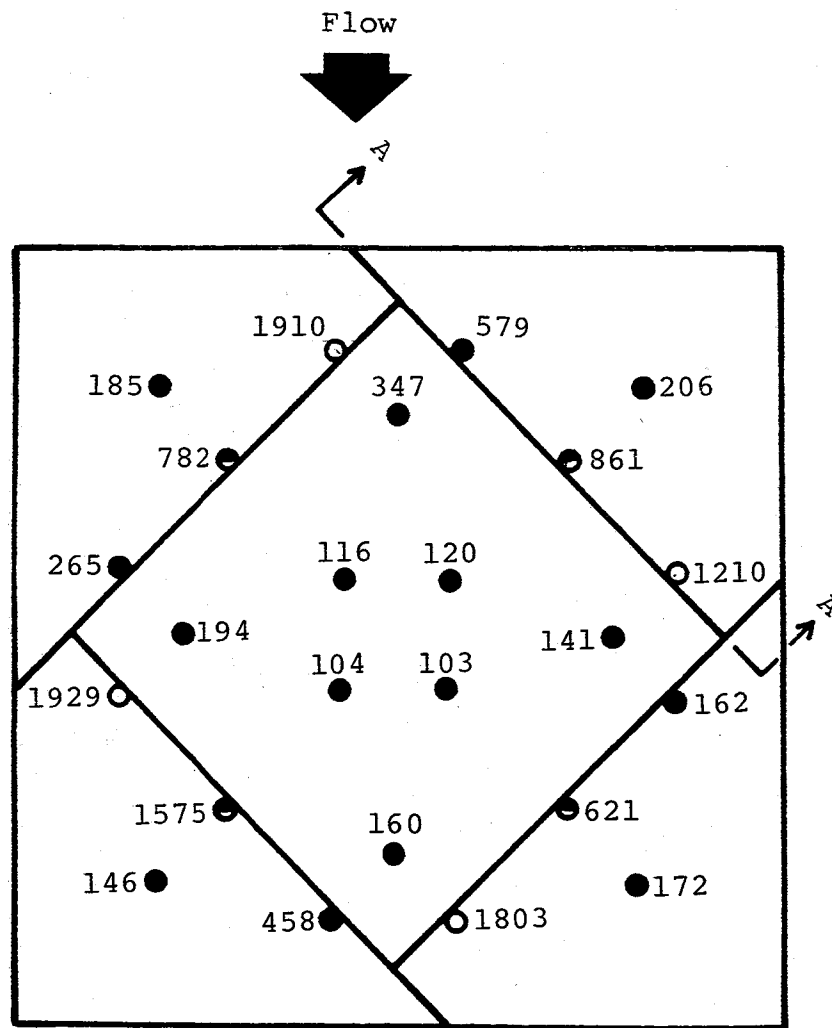
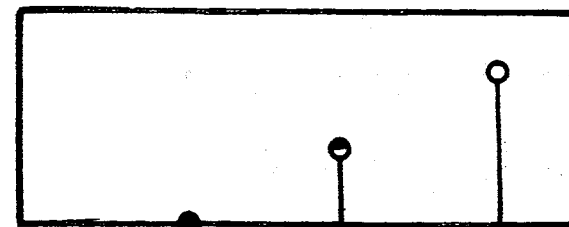
(d) Panel no. 4, SLA-561  
400s entry at 20 Btu/ft<sup>2</sup>s

The fourth SLA-561 panel was tested at a higher heating rate (20 Btu/ft<sup>2</sup>-s) than the other SLA 561 panels and in general, higher back surface temperatures were recorded (fig. 7(d)). The differences in temperatures at the base of the gaps and at nearby back surface locations were not appreciably different than for the panels tested at the lower heating rate. Again, no correlation was apparent between gap width and temperatures within the gaps.

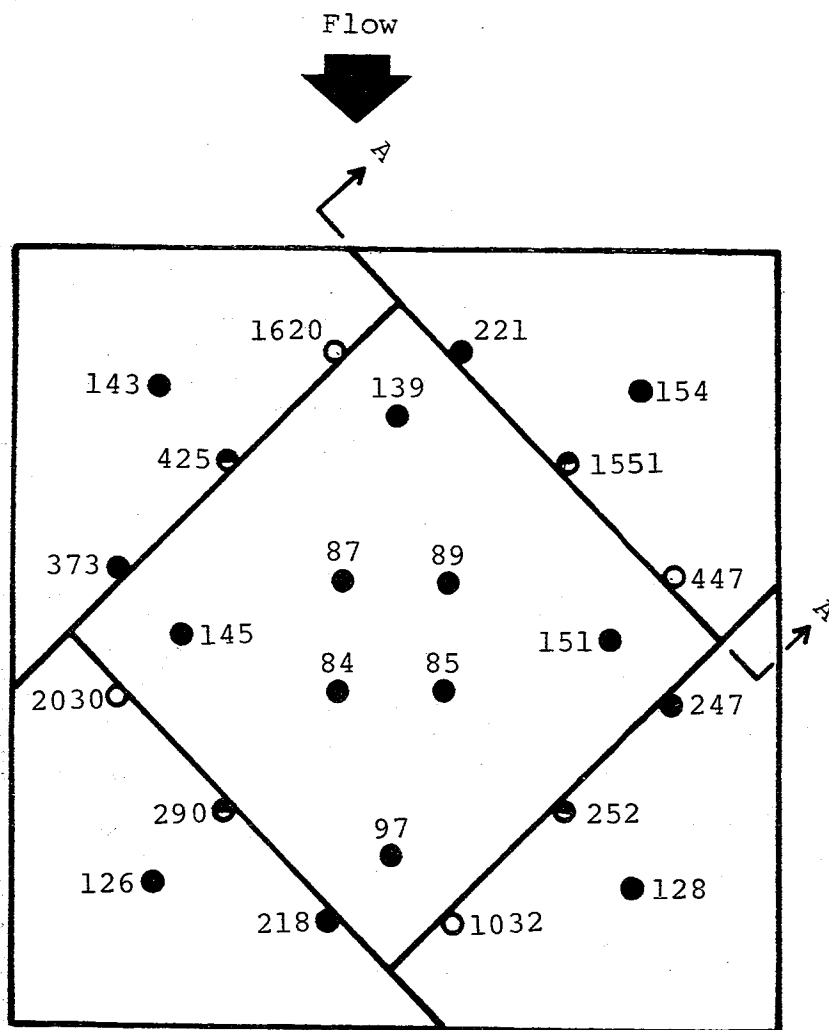
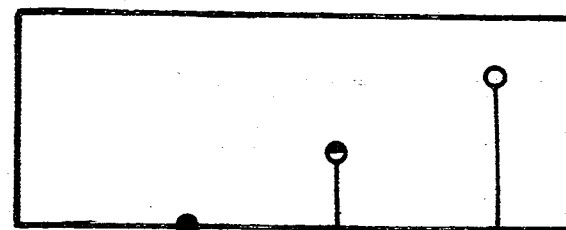
(e) Panel no. 5, ESA-3560  
400s reentry at 20 Btu/ft<sup>2</sup>s

Figure 7(e) shows the temperatures at the end of entry testing of panel 5 (ESA-3560). One anomaly in the data is that the thermocouple nearest the front surface in gap 2 indicated a lower temperature than did the deeper thermocouples. The reason for this behavior is not known. Otherwise the panel performed well and as expected with the temperatures at the base of the gaps ranging from 82 to 230 °F higher than surrounding back surface temperatures.

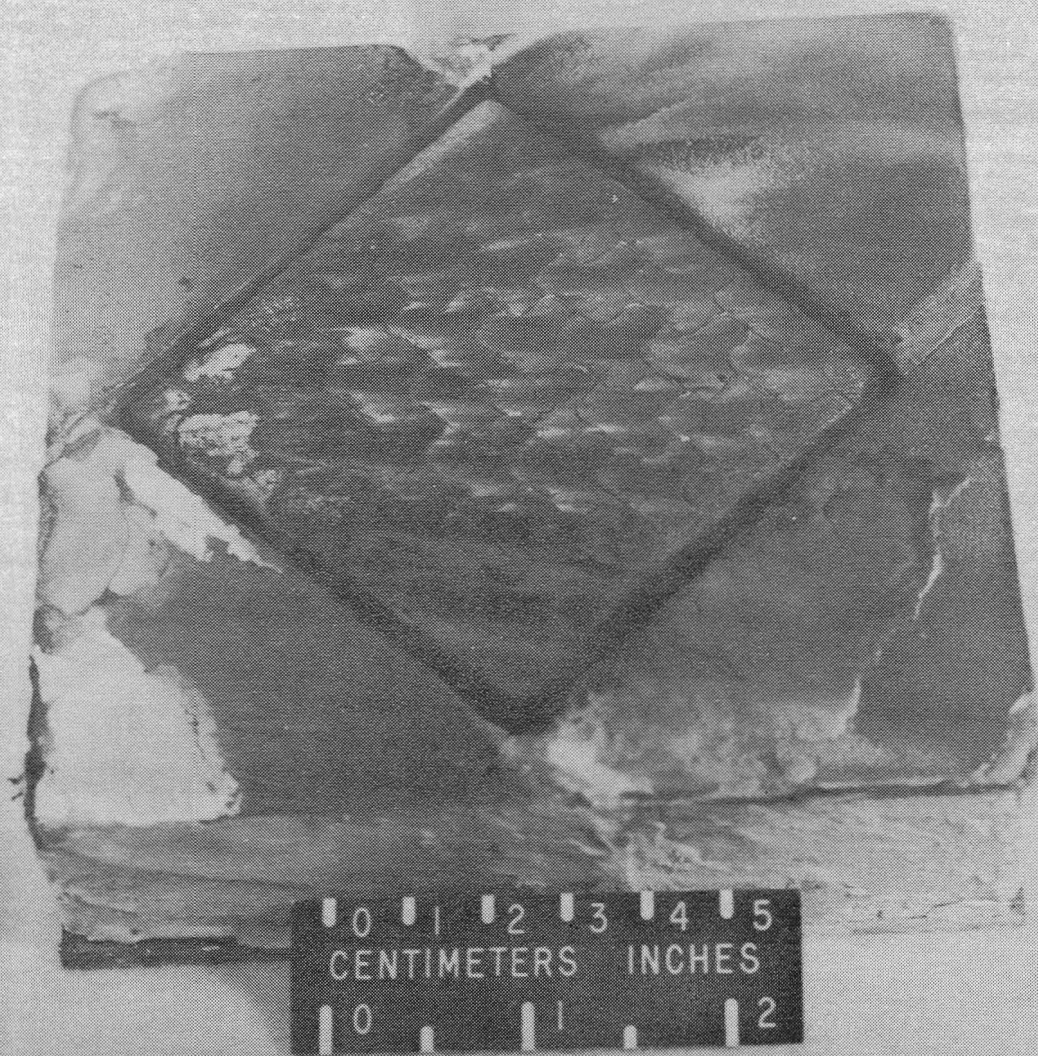
Figure 8.- Panel no. 4, SLA-561 after 450s entry test at 20 Btu/ft<sup>2</sup>s.

Photographs of panels 4 and 5 after entry testing are shown in figures 8 and 9, respectively. The extensive damage to the RSI was done in a prior test when the arc-jet developed a water leak and the surface of the test panel was exposed to high velocity steam. Because of the limited supply of RSI, the damaged material was patched and reused.

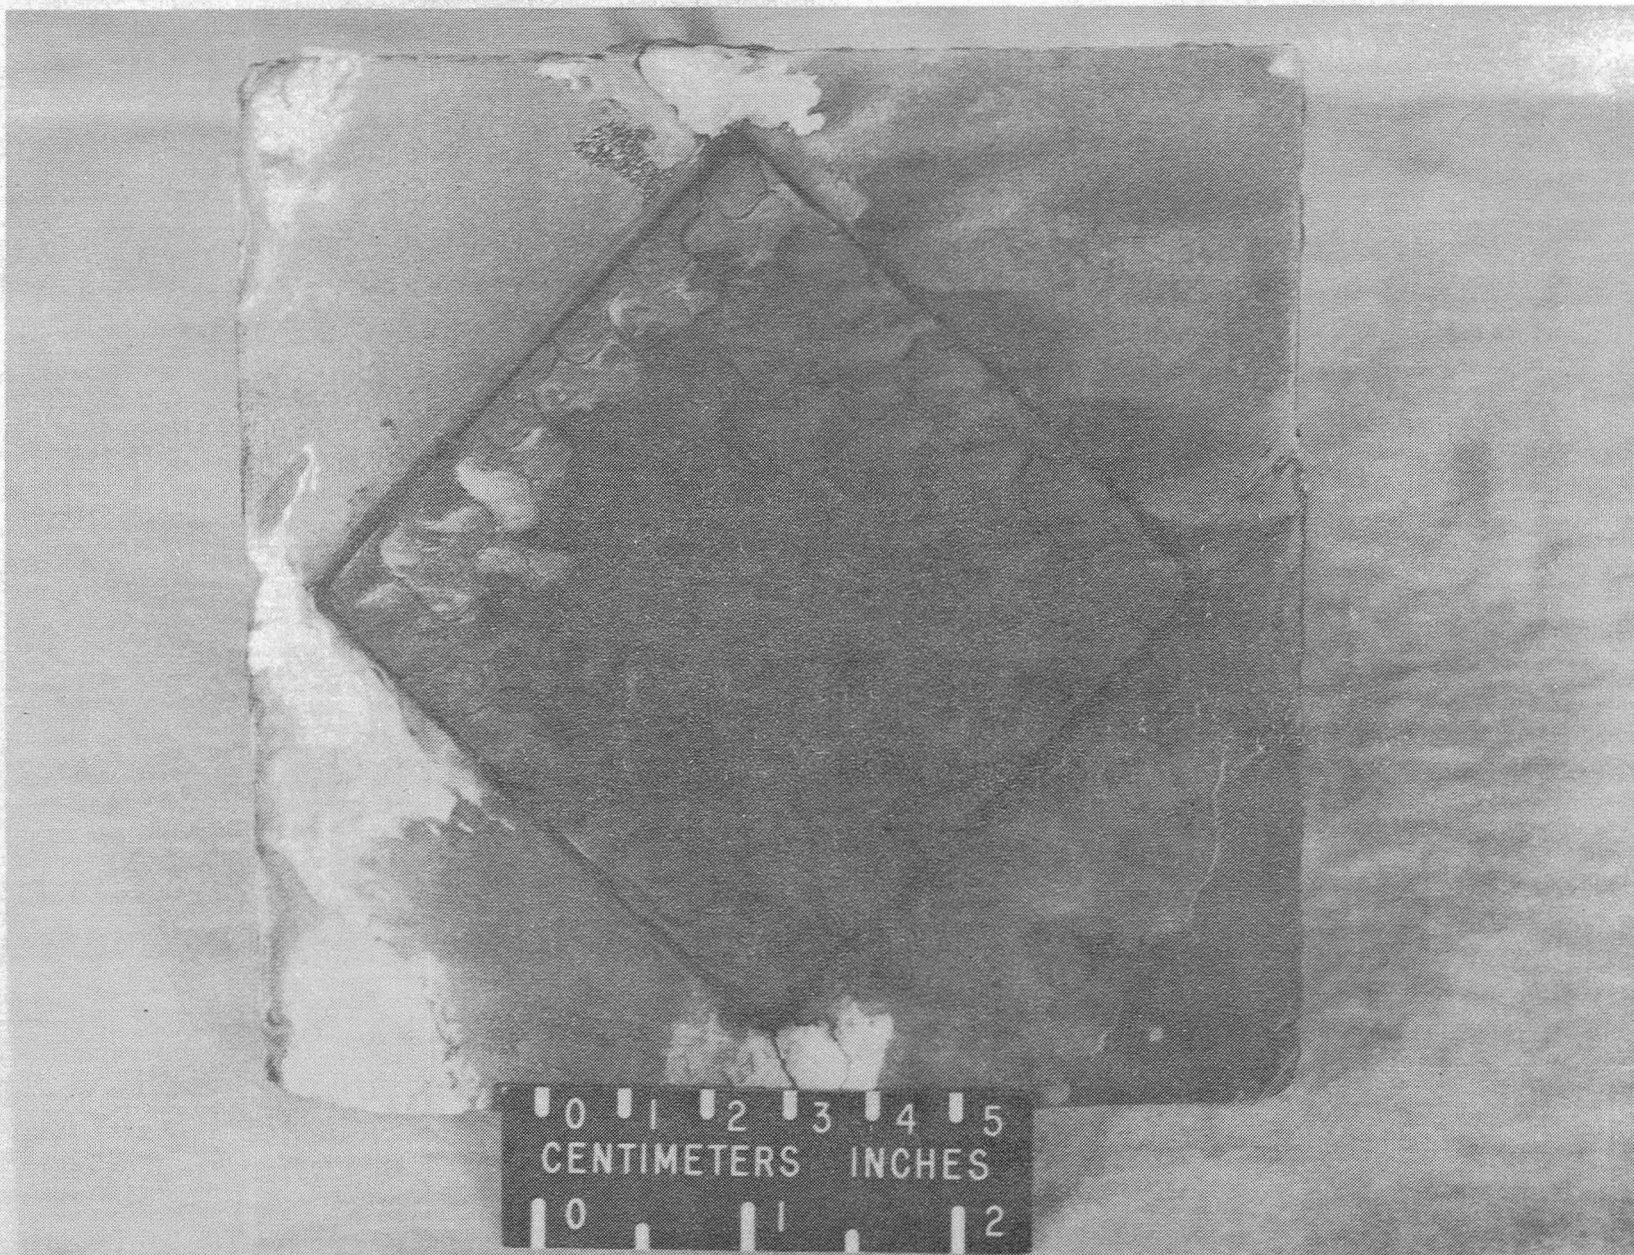
Figure 9.- Panel no. 5, ESA-3560 after 400s entry test at 20 Btu/ft<sup>2</sup>s.
